Damage to the 9-ft Tunnel at Mud Mountain Dam

Northwest Regional Technical Forum
August 7, 2008

Presented by: CENWS-EC-TB-HH
Douglas D. Knapp, PE

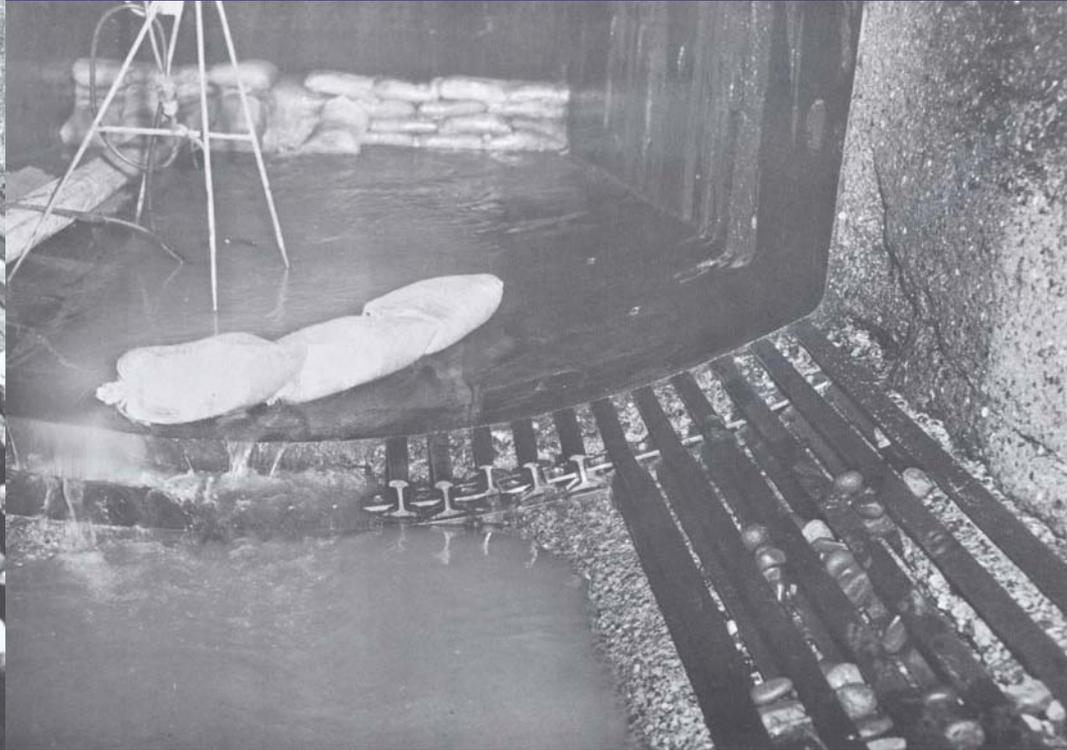
- Periodic Inspection No. 1 (1968)
- Damage due to abrasion starting at the rail interface

M M Dam #4626 Upstream View of the Upstream End of 9 foot Tunnel at Transition from Liner to Rails.
Note Cavitation at Junction of Liner and Rails

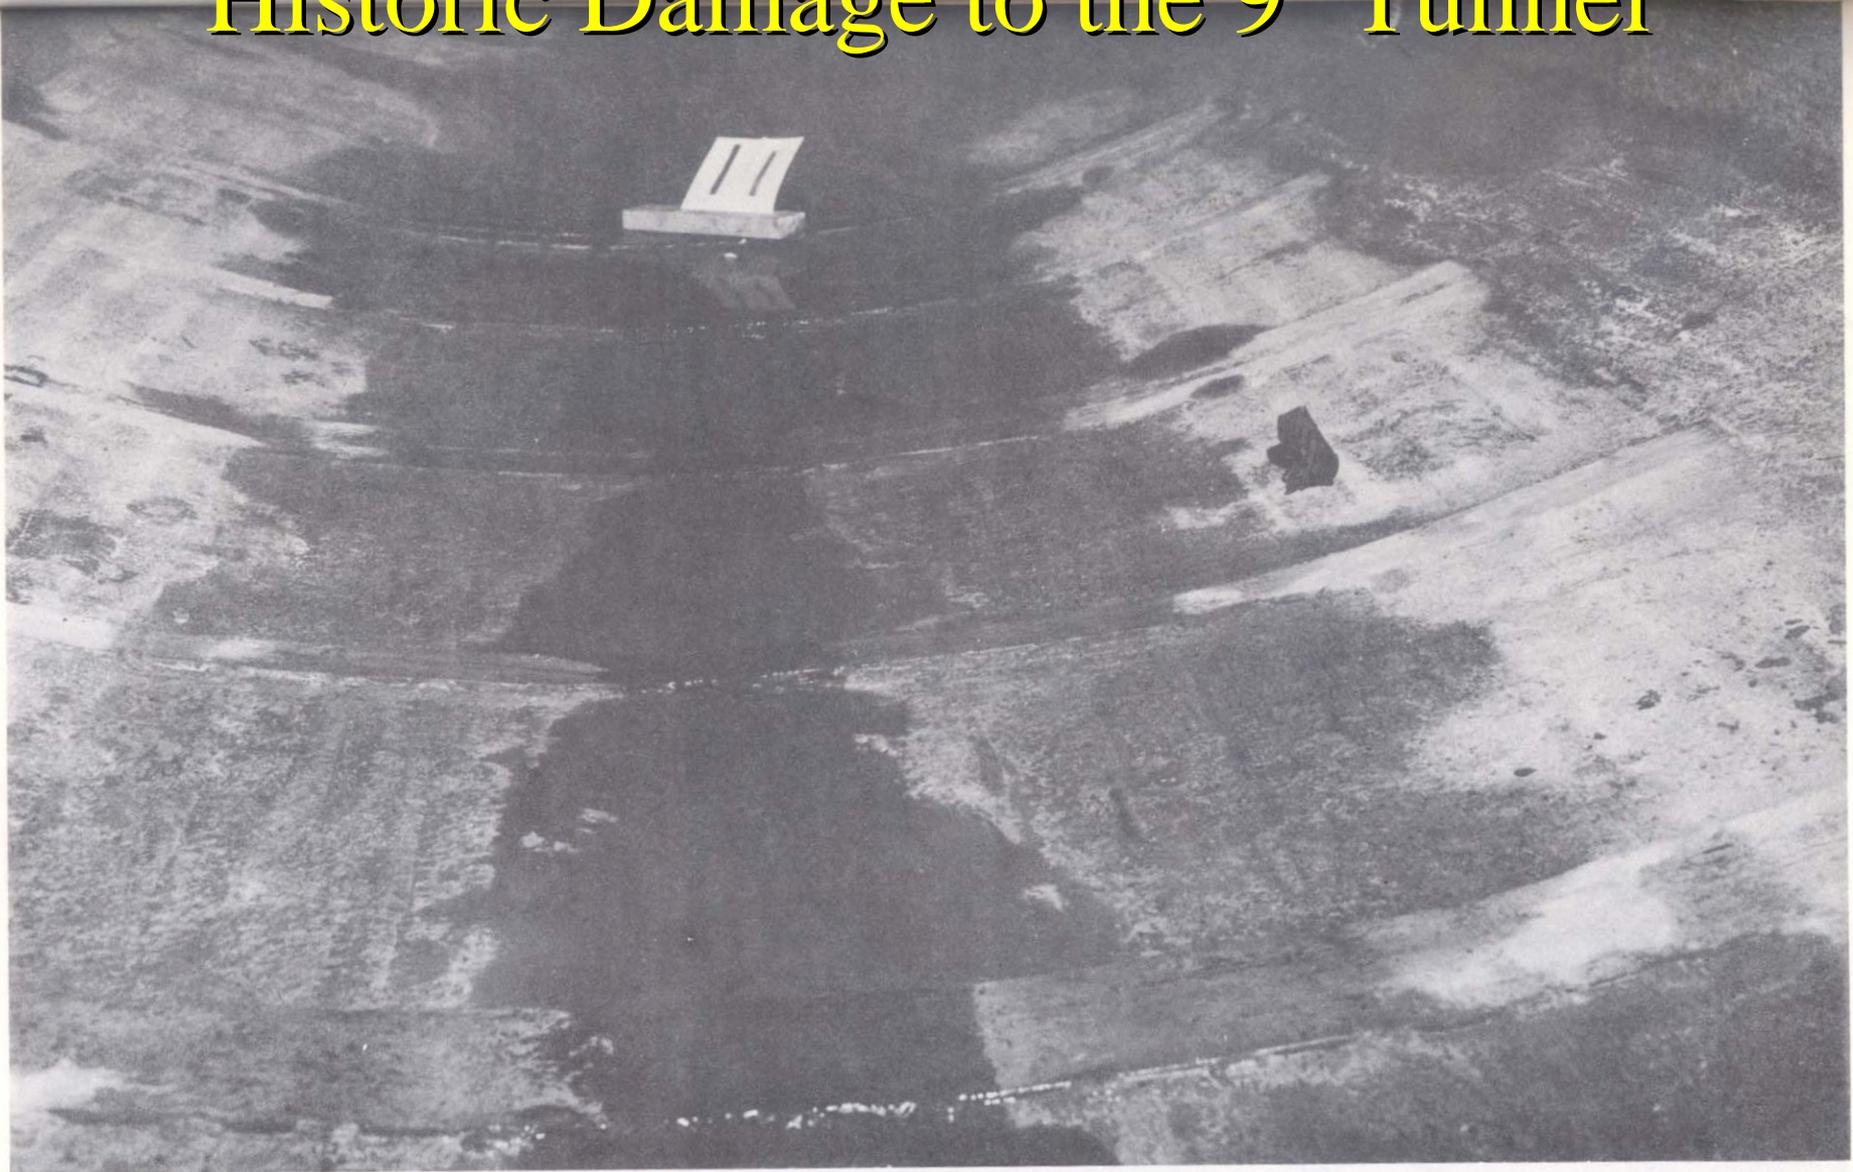
M M Dam #4873 - View of Nine Foot Tunnel Test Section Showing 1/2" X 3" Flat Bars Welded to Rails Before

Exposure to Abrasion - 8 Jan 1971

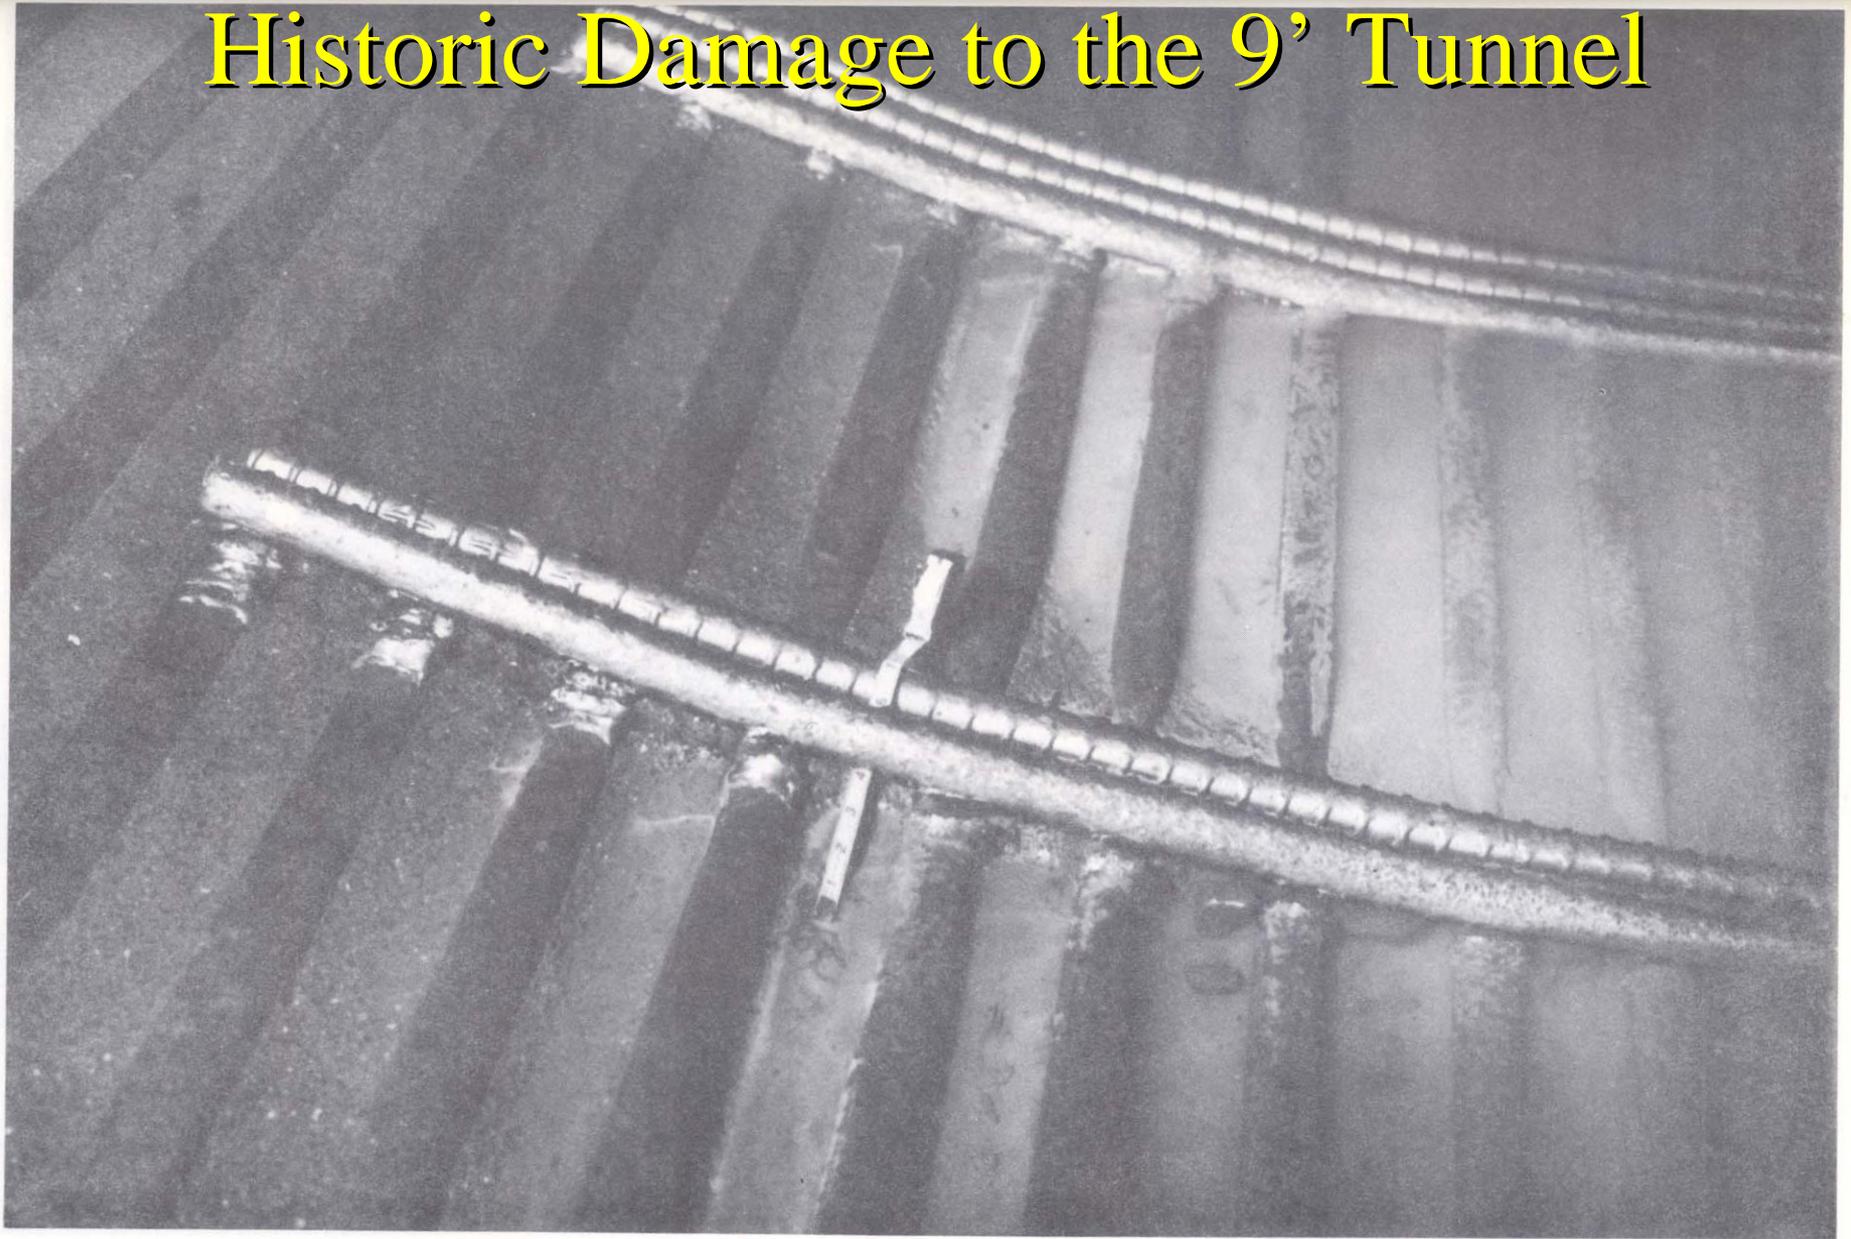
M M Dam #4955 - View of Nine Foot Tunnel Test Section Showing #11 Reinforcing Bars Welded to Rails After Exposure to Abrasion - 8 Sept 1971

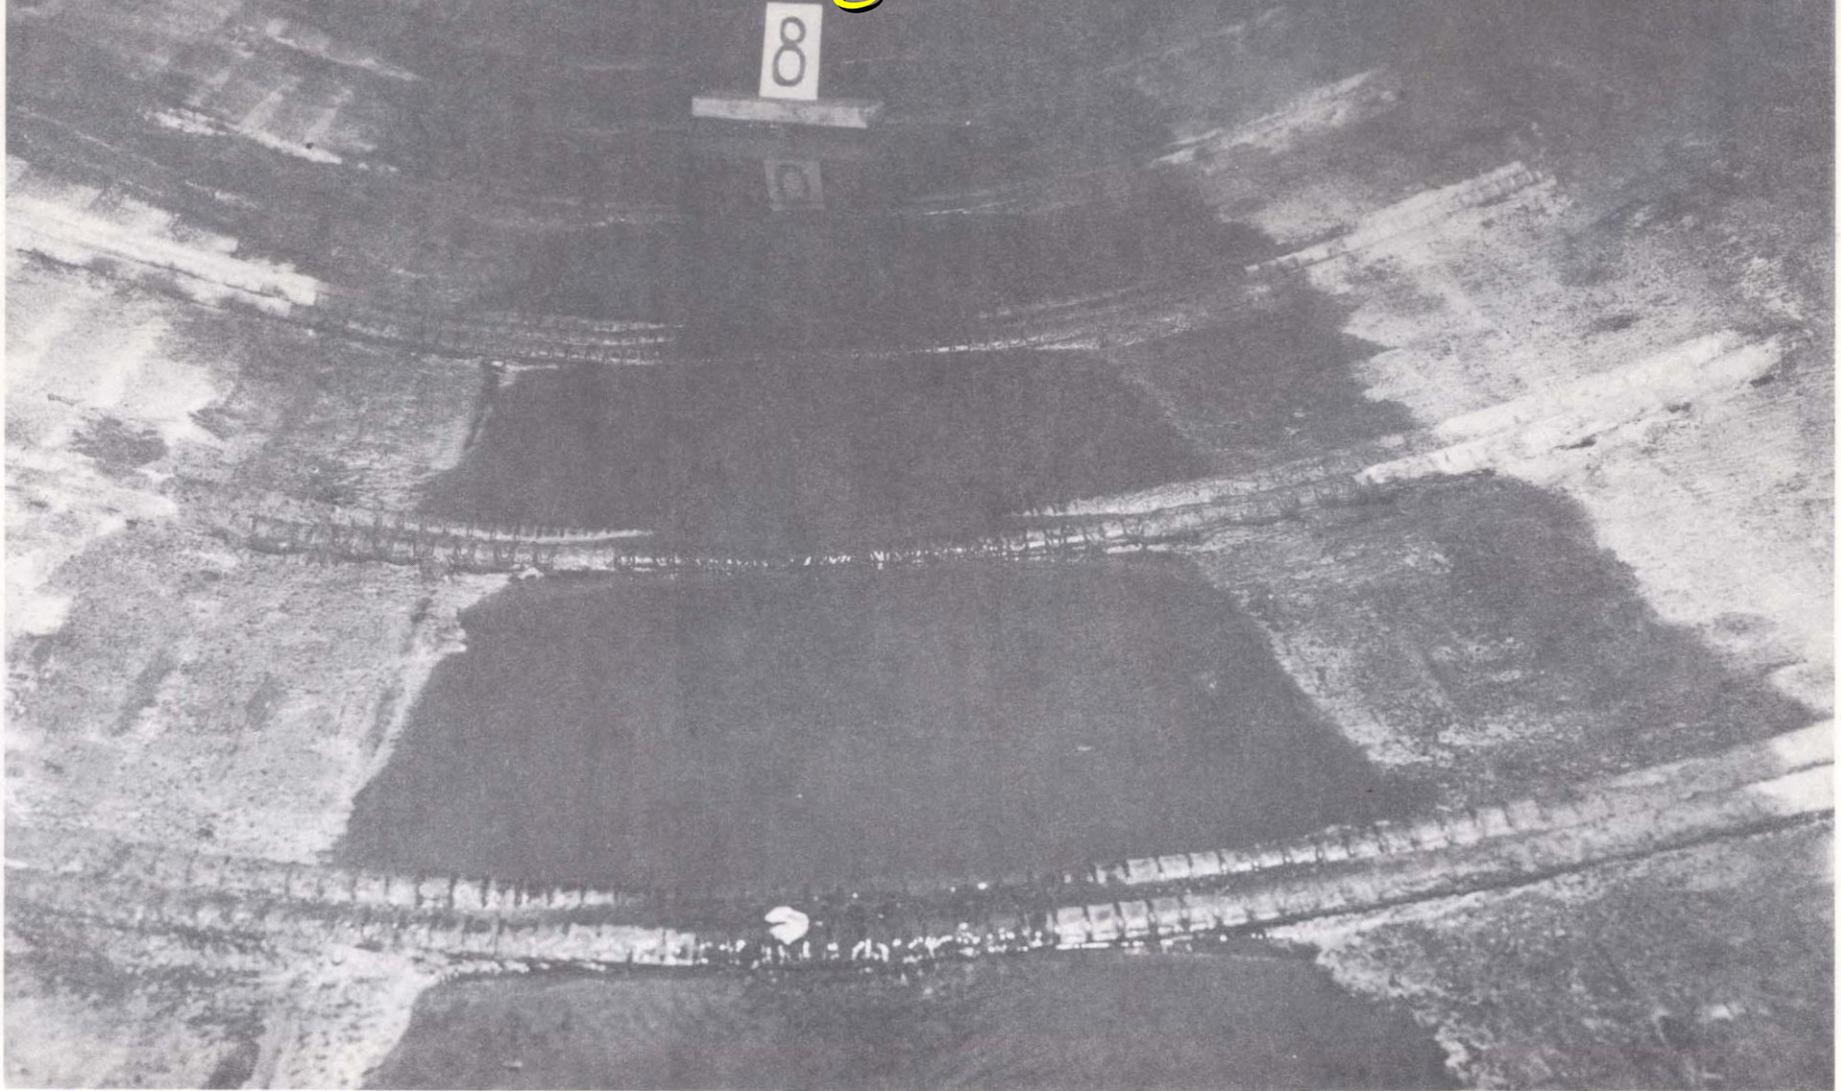
M M Dam #4870 - View of Nine Foot Tunnel Test Section Showing #11 Reinforcing Bars Welded to Rails Before Exposure to Abrasion - 8 Jan 1971

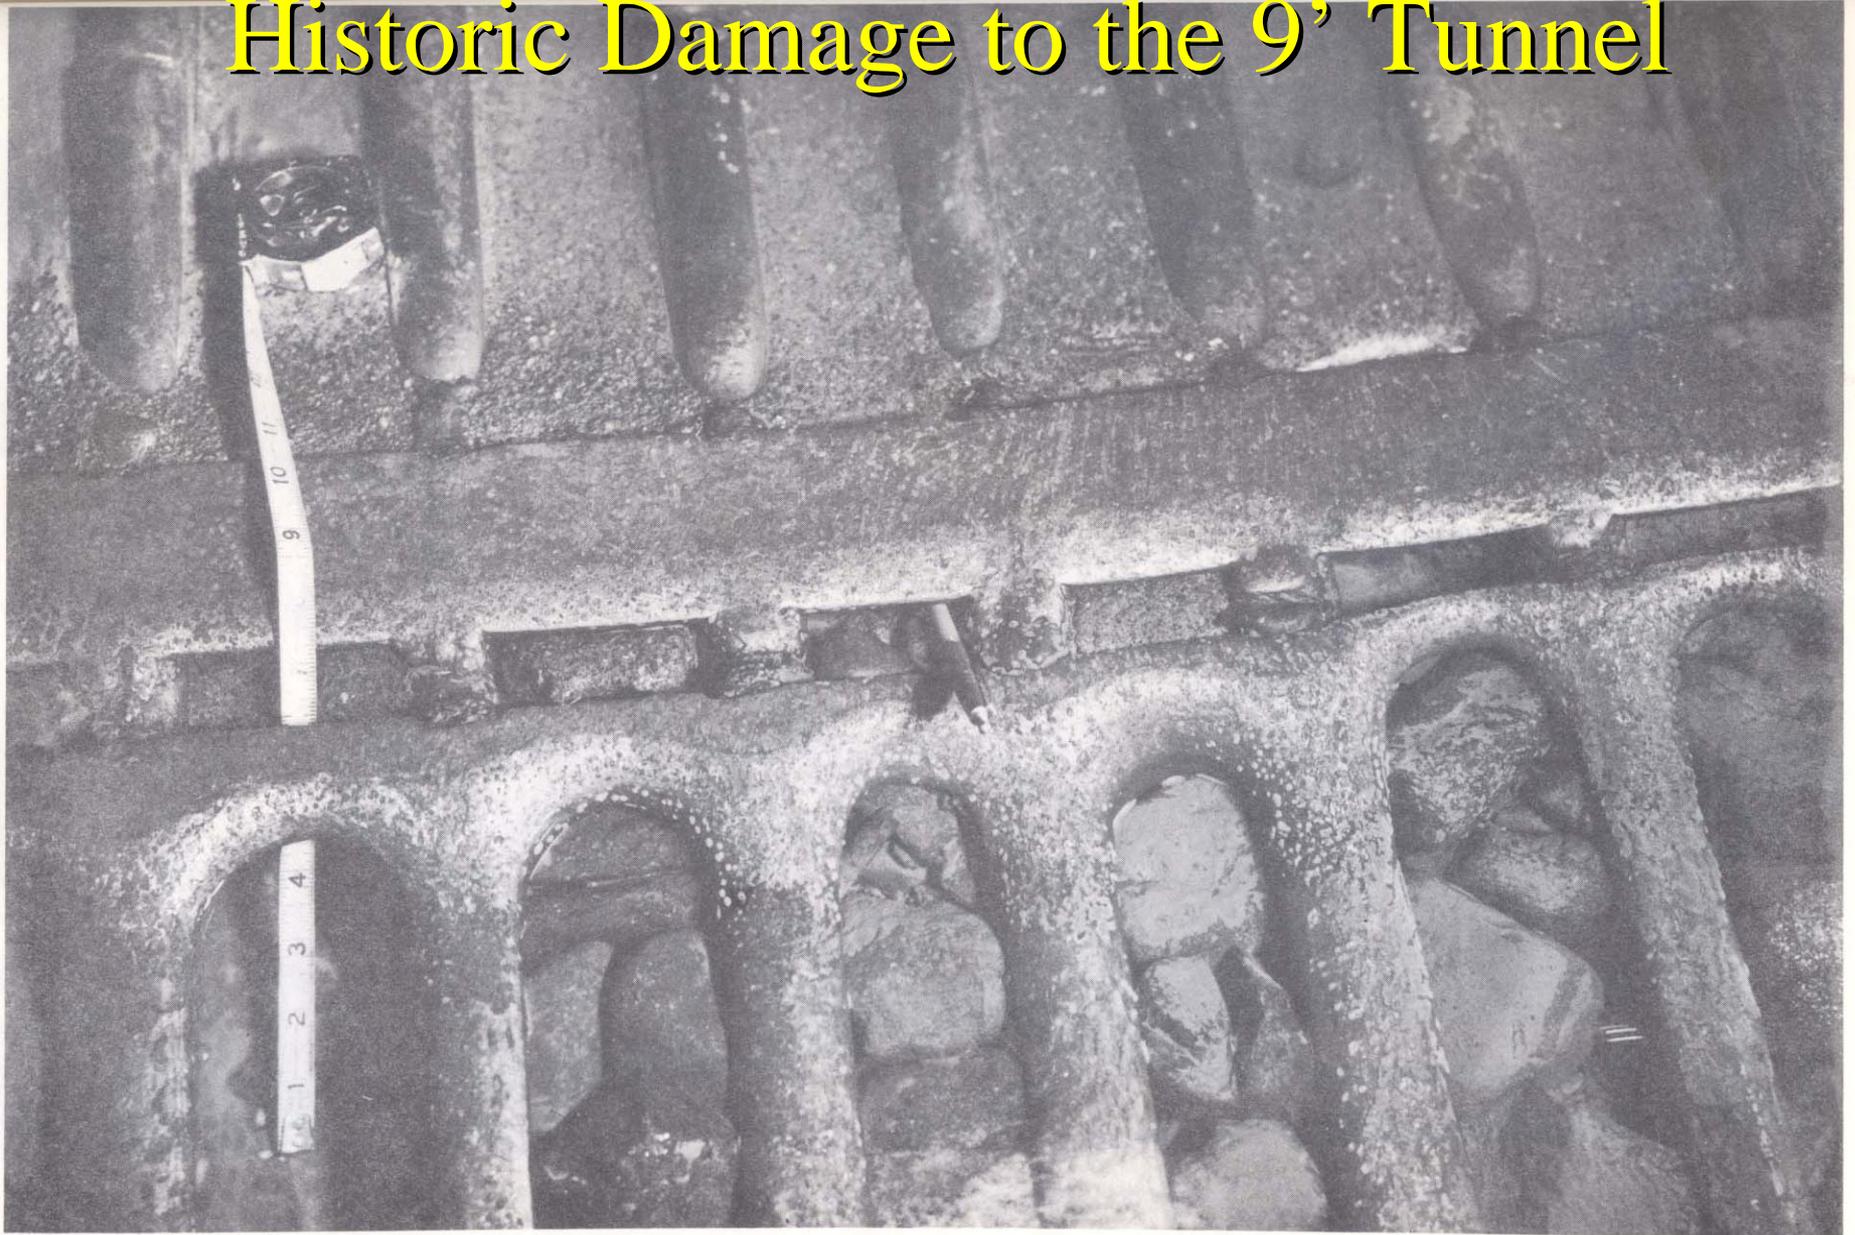
M M Dam #4962 - View of Nine Foot Tunnel Test Section Showing 1/2" X 3" Flat Bars Welded to Rails After Exposure to Abrasion - 8 Sept. 1971

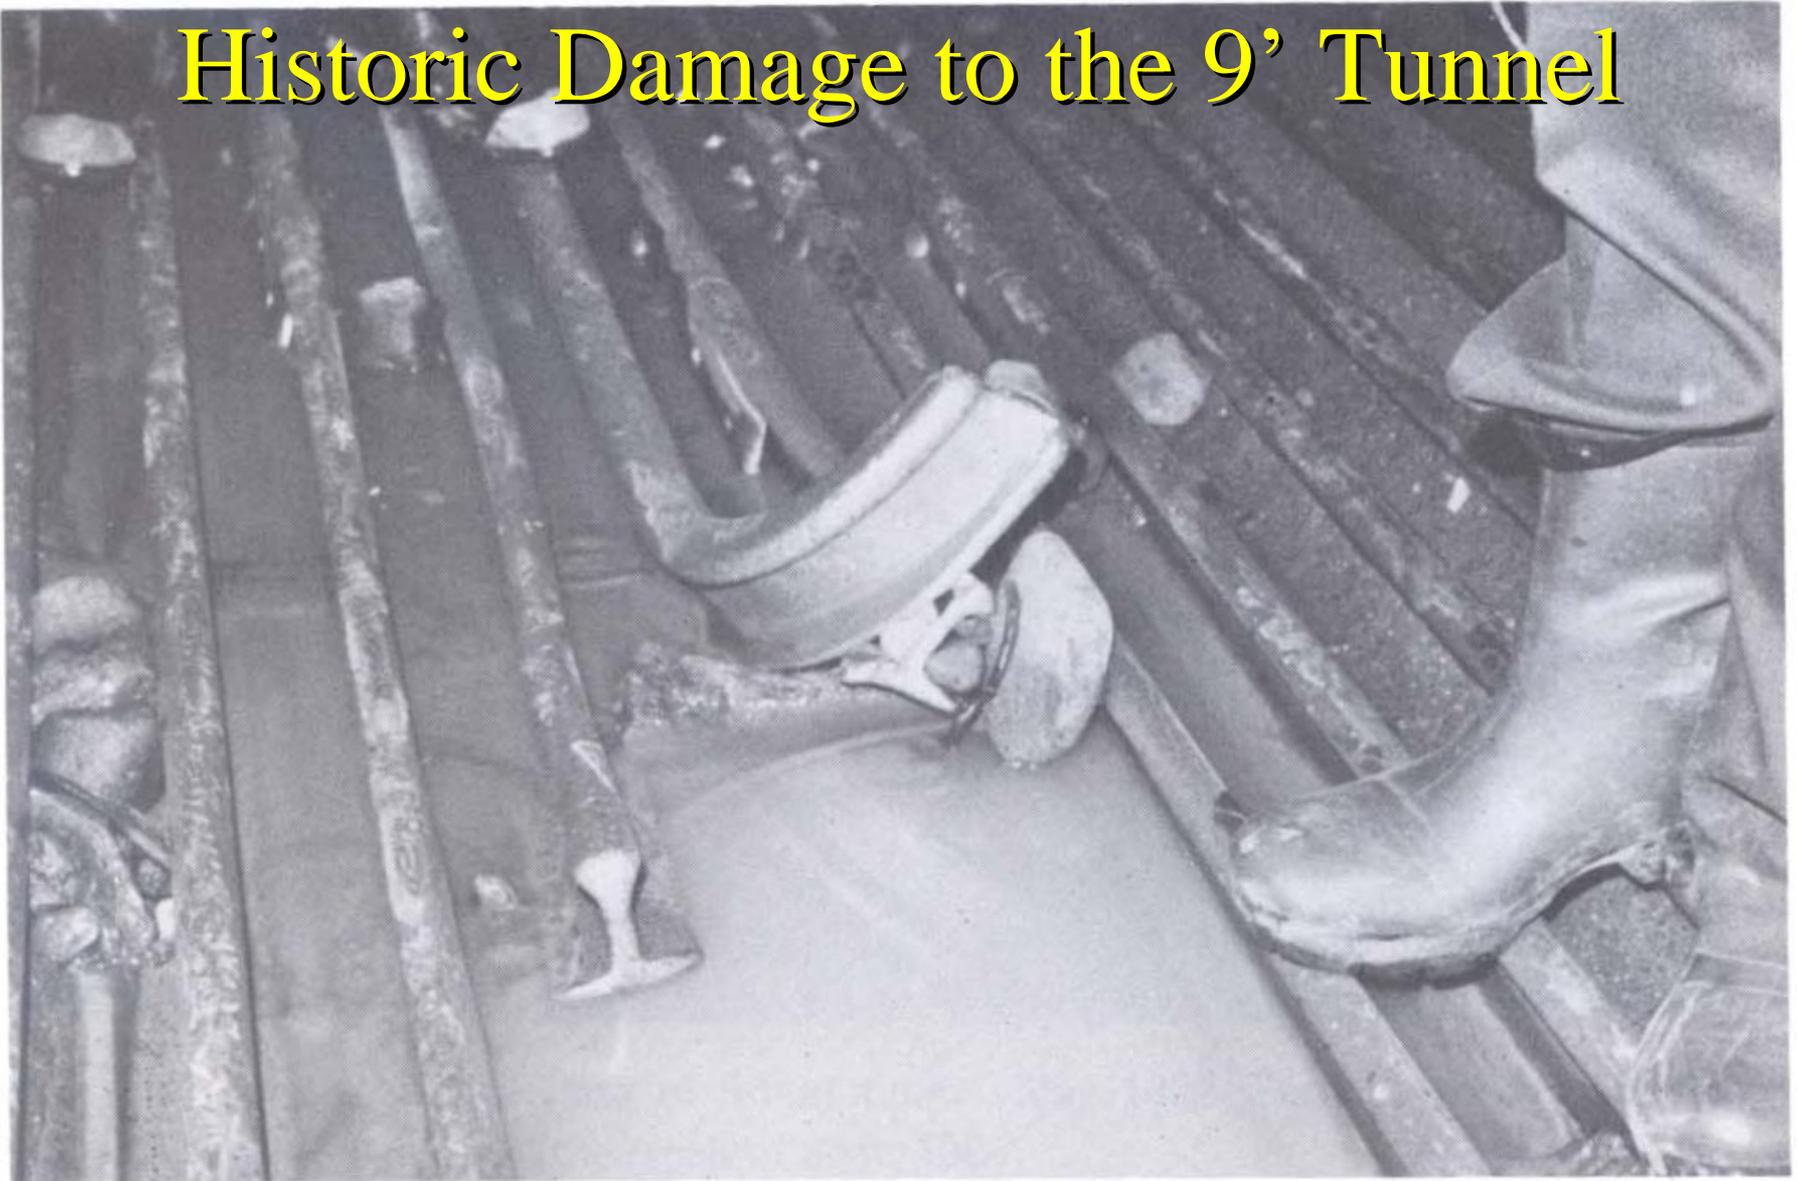
Photo 9 Condition of floor of 9-foot tunnel, July 1981, prior to repair performed in September 1981.

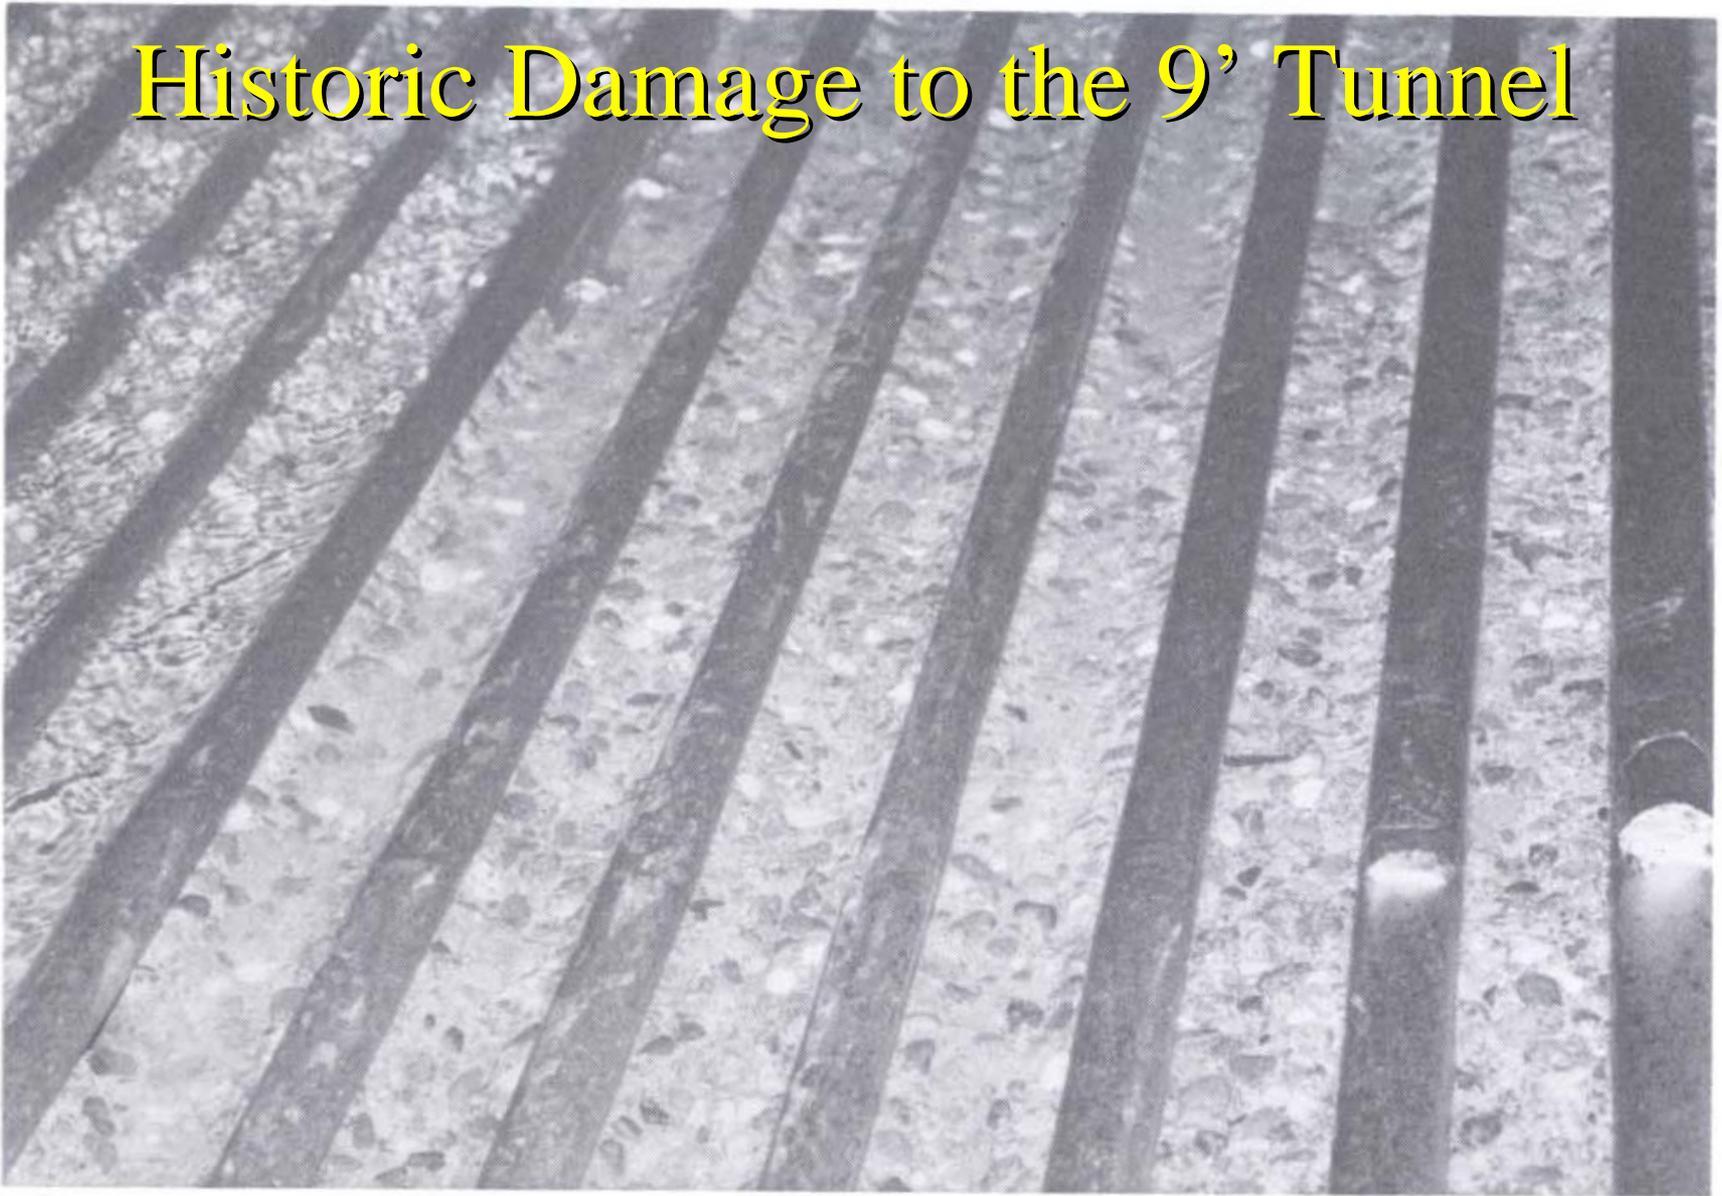
Photo 11 Condition of floor of 9-foot tunnel, May 1982. Section where concrete was placed between rails during the repair of Sept. 1981.

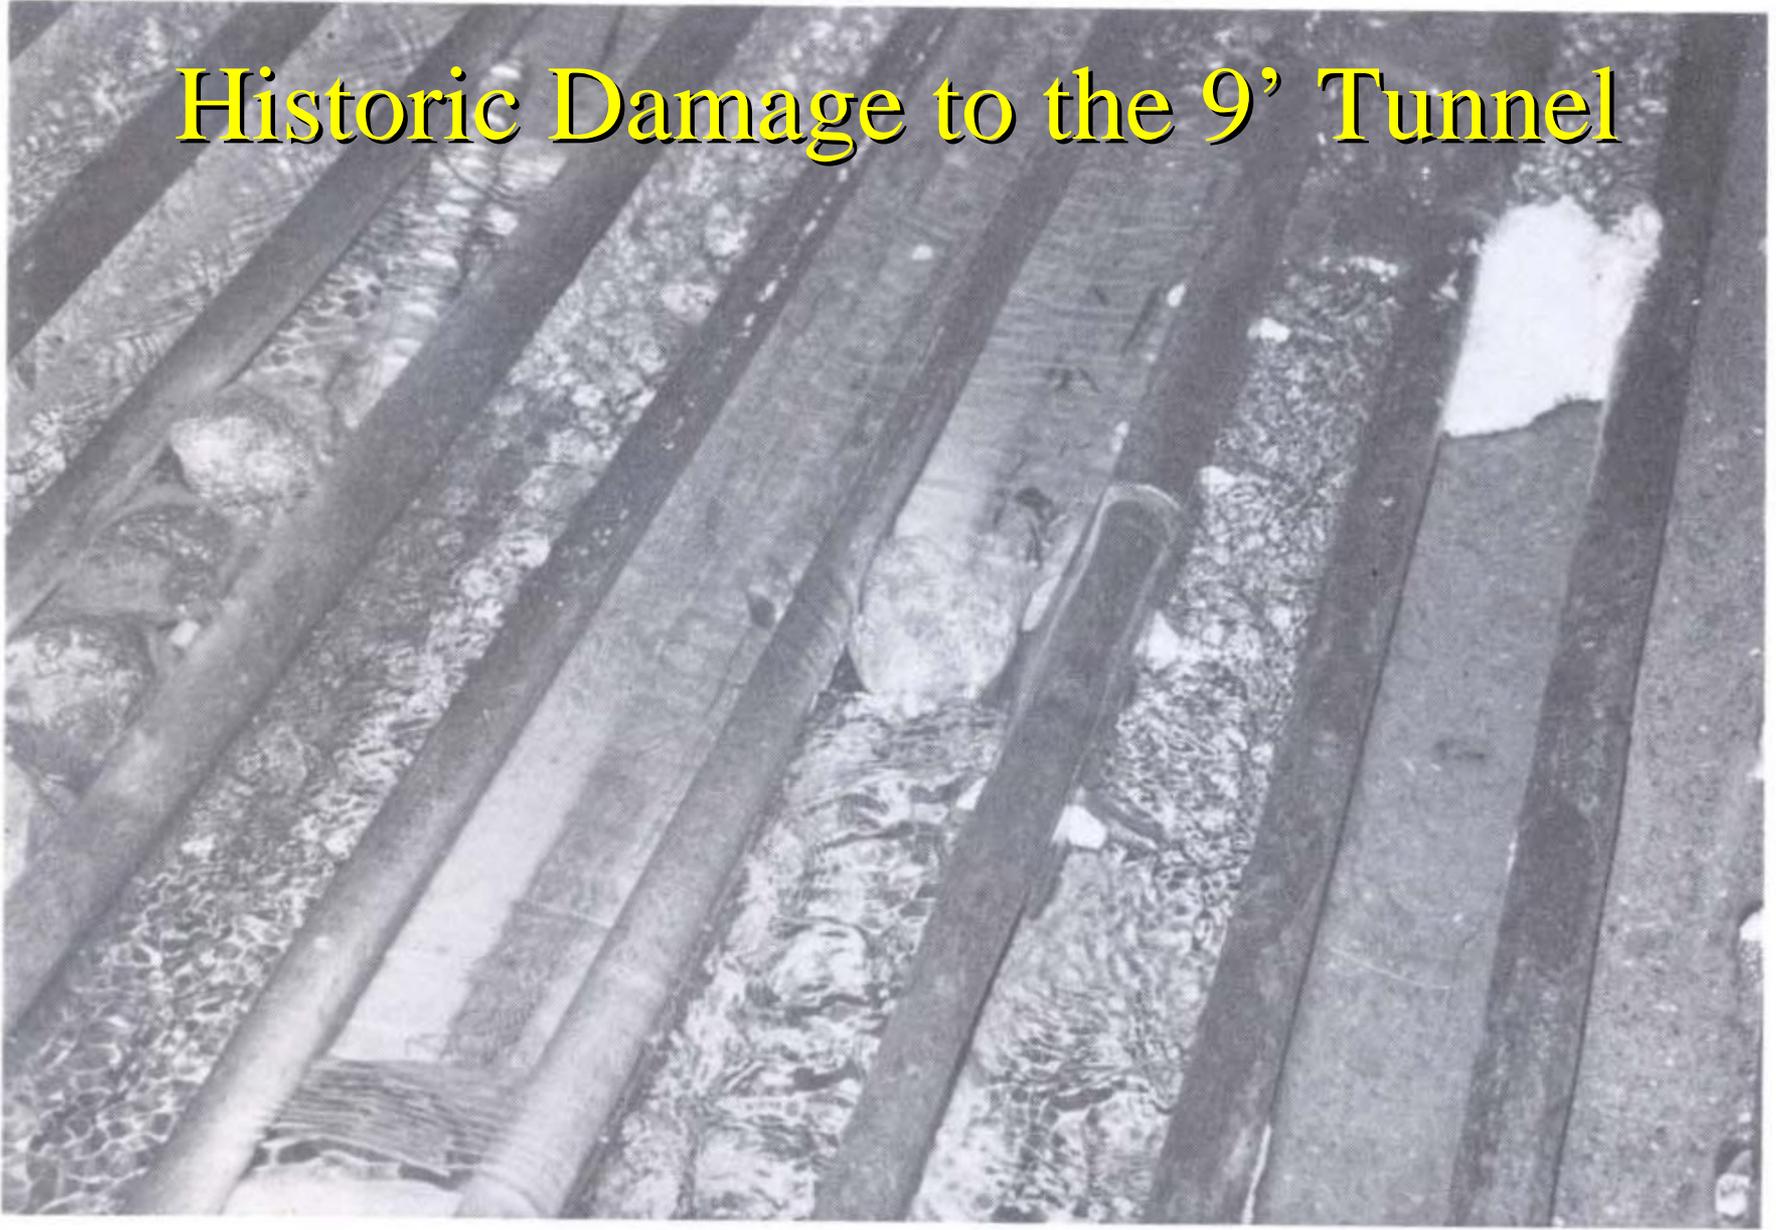
Photo 10 Condition of floor of 9-foot tunnel, May 1982. Section where grout was placed between rails during the repair of Sept. 1981.

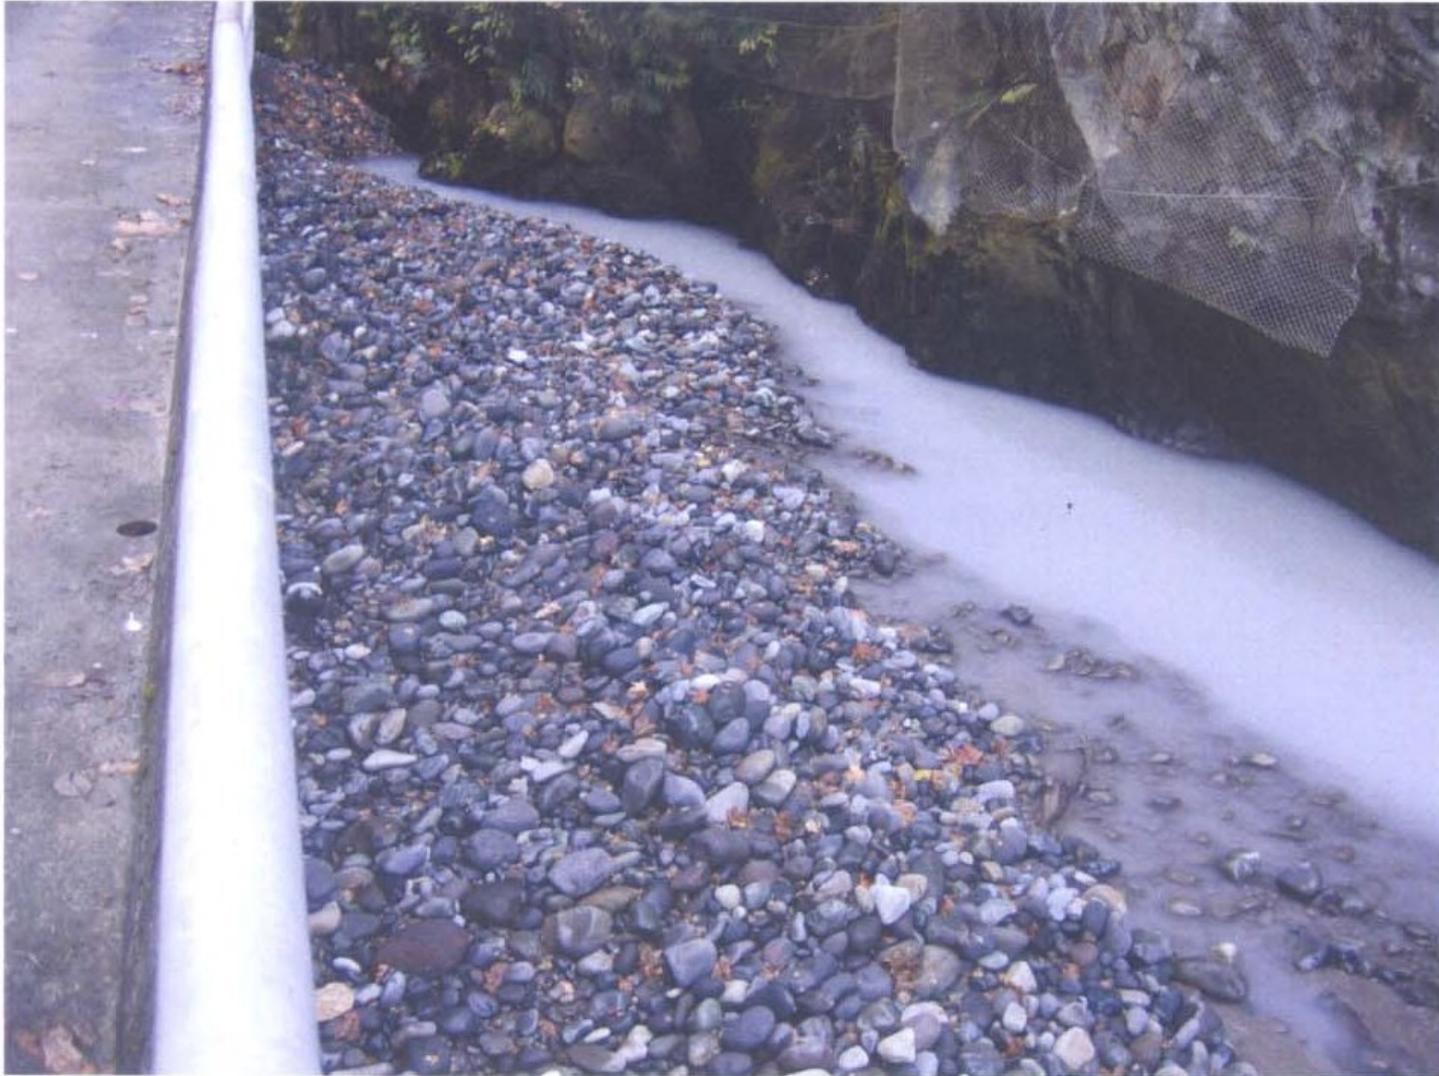
PHOTO 21 – View of Downstream Bedload that Passed thru 9-Foot Tunnel

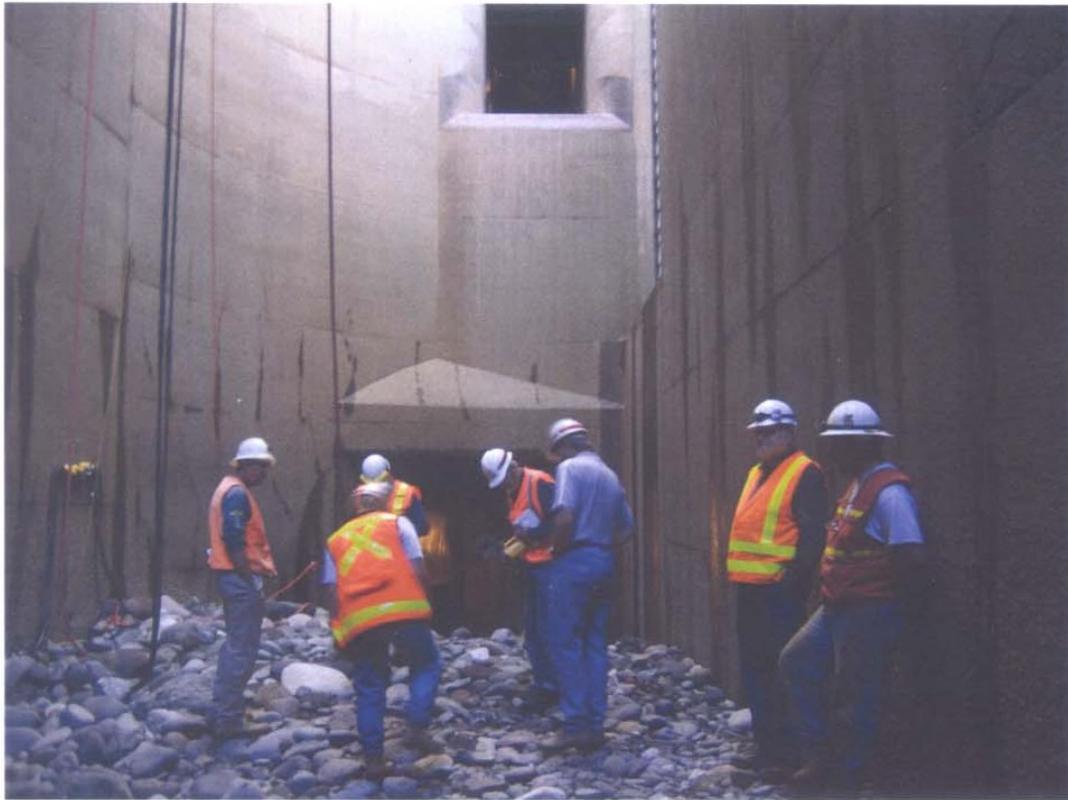
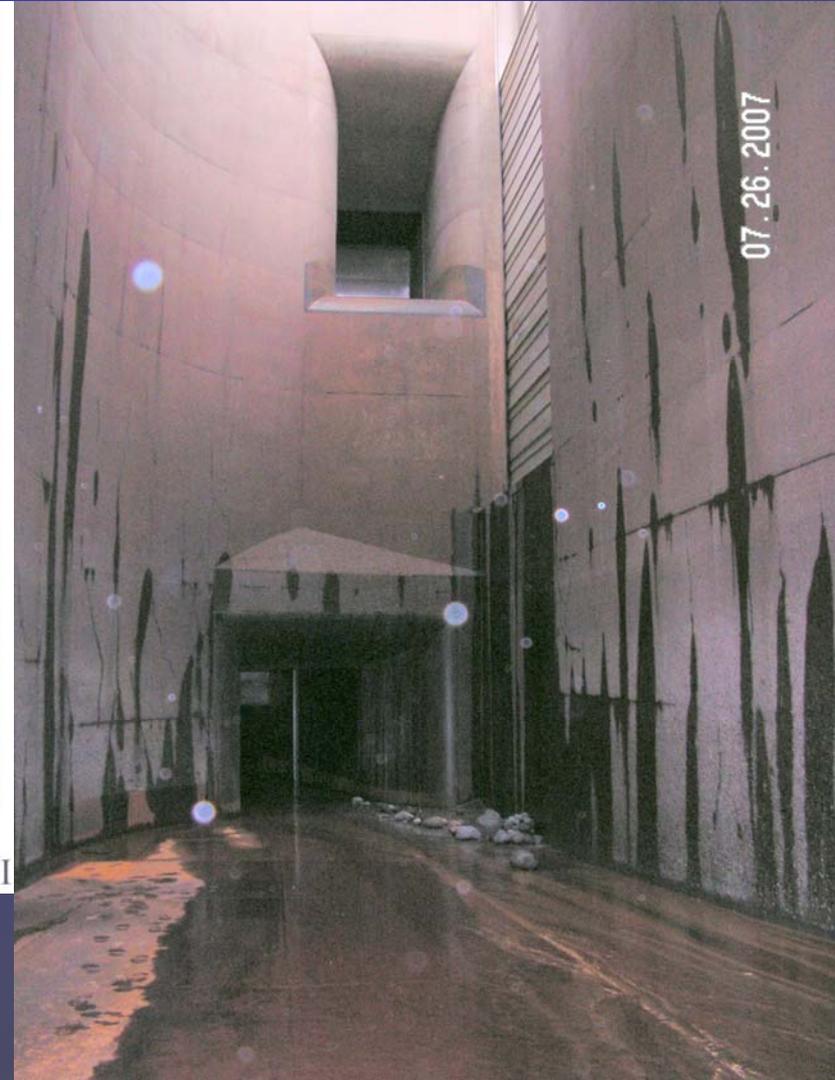
PHOTO 20 – Typical 9-Foot Tunnel Bedload, ~ 4 feet deep during the PI

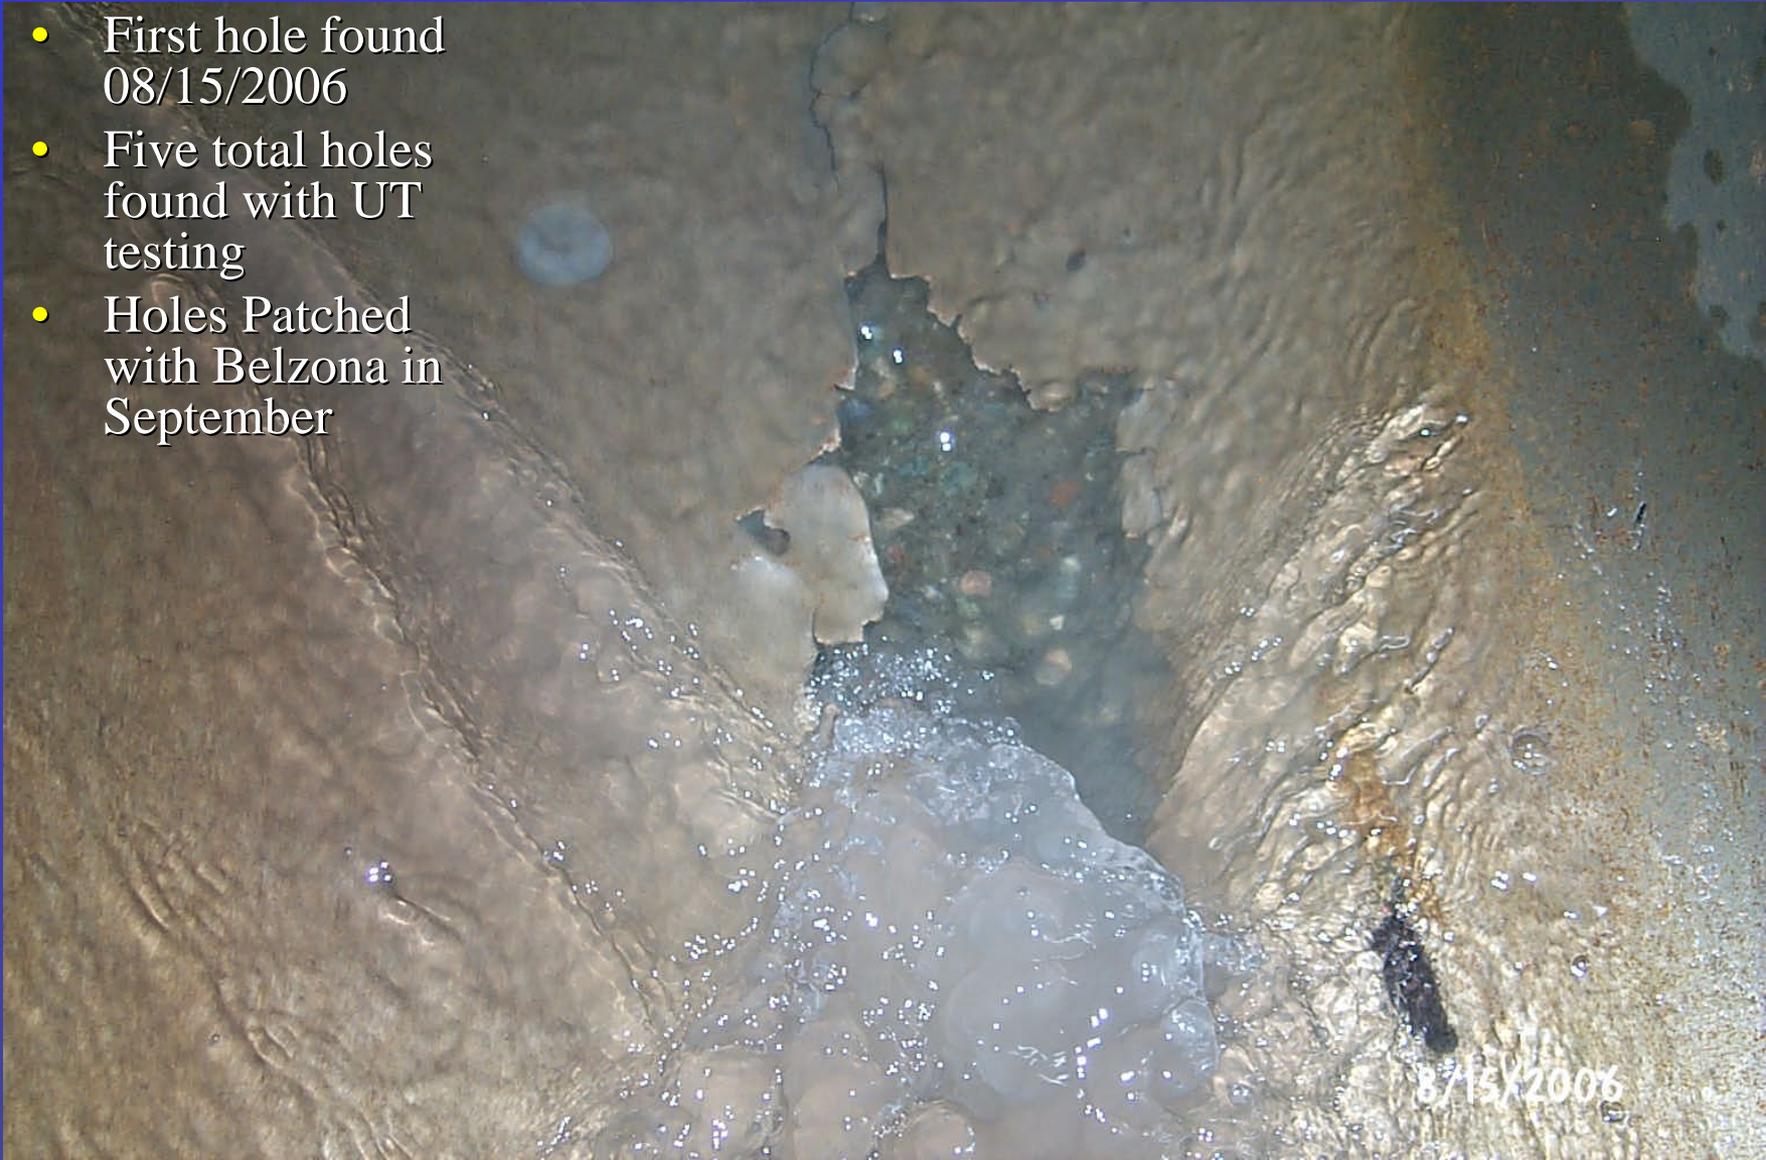
- First hole found 08/15/2006
- Five total holes found with UT testing
- Holes Patched with Belzona in September
