Damage to the 9-ft Tunnel at Mud Mountain Dam

Northwest Regional Technical Forum
August 7, 2008

Presented by: CENWS-EC-TB-HH
Douglas D. Knapp, PE

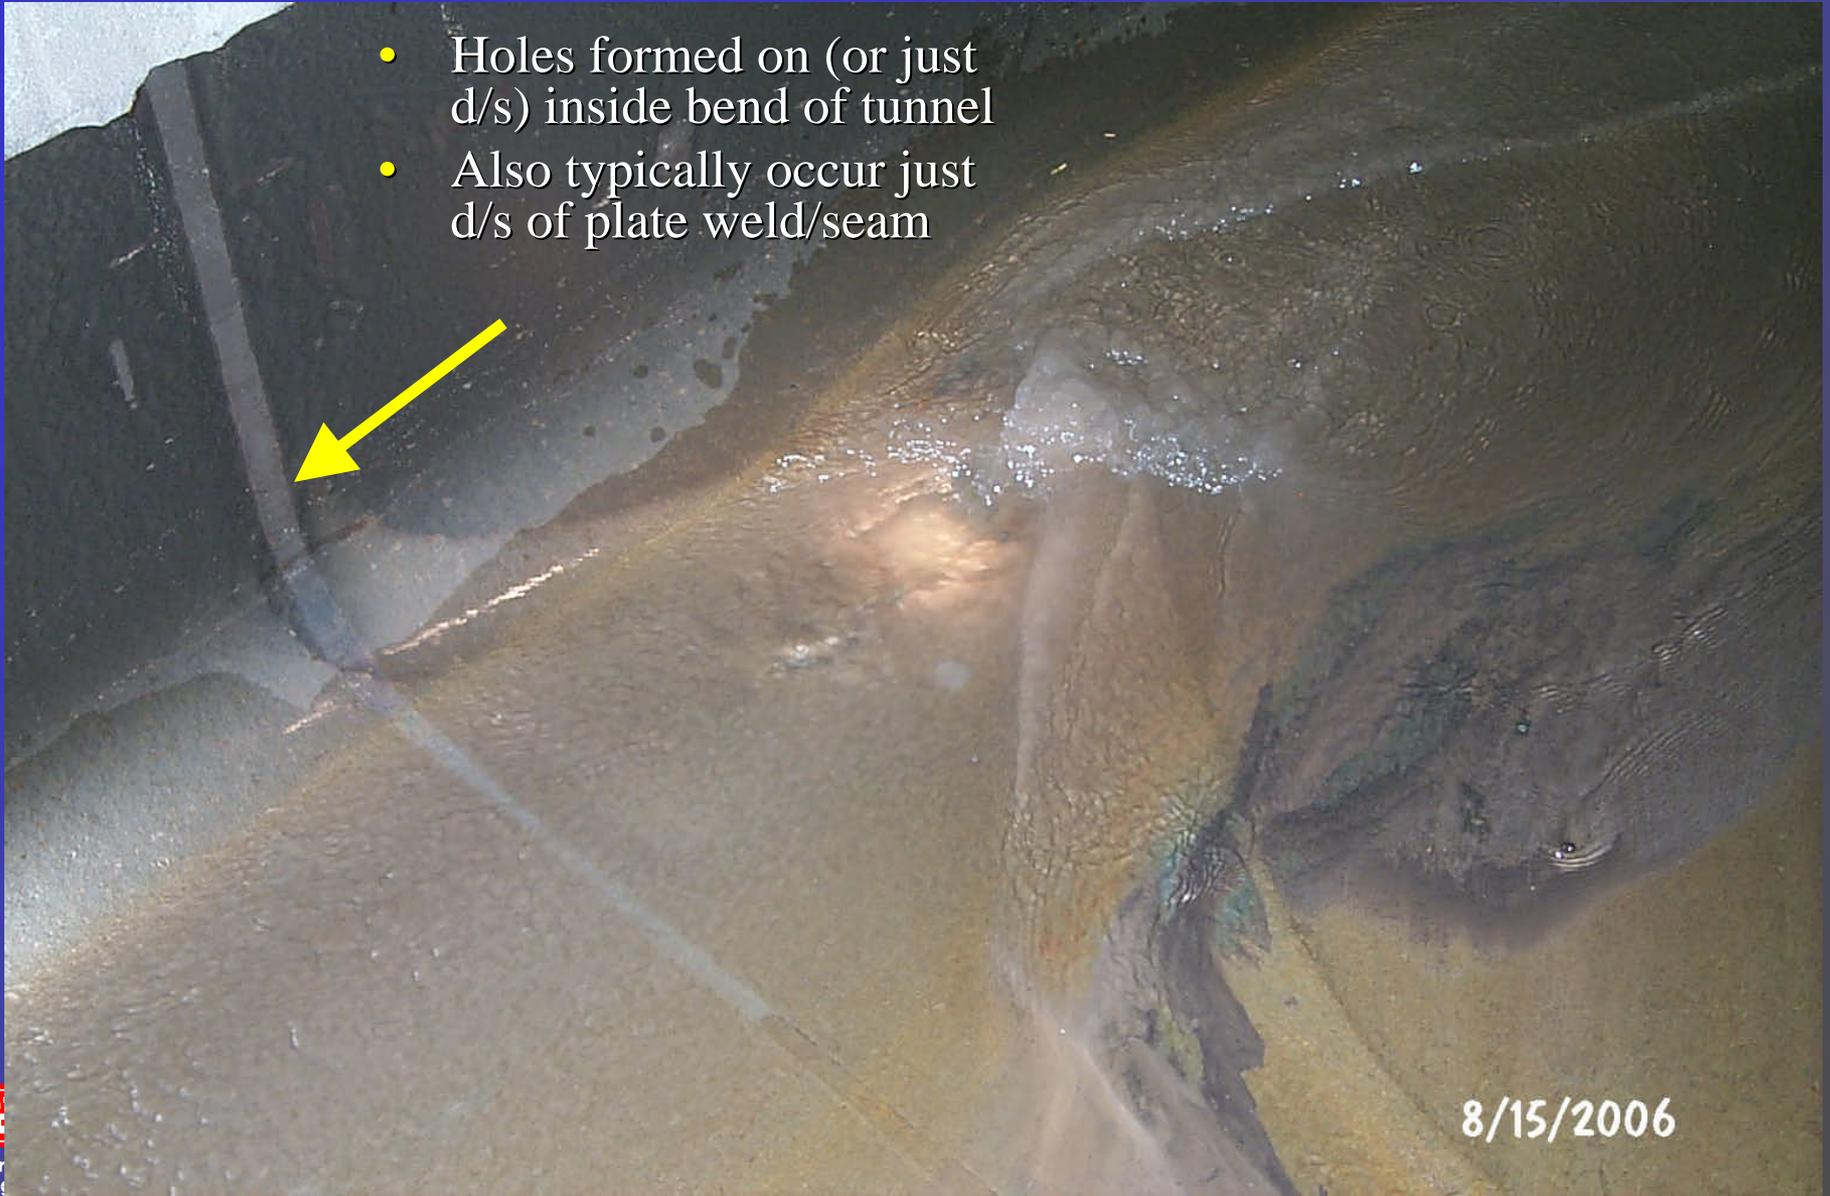
- Holes formed on (or just d/s) inside bend of tunnel
- Also typically occur just d/s of plate weld/seam

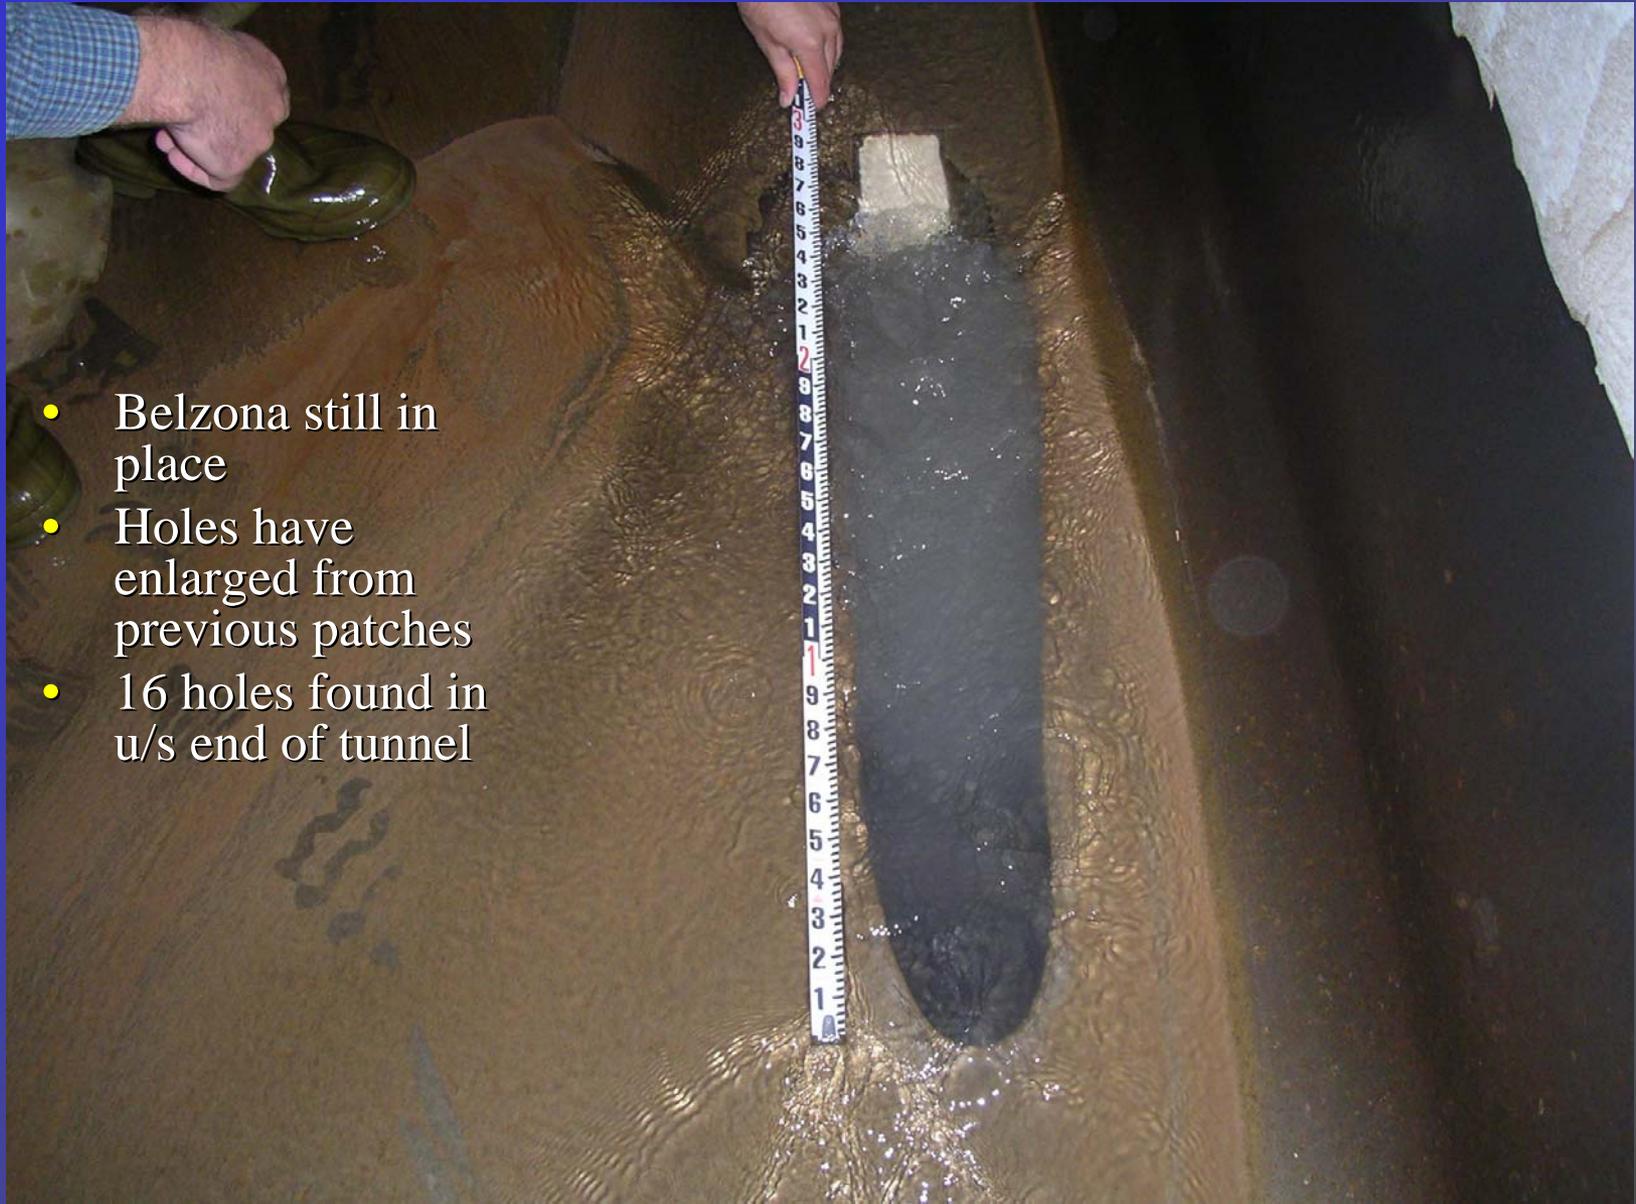
- Belzona still in place
- Holes have enlarged from previous patches
- 16 holes found in u/s end of tunnel

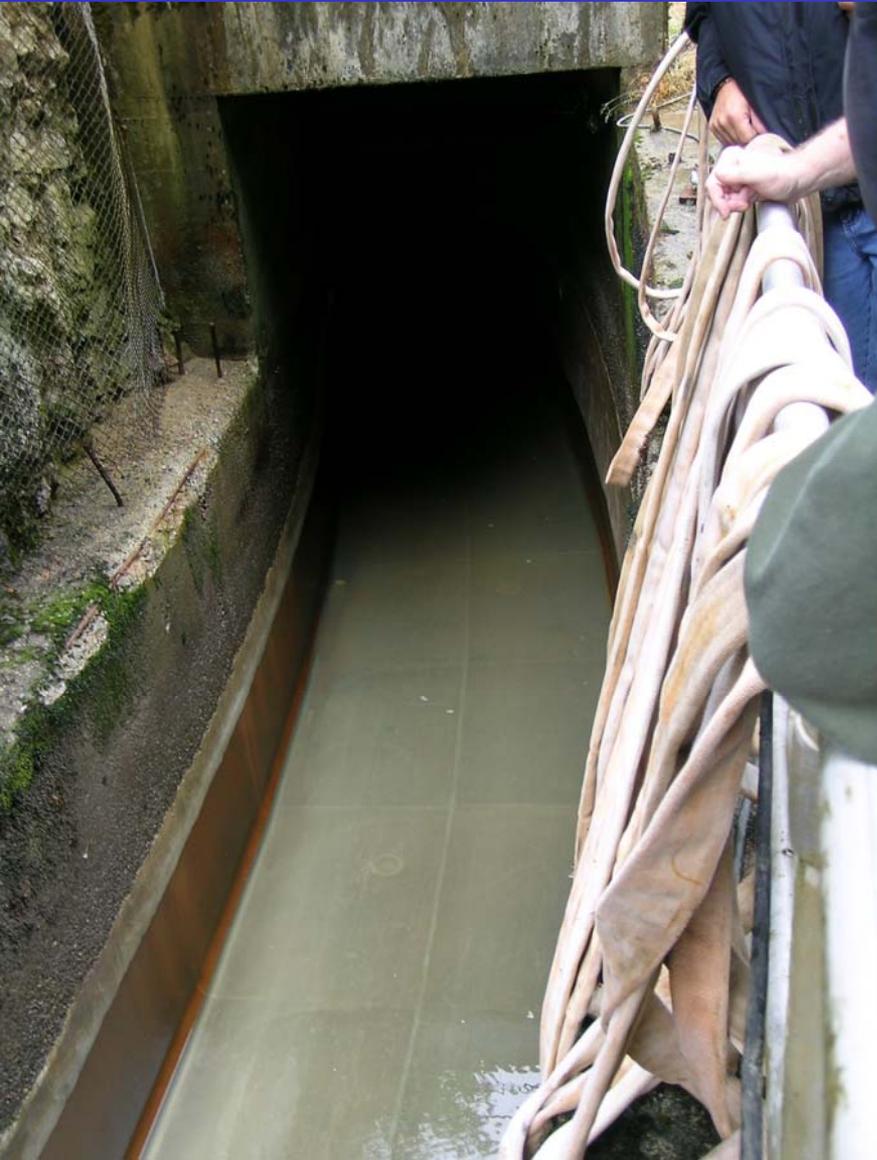
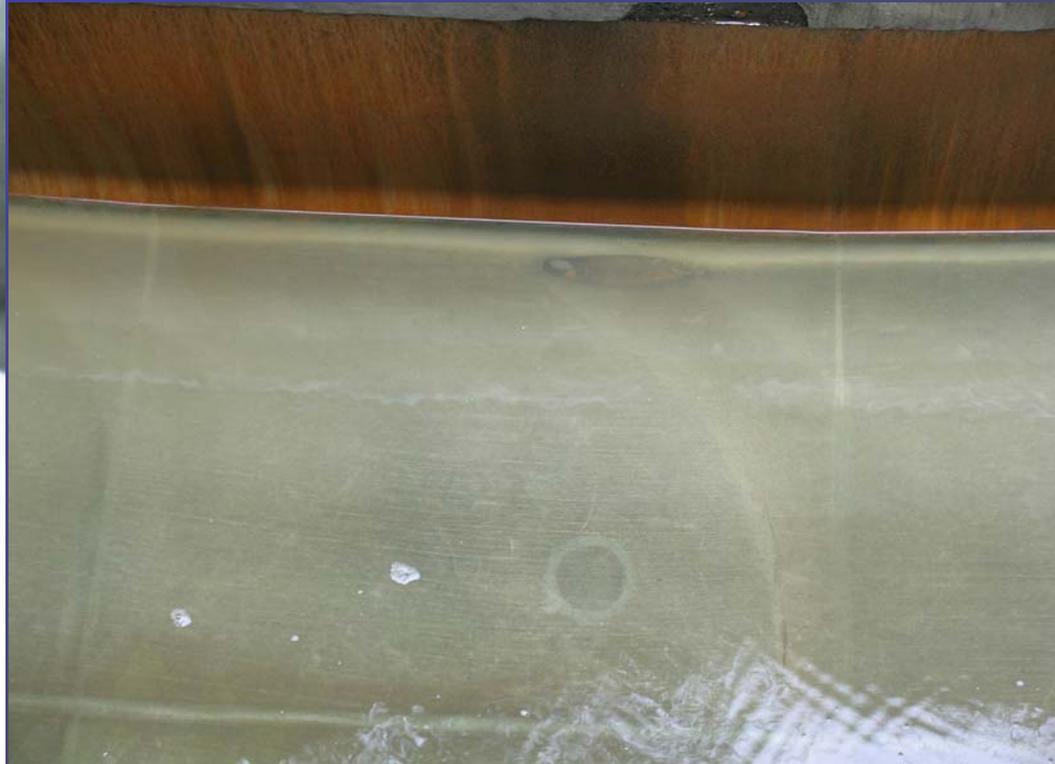
- d/s stoplog placed and 11 additional holes found
- Holes much larger than u/s
- NDT of tunnel takes place in October
