Subject: B2CC Interior channel Inspection 11-4-08.

Matt Hanson
CENWP-EC-DS
503-808-4934

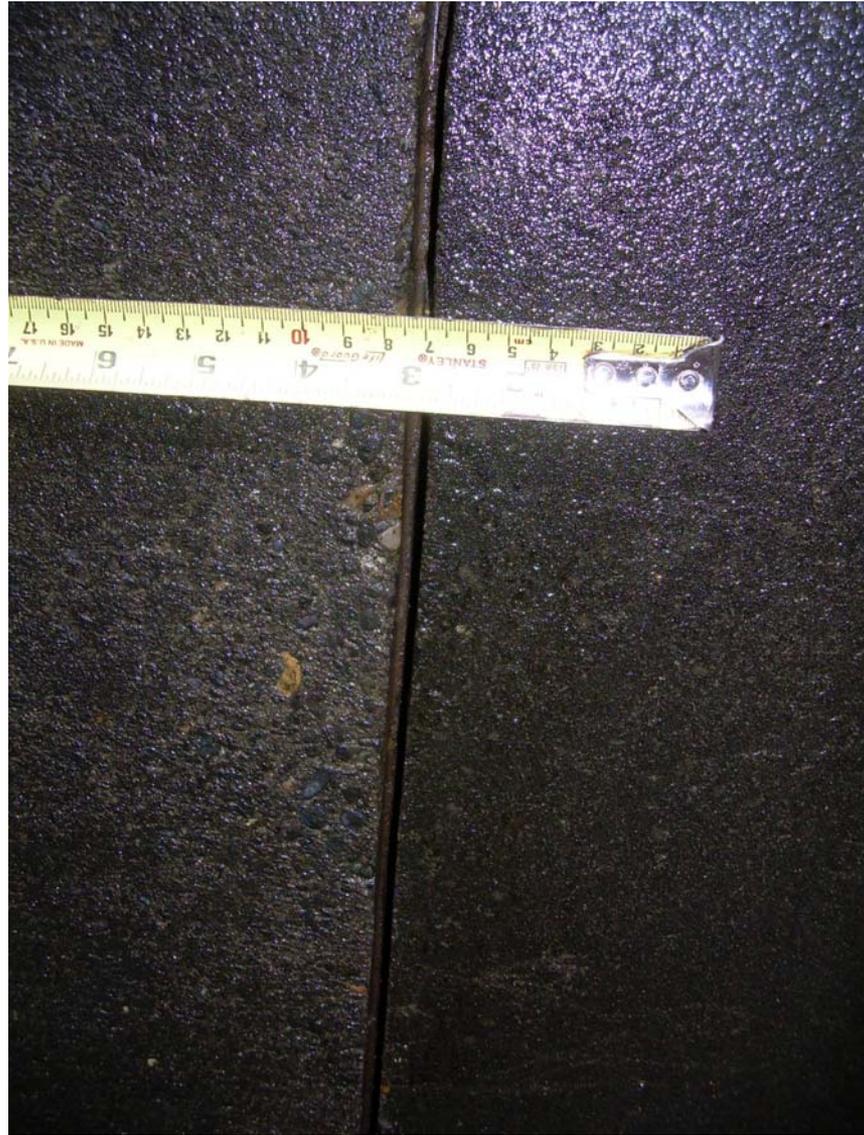
Photo 1 - Typical monolith join with 1/4" gap

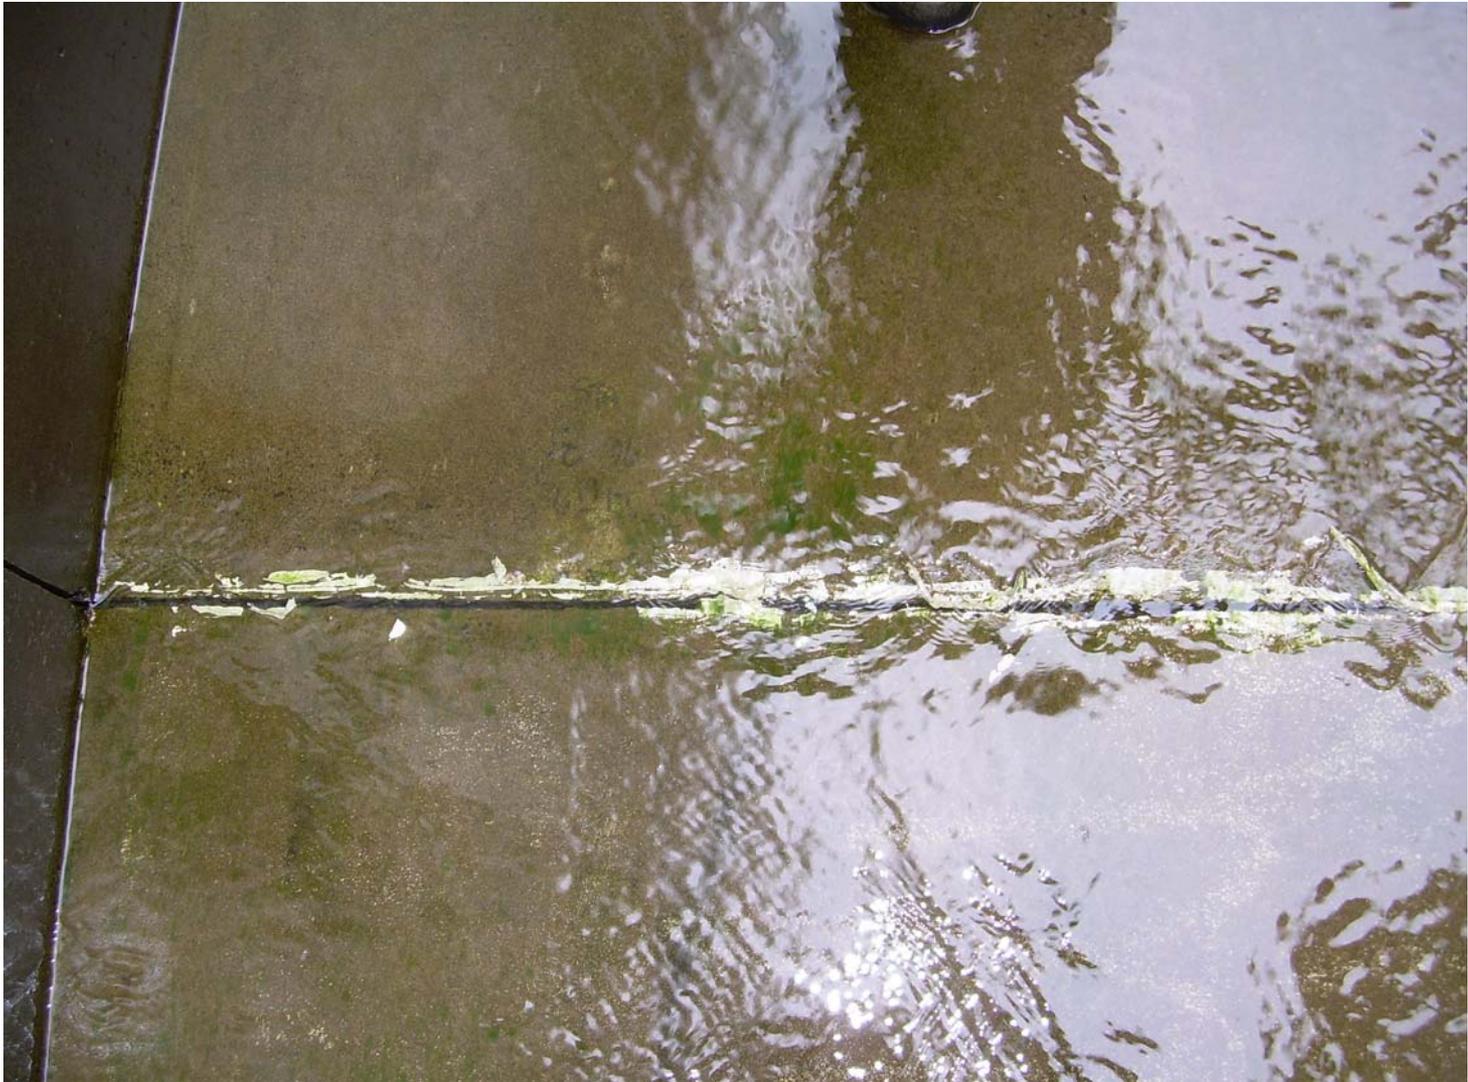
3. Most joints in the floor were ¼” to about 1” at the maximum gap. Many of the joints had been filled with a flexible joint sealant. At most locations, the joint sealant was coming out of the joint and was not adhering to both sides of the joint.

Photo 2 - Typical loss of flexible sealant. Joint gap ranged from ¼ to 1" on floor joint

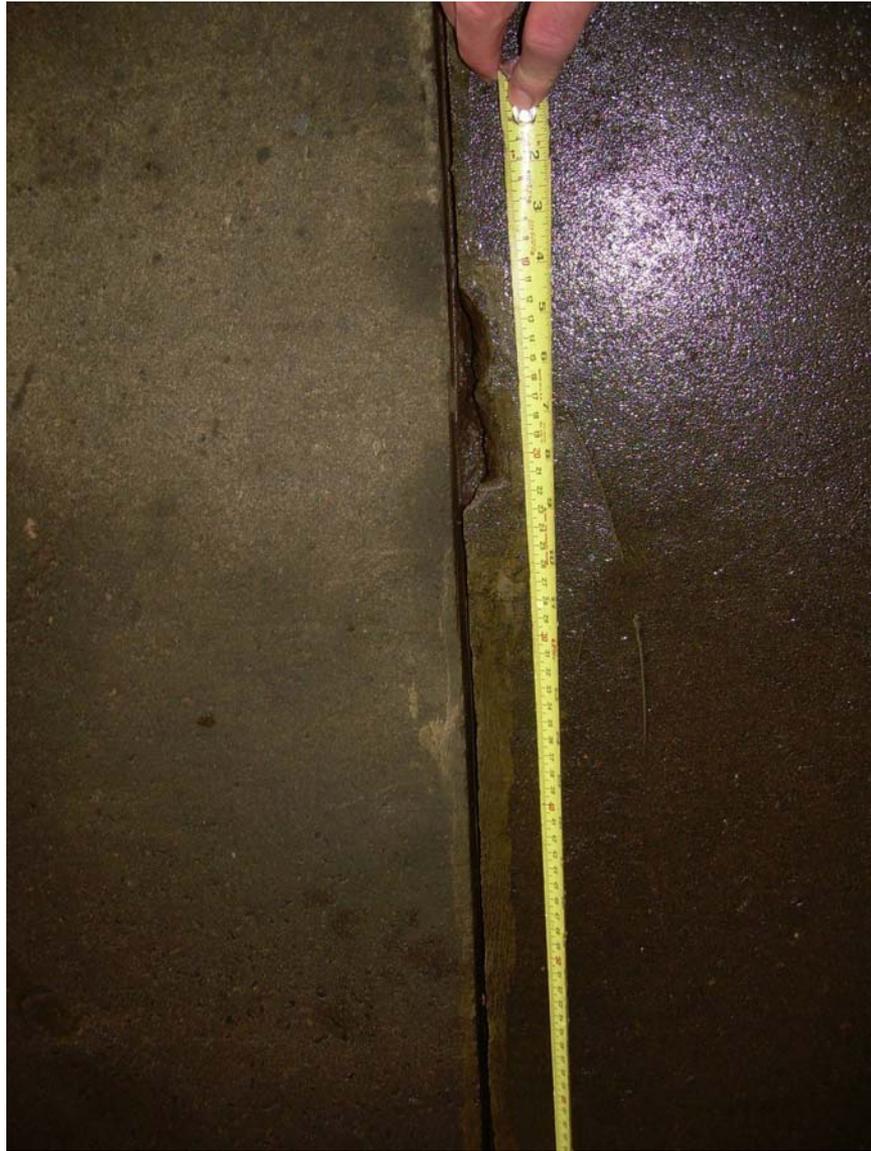
Photo 3 – Sta 21+30 4 ½" vertical on left wall by 1" wide to the downstream side of the joint

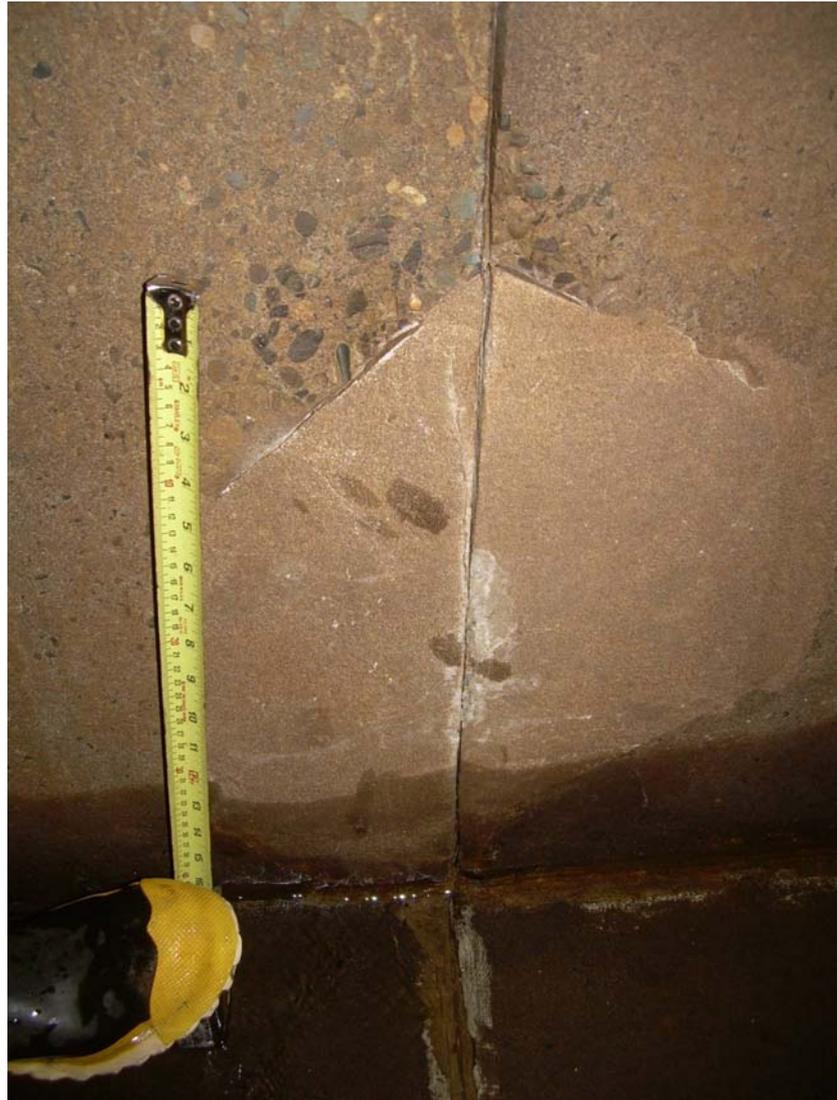
monolith joints should be maintained. Some of the repairs appeared to have been installed across the joints where they have bonded to one side or the other and separated from the original channel.

Photo 4 – Sta 23+84 right side, spall repair coming out. 14” high by 18” wide at max width.

12. Conclusions:
 - a. Any spalls over 2 square feet and greater than 1” should be repaired with a material as designated by Jim Hinds. In any repair, the gap at the

- b. Some of the larger spalls may need a concrete patch rather than a grout or epoxy grout surface. Any concrete patch should be installed with reinforcement to anchor the patch and a mix design of at least 6000psi to match the surrounding concrete. Any repair surfaces will be required to be dry during repair or the repairs will likely not hold. If repairs are performed with care, they should be permanent.
 - c. PIT Antennae – the corner where the left wall and antennae meet should be resealed with flexible joint sealant.
 - d. It is recommended to have an engineer walk the exterior of the channel from the stairway at the second powerhouse to the outfall to insure that erosion of the riprap is not occurring.
 - e. All other components of the Corner Collector were in good condition.
13. If you have any questions, please contact Matt Hanson, 503-808-4934.

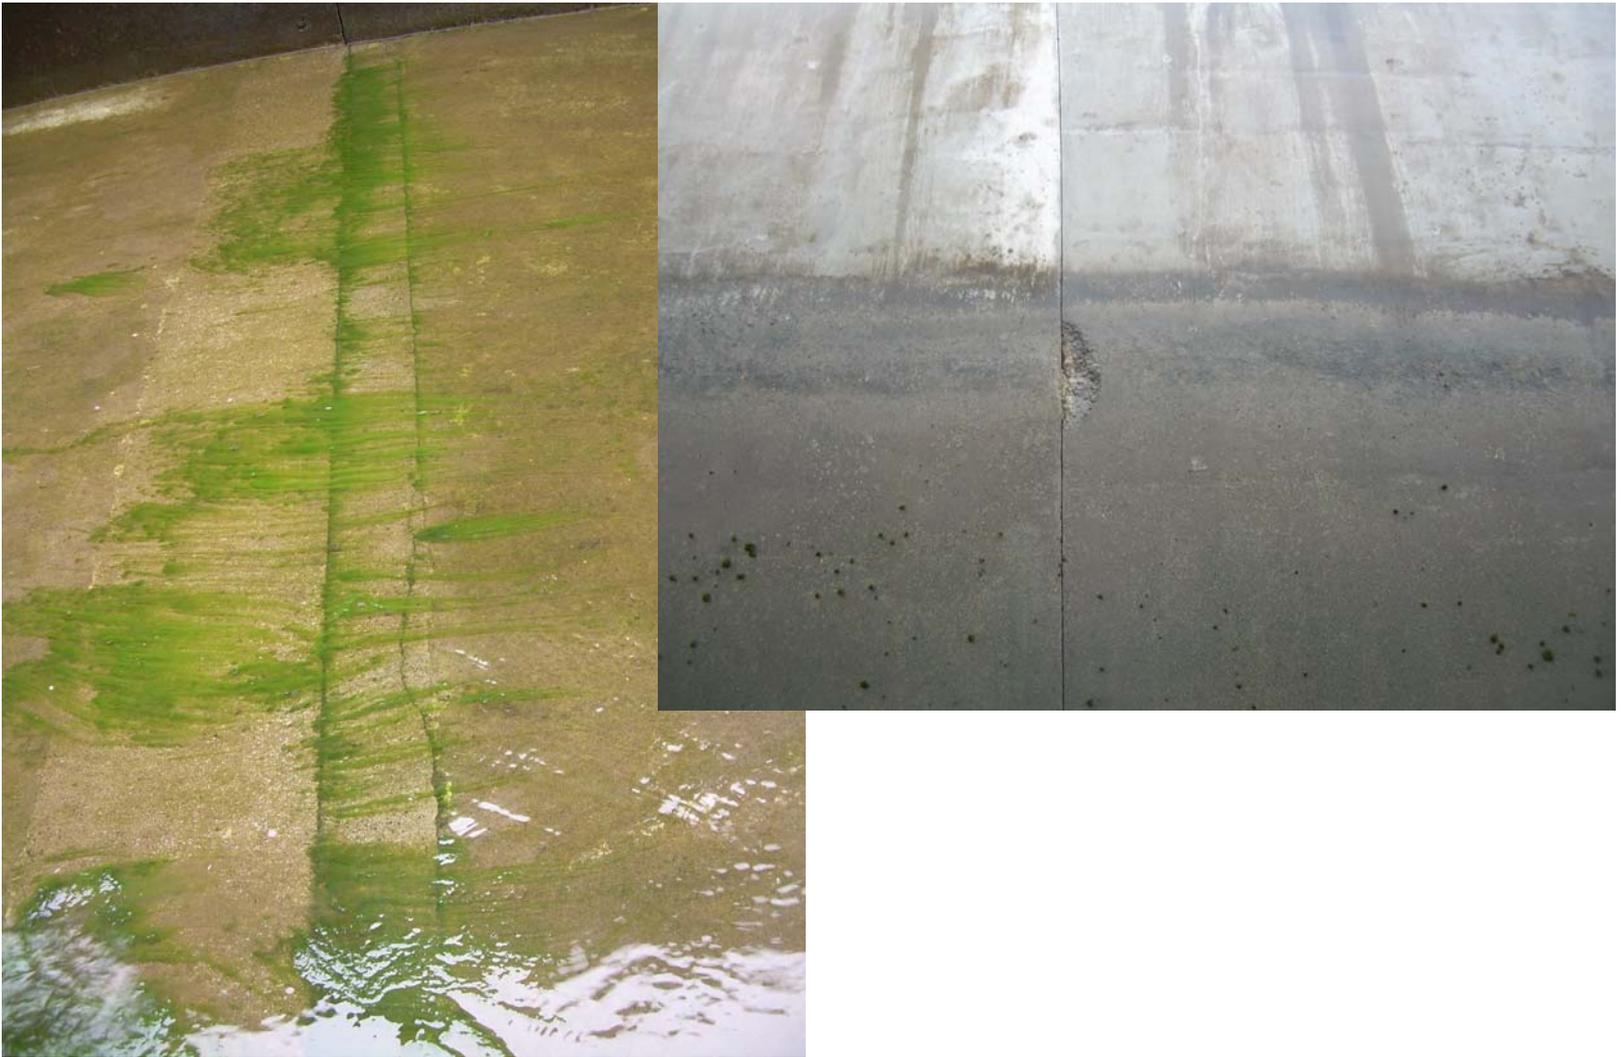
Photo 5 – Sta 24+86 iover crack, spall 18” by 6” located 14’ up on wall

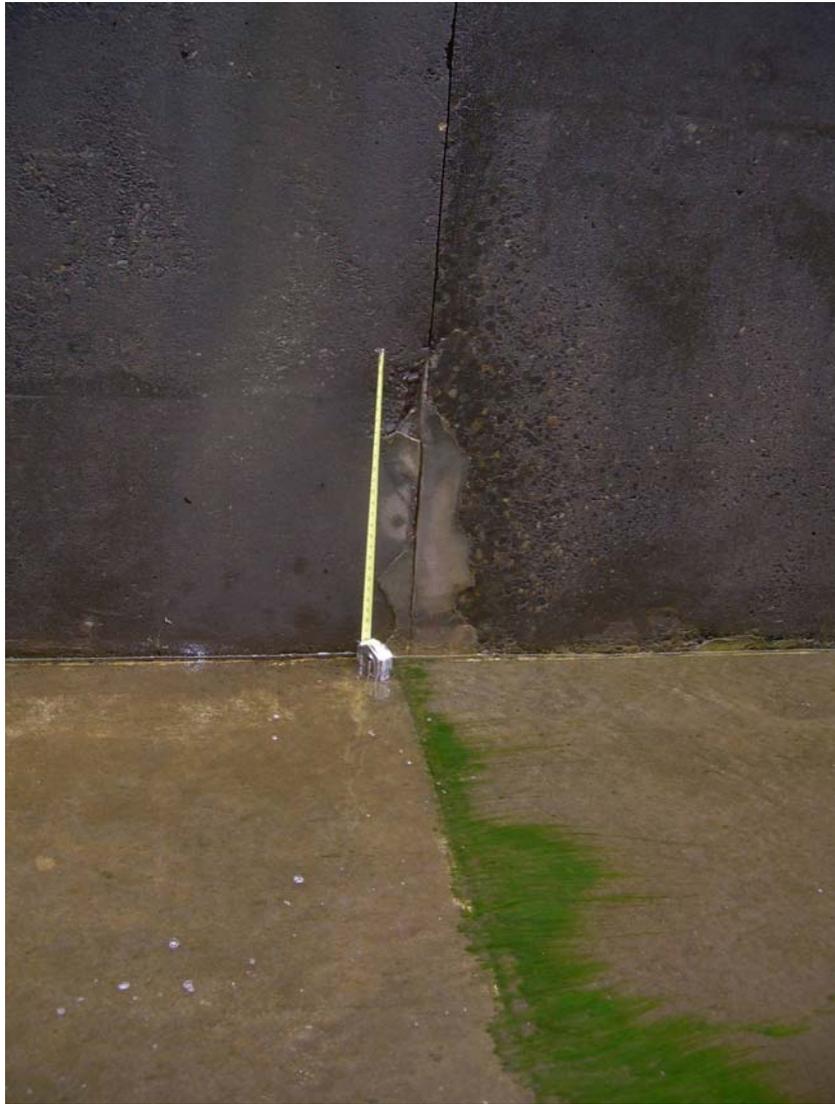
Photo 6 – Sta 25+46 left side channel spall repair 28" high by 8" wide max. Spall is not adhered to concrete

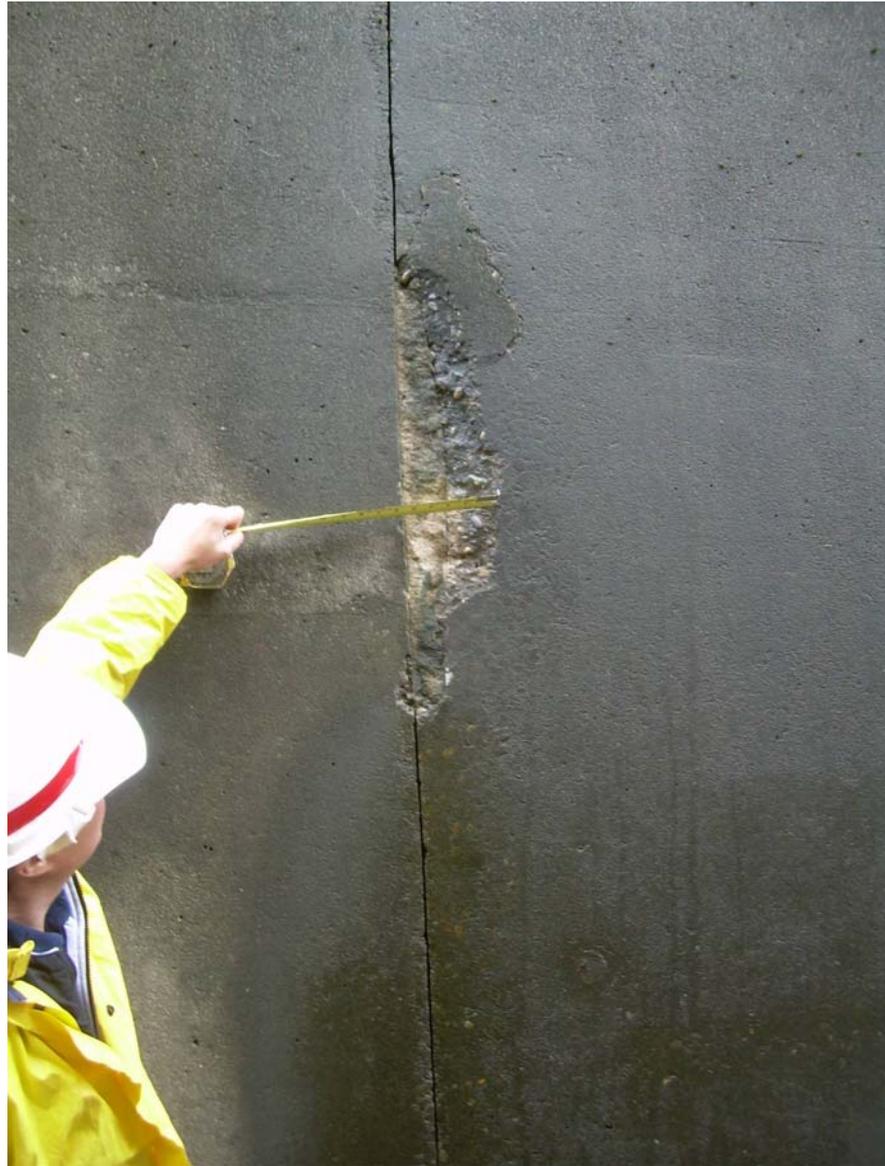
Photo 7 – Sta 26+06 18" high by 4" wide by 1/2" deep

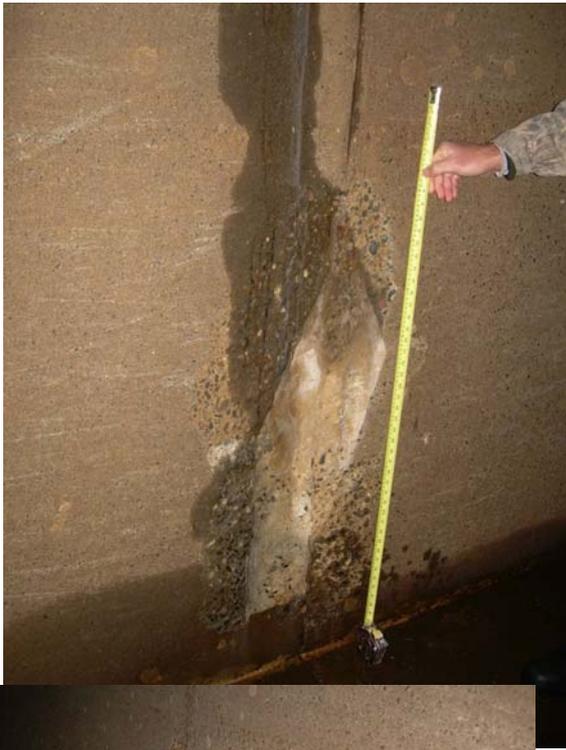
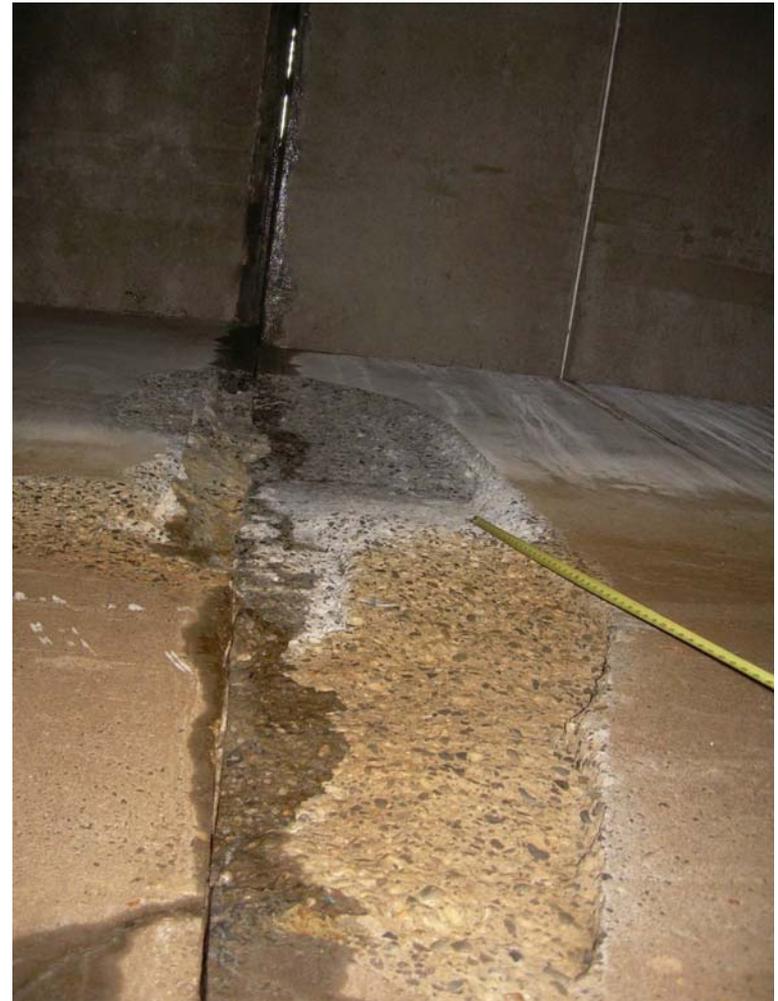
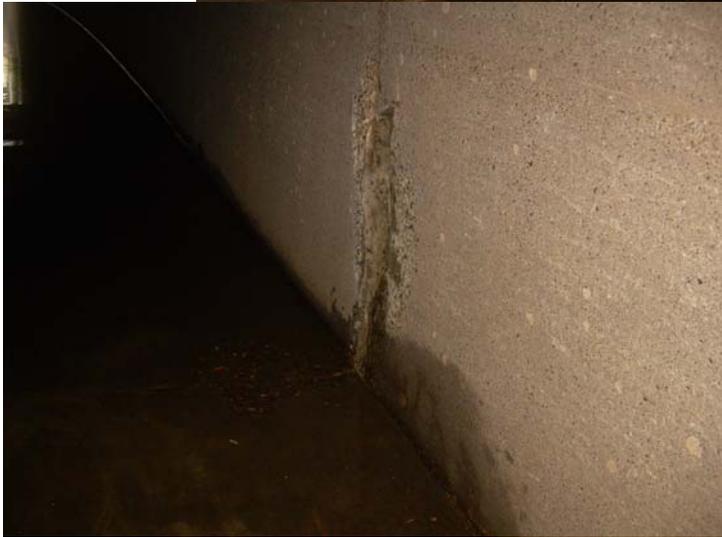
Photo 8 – Sta 12+78 right side 48" by 2" deep, left side channel spall in 2 locations, a 4' lower spall and a approx 15' high by 36" wide larger spall

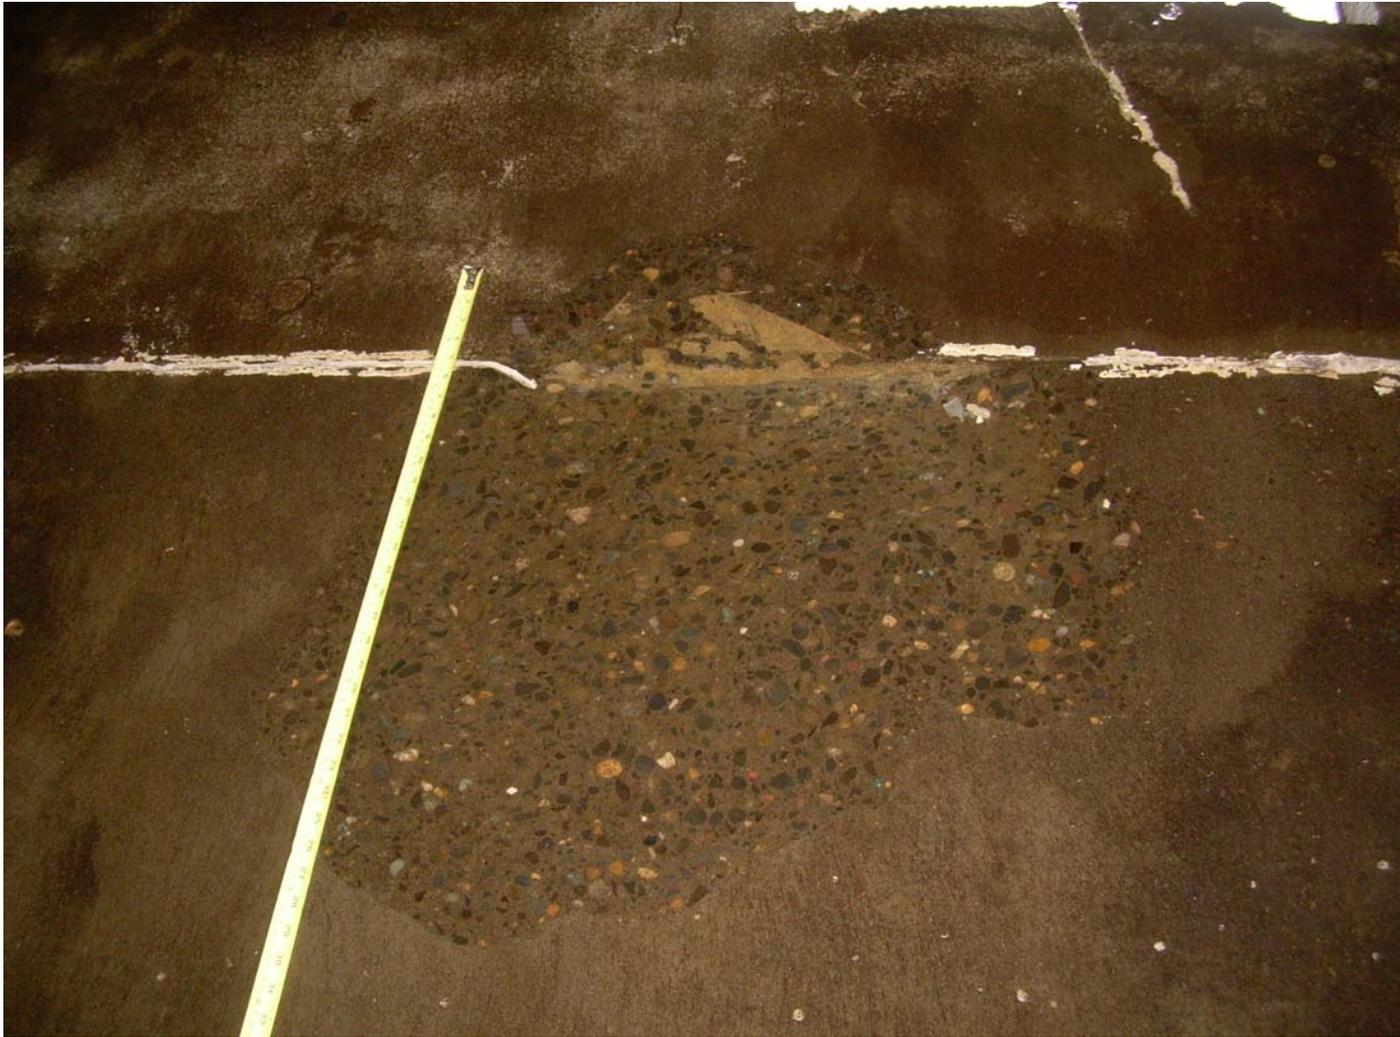
Photo 9 – Sta 11+58 here is also a spall in the channel invert, 2" deep by about 30" long ad 24", similar cracking noted at Sta 7+05 where there are 2 - 16" wide spalls about 12" downstream and 1" maximum depth

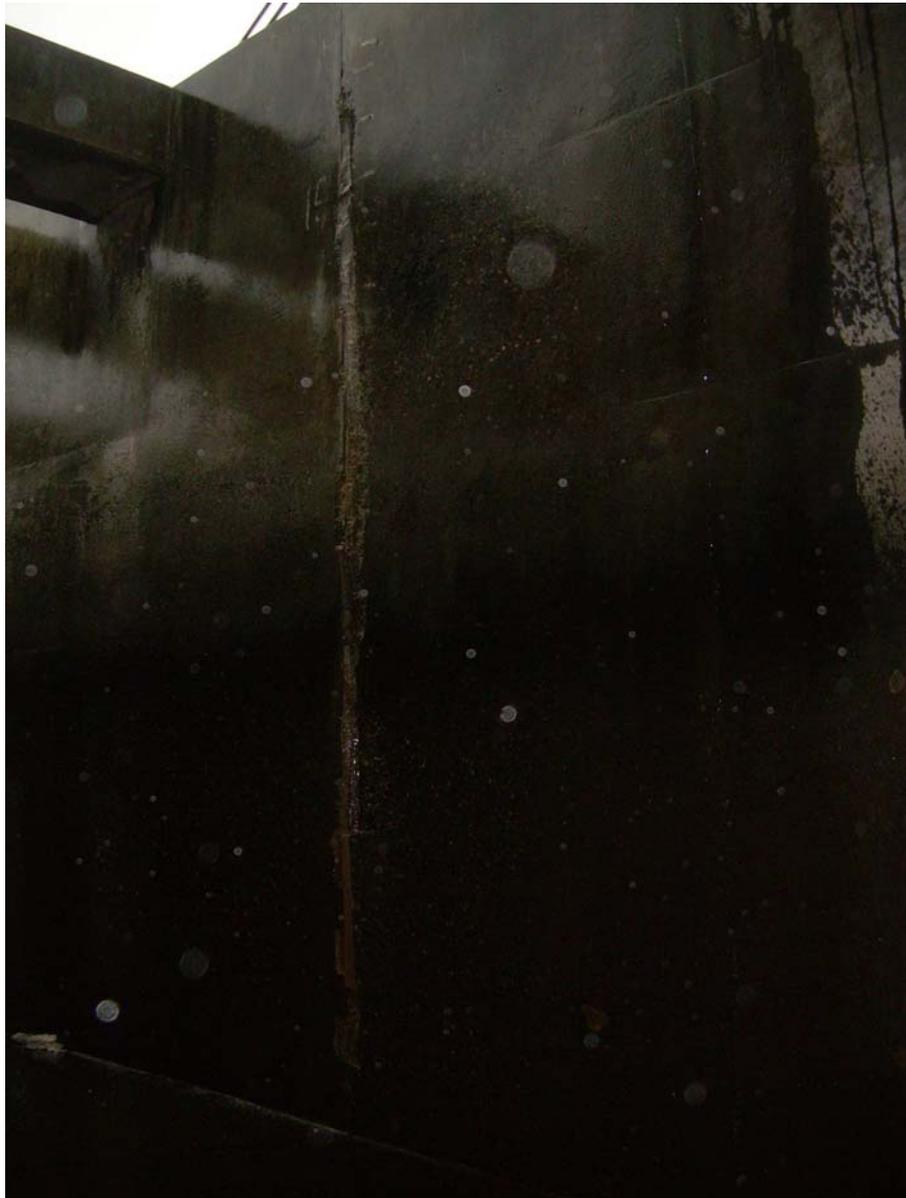
Photo 10 – Sta 25+46 left side channel spall repair 28" high by 8" wide max. Spall is not adhered to concrete

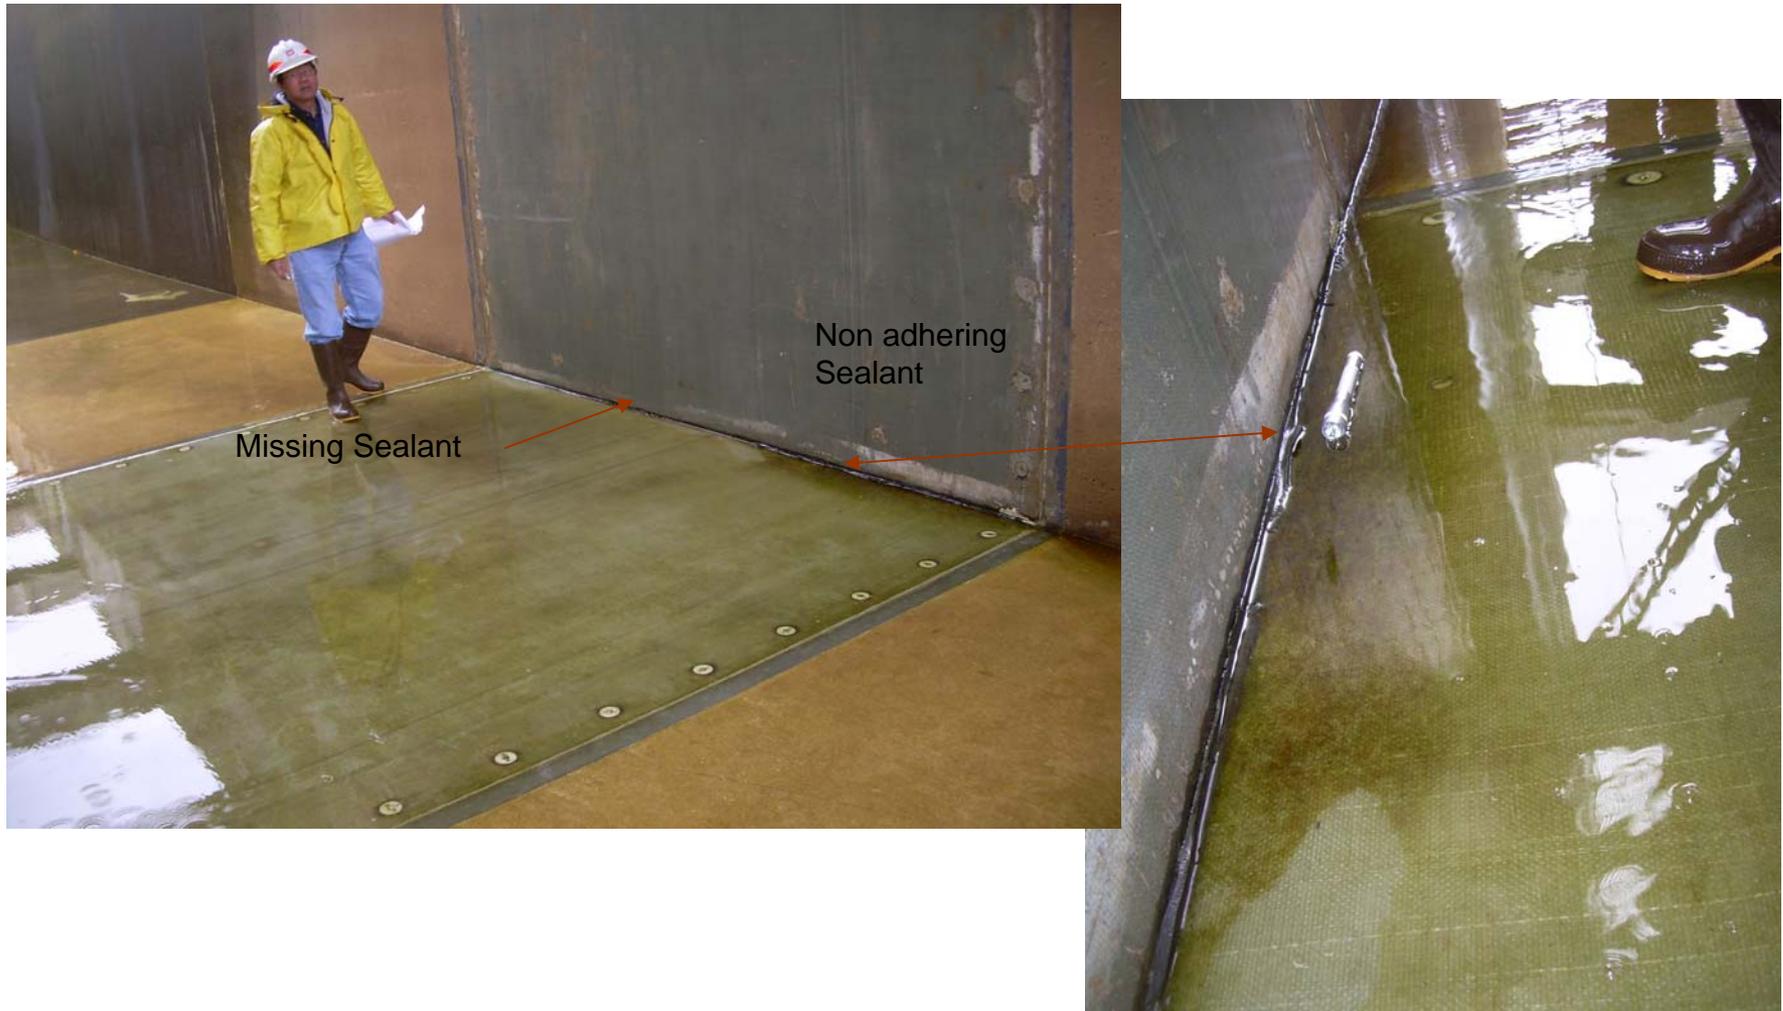
9. The Hi Flow Antennae joints appeared to be in very good condition. Generally, joints around the PIT antennae were in good condition. However, the flexible joint sealant where the left wall (looking downstream) and the antennae floor meet was missing or not adhering to the corner. The surface of the antennae was also in good condition.

Photo 11. PIT Antennae Flexible Joint Sealant Missing or Not Adhering to Joint Between the Wall and Floor.
