MEMORANDUM FOR THE RECORD

SUBJECT: *15JDA03 MFR* – Failed operating shaft’s connection with the orifice plate at MU 4C STS –Gate well caused juvenile fish mortalities and migration delay.

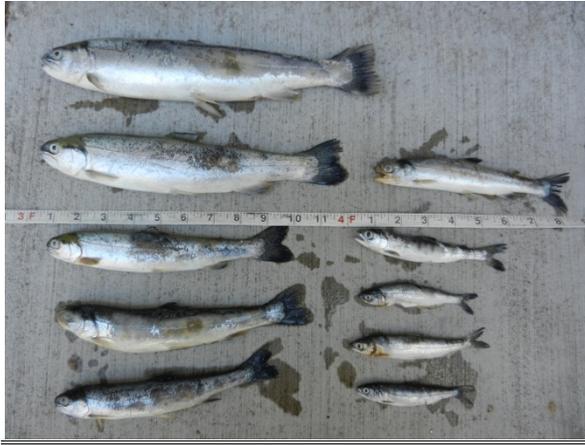
At 0842 JDA Operations discovered the MU 4C gatewell orifice valve plate had separated from the shaft. This prevented fish from exiting the gatewell into the JBS. MU4 was immediately taken OOS and an underwater camera inspection confirmed that orifice 4C was closed in spite of a surface indication to the contrary. JDA orifices are 15 feet below the water surface and therefore invisible to a direct visual inspection. If the shaft disconnects from the orifice plate there is a false indication that it is open while in reality it is closed.

I was the two bolts attaching the shaft to the plate, which sheared off and had to be reinstalled.

JDA Project dipped the MU4 gatewells and released a few hundred juvenile salmonids, in good condition, into the forebay. Bulkheads are installed and repairs are expected to be complete by COB on 4 June 2015.
