**John Day Dam  
South Fish Ladder  
Section 12  
Wall Leak**

**January 28, 2015**

## Inspection Report

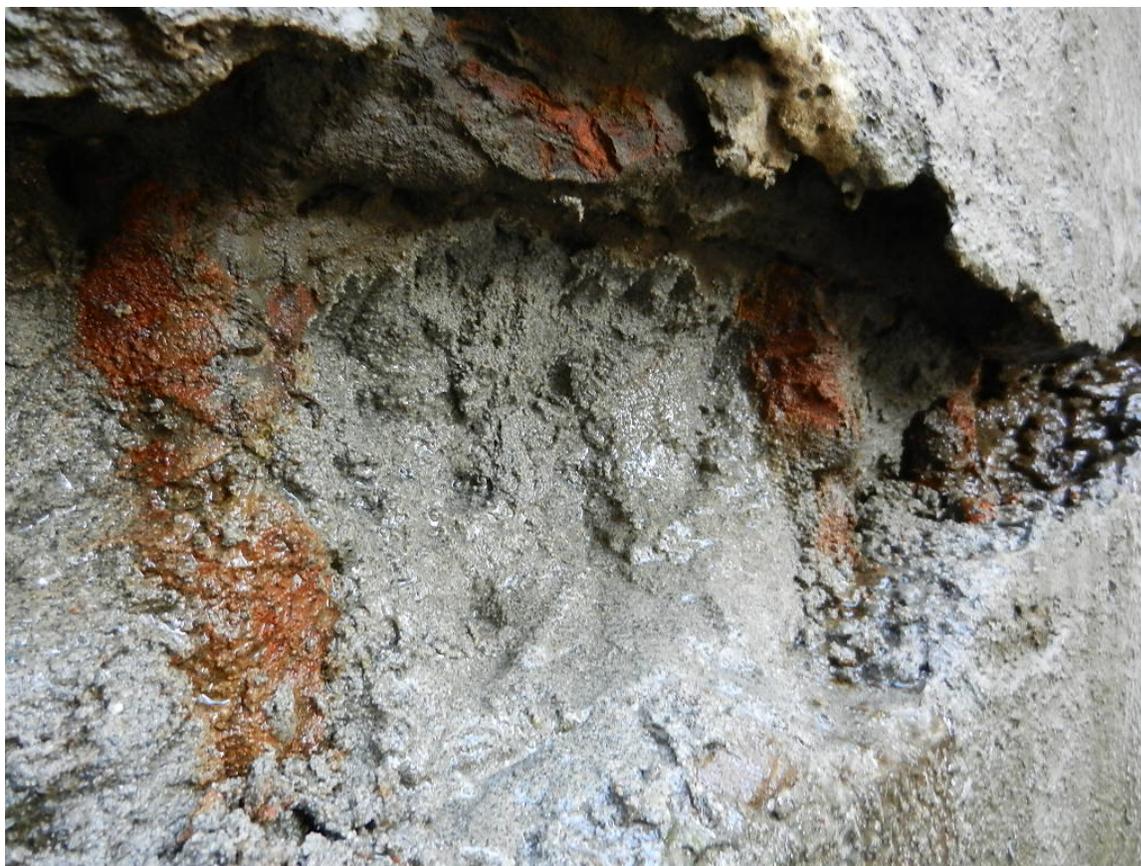
- a. The size of the hole was approximately 24” wide by 18” tall.
- b. The portion of the concrete plug that was removed for patching preparation was approximately an inch deep. Beyond this thin concrete, vertical reinforcement was seen. The reinforcement did not have concrete around it but rather had sand and silt with a pasty consistency (Figure 4, Figure 5 and Figure 6).

**Figure 6 - Close up before Patch Installed, 2014**

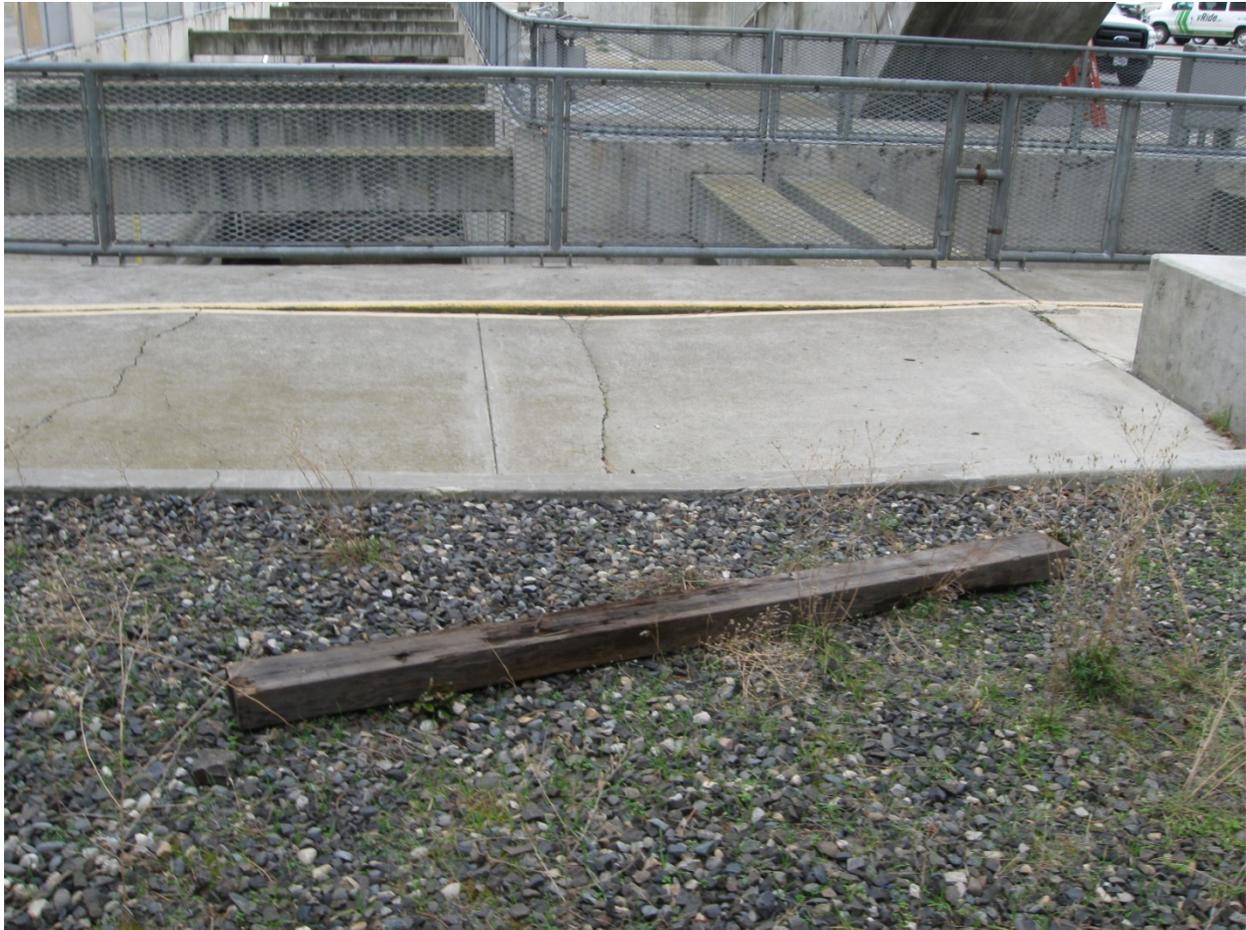
- c. Bags of Sakrete were mixed to a damp consistency and then packed into the hole while water was running out of it.
- d. Sheet metal plates were applied over the patched areas with expansion anchors. The anchors were noticed to be in 'soft' concrete as they were installed
- e. The sidewalk at grade level above the wall leak has subsided and cracked (Figure 7 and Figure 8).

**Figure 7 - Subsided Sidewalk above Leak Location**

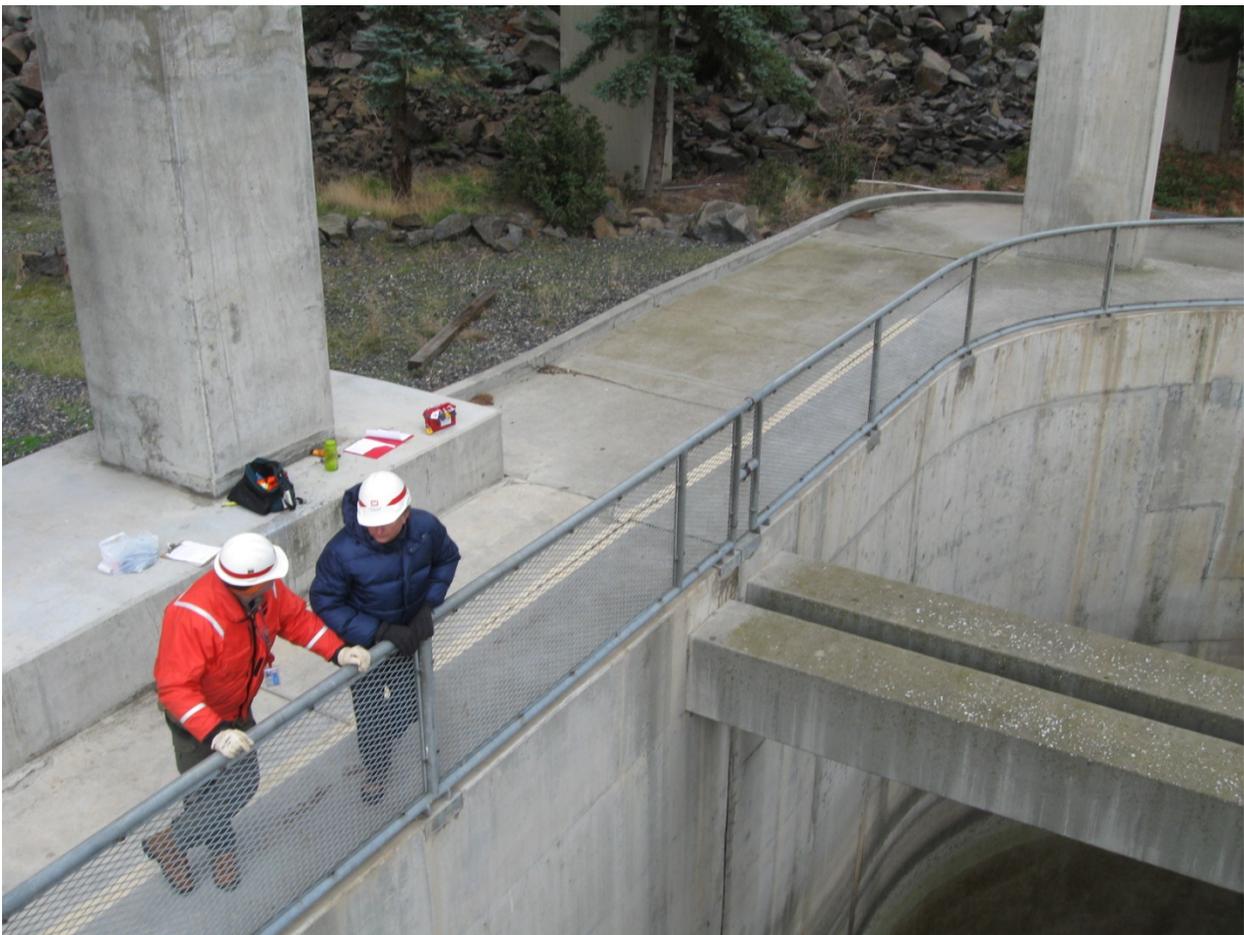
Figure 9 - Structure Overview of Area

There are several large, elevated structures in the area. The elevated portion of the south fish ladder is to the south and the elevated juvenile bypass chute is directly overhead. The columns of sections 12 and 13 of the elevated ladder can be seen in the background of Figure 9. The tree shown is the start of Section 13. Section 12 is to the right (west) and the ladder is running from east to west. One of the juvenile bypass chute columns can be seen in the foreground of Figure 9. There are actually 2 columns here that land on a pile cap which is in turn supported by multiple plumb and vertical piles. The columns of both structures were measured for plumbness with a 4' bubble level and found to be plumb. A visual observation was performed looking for distress in the structures such as cracking and spalling. No distress was found.

2. Monitor the ground area for future sink holes on a monthly basis.
3. Monitor the structures in the immediate area for signs of distress such as cracking, spalling and out of plumbness on a monthly basis.

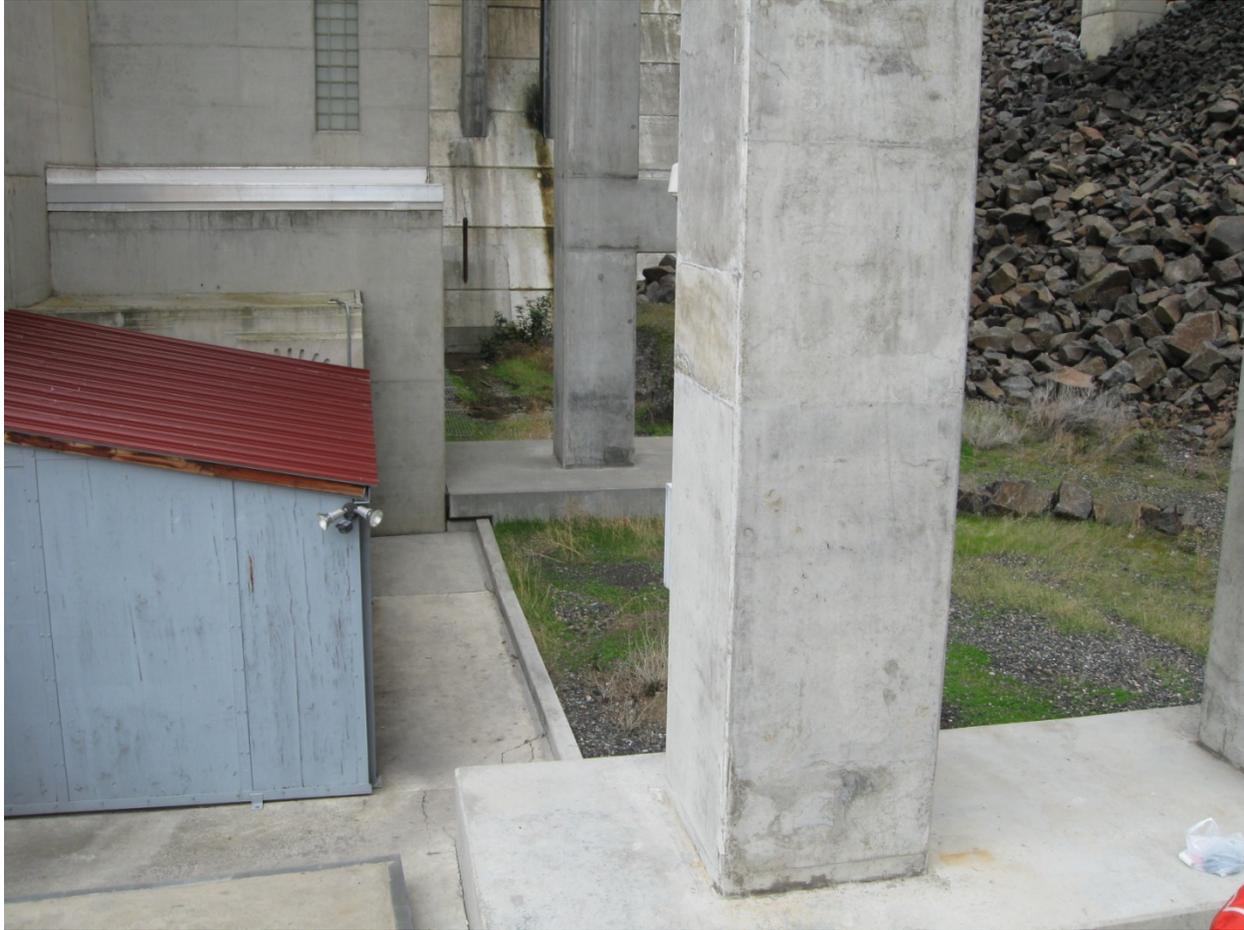
Sinkholes were looked for in the ground to the east of the fish ladder. None were found. Reference Figure 10.

Figure 10 - Area to East of SFL (Chute Columns in fore and background, non-overflow Dam Beyond)
