**GROUND
PENETRATING
RADAR
SYSTEMS, INC.**

Re: GPR Report of Investigation and Survey of Concrete – John Day Dam, Rufus, OR.

Date of Inspection: February 23, 2015

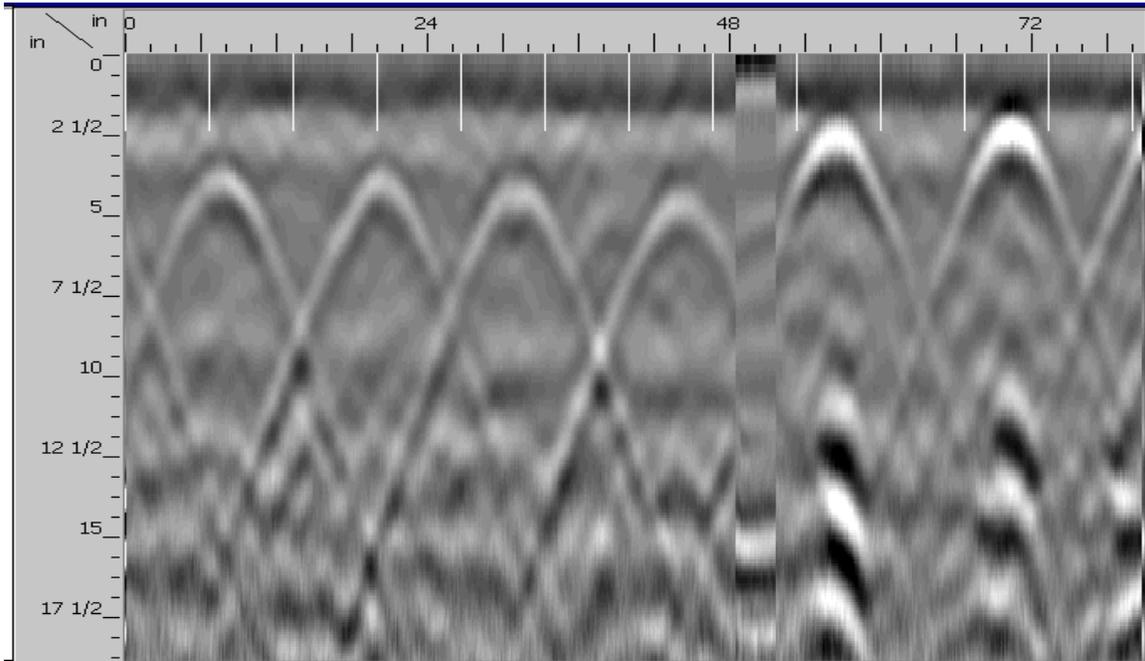
The above data was taken to the left of the failing concrete, and shows "normal" conditions
The left side of the image is a scan from left to right and the right side is a scan from bottom to top

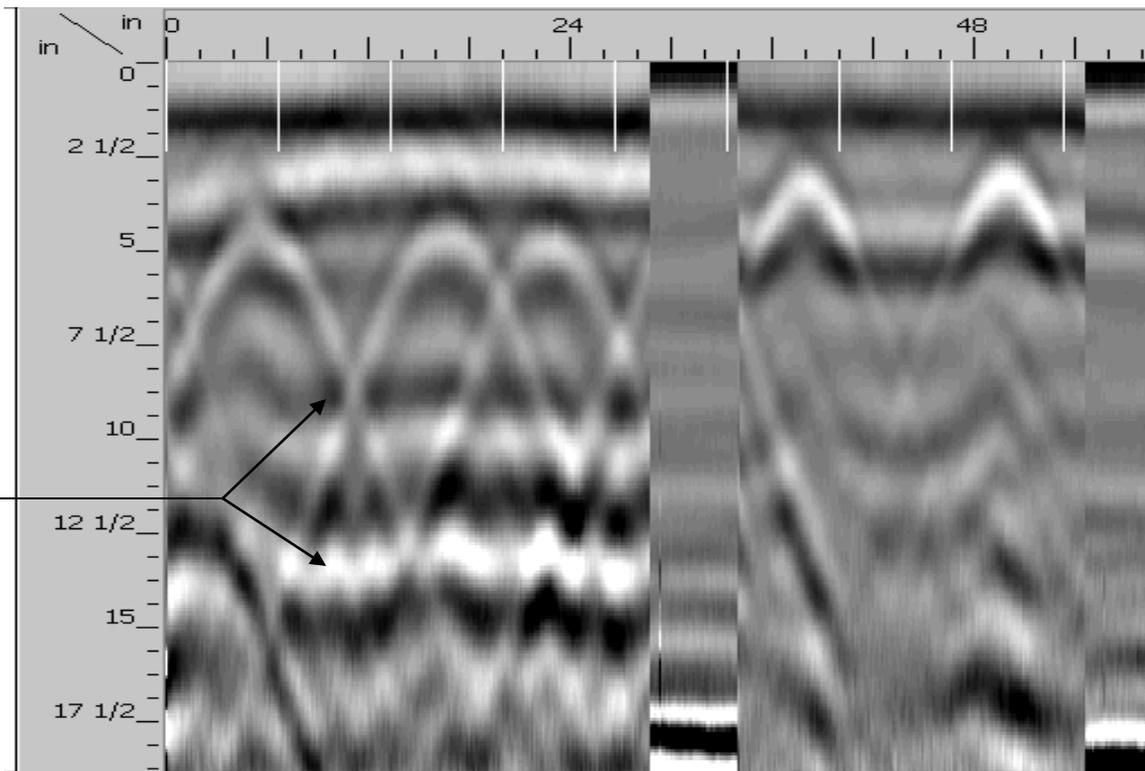
The results above are based on the field findings from the relatively simple survey conducted. Restating the findings, it is my professional opinion that the concrete in question is indeed in sub-par condition, while the other areas scanned looked to be fully functional.

The above data was taken from the failing concrete, in the same manner (left/right, bottom/top)
Evidence of voiding behind the wall

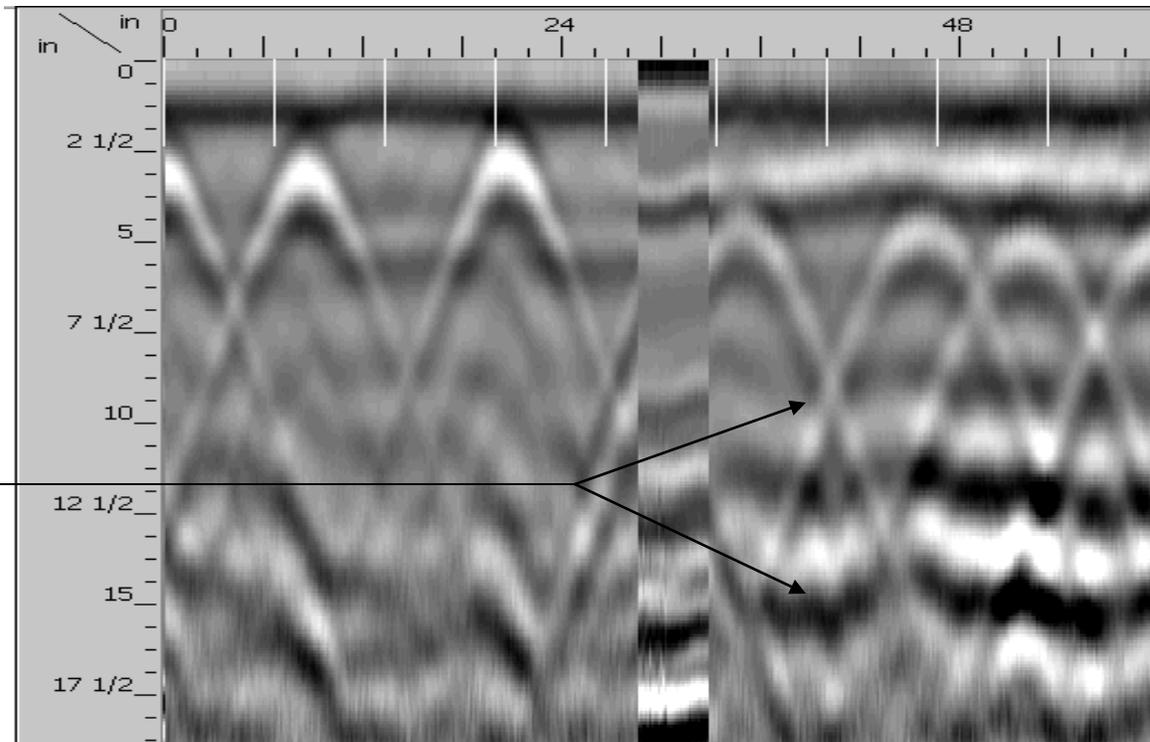
The above data is from another section of the failing concrete
Again, evidence of voiding behind the concrete

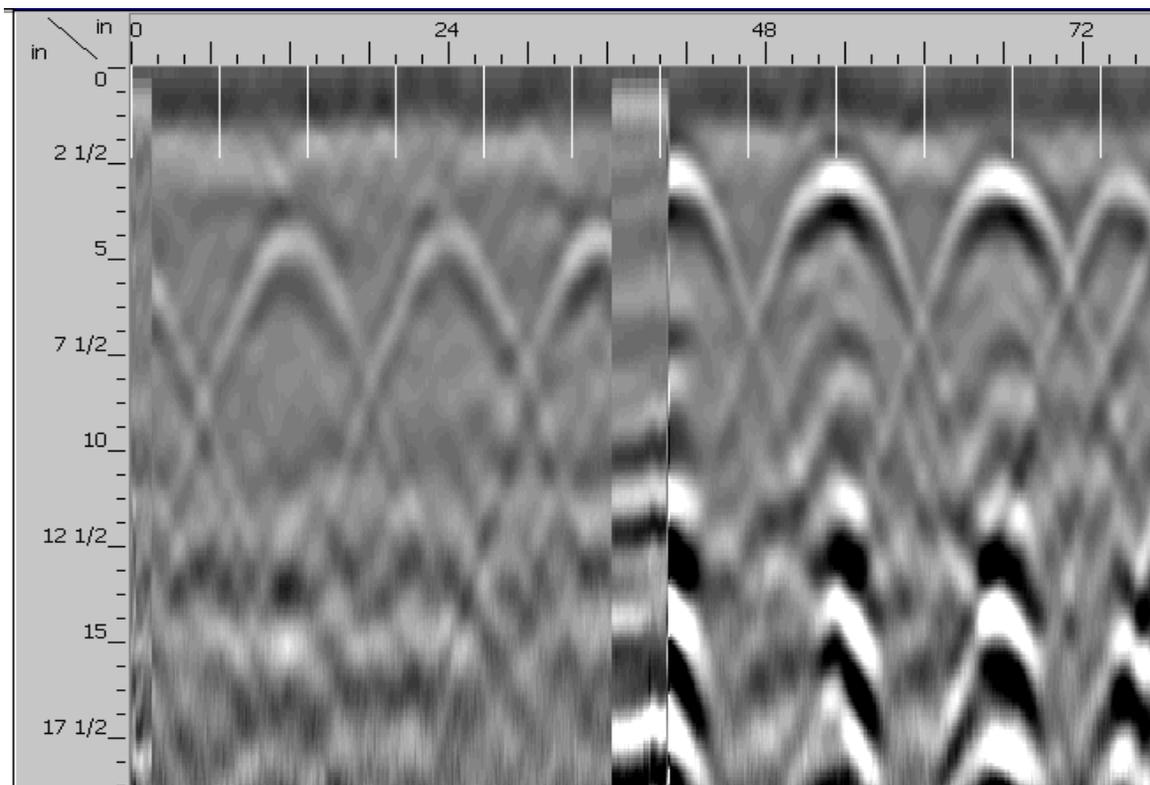
The above data was taken to the right of the failing concrete, and again shows normal conditions.

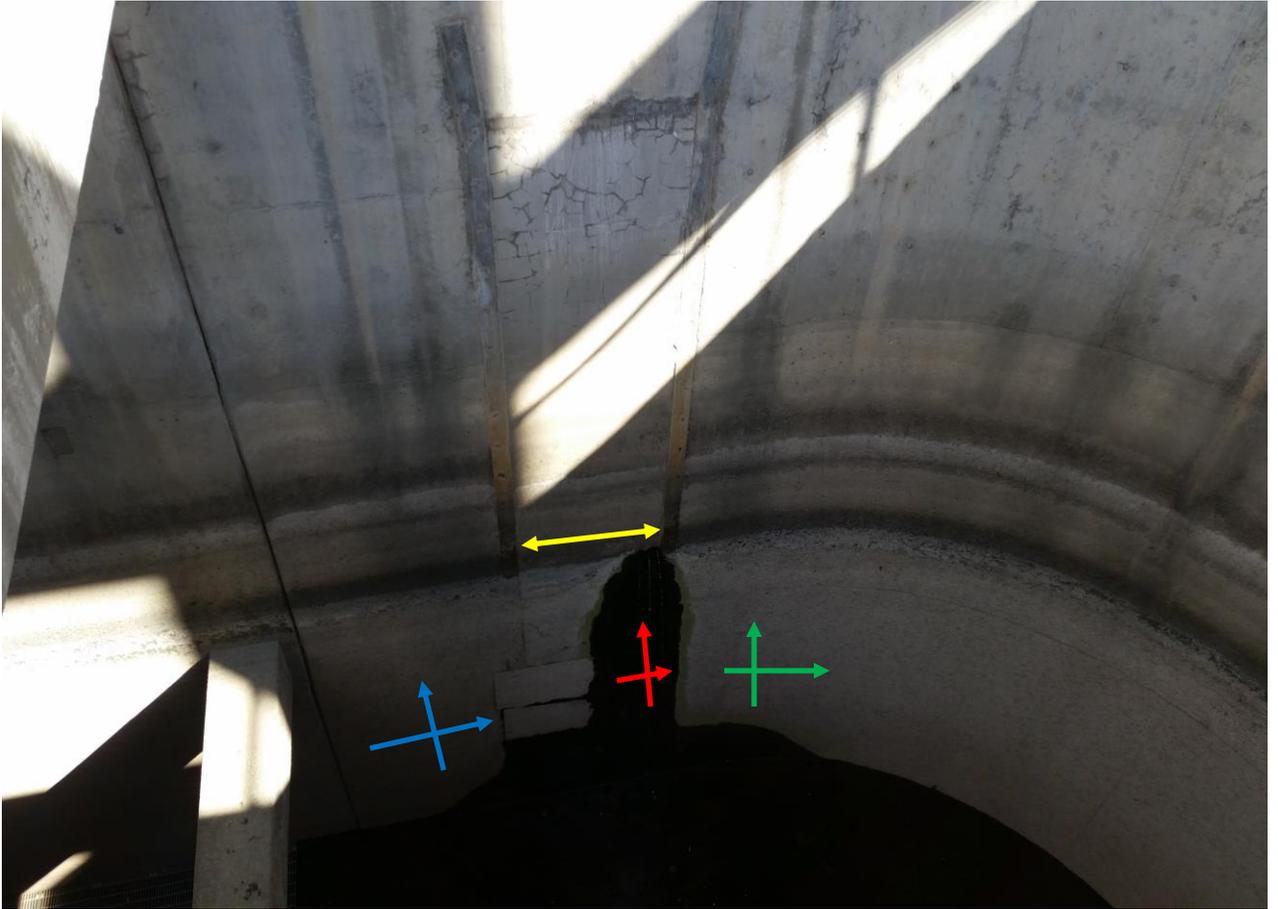
Blue arrows are areas scanned to left of failing concrete
Red arrows are areas scanned of failing concrete (yellow arrows)
Green arrows are areas scanned to right of failing concrete
