## Technical Memorandum

To:	Mort McMillen, PE	Project:	North Fishway Hydroelectric Project
From:	Bryan Duevel PE, GE, Jamie Schick, CEG	cc:	
Date:	March 5, 2015	Job No.:	5020.0
Subject:	Plunge Pool Condition Assessment and Scour Evaluation

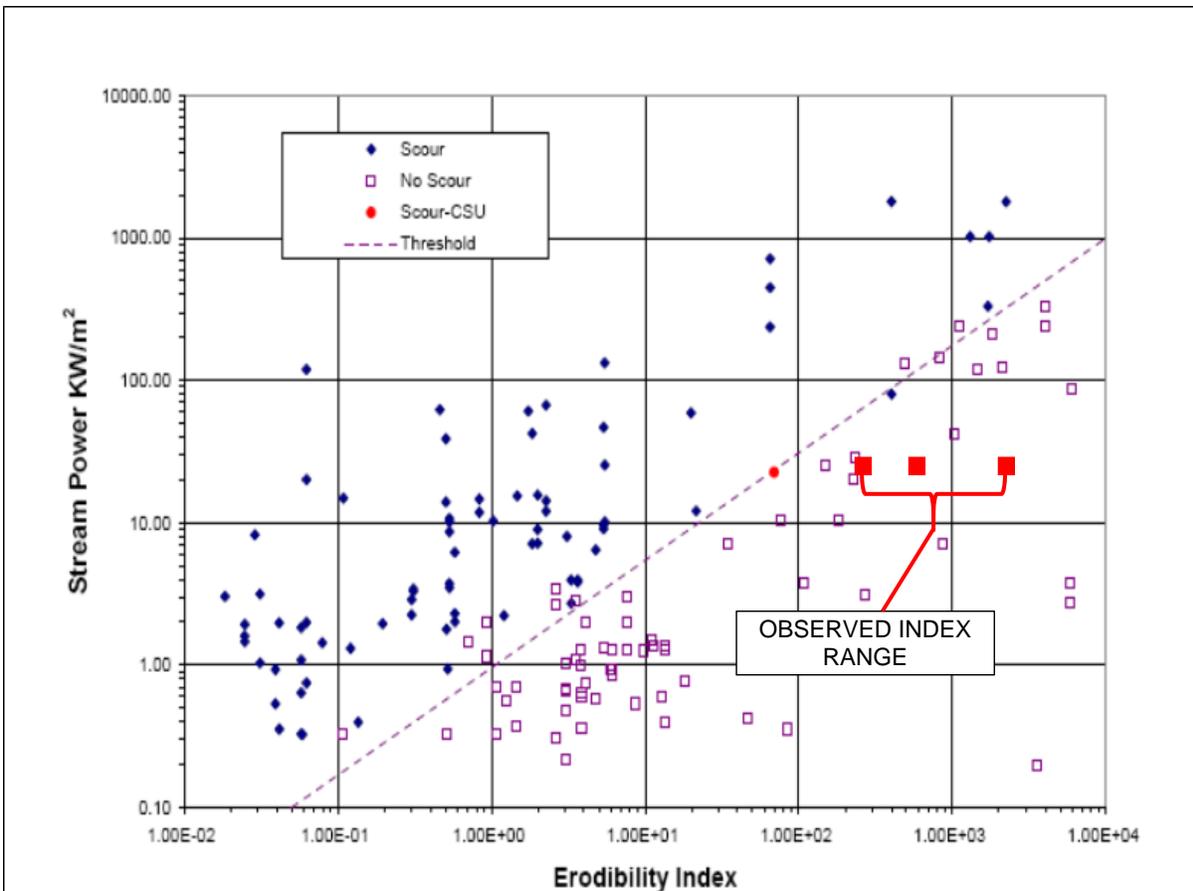
Figure 3. Erodability Index Plot

Figure 3 shows the erodability index values plotted against the stream power. Each value falls below the erodability threshold. Based on this analysis, the available stream power generated by the test flows are not large enough to initiate scour.

The analyses indicate that the available stream power at a channel discharge of 800 cfs is not sufficient to initiate scour within the plunge pool considering the rock mass conditions. This is consistent with the observations made in the pool during the current assessment, and with the overall performance since implementation of the plunge pool reinforcement. We note that localized highly fractured zones in the rock approach the erodability threshold, which is consistent with the small scour hole observed on the west wall.

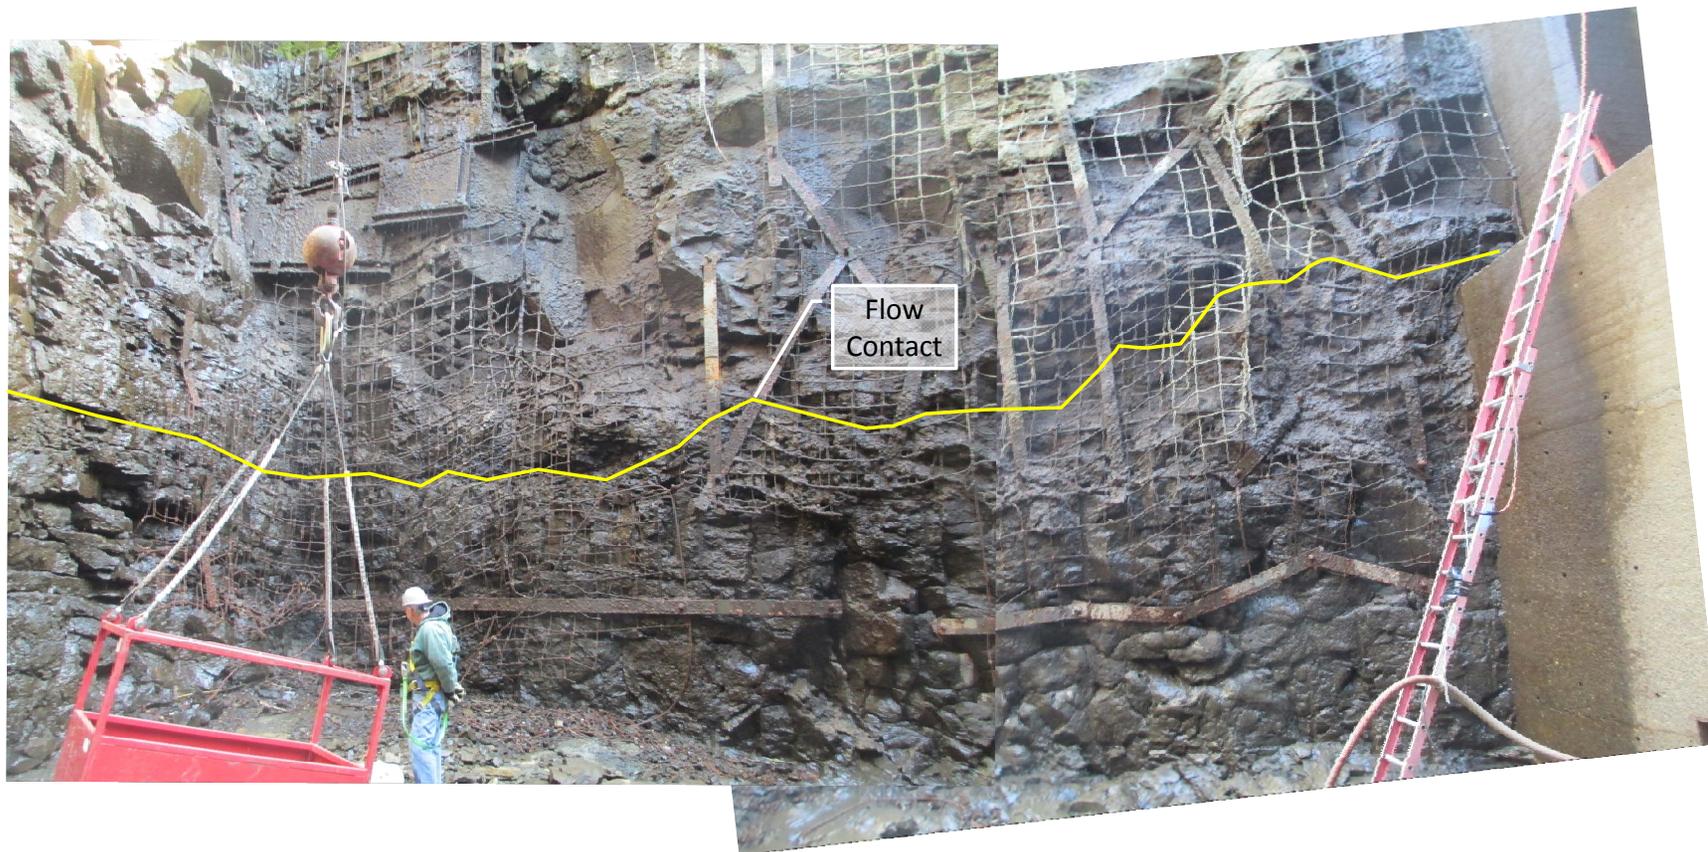
FIGURE  
1

straps were installed on a 'X' pattern between the pattern bolts on both the west and east walls (Figures 1 and 2). These straps were rusted on their surfaces but intact.

LOWER EAST PLUNGE POOL WALL

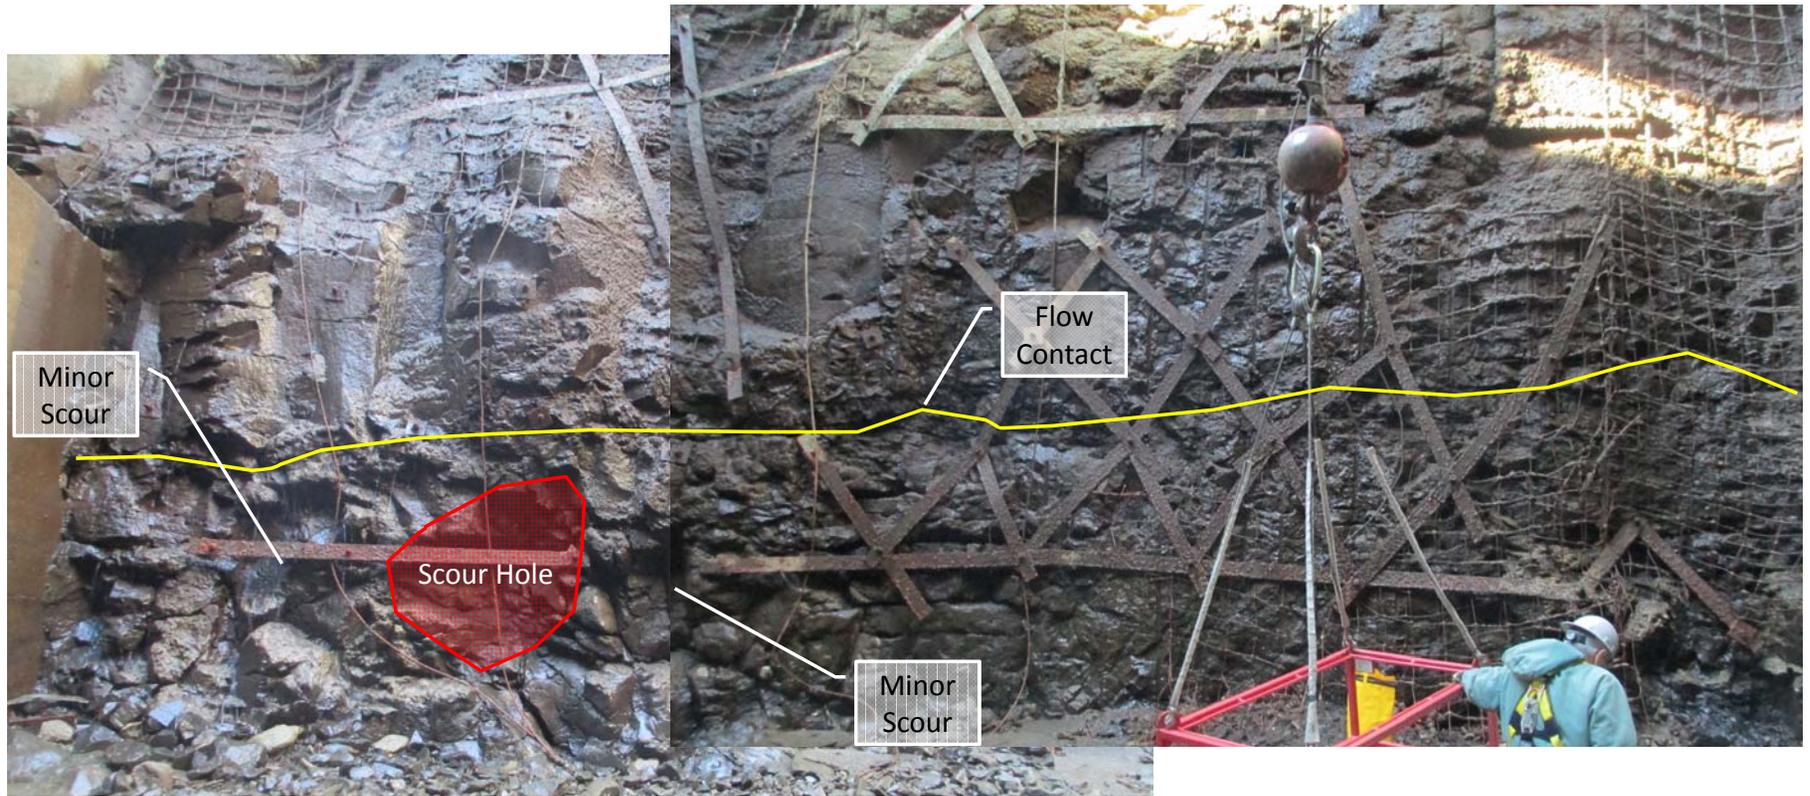
FIGURE  
2

The P-1 unit is typically moderately fractured but fracture spacing is more variable with zones of closely spaced (2 to 8 inches) fractures. This variability is most pronounced along the west wall within 15 to 25 feet of the plunge pool weir. An area of very closely (1 to 2 inches) to closely spaced joints was mapped at approximately 5 feet off the floor and 15 feet from the weir (Figure 2). The zone is approximately 6 feet in diameter.

LOWER WEST PLUNGE POOL WALL

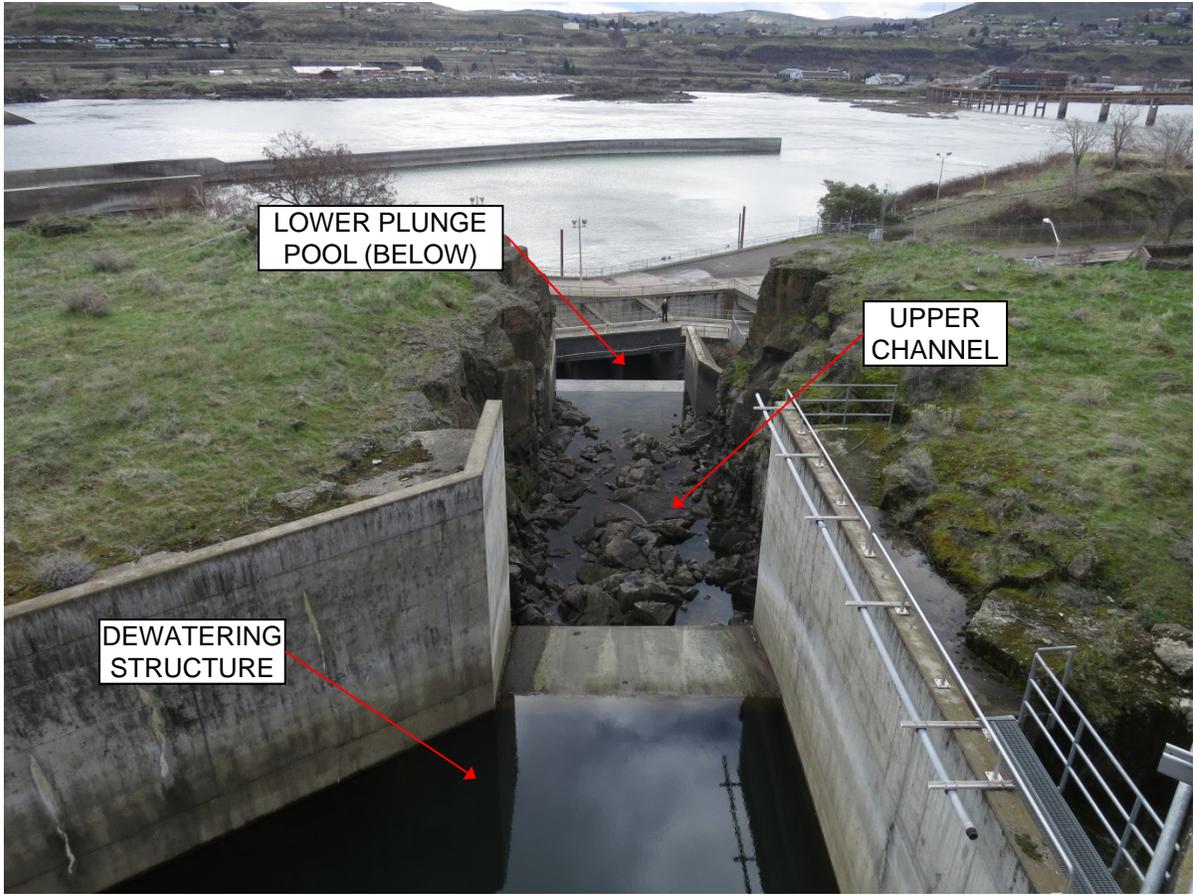
**Photograph 1.** View of the AWSS channel from upstream end. Lower plunge pool cannot be seen in photograph.

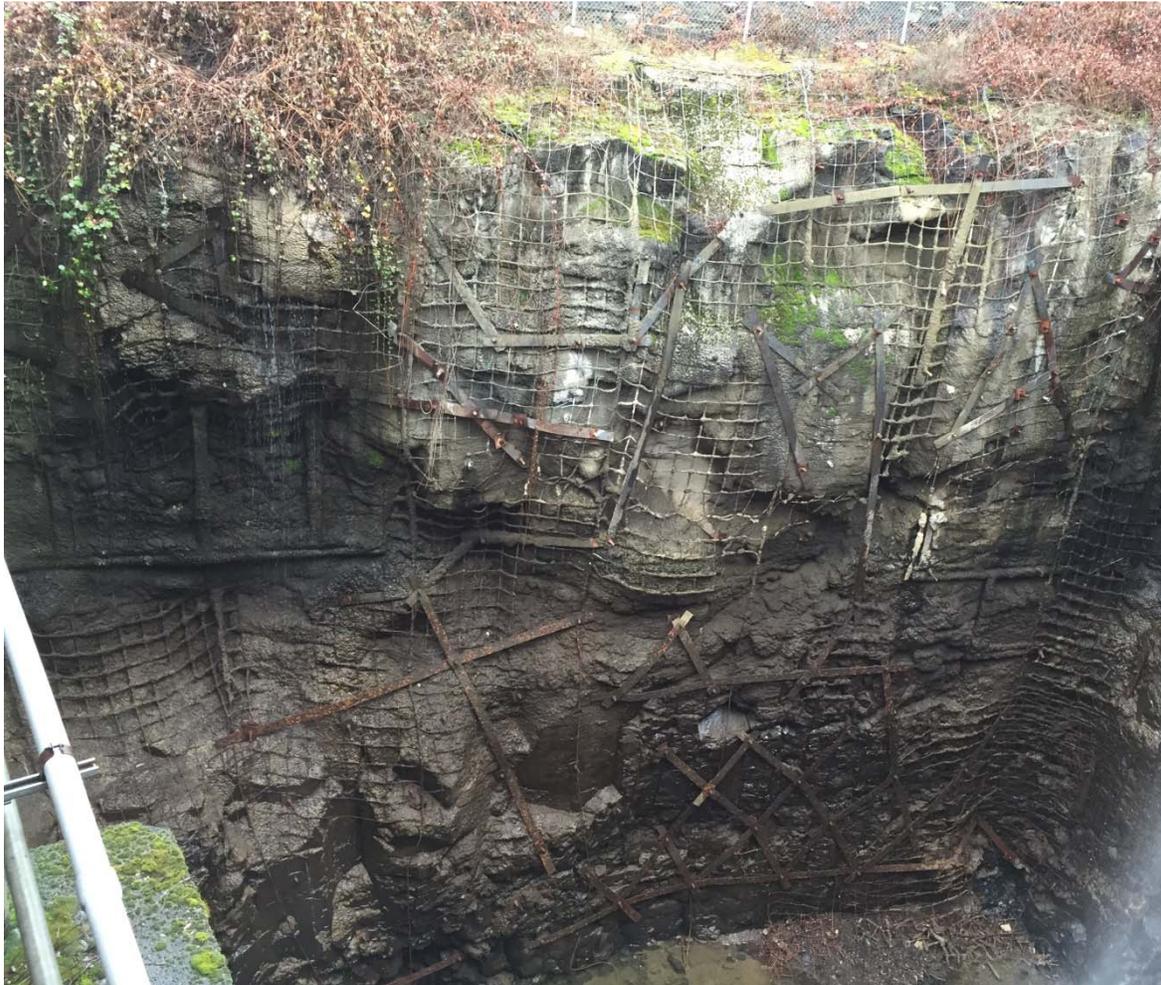
**Photograph 2.** View of the west wall of the lower plunge pool. Ground support on this wall includes shotcrete, cable mesh, rock bolts and metal straps. The shotcrete and cable mesh are missing from most of the lower portion of the lower plunge pool.

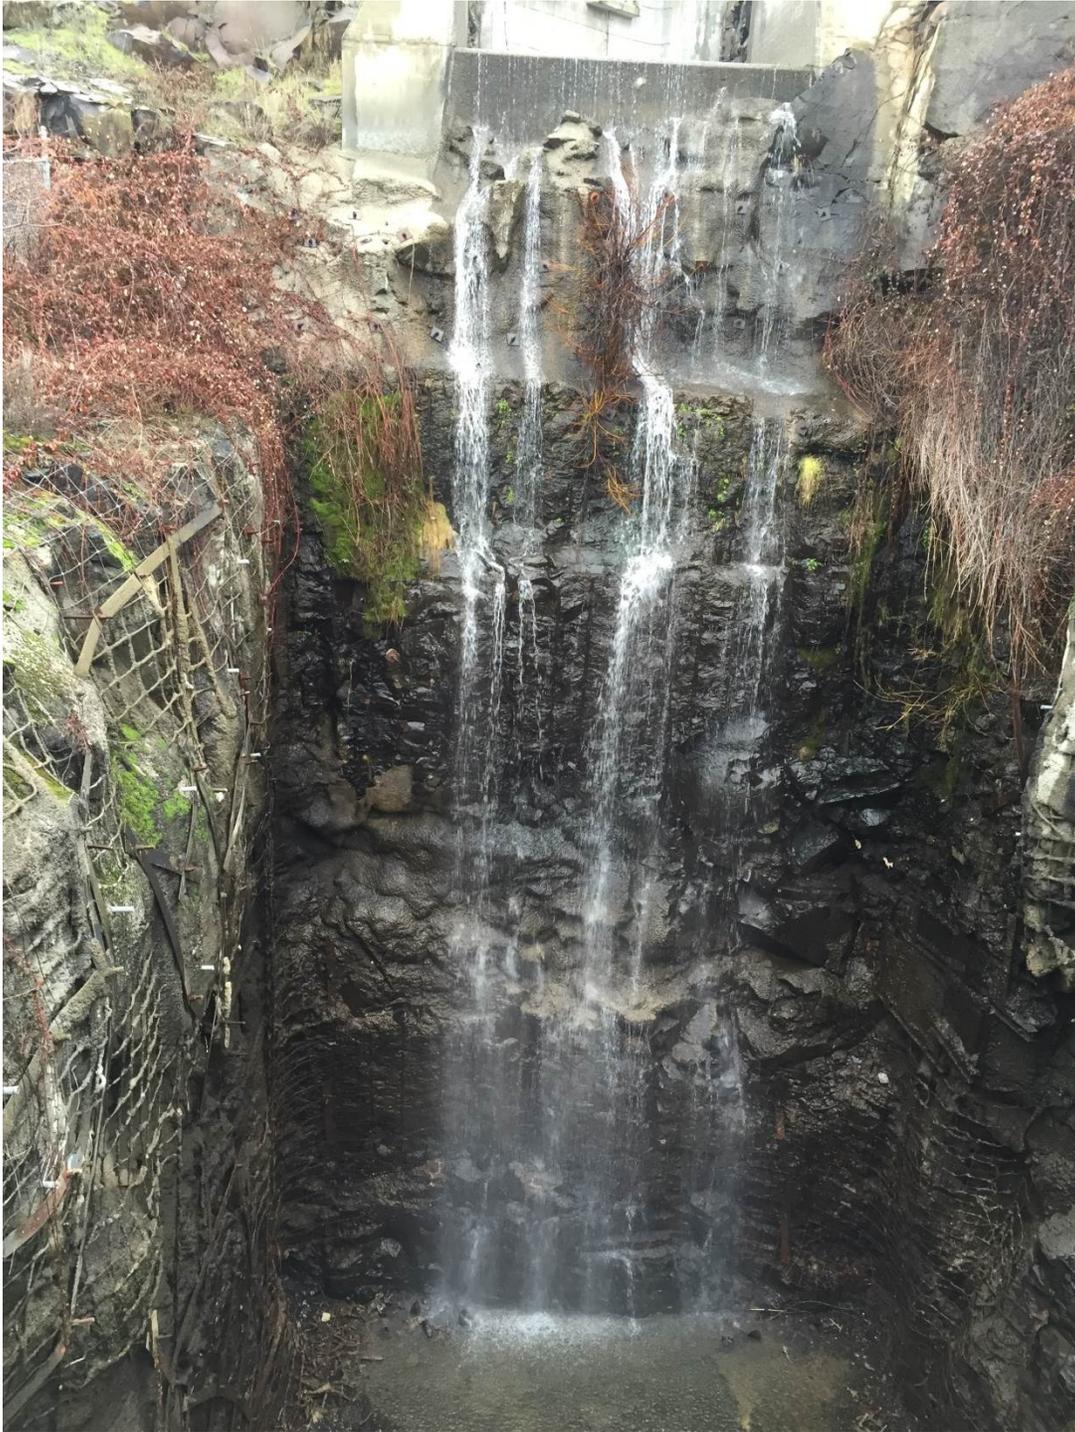
**Photograph 3.** View looking north at the back of the lower plunge pool. This face was supported primarily with pattern bolts and some shotcrete in the middle and immediately below the spillway..

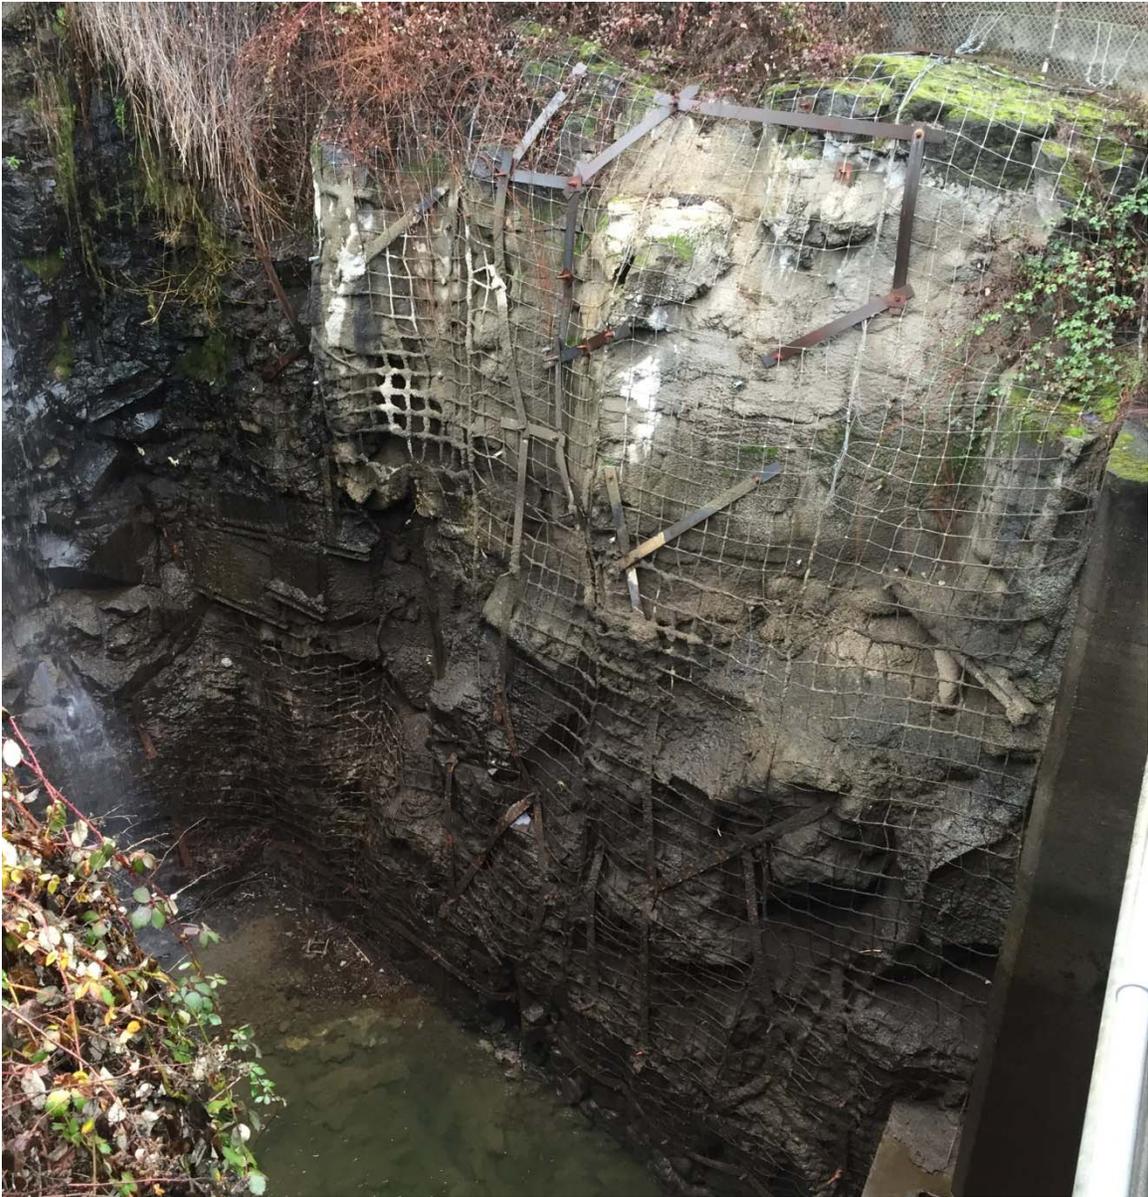
**Photograph 4.** View of the east wall of the lower plunge pool. Ground support on this wall includes shotcrete, cable mesh, rock bolts and metal straps. The shotcrete and cable mesh are mostly intact down the cut face.

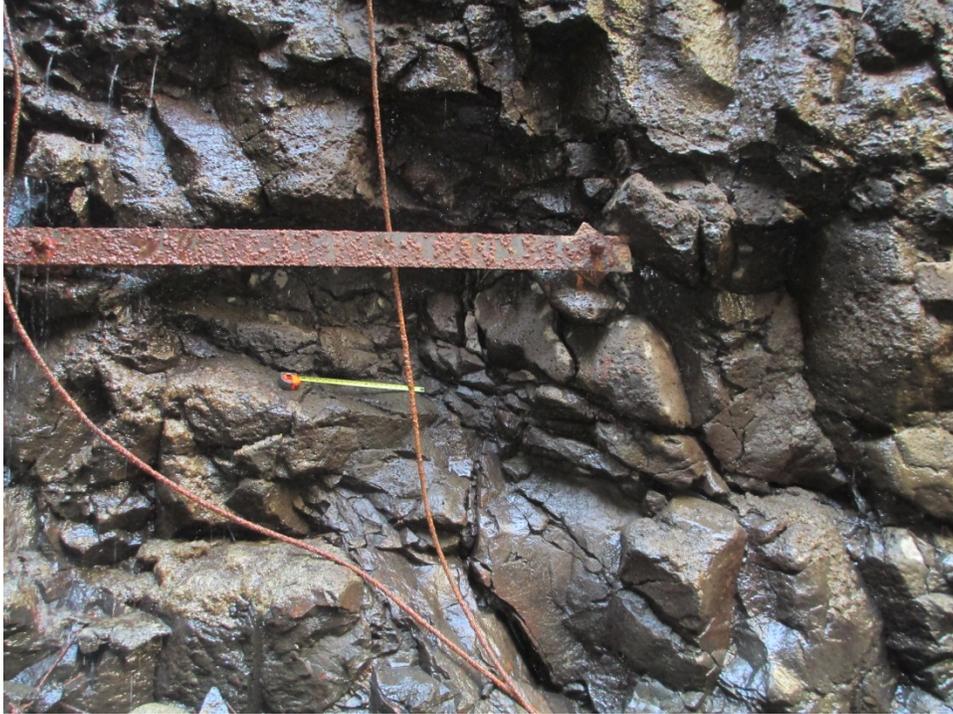
No significant scour within the plunge pool was observed. The majority of ground improvement within the pool was in good condition with the exception of the lower slope netting and possible erosion of shotcrete on the lower west and east walls. One area of apparent scour was identified near the bottom the west wall within the P-1-Unit. As discussed above, this area is more closely fractured and includes an area of very closely to closely spaced fractures (Figure 2). Several blocks appear to have been plucked from this area and a minor scour hole approximately 6 foot in diameter and 3 to 4 feet deep has developed (Photograph 5). This scour hole coincides with the very closely to closely fractured rock.

**Photograph 5.** View of scour area on the west wall. Scoured area is ~ 6 feet wide. 4 feet high and 3-4 feet deep. Exposed tape is ~ 2 feet in length.

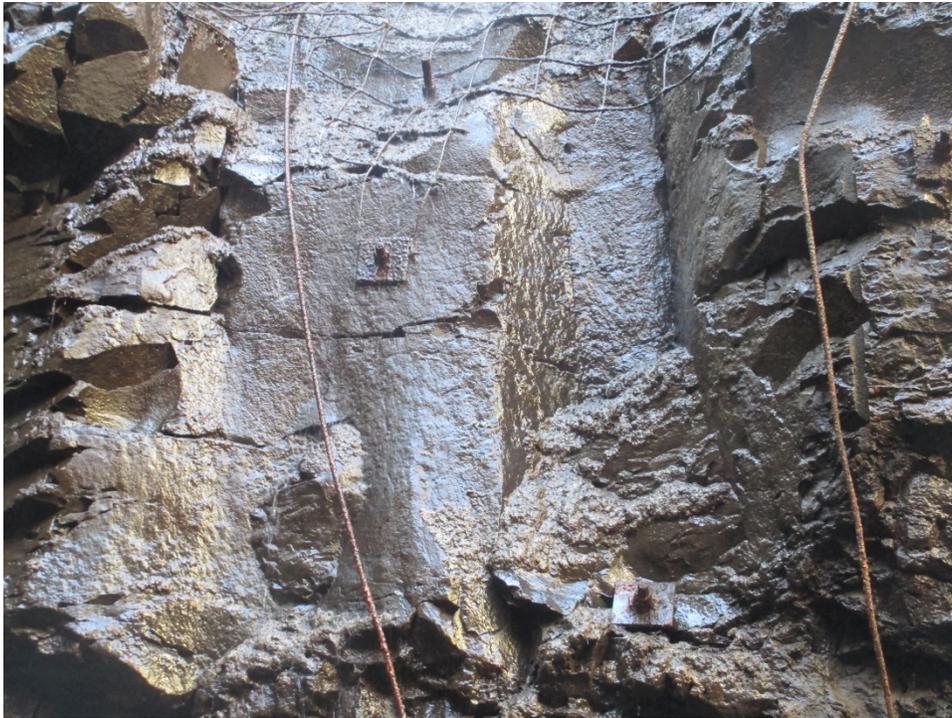
**Photograph 6.** Photograph of the ground above the scoured area presented in Photograph 4. Note the pattern bolting and relatively massive basalt with crudely developed columnar jointing.

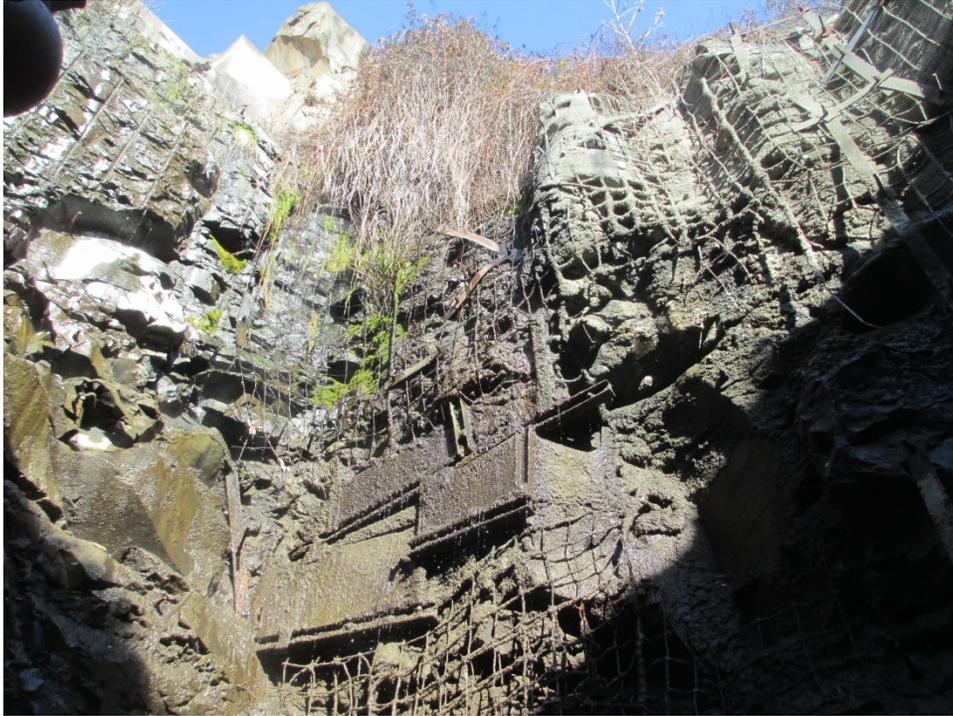
**Photograph 7.** West wall scour holes covered by steel beams and concrete fills.

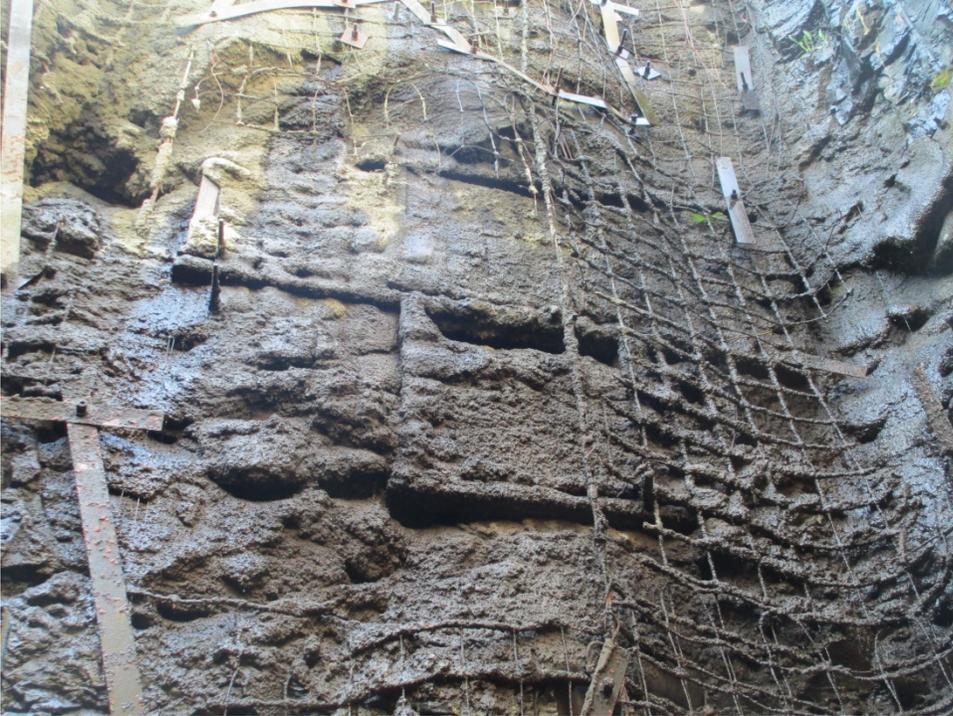
Several large scour holes were noted in the USACE plunge pool repair report (USACE, 1997). Several of these were apparently repaired by bolting several H-beams to the walls on approximately 3 to 4 foot centers and backfilled with concrete. This repair was completed on the west wall approximately mid-depth, adjacent to the intersection with the north wall (Photograph 7) and above the plunge pool weir. On the east wall, this mitigation was completed approximately mid-depth adjacent to the intersection with the north wall (Photograph 8).

**Photograph 8.** East wall scour holes covered by beams and concrete fills.

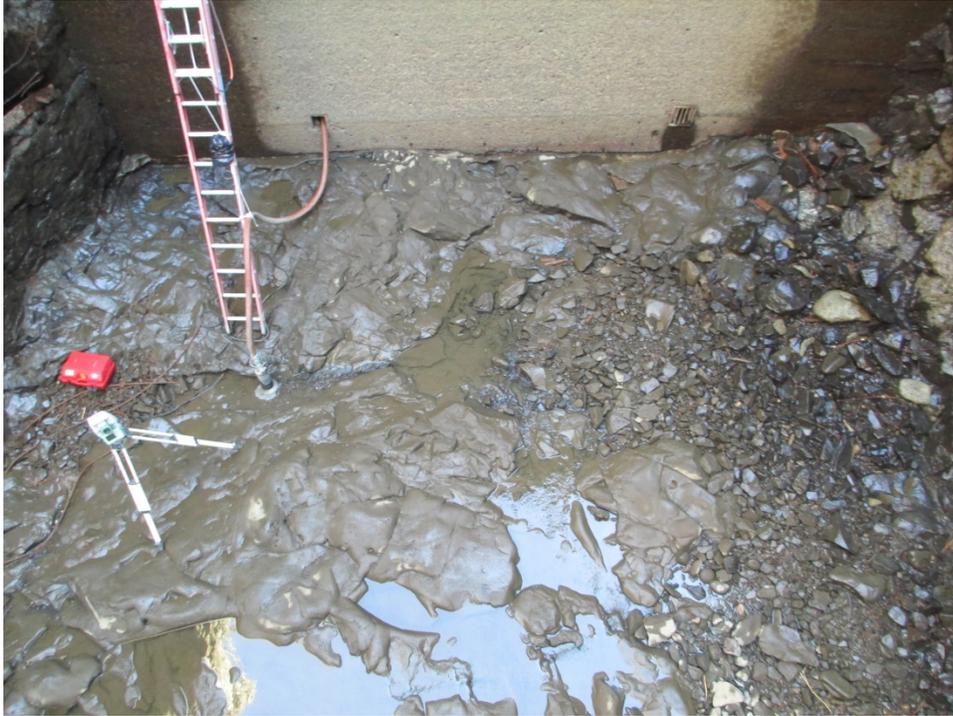
The plunge pool floor has a 'subrounded' surface associated with grinding down of the exposed rock by loose debris within the pool (Photograph 9). The surface has been scoured down 3-5 feet since initial construction in the 1950s. Based on the smooth surfaces, 'plucking' of rock blocks is not actively occurring. The observed scour may be associated with grinding of rock blocks on the floor during spilling events.

**Photograph 9.** Lower plunge pool floor
