<b>DESIGN DOCUMENTATION REPORT</b> The Dalles Dam, Columbia River North Fish Ladder Rock Wall Stabilization	
	Issue/Revision No.: I1-R1
	Issue/Revision Date: August 25, 2015

**Design Documentation Report**

**THE DALLES DAM  
COLUMBIA RIVER**

**NORTH FISH LADDER ROCK WALL STABILIZATION**

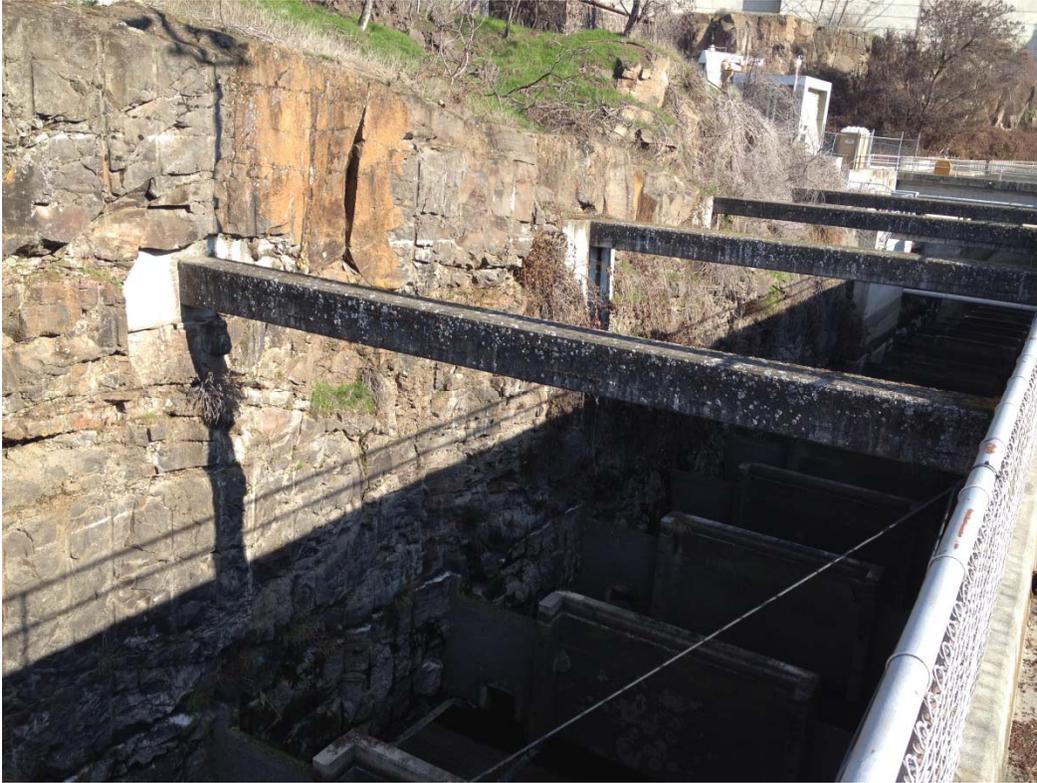
**Figure 4 – Photograph looking north-northeast towards section of fish ladder between weirs No. 77 and 92. Note concrete struts supporting wall to the right of the photo.**

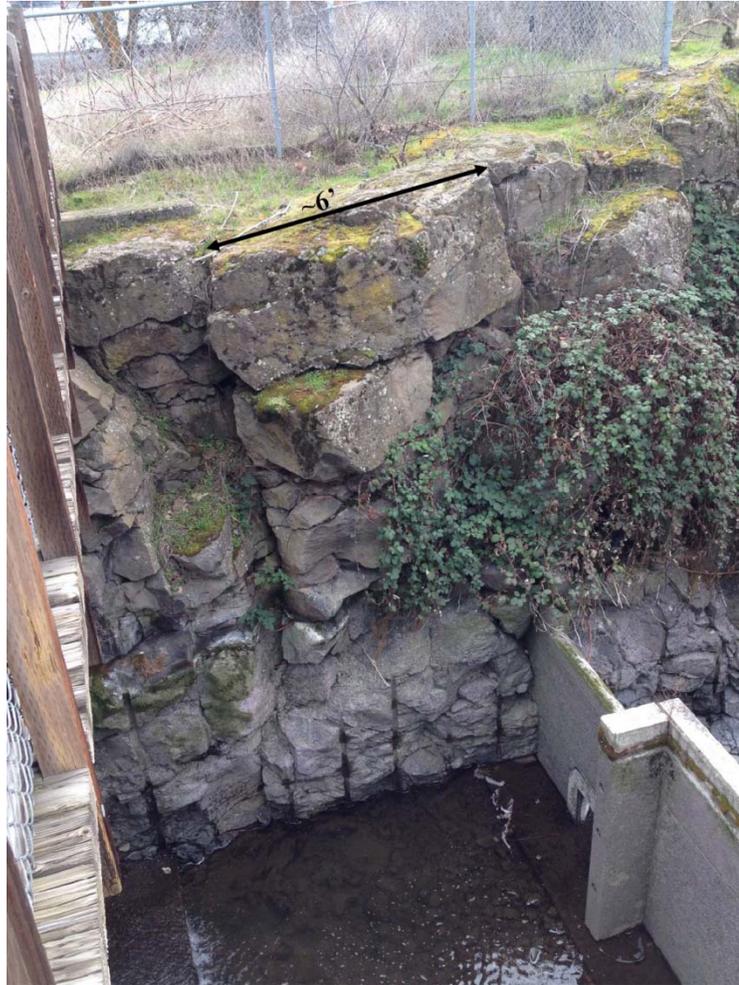
Fracturing in the basalt rock exposed in the north fish ladder and AWS channel generally consist of widely spaced primary fractures (cooling joints) and close to moderately spaced secondary fracture which bisect the blocks formed by the primary fractures. The fractures are tight to slightly open and often curve away from the vertical toward the bottom of a flows. Based on mapping completed in the AWS channel, fracture surfaces are generally smooth, and are typically stained with iron oxide or coated with an altered secondary mineral. Average fracture spacing ranged from 0.7 feet to 1.6 feet with an overall average spacing of about 1 foot. However, intact blocks or boulders which have weathered from the exposed rock cut faces in the fish ladder are commonly greater than 2 feet diameter, and can be up to 6 feet in diameter (Figure 11).

***Figure 11 – Photograph looking south towards the southern fish ladder rock cut near weir 130. Rock blocks up to 6 feet in diameter have weathered out of the cut face in this area.***

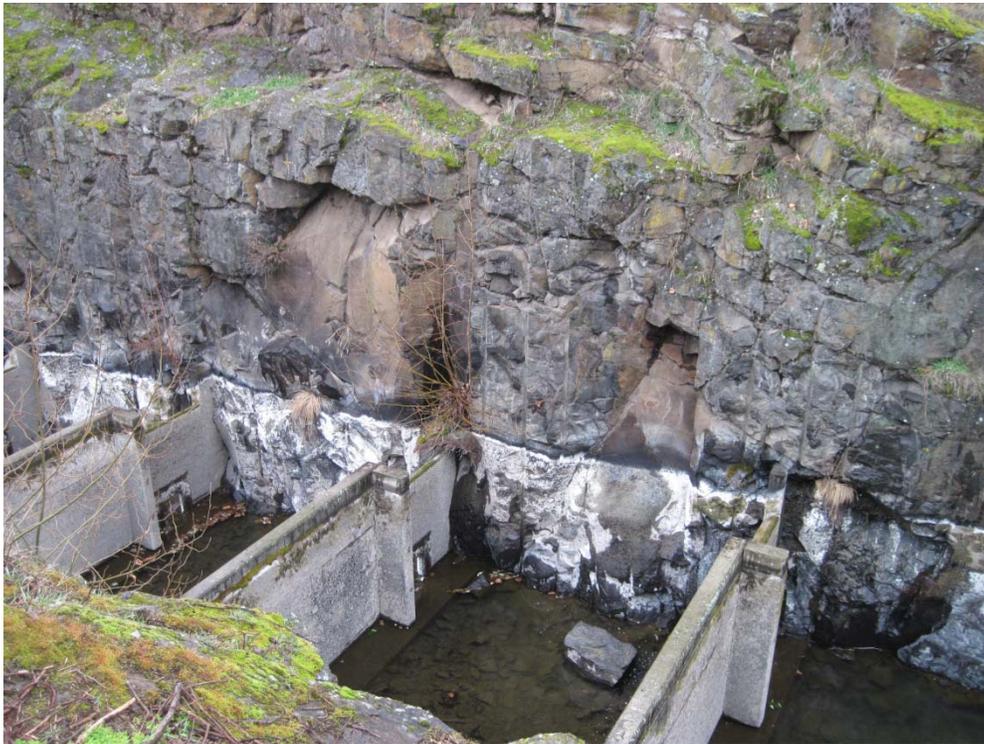
Based on site observations of the north fish ladder slopes, the primary block failure types are wedge to planar-wedge (Figure 13). Both types of failures are primarily controlled by the orientation and the spacing of the discontinuities with respect to the slope face. There are also indications of the occurrence of toppling type failures in some locations, where columns of rock, formed by steeply dipping discontinuities in the rock, rotates about a fixed point causing rock fall. In general, the fragments and blocks that fail are a few inches to a few feet diameter. However, large failures are possible, which can mobilize blocks up to 6 feet diameter (Figure 11)

**Figure 13 – Photograph looking west towards the northern part of the fish ladder, showing recent rock fall.**

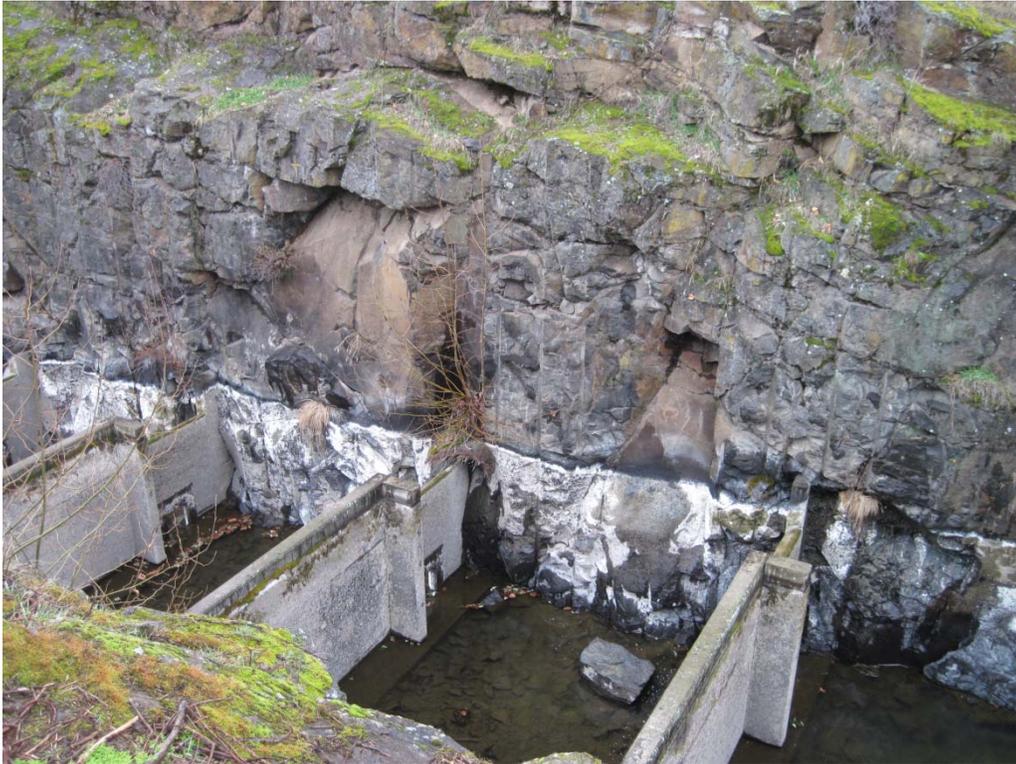
**Photo 2 - Showing areas of recent rock block fall. Localized rock anchors are required.**

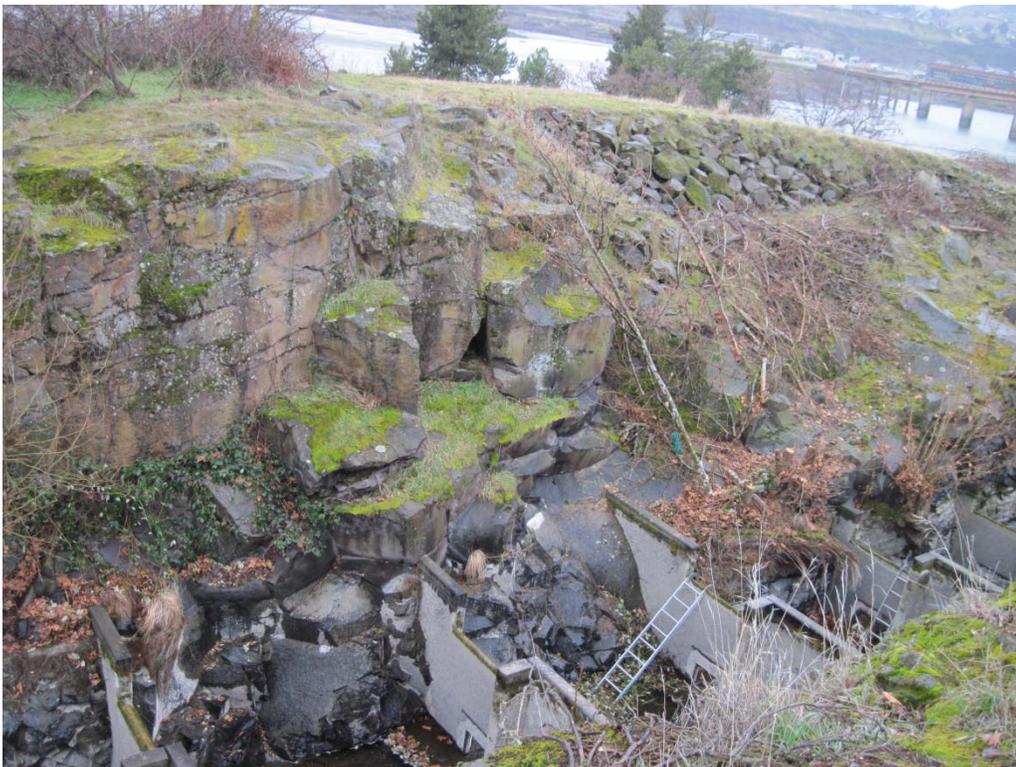
**Photo 3 – Showing large rock blocks that may be at risk of toppling. Localized rock anchors may be required.**

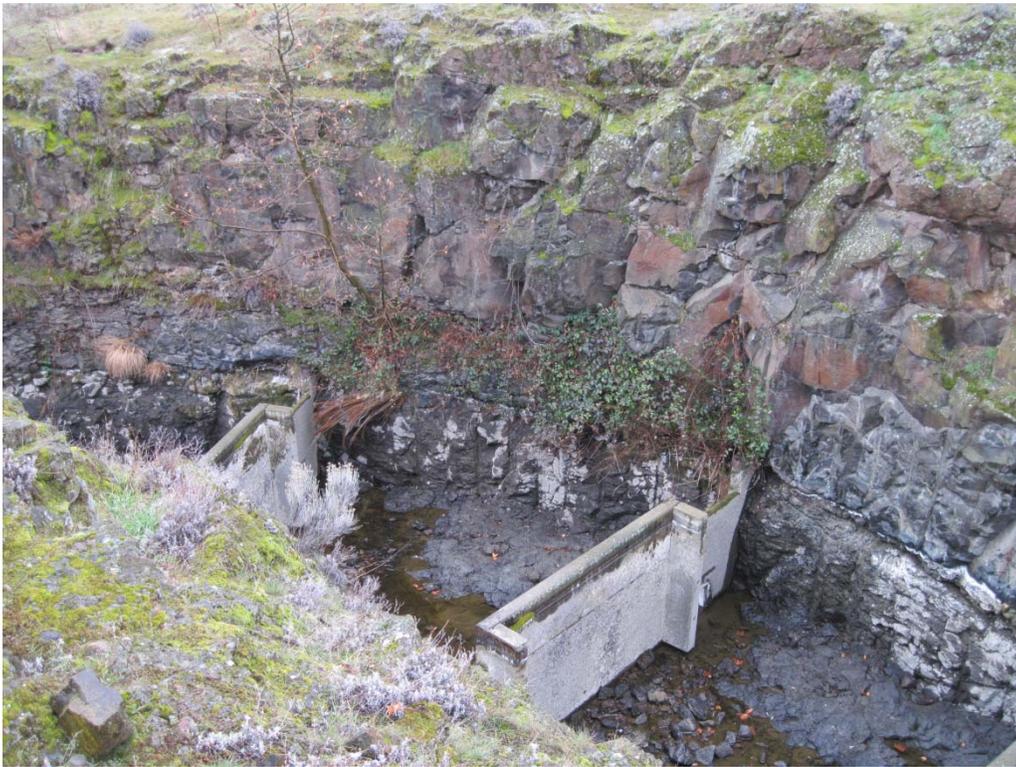
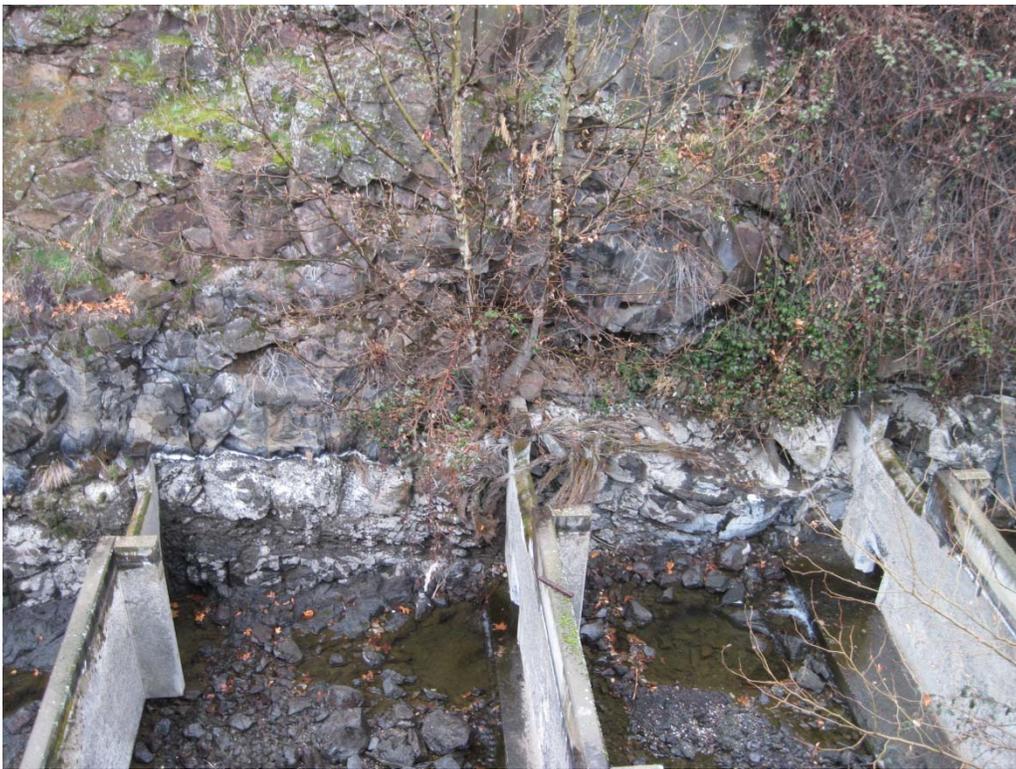
Photos 4 & 5 – Sections of rock cut needing vegetation removal and scaling.

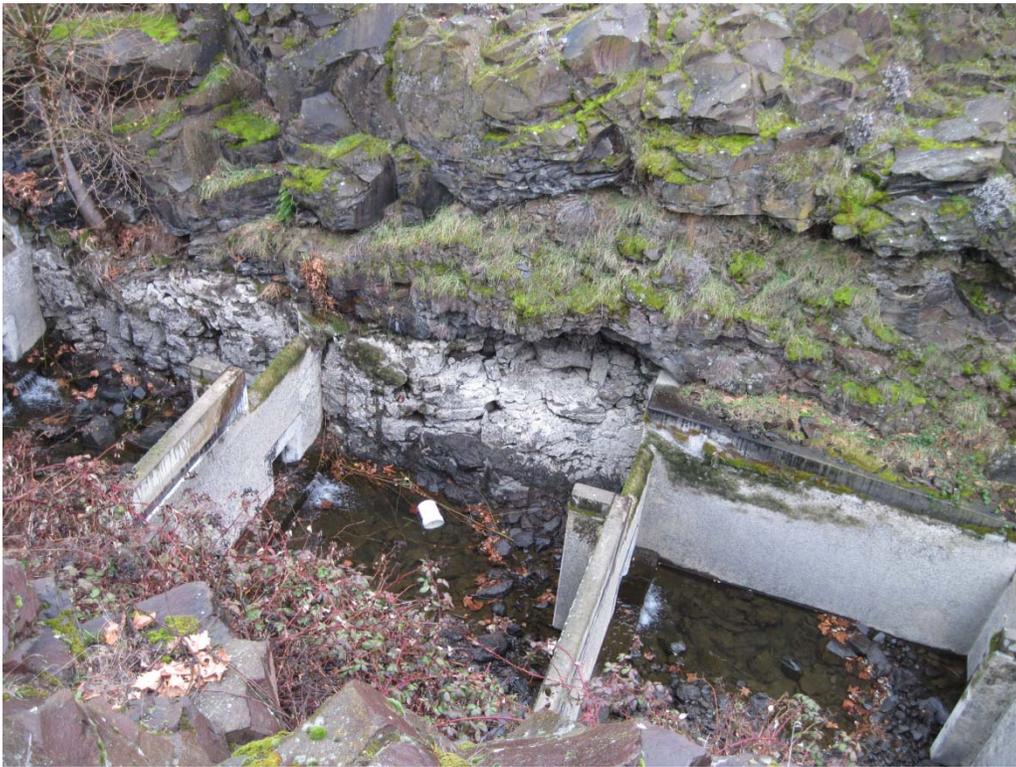
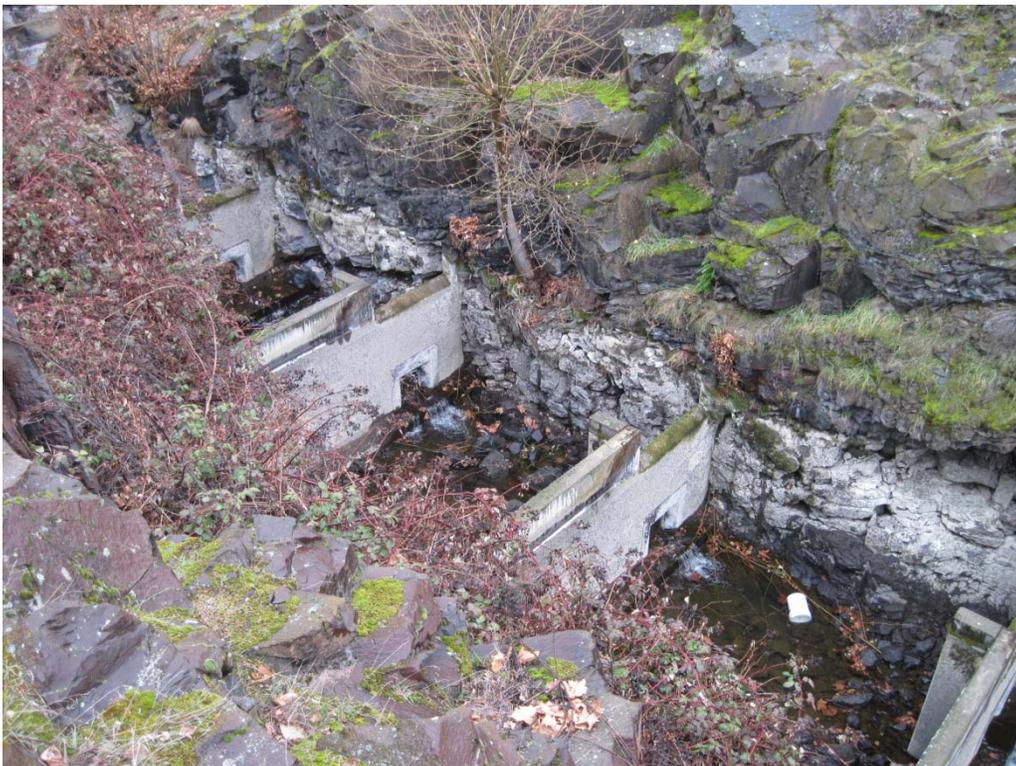
No Action: Water flow in the fish ladder has cause significant erosion and undercutting along a bedding plane between weirs 120 and 123. This erosion has caused undercutting of several feet in one location, which threatens to cause failure of the overlying rock face, which can damage the weir. Because of the fractured nature of the rock above the eroded section, it was determined that installing rock anchors alone would not protect the weirs from future rock failure. Because of the rock fall threat to the weirs, the 'no action' alternative was not selected as a preferred alternative.

**Photos 6 & 7 – Area of lower rock cut being eroded and undermined by water flow. This area of cut may require construction of a concrete wall structure to protect lower rock cut for further erosion.**

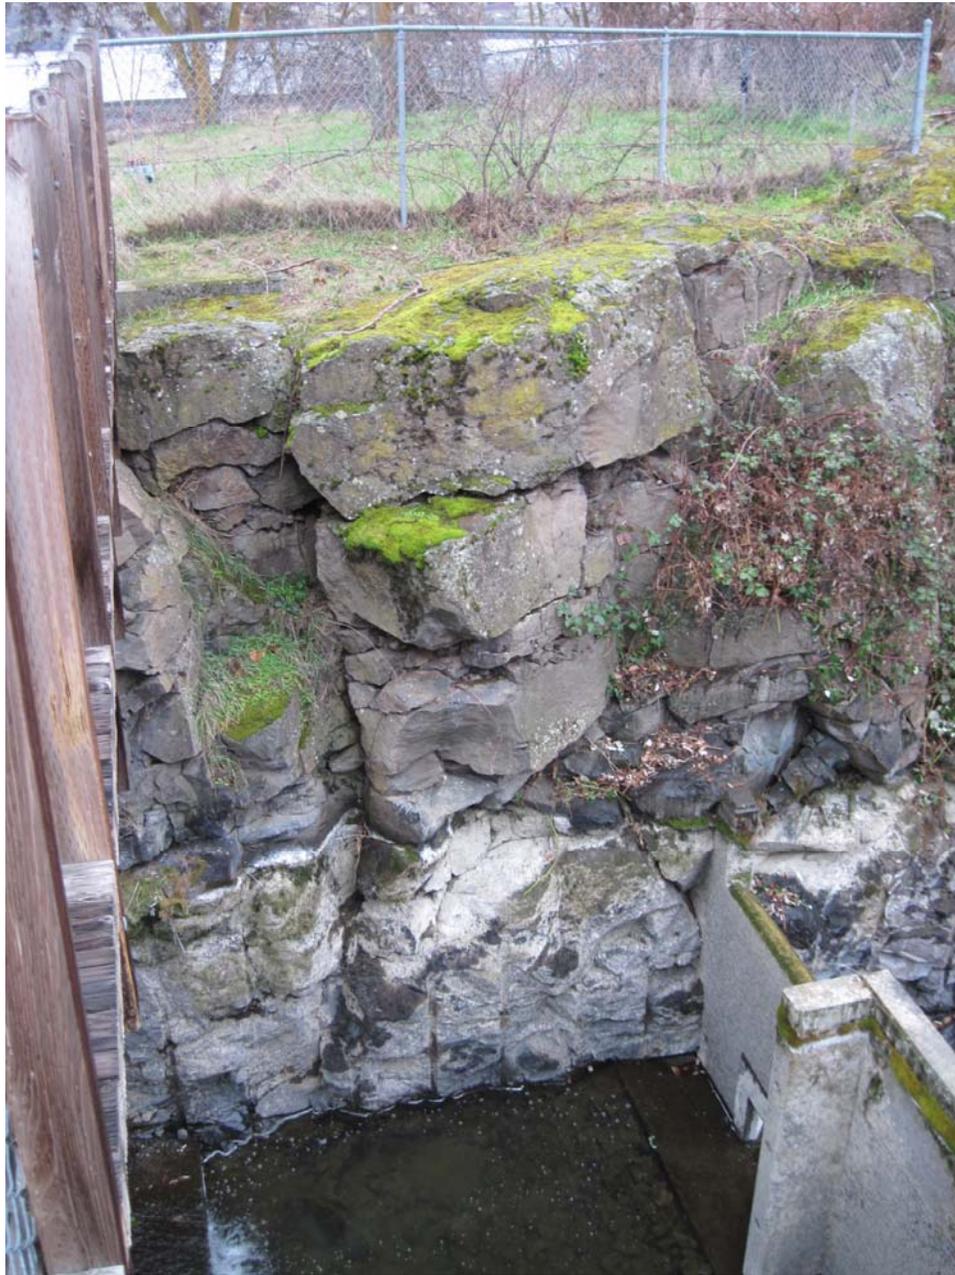
**Photo 8 – Area of unstable rock blocks, near footbridge. Although these blocks appear unstable, it would be difficult to anchor or scale this area without threatening damage to the fish ladder. This area should be monitored, and any work in the area should be done to limit impacts to the slope. Workers access to this area should be limited.**
