**JOHN DAY DAM
TRIP REPORT
SOUTH FISH LADDER SUBSIDENCE
May 6, 2015**

1. GENERAL. Subsidence at the south fish ladder (SFL)/Juvenile Bypass System outfall chute (JBS outfall chute)/JBS elevate chute was observed on May 6, 2015 during the 2015 Annual Inspection. A potential void area of at least 4' x 6' x 3' deep below the existing sidewalk between the SFL Section 10 and the JBS outfall chute is likely caused by internal erosion from leaking contraction joints in the JBS outfall chute. Further erosion could possibly affect the stability of the SFL, JBS outfall chute, and/or JBS elevated chute, and should be further evaluated. Recommendations are included in Section 4 of this trip report.

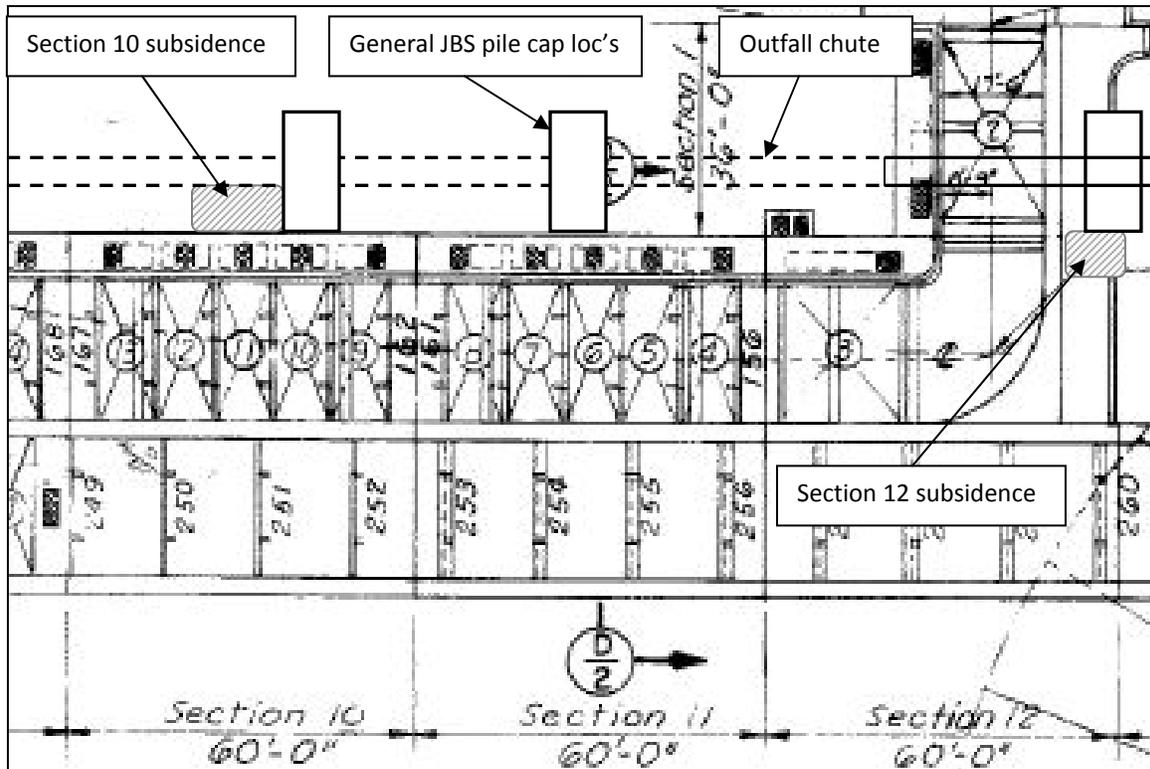
A similar depression was observed and studied at Section 12 in January 2015 and was documented in a trip report dated January 28, 2015 (Figure 1). It is likely that the failing concrete from the abandoned temporary fish ladder plug is allowing backfill to erode thus creating a void.

Figure 1. South Fish Ladder general plan showing subsidence and critical JBS features

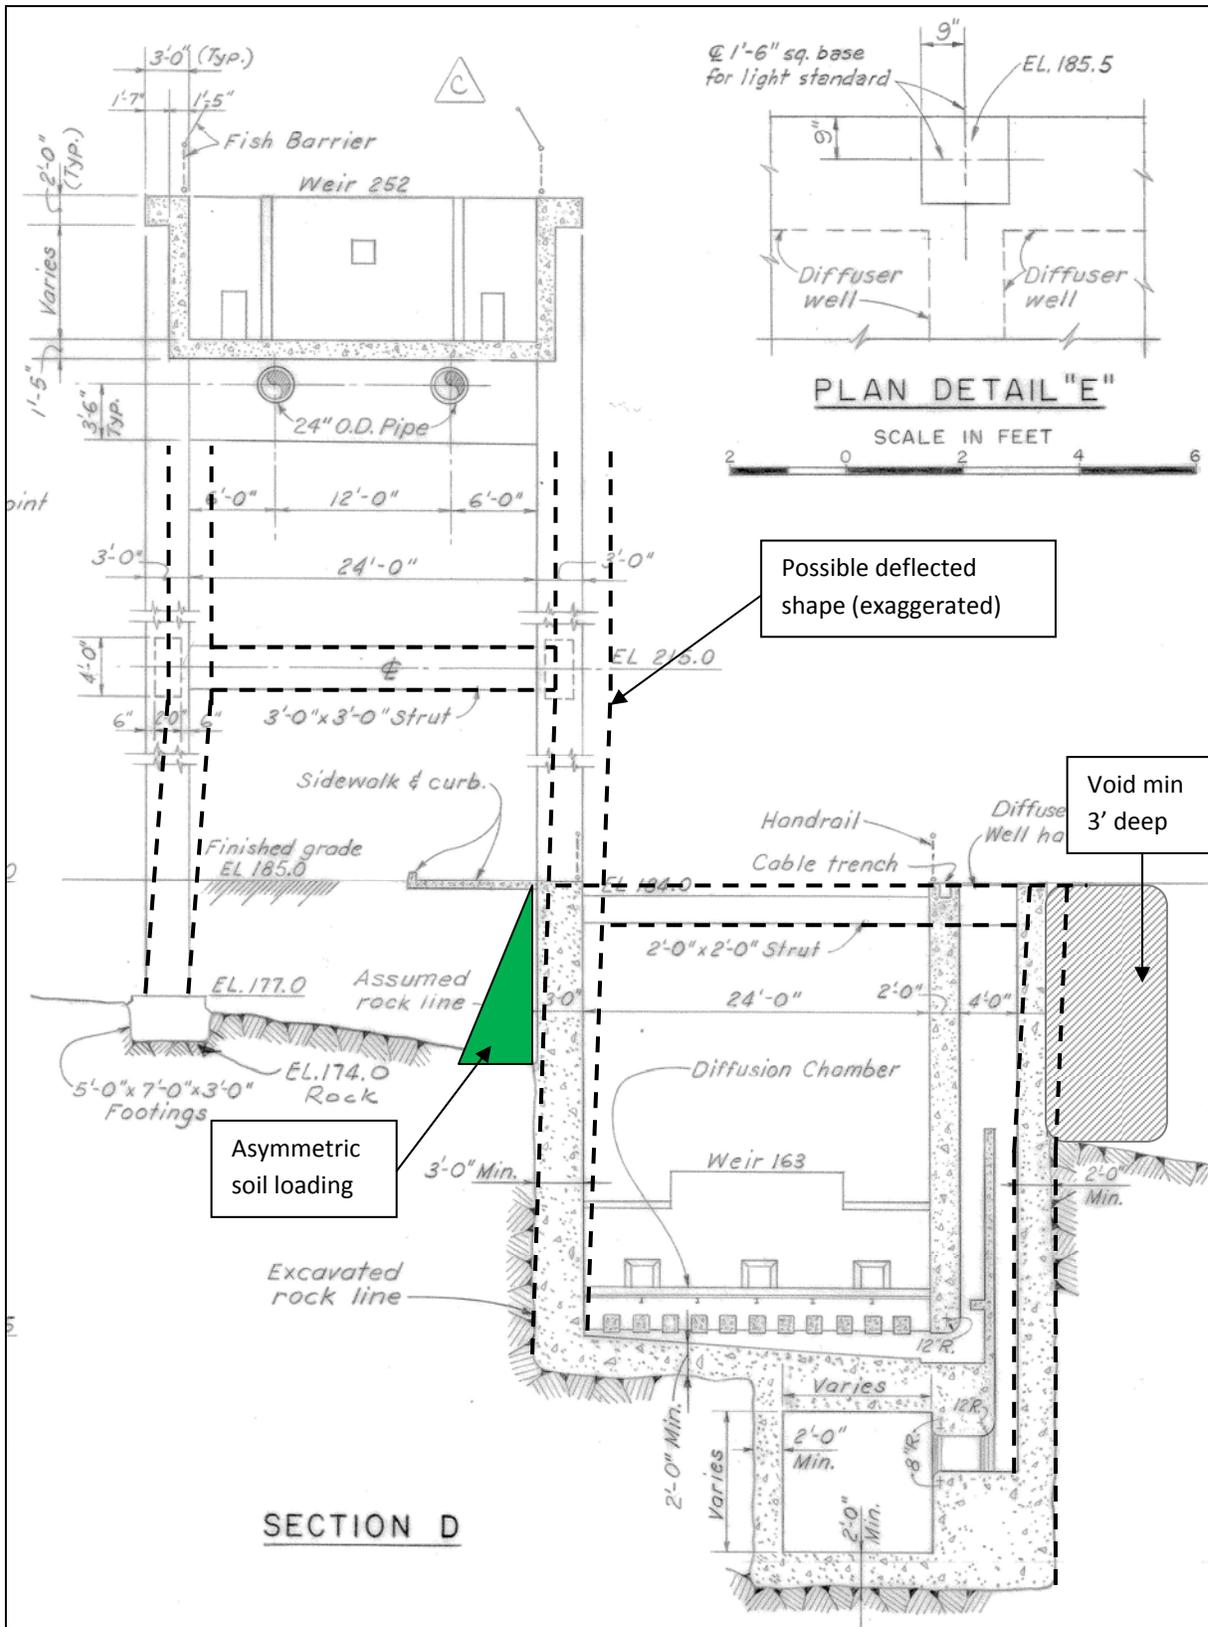
Construction drawings indicate that the SFL is excavated into hard basalt so global stability of the fish ladder is probably not a concern. However, if the fish ladder was not designed for asymmetrical soil loading, a large enough void on the north side could create an internal stability problem as indicated by the exaggerated deflected shape shown in Figure 3. It is not known at this time if the SFL design considered this condition. The structural calculations should be reviewed and the SFL should be evaluated for internal stability with asymmetrical soil loading on one side if the original design did not consider asymmetrical soil loading.

Figure 3. SFL Section 10 showing possible effect of void and exaggerated deflected shape due to asymmetrical soil loading

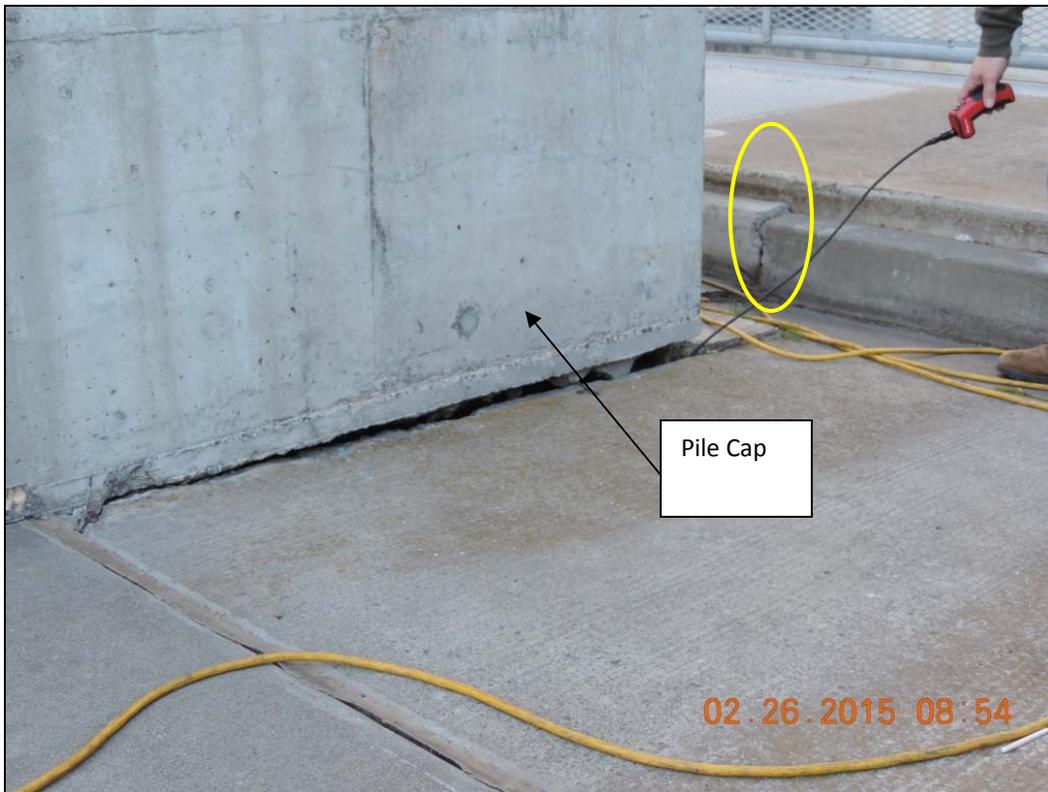
In February 2015 the Project discovered a void area below the sidewalk at the north side of the SFL at Section 10, adjacent to a JBS column pile cap (Figure 1). Project staff used a camera to probe the void area below the sidewalk. The probe has a 3 ft reach and never reached the bottom of the void (Photo 1). Approx 3½ subsidence was measured at the curb (Photo 2). The Project notified the District. The District concluded that erosion in the area is likely caused by leaking waterstops in the outfall chute which could be eroding fine materials in the area and causing the sink. The District did not feel that the SFL was threatened since it is founded much deeper than the JBS outfall chute and is excavated into hard basalt. The District also did not feel that the JBS column was threatened since it is pile supported. However, the District could not be completely sure since there were no calculations available to verify the assumption that the piles do not require lateral earth pressure for design.

Photo 1. South Fish Ladder Section 10 subsidence with Project camera probe

- a) Carefully demolish sidewalks over subsidence areas in Sections 10 and 12 to quantify the extent of subsidence/internal erosion.
- b) Photograph and measure extents of subsidence/internal erosion and backfill with crushed rock. District Structural and/or Geotechnical engineer should be onsite to characterize the erosion areas. Leave areas exposed and cordoned off until subsidence ceases.
- c) Establish a means to measure settlement and continue to monitor.

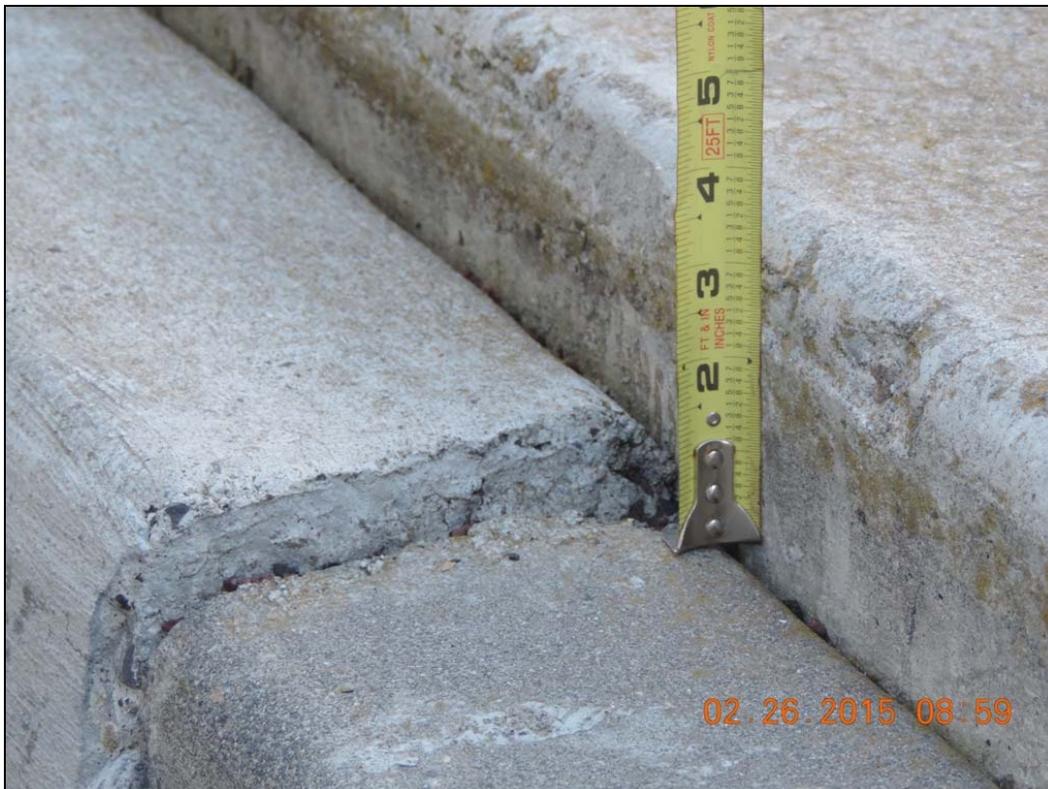
Photo 2. South Fish Ladder Section 10 showing approx 3 1/2 inch subsidence

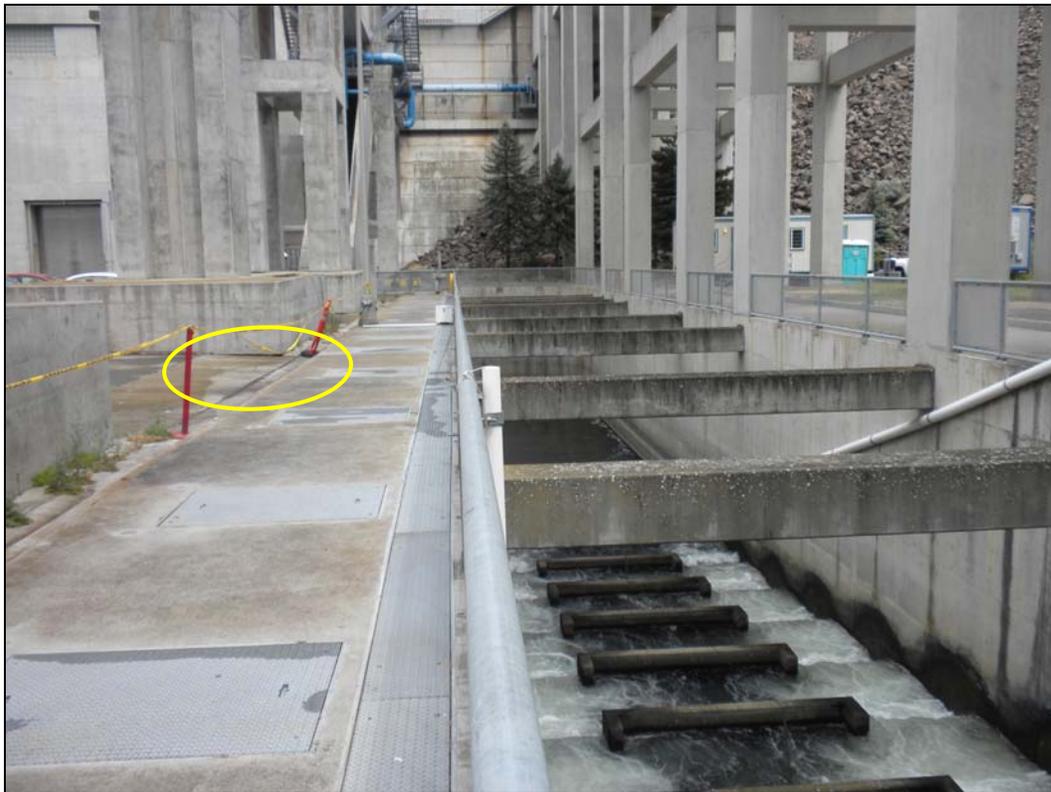
During the 2015 Annual Inspection the subsidence area at the SFL Section 10 was observed. As documented, the subsidence area is occurring beneath the sidewalk between the SFL and the JBS outfall chute in Section 10 (Photo 3). Subsidence is indicated by differential vertical settlement between the sidewalk and surrounding areas, separation between the sidewalk and the adjacent JBS elevated chute pile cap, and hollow "drummy" sound of the sidewalk (Photo 4).

Photo 3. South Fish Ladder Section 10 showing subsidence area

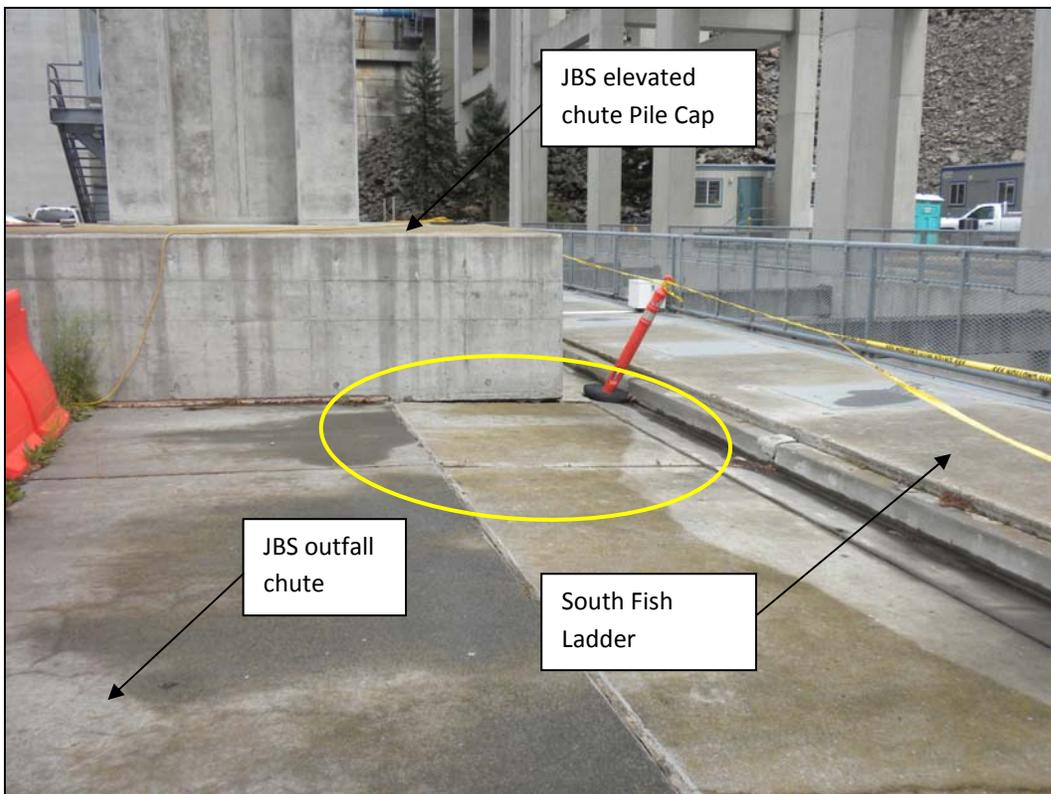
Photo 4. South Fish Ladder Section 10 showing subsidence area and drummy concrete

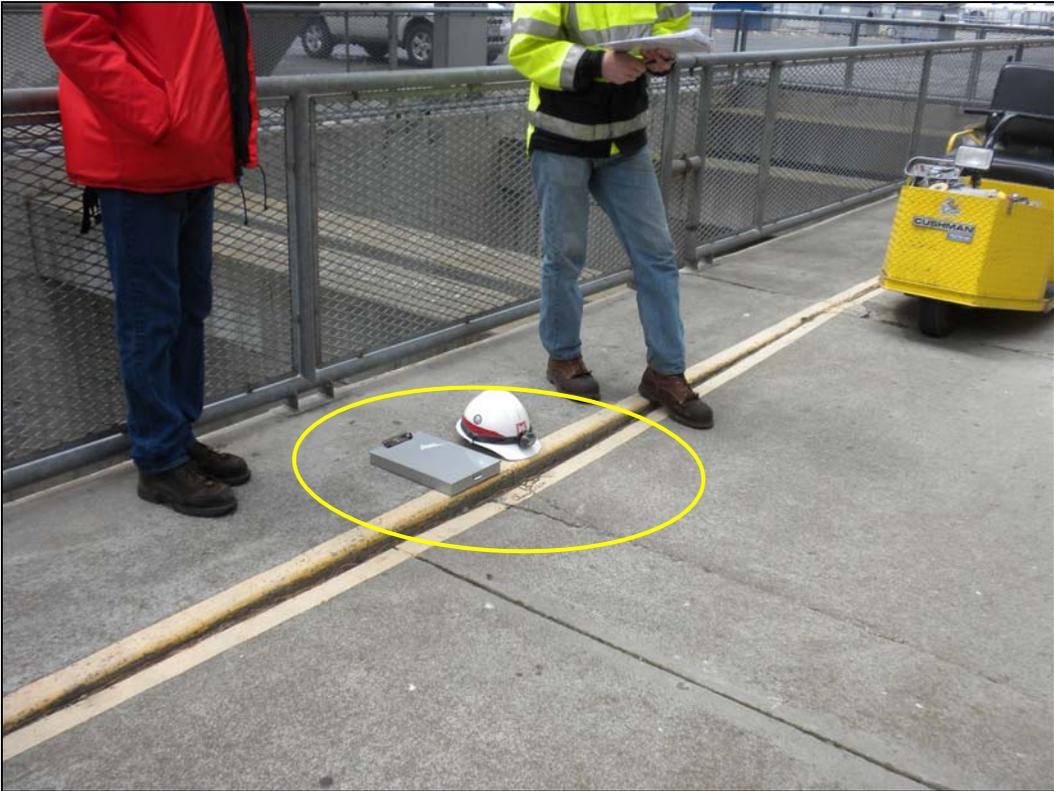
The subsidence at Section 12 was also observed. There did not appear to be any change since January 2015 (Photo 5). The settlement between top of fish ladder wall and top of sidewalk curb was measured at 2-3/8" for future reference (Photo 6). Concerns for the Section 12 include JBS pile cap stability, stability of the South Fish Ladder Wall, and stability for the Section 13 fish ladder column footing.

Photo 5. South Fish Ladder Section 12 showing subsidence area

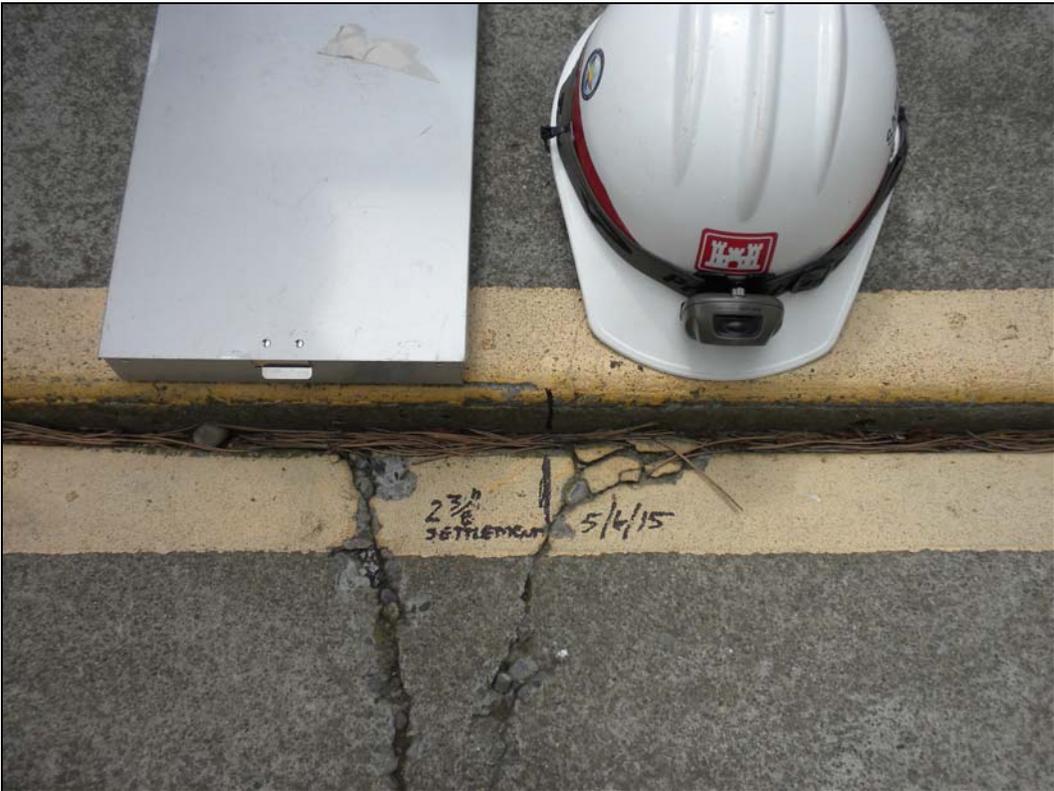
Photo 6. South Fish Ladder Section 12 measured subsidence
