**John Day Dam  
South Fish Ladder  
Section 12  
Wall Leak**

**January 28, 2015**

## Inspection Report

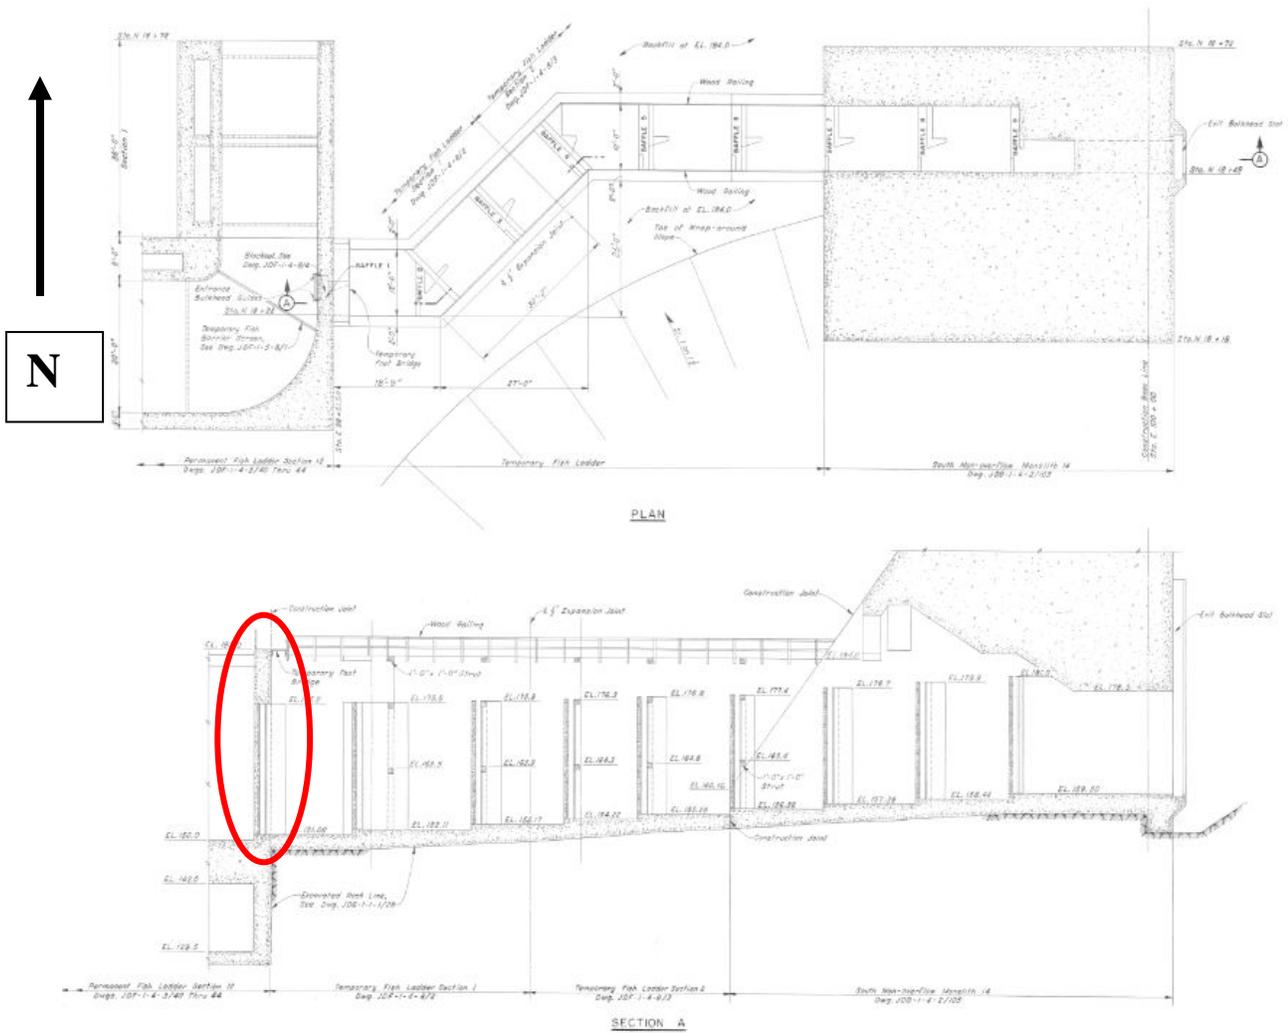
Figure 2 - Abandoned Fish Ladder at SFL, JDF-1-4-8/1

Drawings were reviewed to gather information and are listed in the front of this report. Drawing JDF-1-4-8/1 noted (note 1c) that *“The blackout in the wall of section 12 of the permanent fish ladder shall be reinforced and plugged with concrete....This concrete will have to be placed while the permanent fish ladder is in operation.”* This is an important note since it is alluding to the plug concrete (or portions of it) were likely placed underwater. Underwater concrete placements can be tricky and can lead to the mix falling apart (dis-associating) as it travels through the water if it is not placed correctly. So, it is likely that the area that is leaking (and the area in the general vicinity) is not solid through its thickness due to a poor underwater concrete placement. Ground water has found this weak spot(s) and is eroding the ground behind the wall (and possibly in other areas unknown to us). This is called internal erosion and is typically a dam safety concern since it can lead to failure whether it is a breach, slope instability or an above ground structure instability due to undermining of foundations.

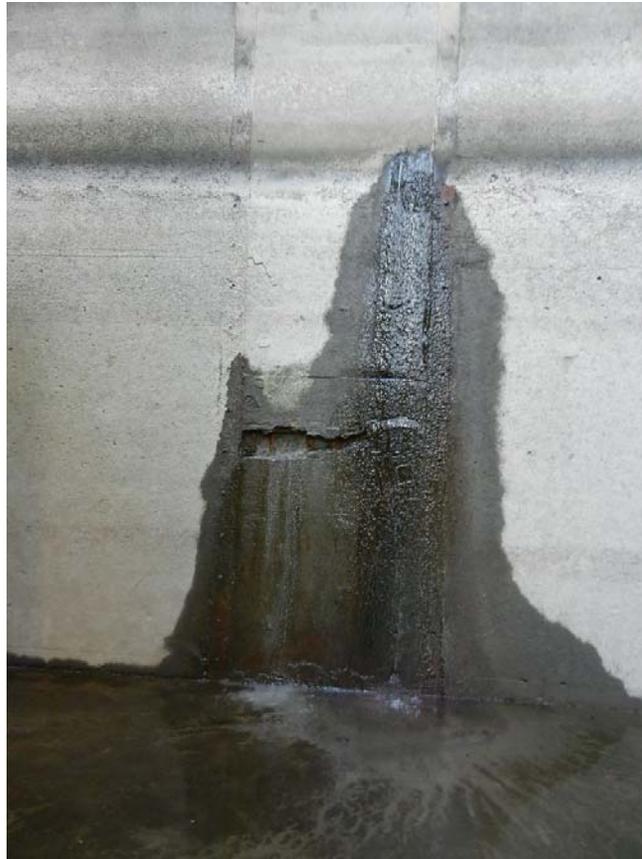
- a. The size of the hole was approximately 24” wide by 18” tall.
- b. The portion of the concrete plug that was removed for patching preparation was approximately an inch deep. Beyond this thin concrete, vertical reinforcement was seen. The reinforcement did not have concrete around it but rather had sand and silt with a pasty consistency (Figure 4, Figure 5 and Figure 6).

**Figure 4 - Patched Area between Abandoned Fish Ladder Bulkhead Slots (Plug is between Vertical Steel Embeds)**

4. Repair the plug.

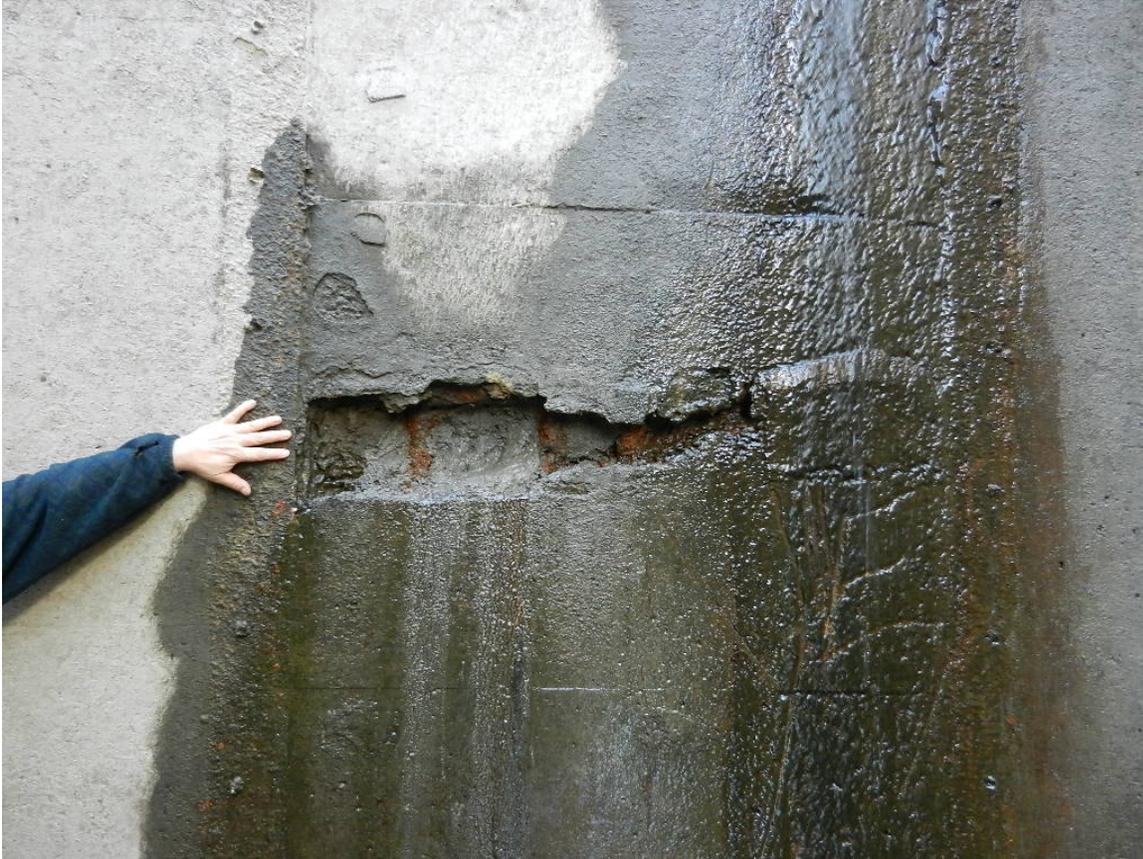
**Figure 5 - Close-up of Leak, 2014**

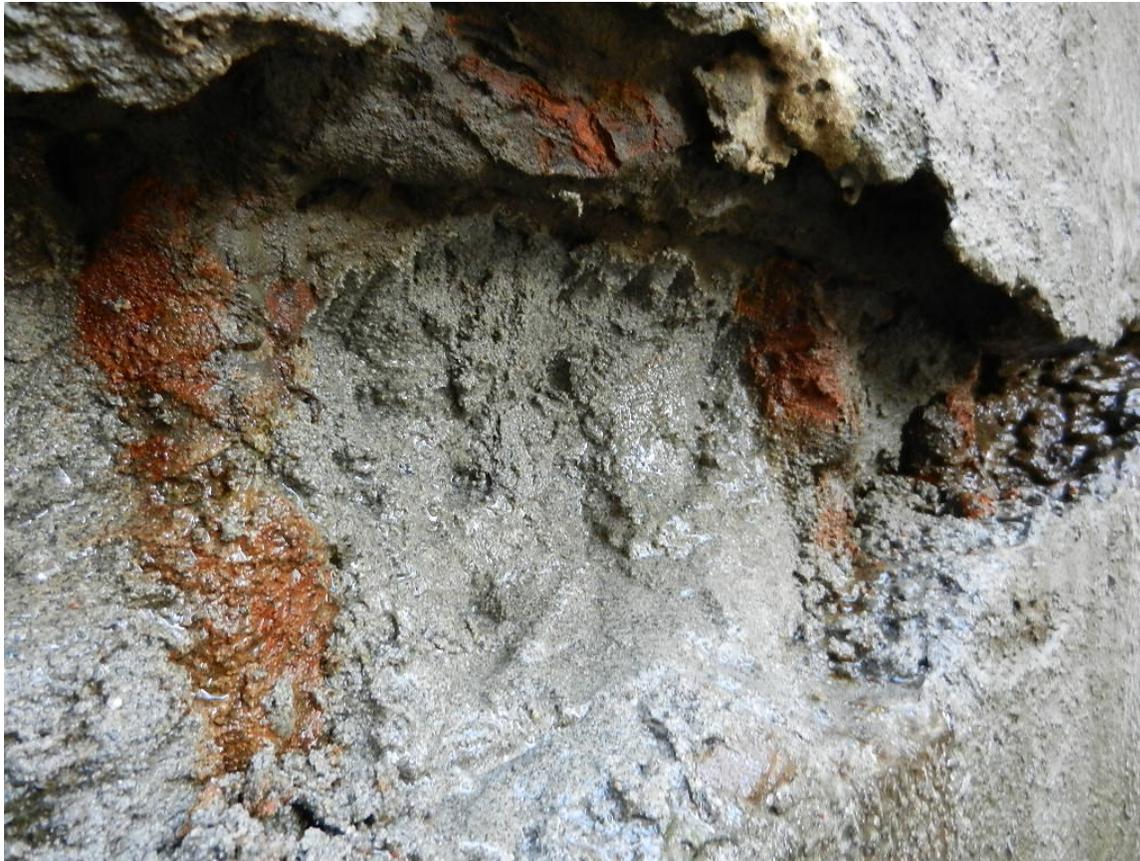
**Figure 6 - Close up before Patch Installed, 2014**

- c. Bags of Sakrete were mixed to a damp consistency and then packed into the hole while water was running out of it.
- d. Sheet metal plates were applied over the patched areas with expansion anchors. The anchors were noticed to be in 'soft' concrete as they were installed
- e. The sidewalk at grade level above the wall leak has subsided and cracked (Figure 7 and Figure 8).

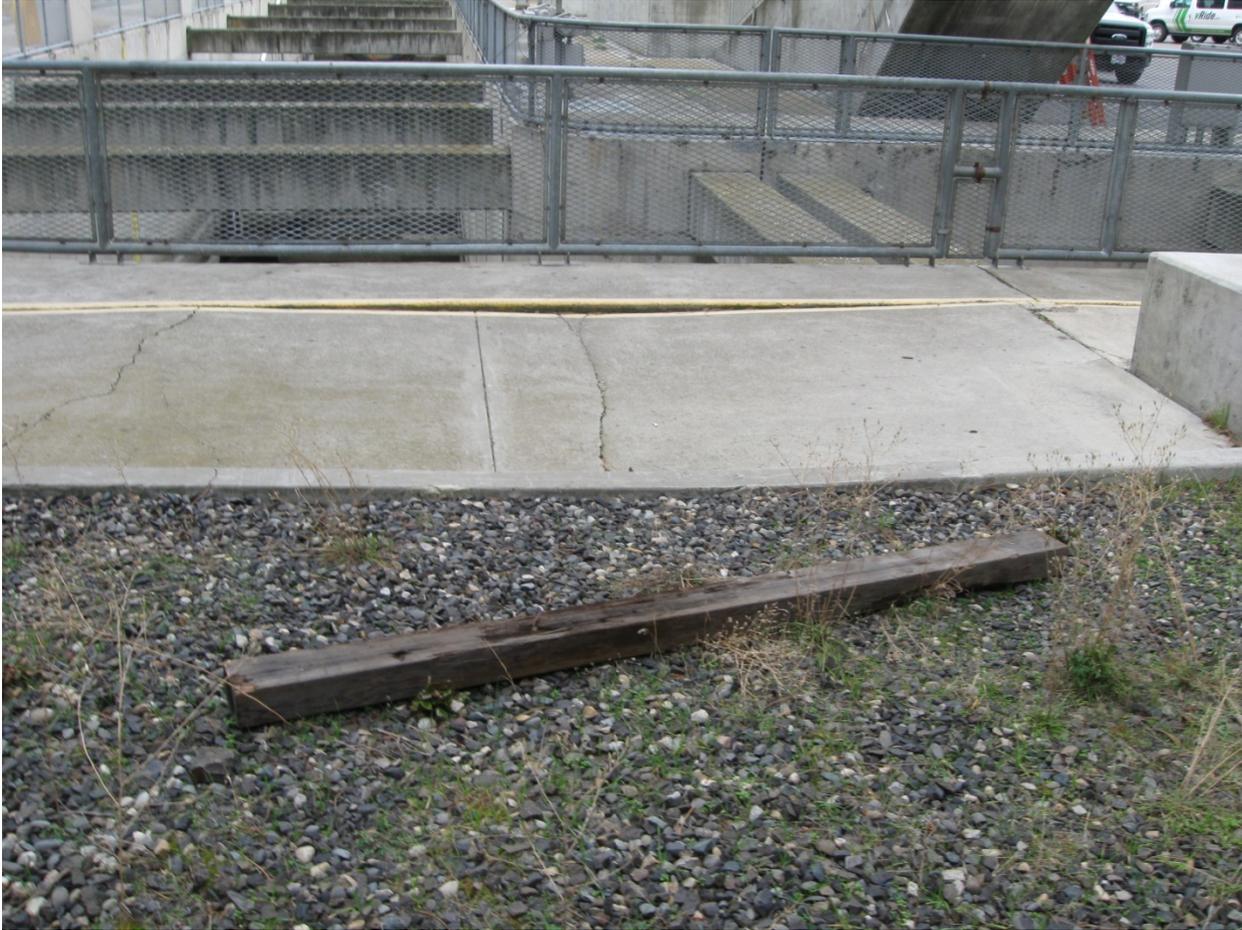
**Figure 7 - Subsided Sidewalk above Leak Location**

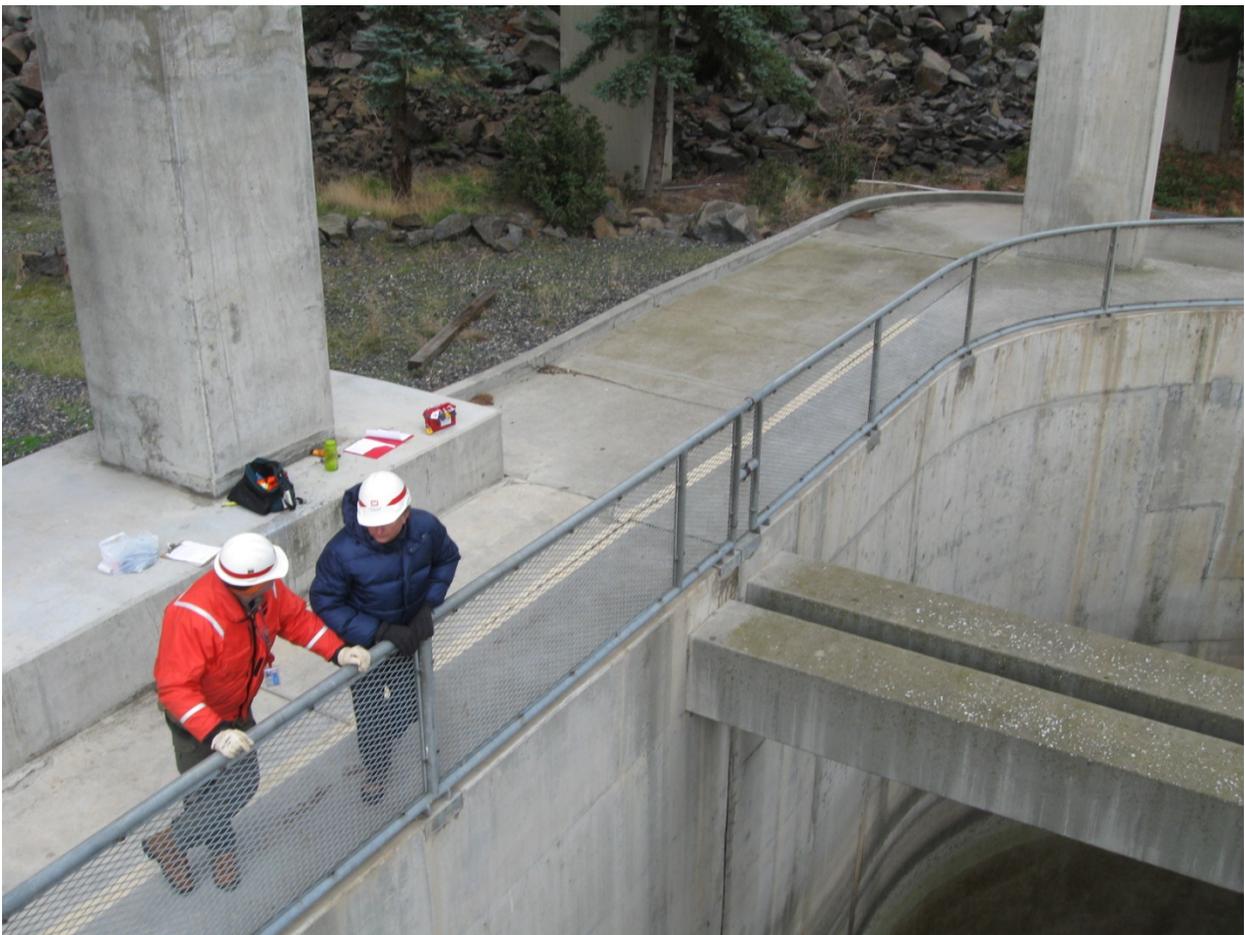
Figure 9 - Structure Overview of Area

There are several large, elevated structures in the area. The elevated portion of the south fish ladder is to the south and the elevated juvenile bypass chute is directly overhead. The columns of sections 12 and 13 of the elevated ladder can be seen in the background of Figure 9. The tree shown is the start of Section 13. Section 12 is to the right (west) and the ladder is running from east to west. One of the juvenile bypass chute columns can be seen in the foreground of Figure 9. There are actually 2 columns here that land on a pile cap which is in turn supported by multiple plumb and vertical piles. The columns of both structures were measured for plumbness with a 4' bubble level and found to be plumb. A visual observation was performed looking for distress in the structures such as cracking and spalling. No distress was found.

2. Monitor the ground area for future sink holes on a monthly basis.
3. Monitor the structures in the immediate area for signs of distress such as cracking, spalling and out of plumbness on a monthly basis.

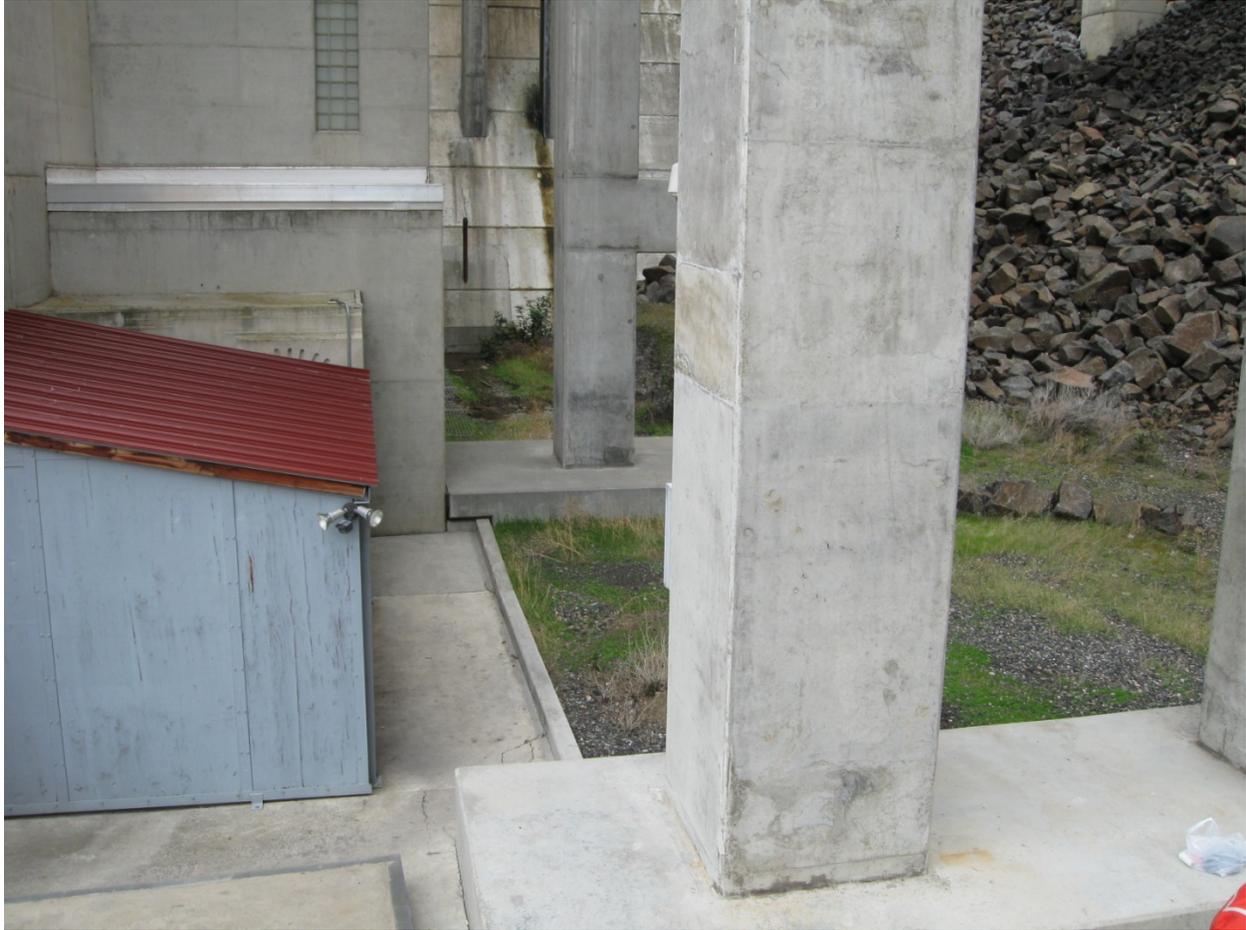
Figure 10 - Area to East of SFL (Chute Columns in fore and background, non-overflow Dam Beyond)

Sinkholes were looked for in the ground to the east of the fish ladder. None were found. Reference Figure 10.

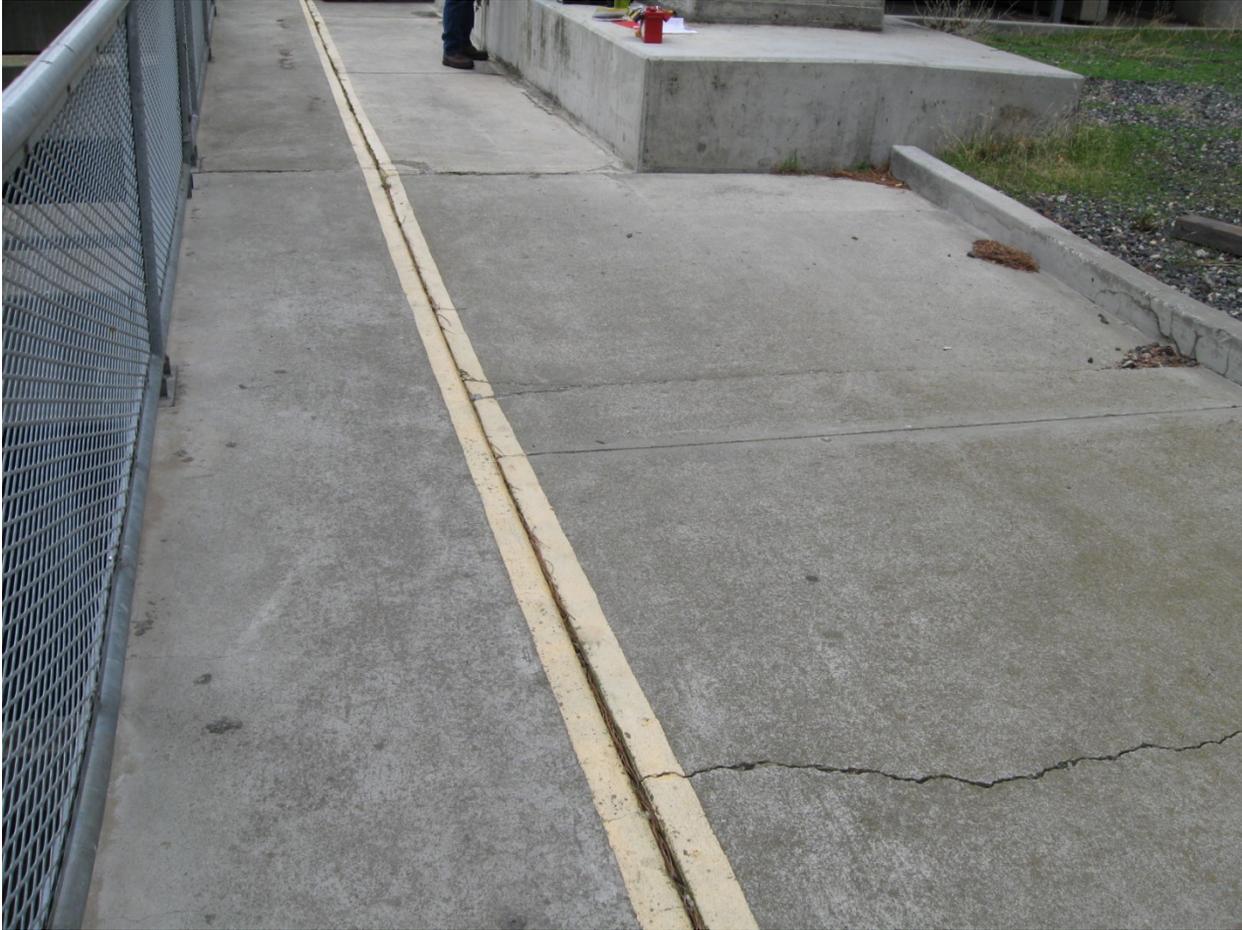
The sidewalk immediately above the wall leak has cracked and sunk. Reference Figure 11. This is undoubtedly from the leak that has been carrying soil away from below the sidewalk into the fish ladder (internal erosion). At the time of the observation the water leaking through the wall was noted to be clear. It appears that at this time the sidewalk is the only structure that has been affected by internal erosion however, there is potential for other structures to experience settlement if this condition goes unchecked. The bottom of the spread footings supporting the columns of the elevated fish ladder (section 12 and 13) are above the leak elevation. The bottom of the leak is approximately at elevation 153'. The bottom of the footing in section 12 is at elevation 158' and the bottom of the footing in section 13 is at elevation 154'-6". The foundation for the juvenile bypass chute (immediately next to the subsided sidewalk) is pile supported. This foundation is labeled 'EC-2' in the Juvenile Fish Sampling and Monitoring Facility drawings from 1995 (Figure 12). The piles have a tip elevation of approximately 137'. The tip elevation is dependent upon the elevation of the top of sound, fresh, hard rock and should be verified with pile installation logs. Reference Figure 13 for pile embedment details and assumed top of rock elevations from the 1995 Juvenile Fish Sampling and Monitoring Facility contract drawings. It is unknown if any of these foundations have been undermined from internal erosion and should be monitored for future distress.

**Figure 11 - Cracked and Subsided Concrete Walk**
