MEMORANDUM FOR THE RECORD

SUBJECT: 15BON03 MFR – Emergency dewater and fish salvage of the Cascades Island fish valve pit.

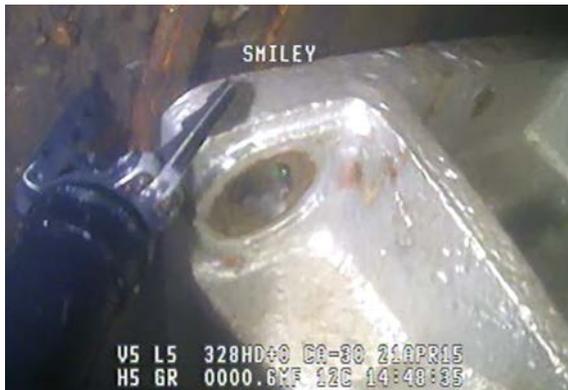
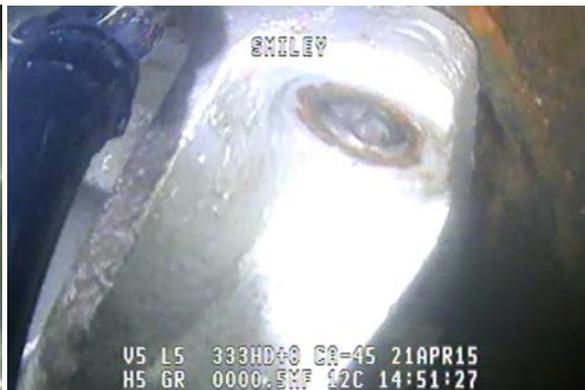
Pictures 1 a & b:

An ROV was sent down into the FV5-4 shaft to examine the trunnion pins which anchor the valve mechanism to the shaft wall. There are two brackets that serve as the anchors, with four bolts per bracket which bolt to a plate and then the wall. Upon examination, three of the six bolts that could be viewed by the ROV had been sheared off (pictures 1 a&b), one had the bolt but no nut (picture 2), and two had the nut attached (picture 3). In addition, the plate had moved (picture 3) and had space between it and the wall (picture 4).

Future and preventative measures – During a special FPOM call on 27 April, a fishway dewatering was coordinated for 12 October, with orifice flow starting 8 October. This dewatering is required in order to completely dewater the FV5-4 shaft and allow personnel to access the failed trunnion pins and hardware. Repairs are estimated to take up to three weeks, though an exact duration isn't possible until the dewatering occurs. The project will pre-fabricate and pre-order the necessary parts to have on hand by October.

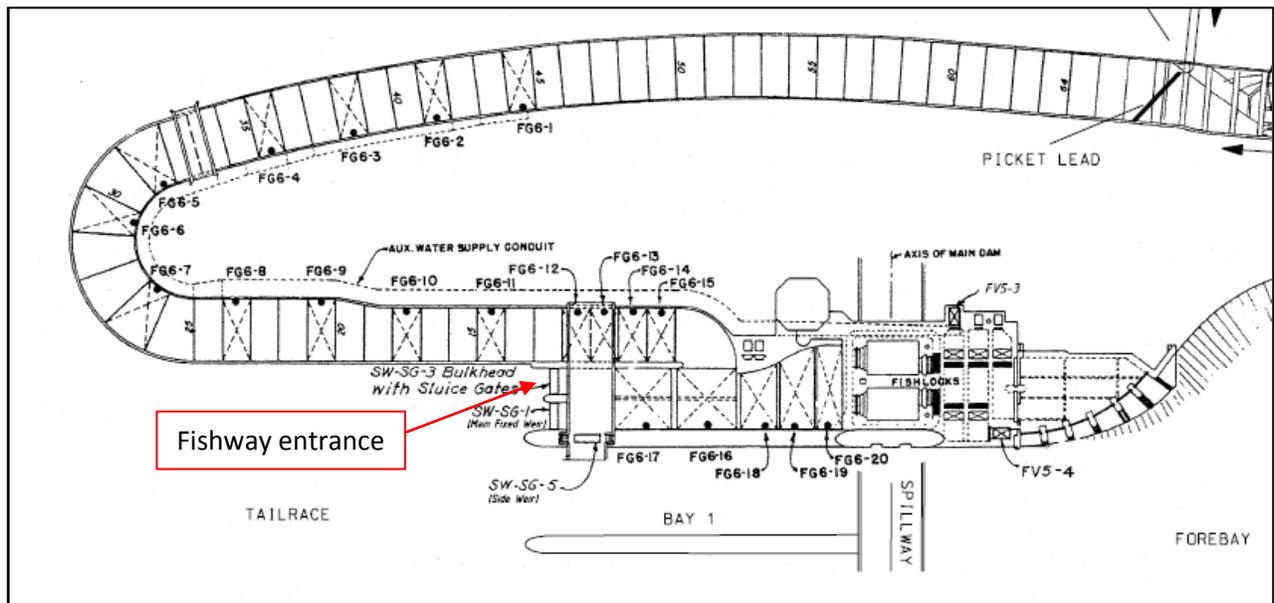
Figure 1. Diagram of the Cascades Island lower fishway, showing FV5-3, FV5-4, and the fishway diffusers FG6-5 through 20. (Diffusers FG6-1 through 4 are removed.)
