**CENWP-OD-B**

**07 August 2016**

**MEMORANDUM FOR THE RECORD**

**SUBJECT: 16BON91 MFR – Closure of the WA shore exit for debris removal.**

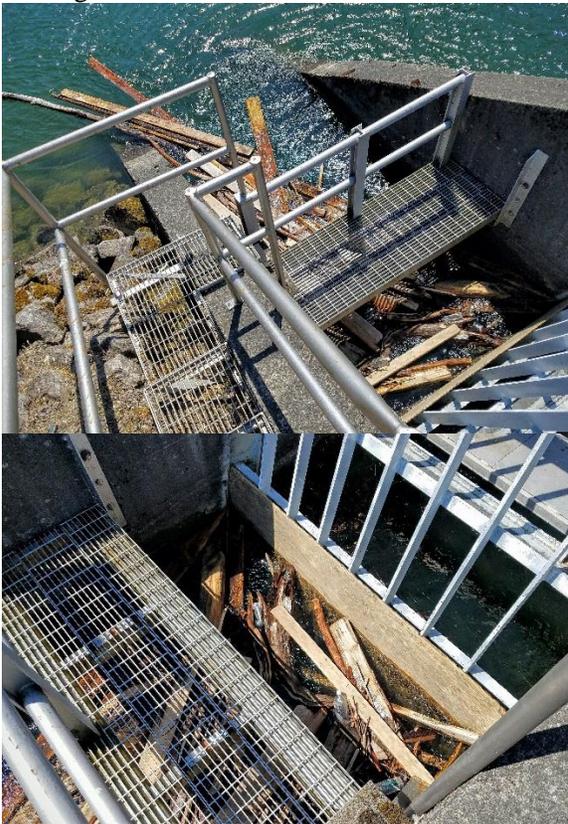
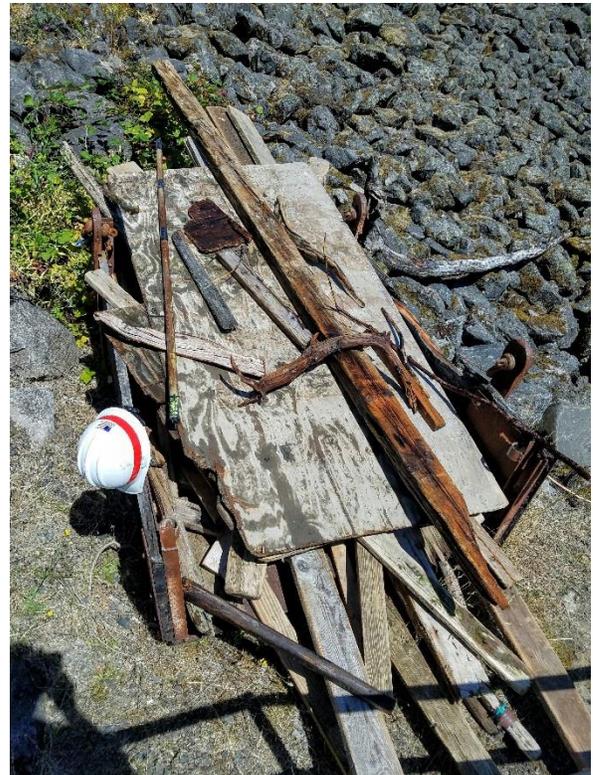
05 August:

On 05 and 06 August, a Project Biologist encountered large amounts of debris at the WA shore fish exit. The debris appeared to be the remnants of a fishing platform, with plywood occluding the fish exit trash rack. Photos from both days are included below. In order to remove the debris, the Biologist, with the assistance of Operations, closed the exit for ~15 minutes on 05 August and ~20 minutes on 06 August to reduce flows and allow removal of the debris.
