MEMORANDUM FOR THE RECORD

SUBJECT: 14 LGS 02 - MFR Forebay Trash-Shear Boom Failure

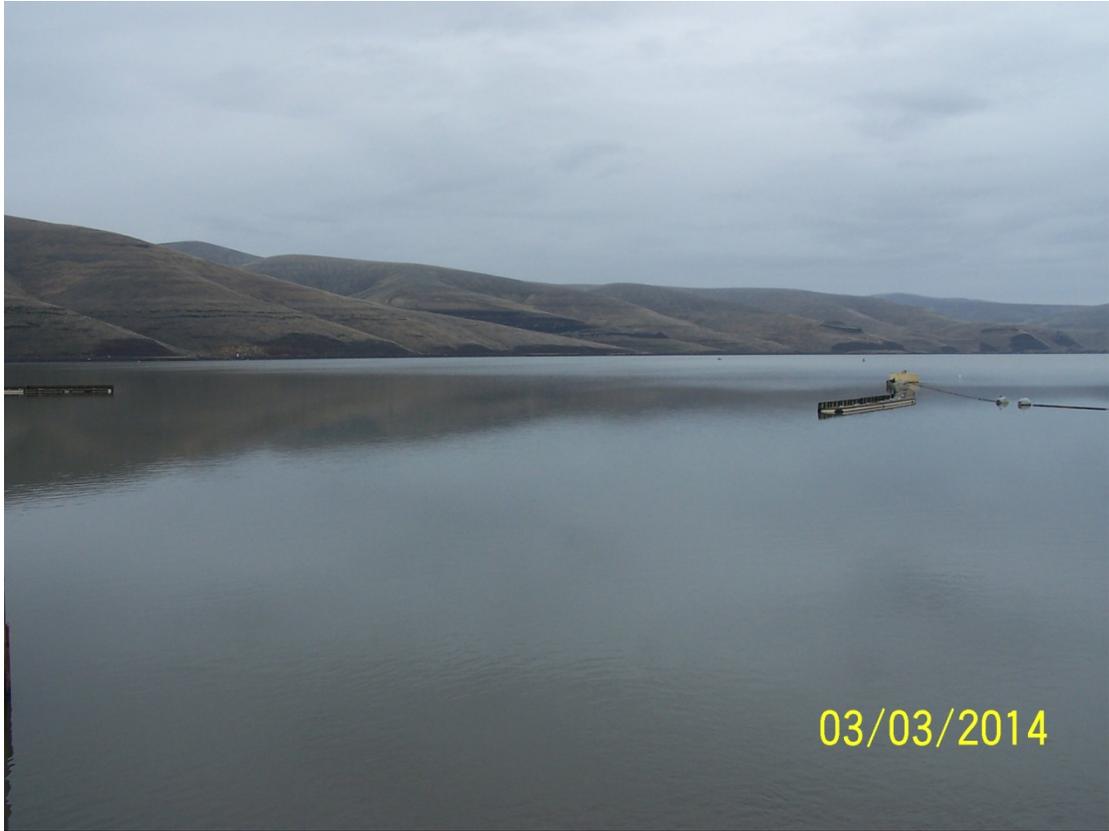
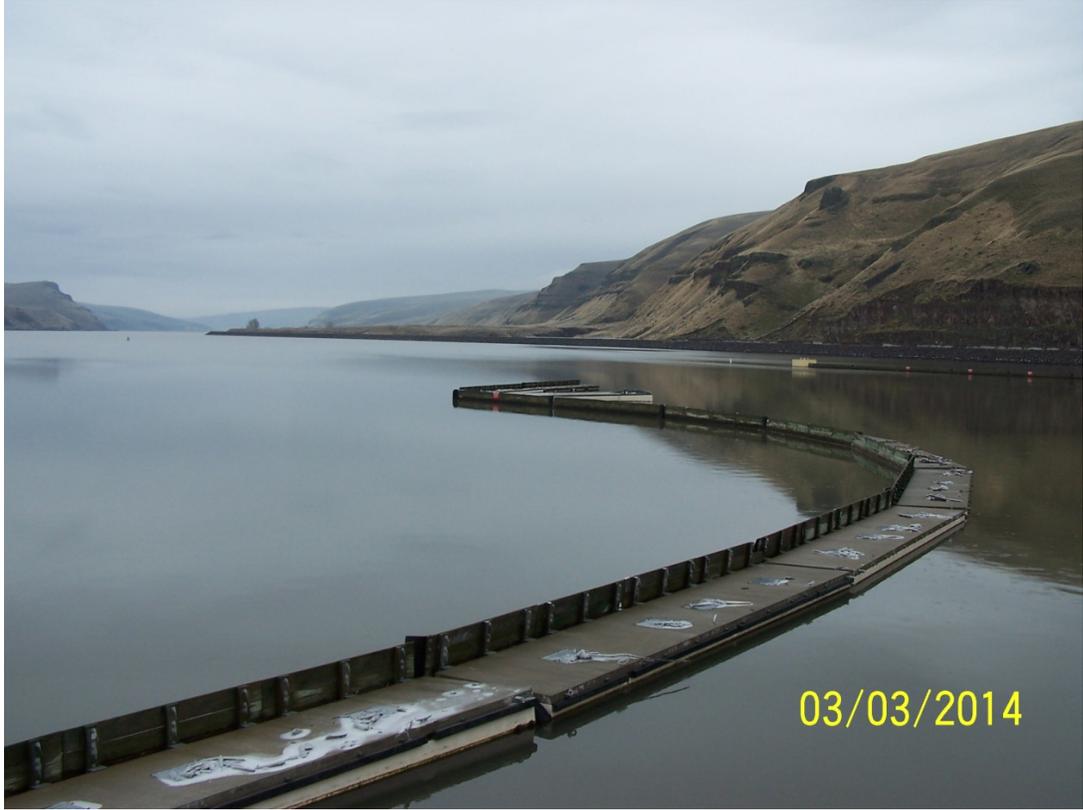
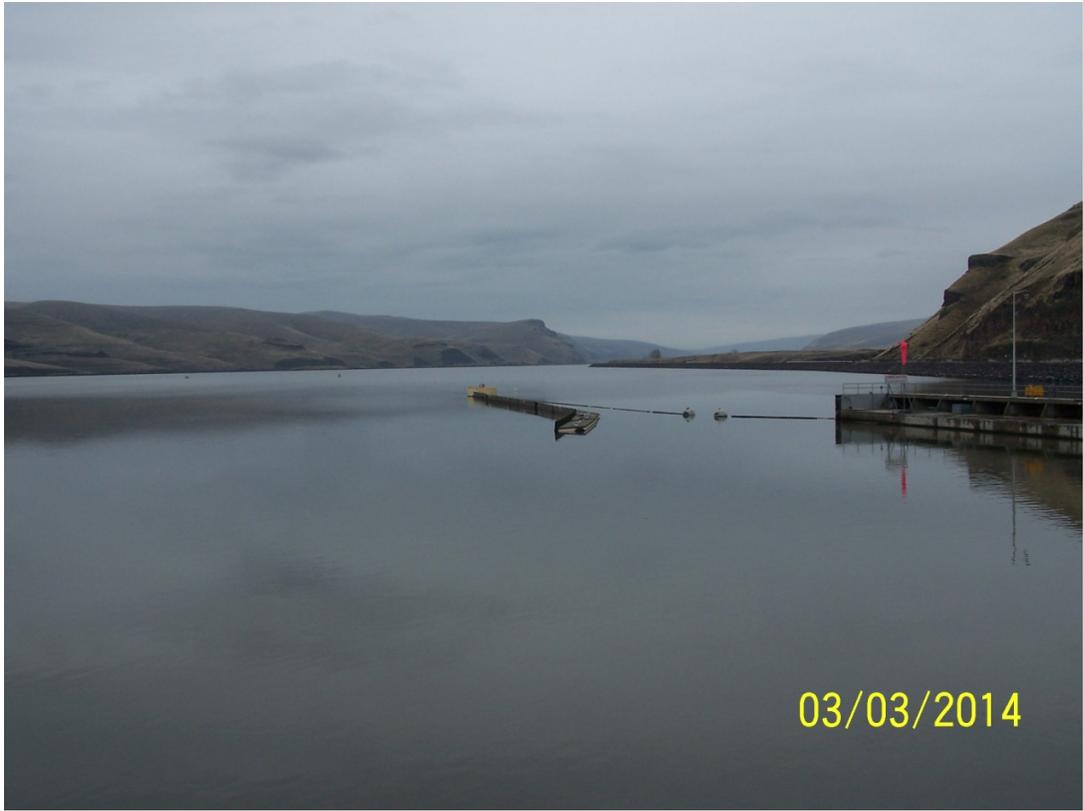
On Saturday March 1, the shift operator reported that the forebay trash/shear boom had parted at approximately mid section. The break is located two floats upstream of the intermediate anchor float. The upstream section of the boom remains attached only to the upstream anchor float and this section is tailing in various directions created by flow and wind forces. The downstream section remains connected at the dam frame and the intermediate anchor float but has increased in slack creating a larger area for trash to collect behind it (see photos below). The loose boom section is being secured to prevent damage to or loss of the boom section. This action will also prevent drift towards the navigation lock or towards the powerhouse or spillway.

Corps technicians and engineers are formulating plans to complete temporary repairs prior to the start of the spill season with more permanent repairs to follow at a later date. Temporary repairs will require dive operations to determine the extent of the damage and to complete repairs. Repair and inspection activities will be coordinated with FPOM when more complete information becomes available.
