MEMORANDUM FOR THE RECORD 16 LGS 07**SUBJECT: 18" Pipe Leak, Delayed Juvenile Fish Collection**

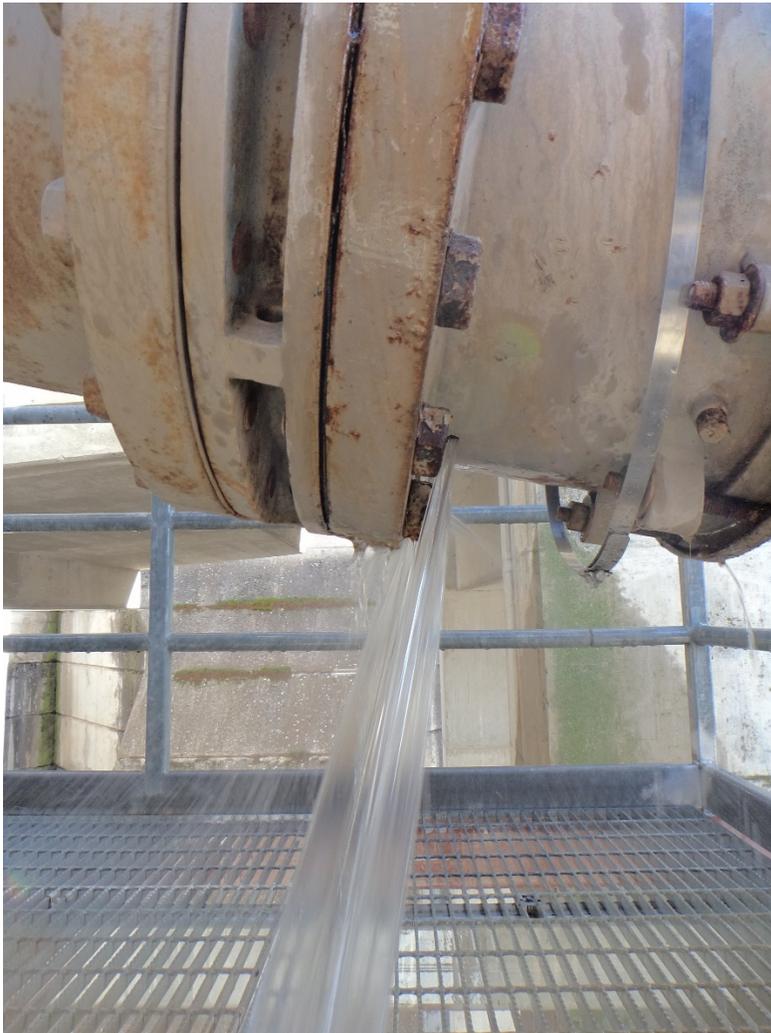
A leak was discovered at the bottom of flanged coupling adapter, downstream of the 18" Knife Gate Valve on the Secondary Emergency Bypass Pipe. The leak was noted at the end of the shift on Tuesday, March 29, 2016. The mechanical maintenance crew attempted to apply an external patch on Wednesday, March 30, 2016. Unfortunately, the parent metal has corroded so much from the inside of the pipe (where inspection is difficult), that the attempted application of the patch caused the leak to increase from its original size and volume. The attached photographs give a fairly good indication of the current leakage. Since Wednesday afternoon, we have been working with local vendors, as well as the manufacturer of this flanged coupling adapter to identify the specific size and part number.

Our current path forward is to dewater the 30" pipe to eliminate the possibility of water leaking from the 18" pipe. This will require us to block off the downstream side of the primary dewaterer for up to two hours, close the valves below the primary dewaterer supplying the 30" pipe while using the 18" pipe as an air vent. Once the 30" pipe is dewatered, the flume can be watered up again and primary bypass can resume. While the 30" pipe is dewatered, the repairs to the 18" pipe can be completed without any safety concerns. We expect to receive the replacement parts for the 18" pipe Tuesday, April 5, 2016. The 30" pipe will be dewatered Wednesday, April 6, and repairs to the 18" pipe will occur on Wednesday and Thursday. On Friday, April 8, 2016, the primary dewaterer will, again, be blocked off for up to two hours to permit water-up of the 30" pipe, using the 18" pipe as a vent. Once the 30" pipe is watered up, we will water up the flume and resume primary bypass. We will collect our next regularly scheduled sample on Saturday, April 9, 2016.
