**OFFICIAL COORDINATION REQUEST FOR  
NON-ROUTINE OPERATIONS AND MAINTENANCE**

**COORDINATION TITLE** - 14 MCN 14 Oregon Ladder Orifice Flow Operations

**COORDINATION DATE**- 17 June 2014

**PROJECT** - McNary Lock and Dam

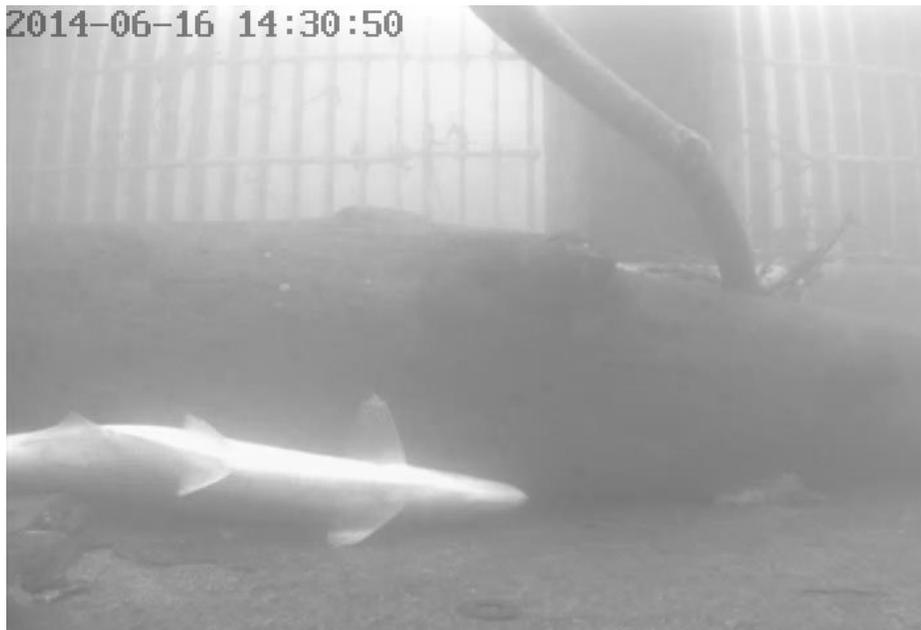
**Description of the problem:** We just learned that there is a sunken log directly above the picketed leads of the Oregon fish ladder. It threatens to move into the picketed leads when we raise them to clean them. We desire to place the ladder into orifice flow in order to access the log and remove it. This will reduce the ladder exit flow from 230 CFS to less than 100 CFS, enabling crews to remove the log with grappling hooks on a crane.

Right now it is unsafe to raise the picketed leads for cleaning, as the log could travel downstream and jam the leads. See picture immediately below.

John, By all means, get the log out of there tomorrow as planned. Seems odd that no one mentioned the apparent dead fish in the photo? What's with that?? Gary

Steve, for your information: a large log has been jammed in the south picket of McNary since we put the cameras in on June 11 (see screenshot from today). One end (north) is located a few feet from the count window slot and extends south across the picket gap probably at least 8 feet. They pull the pickets most days for cleaning but this log is not moving.

**Type of outage required:** Enter into orifice flow for up to 1 hour.

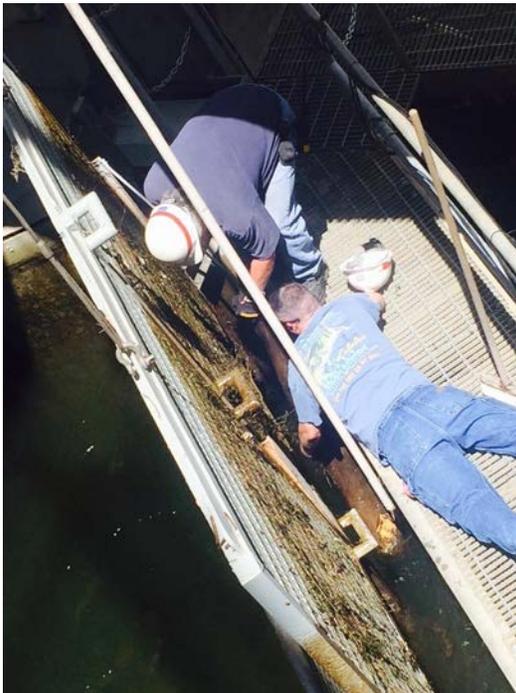
Log Being Removed

On June 18, project personnel successfully removed the log that was above the picketed leads on the Oregon ladder, and also conducted the camera inspection of the faulty lamprey gate. Photos of the log are shown below.

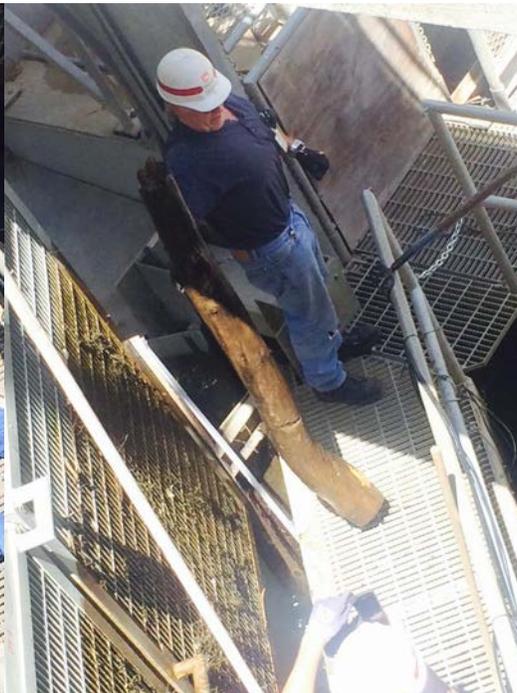
Removed Log
