The Dalles Dam Fishway Status Report

12/20/2015

Inspection Period: 12/13/2015 - 12/19/2015

THE DALLES DAM

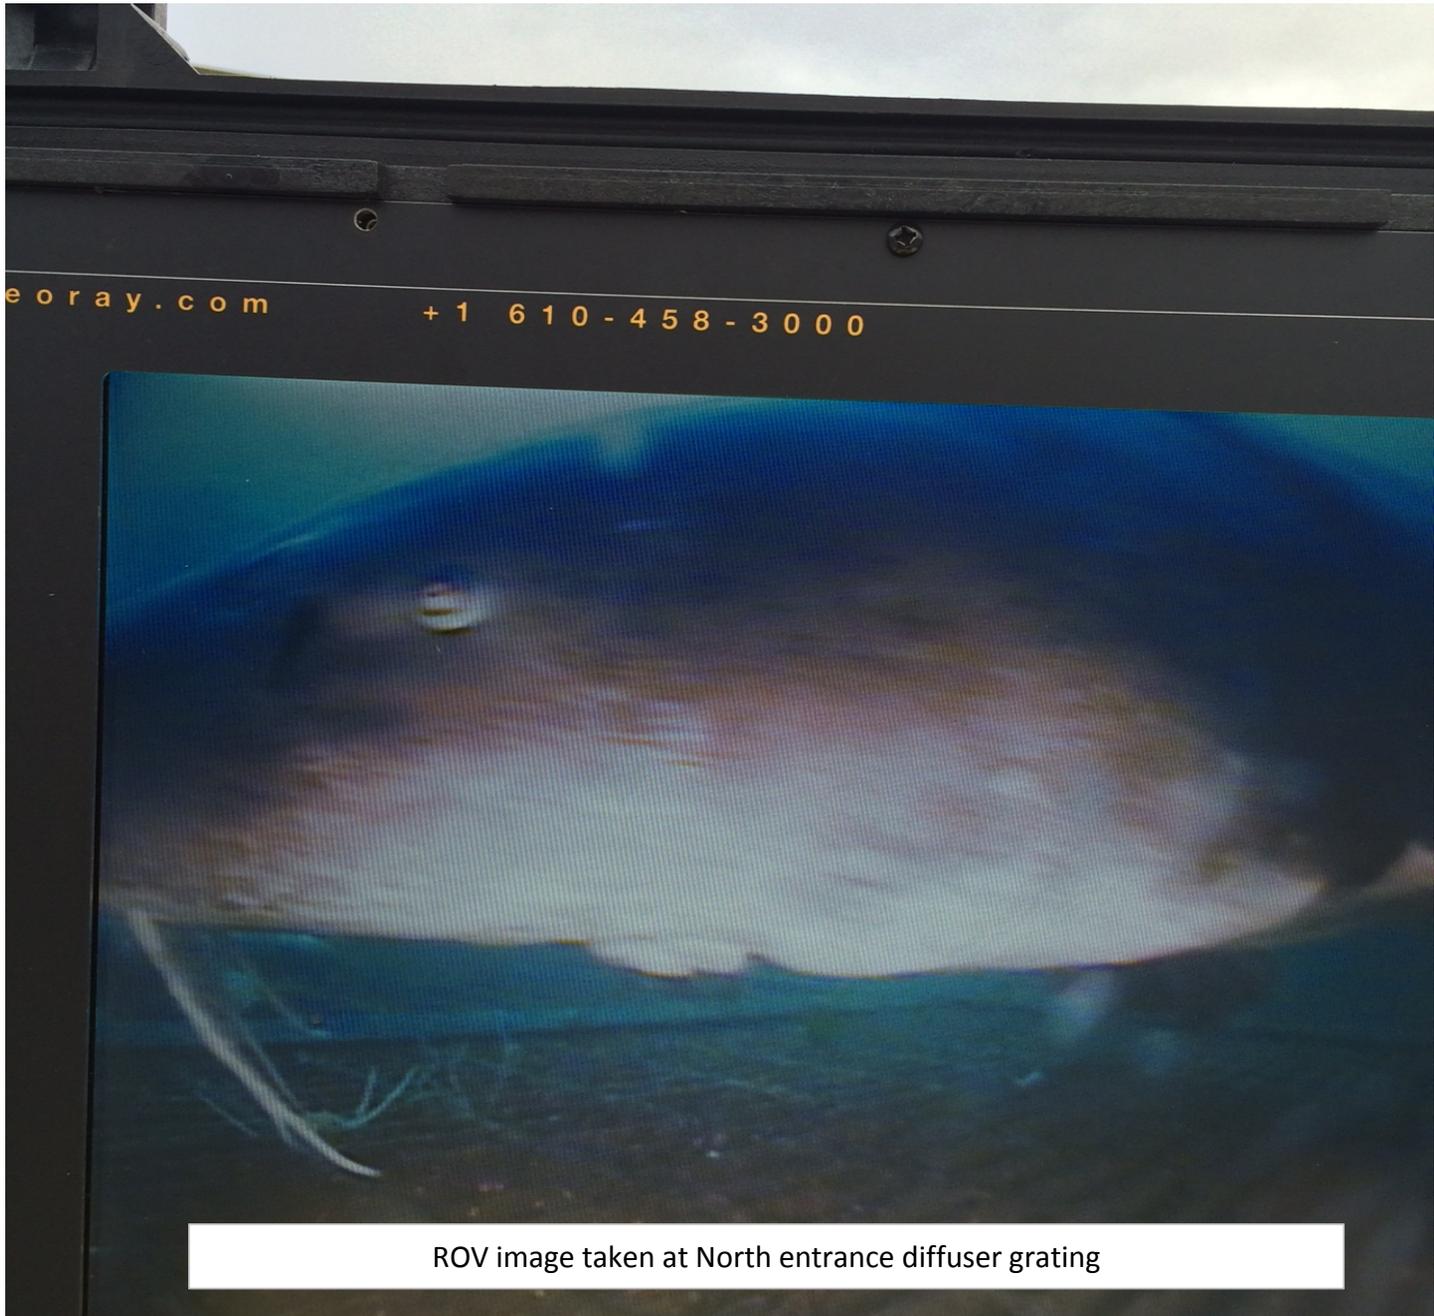
ROV inspection of North PUD intake trash racks and North entrance diffuser grating shown all intact and in good working condition. East fishway dewatering scheduled for Jan 5. Entrance weir guide repair and wheel replacement will continue from last year. Two failed collection channel dewatering pumps on deck for repair. Repair/installation underway. Entrance/Exit weir sensor and PLC replacement being investigated. On budget list. East exit weir electrical panel FCQ7 parts on hand. Funding not presently available for installation. Updating inventory on all fishway component spare parts. New dewatering pump motor for north fishway entrance expected delivery this spring. Install planned for dewater season 2016/2017. East fishladder expansion joint leakage increasing with lower temperatures. Repair deferred to next season due to funding constraints. Upcoming winter maintenance period workload; adjust 158 weir, finish entrance weir wheel replace, east entrance weir guide repair. *Long Term repair plans*; 154 -157 weir replacement, removal/permanent closure of collection channel diffusers, repair north failed diffusers, *Fish related /non-fish funded items*; spillway evaluation, spillway crane rehab, spillgate 9 trunnion pin replace, sluiceway chaingate rehab (approx 50% complete), fish unit breaker replace (in planning), and transformer replace (in planning). All spillway items on Critical Infrastructure list and Unfunded Requirement list. Spill gate 9 repair on hold awaiting funding.

ROV image taken at North entrance diffuser grating
