FPP Change Form

Change Request Number: 11LMN003_Spill Change for Navigation Safety

**Attachment 3: Lower Snake Project – Navigation Issues Associated with
Late Season Spill Operations**

SUBJECT: Lower Snake Project - Navigation Issues Associated with Late Season Spill Operations

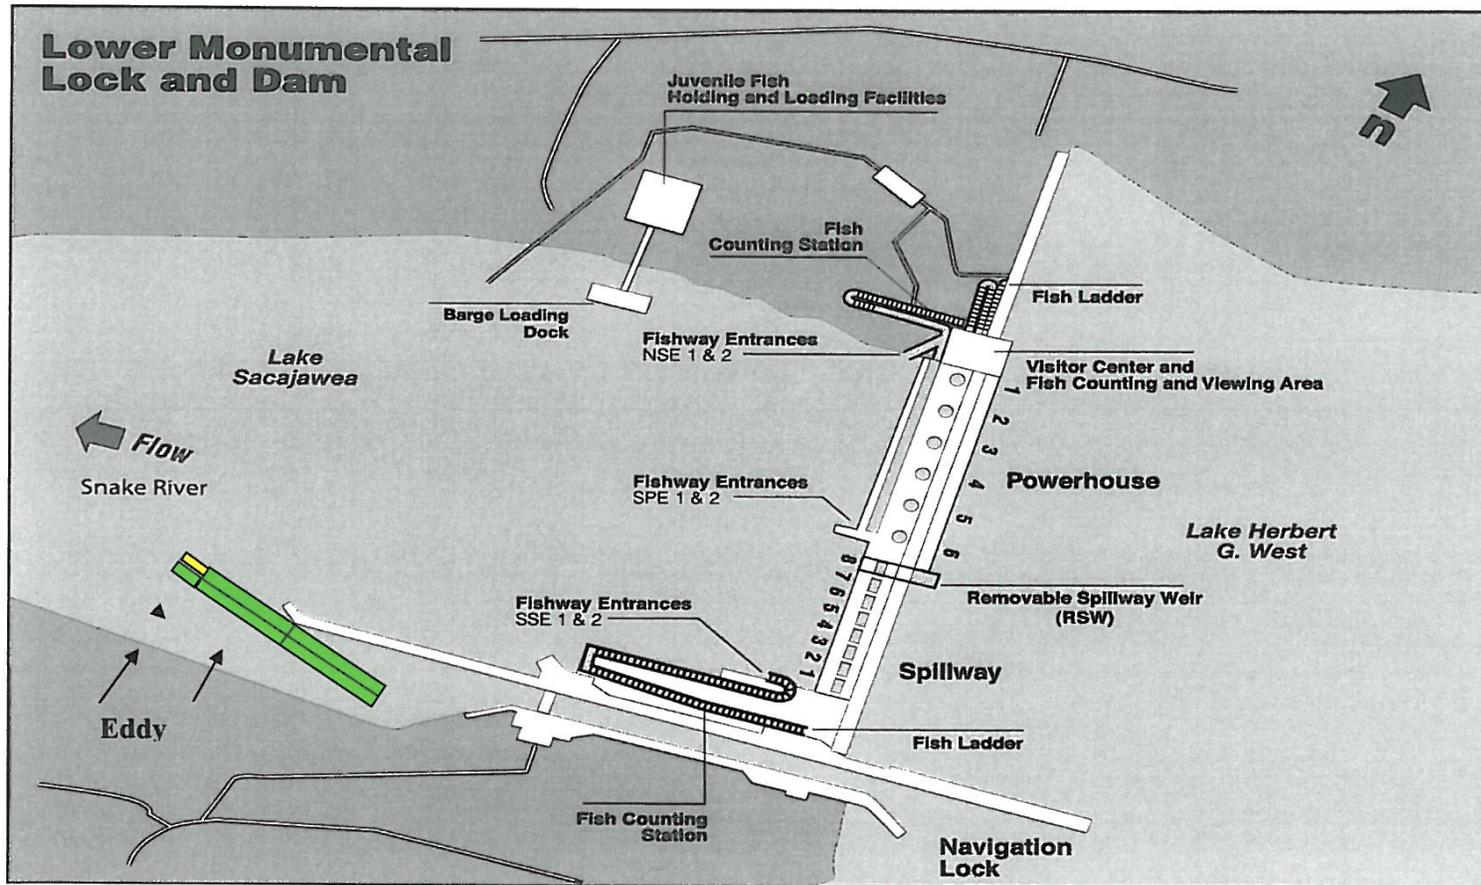
Figure 1. Lower Monumental Incident Diagram.

1. Upon approach to the lower basin (lock entrance), eddy currents forced the bow of the tow towards the outer (north) guide wall. The tug had to burn to get the tow around the corner of the guide wall and safely into the lower basin. Figure 1 shown on page 4 shows the angle of the barges on the approach.

2. Tug Capt. Bob also had a full tow but with a loaded chip barge (wood product). Capt. Bob had basically the same approach as Defiance incident in 1.), above. The operator had to steer towards the south bank to keep the bow of the tow on the good side of the lower basin. This action forces the stern section of the tow to swing to the north which produces the angle you see in the diagram (Figure 1).

3. Similar set by eddy towards guide wall 2 and 3 above, but no difficulty in entering lower basin.
4. On approach, the tow was pulled into the guide wall by eddy current. The port bow of the barge sustained a seven-inch long puncture, but proceeded through lockage for repairs at destination. No damage reported to guide wall. Angle of approach similar to Figure 1, but with tow bow impacting guide wall before entering.

Tug Defiance/Lower Monumental Dam
Near Miss on 8-5-10 at 1910

Incident Details: The tug Defiance was making an approach into the lower basin of Lower Monumental Dam. Total flow was 34 kcfs with 17.40 spill. The tow consisted of 5 barges, one being a loaded fuel barge. As the tow was lining up to enter the lower basin the eddy created by the low flow and spill gate configuration began pulling the bow of the tow towards the end of the guide wall. The tug (in yellow) had to bend the tow around the end of the guide wall to get into the lower basin. The barge directly in front of the tug was the loaded fuel barge. The operator had to make an evasive maneuver to keep the fuel barge from coming into contact with the wall and get safely into the lower basin.

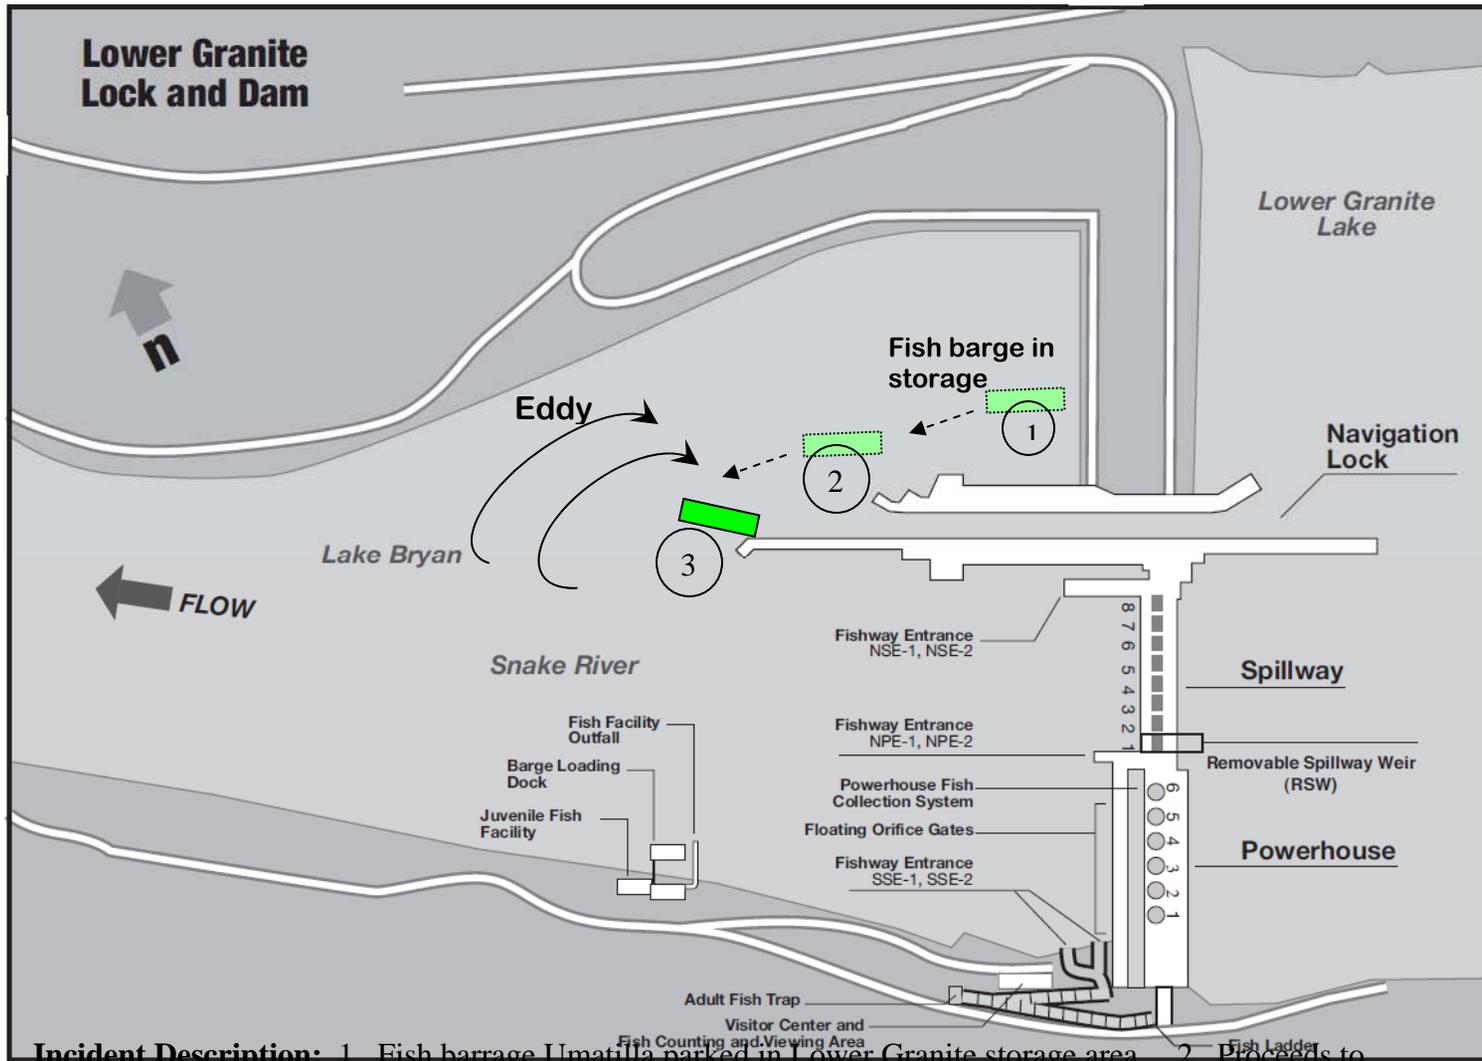
Figure 2. Lower Granite Incident Diagram.

1. Umatilla 8106 fish barge backing out of storage area at Lower Granite collided with guide wall when rounding corner tip of wall (See Figure 2 on page 5). Note that incident details were compiled from dam operator, awaiting official incident report.
2. Cruise vessel possibly entering upper navigation lock and struck guide wall. Details will be finalized after official incident report is completed.
3. No known difficulties.

Incident Description: 1. Fish barge Umatilla parked in Lower Granite storage area. 2. Proceeds to back out of storage area and maneuver to juvenile fish facility on south shore. 3. Eddy current forces starboard side bow into guide wall
