2011 Fish Passage Plan Change Form

Change Request Number: 11LWG001_Navigation Spill Operations

Attachment 1: Lower Granite Lock and Dam

**Attachment 4: Lower Snake Project – Navigation Issues Associated with
Late Season Spill Operations**

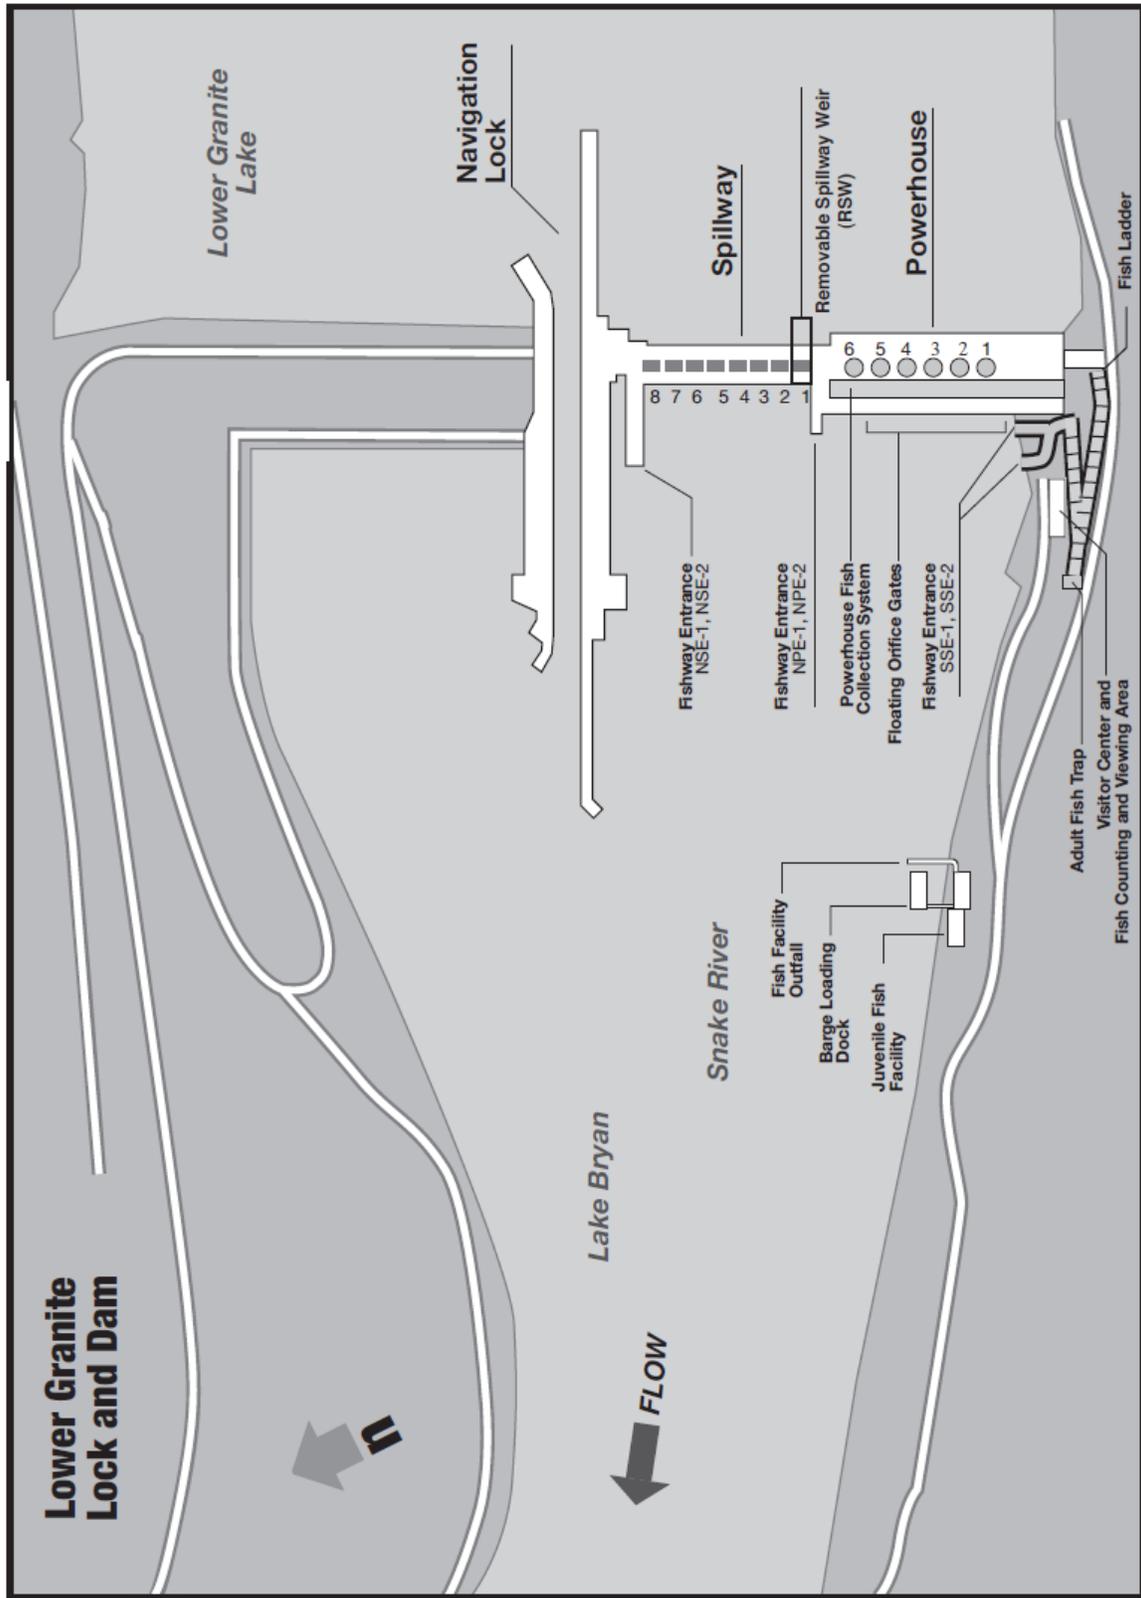
The Corps would like to prevent navigation guide wall collisions in 2011. In 2010 a fish barge collided with the navigation guide wall (Attachment 1). Navigators also expressed navigation safety concerns at Lower Granite in 2006 (Attachment 2). The Corps presented the navigation safety concern to TMT (Attachment 3) and FPOM resulting from the collisions that occurred in 2010 (Attachment 4). In coordination with the region the Corps developed and implemented a modified spill operation (temporarily shutting off spillway weir and spilling in a uniform pattern) to provide safe navigation conditions in the LWG tailrace. No additional collisions with the guide wall occurred after the Corps implemented the modified spill operation for navigation safety. To avoid collisions in the future the Corps would like to include the modified spill operation implemented in 2010 in the FPP. This change form updates the existing fish barge navigation discussion by adding additional details to clarify operations associated with navigation.

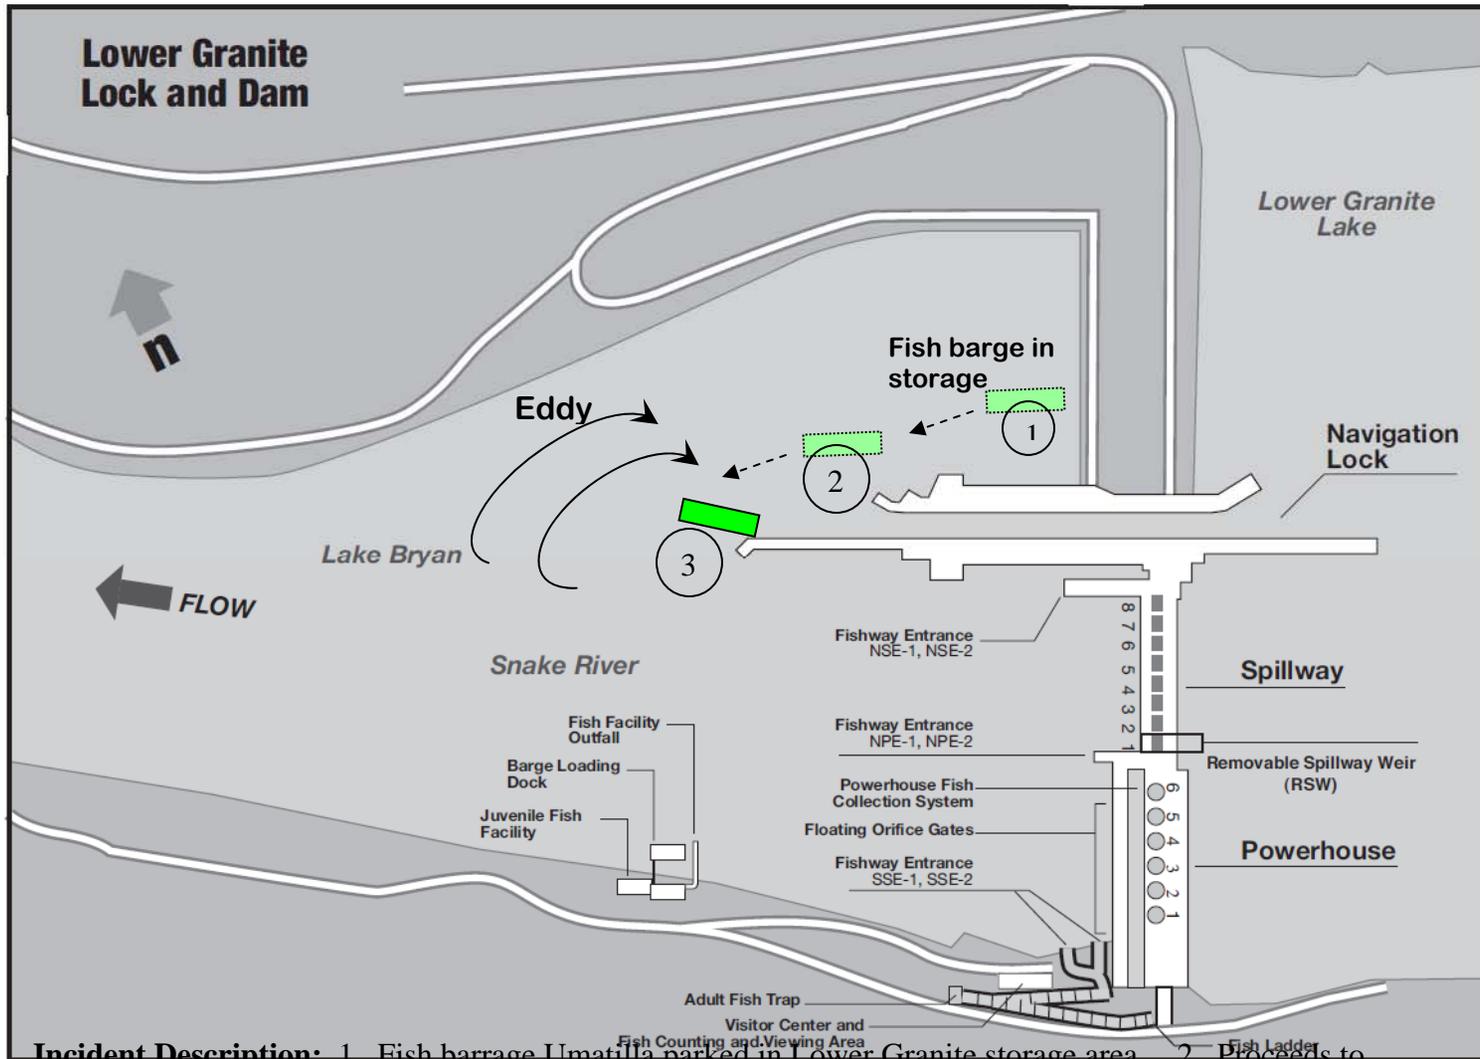
Figure 2. Lower Granite Incident Diagram.

1. Umatilla 8106 fish barge backing out of storage area at Lower Granite collided with guide wall when rounding corner tip of wall (See Figure 2 on page 5). Note that incident details were compiled from dam operator, awaiting official incident report.
2. Cruise vessel possibly entering upper navigation lock and struck guide wall. Details will be finalized after official incident report is completed.
3. No known difficulties.

Incident Description: 1. Fish barge Umatilla parked in Lower Granite storage area. 2. Proceeds to back out of storage area and maneuver to juvenile fish facility on south shore. 3. Eddy current forces starboard side bow into guide wall

On August 12, 2010, FPOM recommended shutting down the RSW temporarily and going to a uniform pattern to provide safe navigation conditions as necessary.
