DEPARTMENT OF THE ARMY  
U.S. ARMY CORPS OF ENGINEERS  
201 NORTH THIRD AVENUE  
WALLA WALLA, WA 99362-1876

17 October 2016

SUBJECT: Results of the Dworshak National Fish Hatchery Water Quality Study During Dworshak Dam Spill Test, Ahsahka, Idaho, April 2016

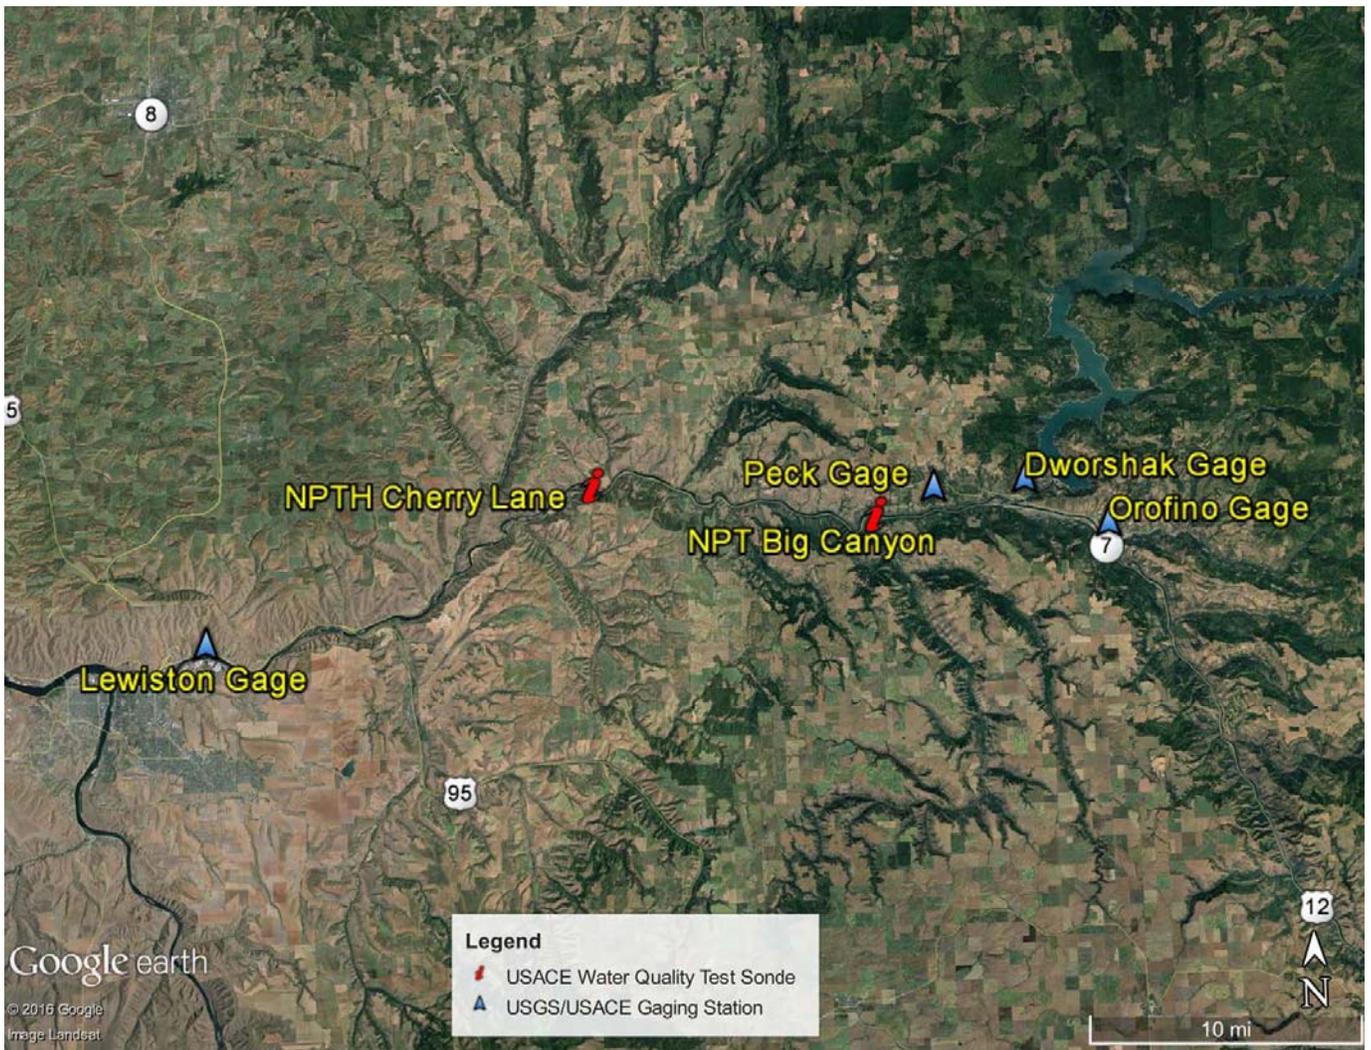
**Permanent USGS/USACE River Gaging Stations and Water Quality Sonde Deployment Sites Used During the TDG Spill Test**

b. Several permanent USGS/USACE in-river gaging stations were used to monitor TDG, flow, and ambient air barometric pressure during the test. In addition to Dworshak gage, these stations included: Peck gage (USACE gage PEKI/USGS gage 13341050),

Lewiston gage (USACE gage LEWI/USGS gage 13343000), and the Orofino gage (USACE gage ORFI/USGS gage 13340000) (enclosure 1). Sondes (water quality sensors), were deployed on April 27, 2016, in a variety of locations within the hatchery and at two sites downstream, and were retrieved on April 30, 2016. Hatchery sites included: NFH Burrows Pond 50, Raceway B29, Degassing Chambers, and Collection Channel (enclosure 2). Two sondes were deployed at key locations downstream of the NFH: Nez Perce Tribal (NPT) Big Canyon Acclimation Facility holding tank and Nez Perce Tribal Hatchery (NPTH) at Cherry Lane water intake sub pump, at request of Nez Perce Tribe (enclosures 1 and 2).

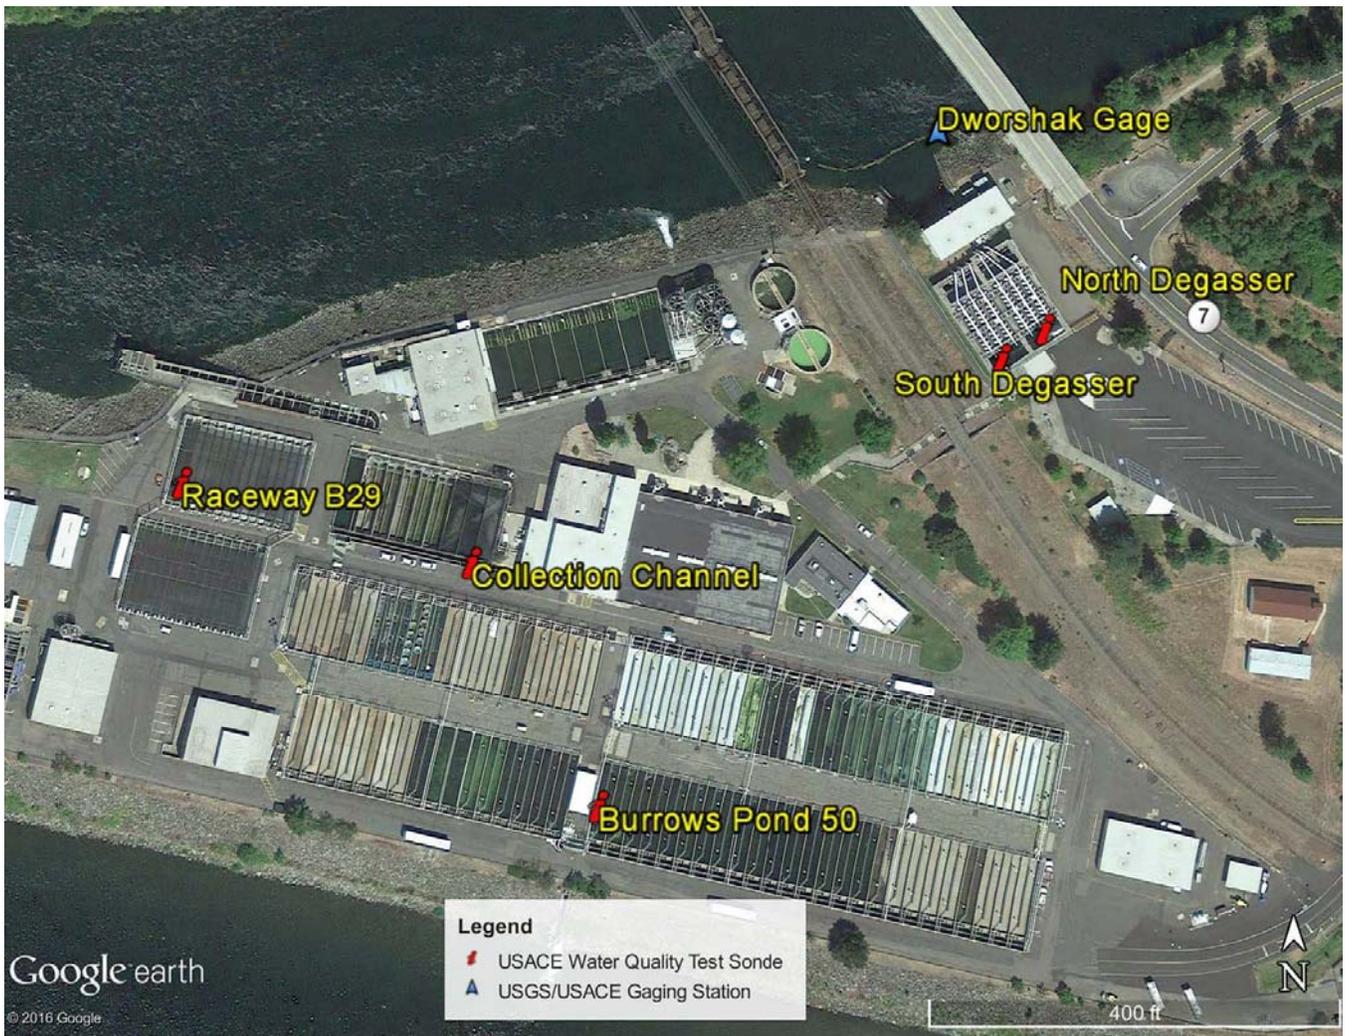
**Dworshak National Fish Hatchery Water Quality Sonde  
Deployment Sites for TDG Spill Test**

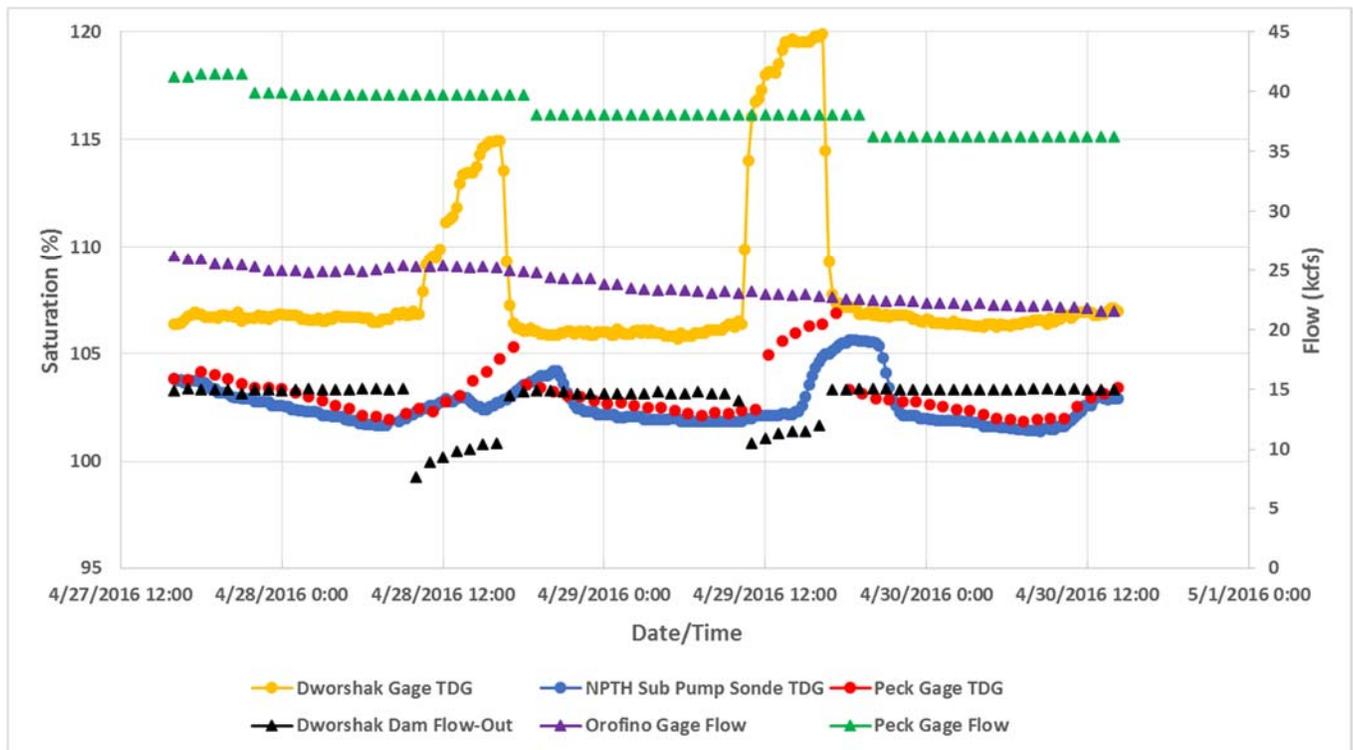
**TDG (% Saturation) and Flow (kcfs) Observed During Dworshak Dam Spill Test From April 27 to April 30, 2016**

a. Target TDG levels were obtained at Dworshak gage of 115% (114.9%) at 10.5 thousand cubic feet per second (kcfs) on Day 1 and 120% (119.9%) at 12 kcfs on Day 2 (enclosures 3 and 4). Operationally, on Day 1 at Dworshak, water was released through units 1 and 2 and over the spill crest, while on Day 2 water spill was switched from the spill crest to the regulating outlets. The 10.5 kcfs Dworshak release on Day 1 contributed to ~26% of the total flow of ~39.7 kcfs observed downstream of the confluence of the North and South Fork of the Clearwater River at the Peck gage on Day 1. This resulted in a reduction of in-river TDG from 114.9% TDG at Dworshak gage to 105.3% TDG at Peck gage (enclosure 4). The 12 kcfs Dworshak release on Day 2 contributed to ~31% of the total flow of ~38.5 kcfs observed downstream at the same gaging station. This resulted in reduction of in-river TDG from 119.9% at Dworshak gage to 106.9% at the Peck gage (enclosure 4).

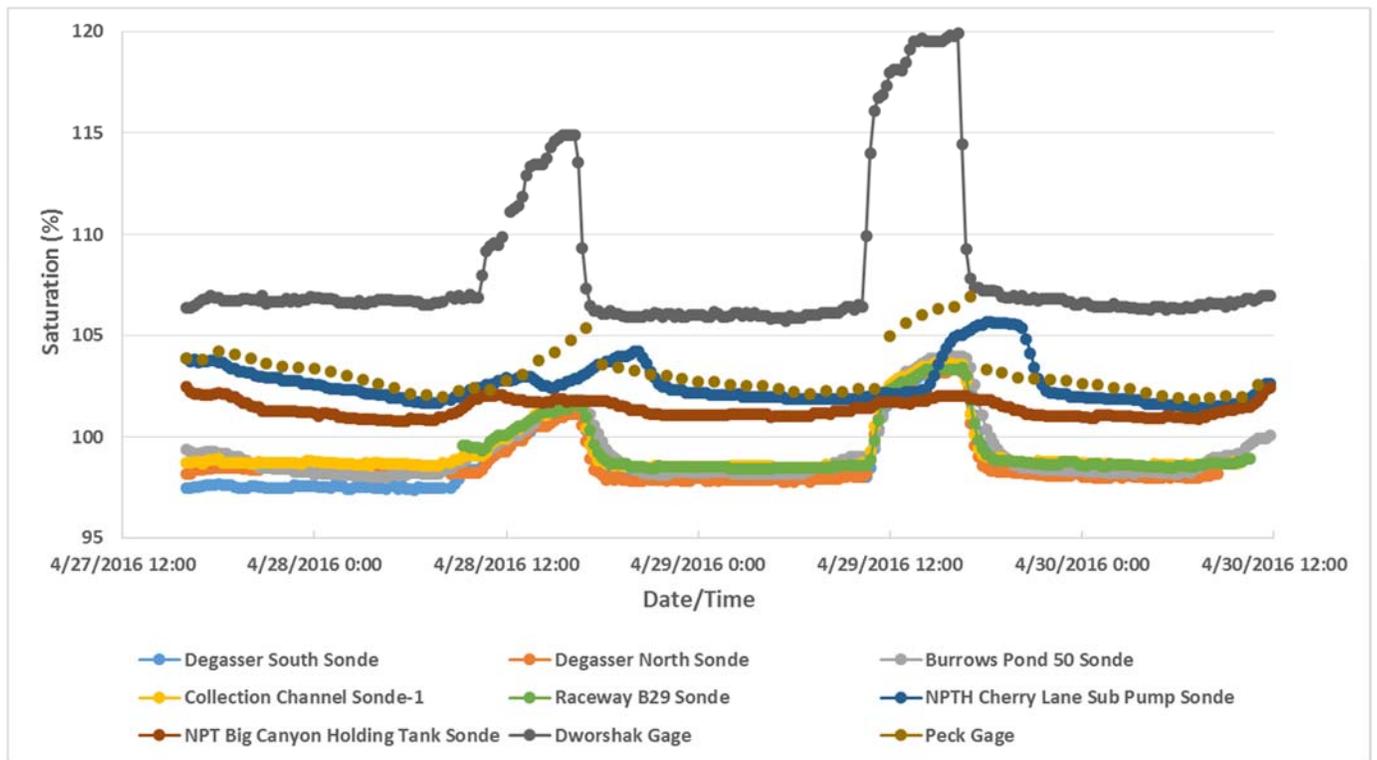
**Total Dissolved Gas Measurements From Water Quality Sondes and River Gaging Stations at Dworshak NFH and the Clearwater River, ID, From April 27 to April 30, 2016**

b. On Day 1, the Dworshak gage TDG value of 114.9% resulted in the highest in-hatchery sonde site reading of 101.8% TDG (Burrows Pond 50) (enclosures 4 and 5). On Day 2 the 119.9% at Dworshak gage resulted in the highest hatchery site reading of 104.0% TDG (Burrows Pond 50). In-river TDG gage at Peck peaked at 105.3% on Day 1 and 106.9% on Day 2. TDG levels at NPT Big Canyon reached 101.9% on Day 1 and 102% on Day 2. TDG levels at NPTH Cherry Lane river water intake sub pump reached 104.2% on Day 1 and 105.6% on Day 2. Natural degassing occurred as expected, peaking downstream at Lewiston gage at 102.7% on Day 1 and 103.8 % on Day 2 (enclosure 4).
