# **Evaluation of an Electric Barrier as a Seal Deterrent on the Puntledge River**

*Prepared For*

February 2009

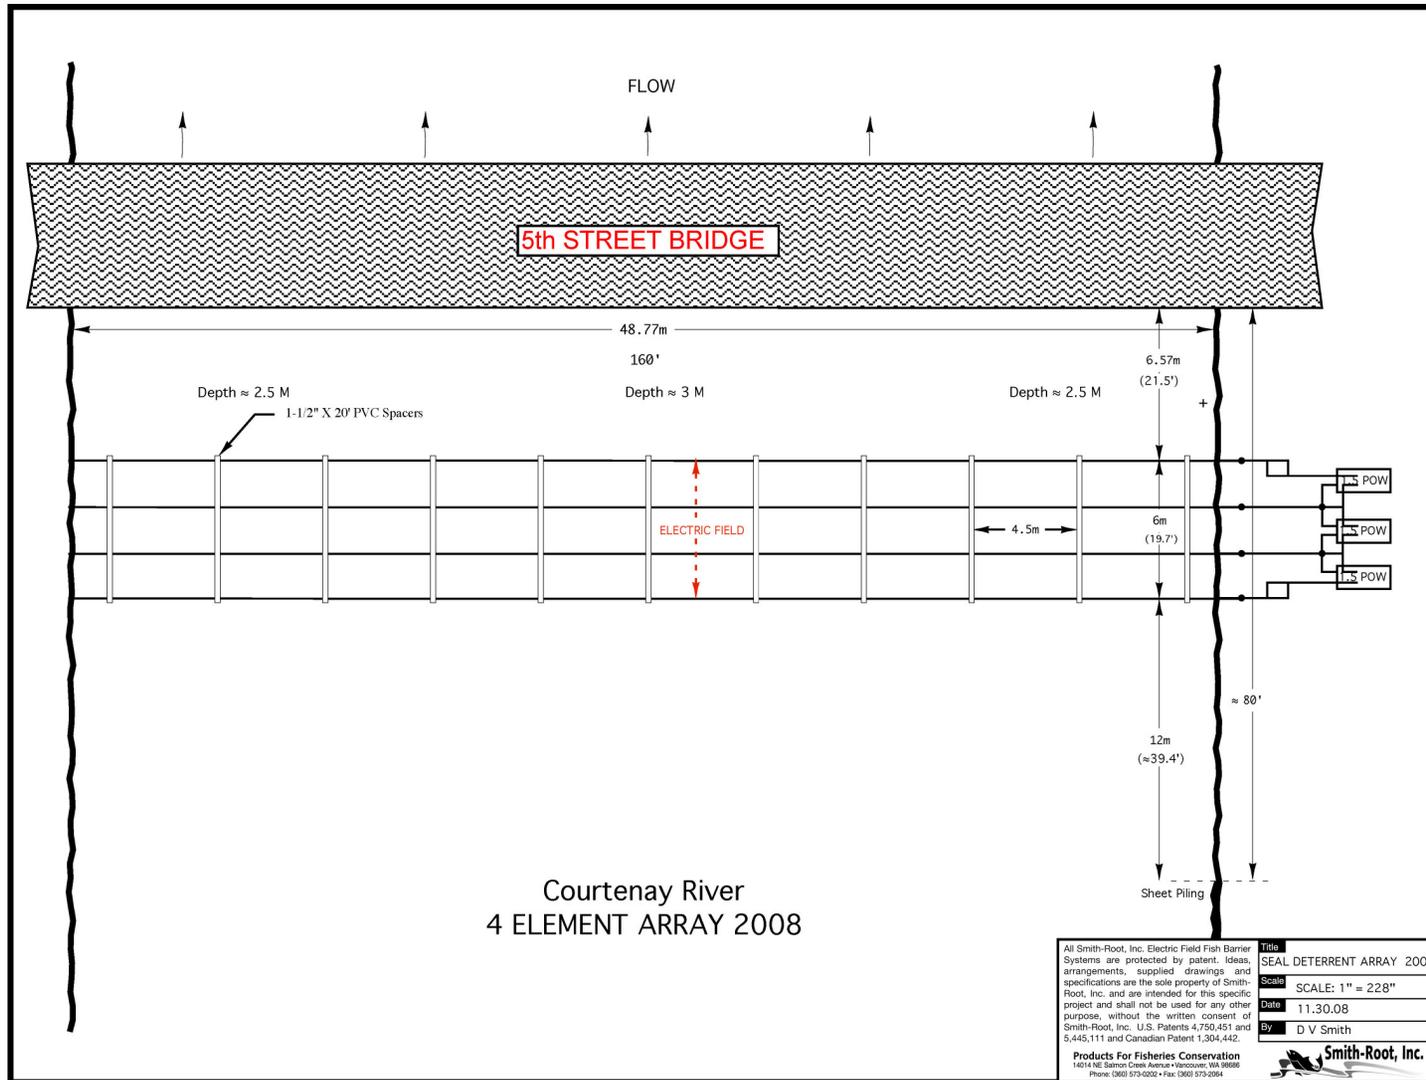
Figure 4. Schematic of the 4-cable array tested in the Puntledge (Courtenay) River upstream of the 5<sup>th</sup> Street Bridge between May 14 and June 5, 2008.

The electrodes of the “**3-cable perpendicular**” array consisted of three copper cables, 12.7 mm (½-inch) in diameter, strung across the river perpendicular to the stream flow. The electrodes were spaced 3 meters apart by securing the cables to PVC pipes each 6 meters long (Figure 3). The “**17-element parallel**” array consisted of 17 copper pipes, 19 mm (¾-inch) in diameter and 6 metres long, laid parallel to the stream flow every 3 meters across the 49 m (160 ft) of river. Although this configuration was originally designed with seventeen copper electrodes, four electrodes were eventually disconnected (see Section 4.2). Insulated cable connected the ends of the copper electrodes to the power source and served to maintain the 3-meter spacing forming a ladder like structure (Figure 3). The orientation of the electrodes parallel to the stream flow was expected to be less likely to affect adult fish upstream migration behaviour as it creates an electric flow across the width of the fish (side to side) rather than along the length of the fish (head to tail) as would occur with perpendicular orientations of the electrodes. The “**4-cable perpendicular**” array was an exact duplication of the array used in 2007, consisting of four copper cables, 12.7 mm (½-inch) in diameter, strung across the river perpendicular to the stream flow, held at even spacing 2 meters apart by securing the cables to PVC pipes each 6 meters long (Figure 4).

The “3-cable perpendicular” and “17-element parallel” arrays were fabricated and installed during the week of April 21 - April 26, 2008. The “3-cable perpendicular” array was situated approximately 4 meters upstream of the 5th St Bridge and the “17-element parallel” array was placed approximately 3 meters upstream of the upstream end of the “3-cable perpendicular” array. Both of these arrays were in the water and operational from April 27th – May 3rd. The “3-cable perpendicular” array was operated on April 27- 28 (2 evenings). The “17-element parallel” array was trialed from April 30 - May 2. During the period of May 5th – 9th the “17-element parallel” array was pulled out and the “3-cable perpendicular” was converted into the “4-cable perpendicular” array. This was done in-situ by adding an additional cable and repositioning two other cables so as to maintain even spacing of 2 meters between cables. The “4-cable perpendicular” array was operated from May 14 to May 22 and was removed from the river on June 5, 2008.

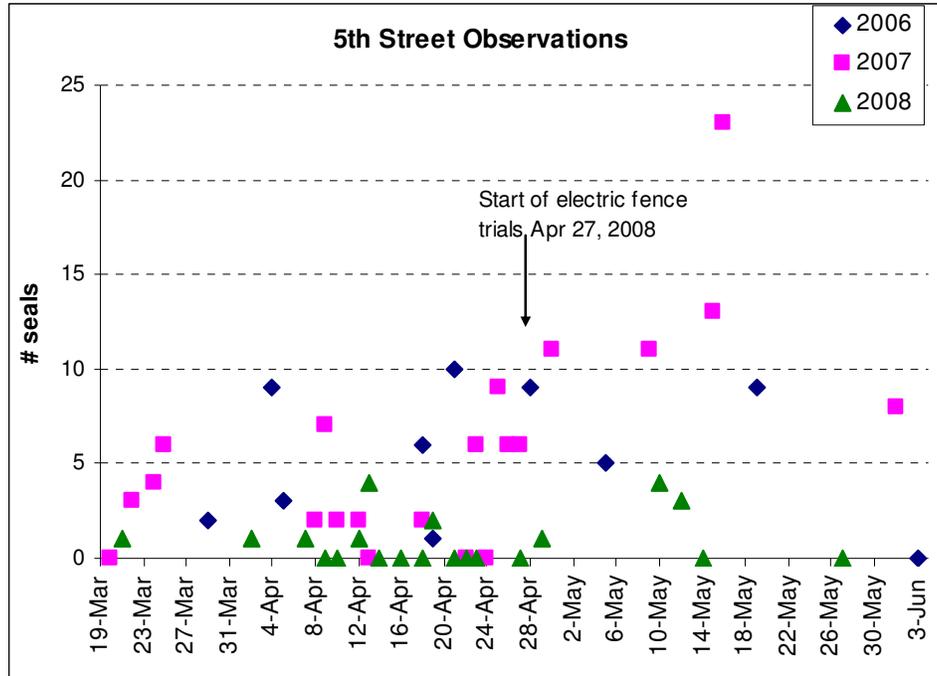
**Figure 5.** Observations of seals in the Puntledge (Courtenay) River at the 5<sup>th</sup> Street Bridge between April and June before lights were shielded (2006-2007) and after (2008). Commencement of the 2008 electric deterrent trials is noted. Trials in 2007 were conducted on April 12-13 and April 23-25

Baseline observations of seal foraging behaviour were collected by Puntledge Hatchery personnel during the months of April and May 2008 before and during electric array operations. Surveys, using night vision equipment, were conducted between dawn and dusk during flood tides at five main areas of the Puntledge / Courtenay River: Condensory Road Bridge, Lewis Park tennis courts, 5th Street Bridge, Central Builders, and the 17th Street Bridge (Figure 2). The 2008 observations are compared to 2007 observations collected during the same months and illustrated in Figure 5.

It appears that the light shields were effective in reducing the number of seals feeding under the 5th Street Bridge. For the period prior to the start of the electric fence trial on April 27, the maximum number of seals observed during any given monitoring event was 4 in 2008 compared to 9 in 2007 and 10 in 2006. The average number of seals observed during this period was 5.2 in 2006, 3.7 in 2007 and 0.7 in 2008. It was noted that the light shields eliminated the distinct shadow line where seals had congregated to feed on outmigrating juvenile salmon in past years. Seals may have been displaced to other well lit areas of the river to feed such as the Lewis Park tennis courts upstream. A comparison of 2007 and 2008 observations at Lewis Park provides limited information due to the disproportionate sampling effort between the 2 years (Figure 6). These comparisons do not take into account other variables that may have influenced seal activity such as timing of juvenile salmon outmigrations, tide level and river discharge. The shielding of lights and displacement of seals from the 5th Street Bridge confounded the objective of assessing whether the electrical array would displace seals from a localized area, and we were only able to assess whether the array served as a barrier in blocking the upstream movement of seals.

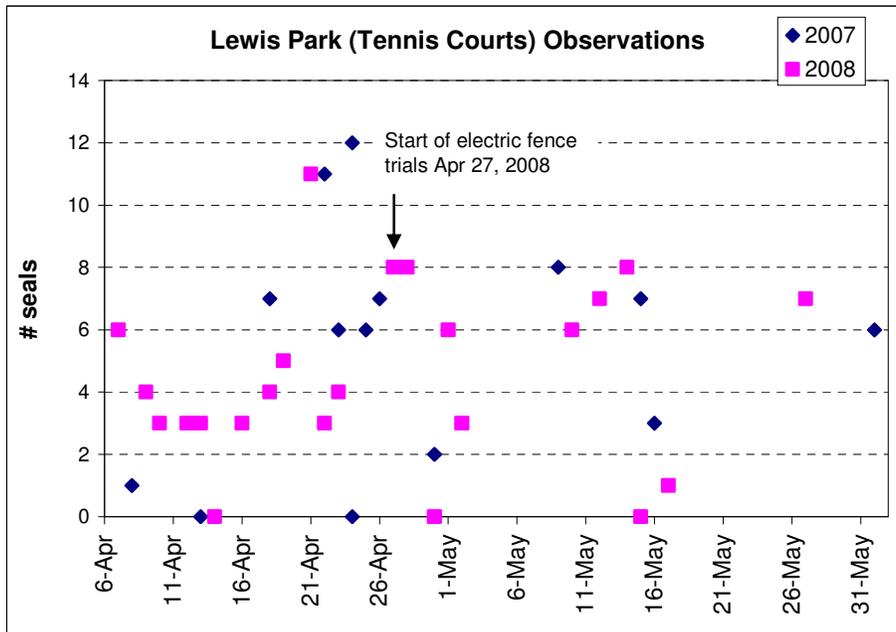
**Figure 6.** Observations of seals in the Puntledge (Courtenay) River at the Lewis Park Tennis Courts (upstream of the 5<sup>th</sup> Street Bridge), between April and June before lights were shielded (2007) and after (2008). Commencement of the 2008 electric deterrent trials is noted. Trials in 2007 were conducted on April 12-13 and April 23-25.

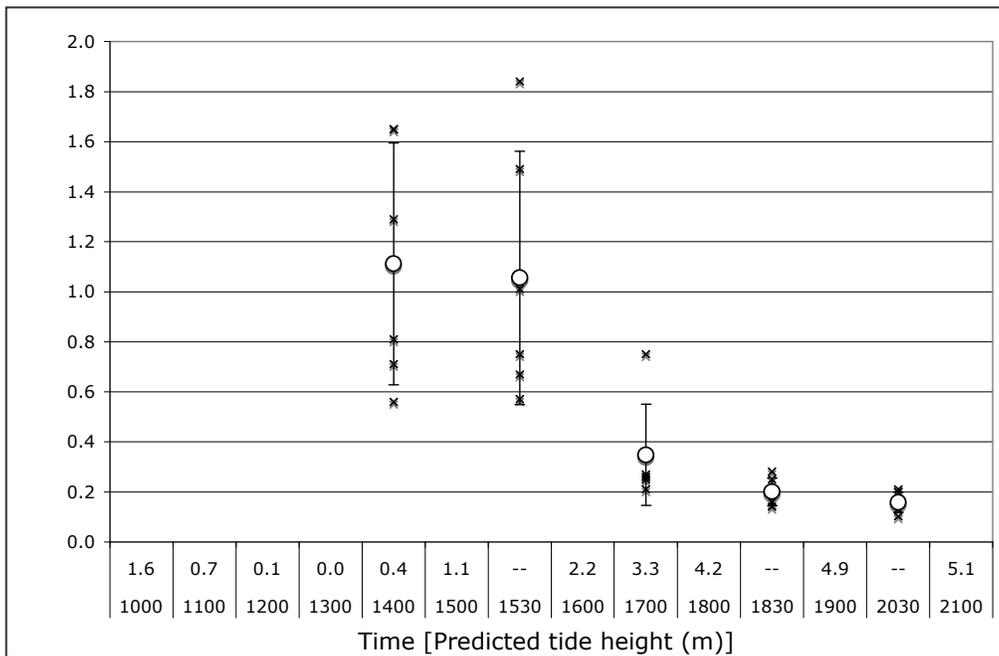
**Figure 7.** Electric field strength [voltage gradient (V/cm), y-axis] over the 4-electrode array, at the surface of the Puntledge (Courtenay) River, as a function of time and predicted tide height (x-axis) on 4 June 2008. The measurements were taken with the EFP-2 voltage probe at random intervals along six transects. Circles are averages with error bars of one standard deviation.

Electric field measurements taken along transects at the water surface at 10:00:00 with an EFP-2 Electric Field Probe [predicted tide of 2.2 m at the Comox Station (#7965)], demonstrated maximum voltage gradients of 0.34, 0.32, and 0.31 V/cm along the west side, the east side, and center of the river, respectively. Electric field measurements along similar transects at 14:45:00 (predicted tide height of 3.5-3.6 m), revealed maximum voltage gradients of 0.20, 0.25, and 0.23 V/cm for the same locations described above. The difference in the field intensity at the surface was likely a reflection of tidally influenced changes in water depth.

Measurements of the electric field conducted on June 4<sup>th</sup> though a large tide cycle (5.1 m / 16.7 ft.) confirmed that the strength of the electric field weakened over the array as the river depth increased from the rising tide (Figure 7). The measurements should best be regarded as indices for comparing changes related to tides since they were taken from a moving boat (speed not controlled, direction not exact, transects not reproduced exactly). Unfortunately, during the testing of the electric field an anchor line of the electrical array entangled the boat used in the testing. The entanglement disturbed the position of the array, the spacing of the electrodes, and the strength and distribution of the electric field relative to those during the trials with seals. That is, field strength measurements taken on 4 June 2008 do not reflect those present in the water column during the trials. These measurements do, however, demonstrate a significant relationship between tide and field strength at the water surface, where field strength at the surface decreased markedly as predicted tides increased.

The effectiveness of the electric array was dependent on the strength of the field provided by the pulse width parameter, but may also have been dependent on the environmental conditions during which the array was operated. As the river depth over the array increased due to tidal inundation and/or increased discharge, the electric field weakened at the surface, potentially creating openings in the electric barrier that seals would exploit. Conversely, the field measurements indicate that at low tides and at the river's shallower margins, the electric field exceeded the 0.32 V/cm approved by the Animal Care Committee based on levels used in captive trials (Figure 7).

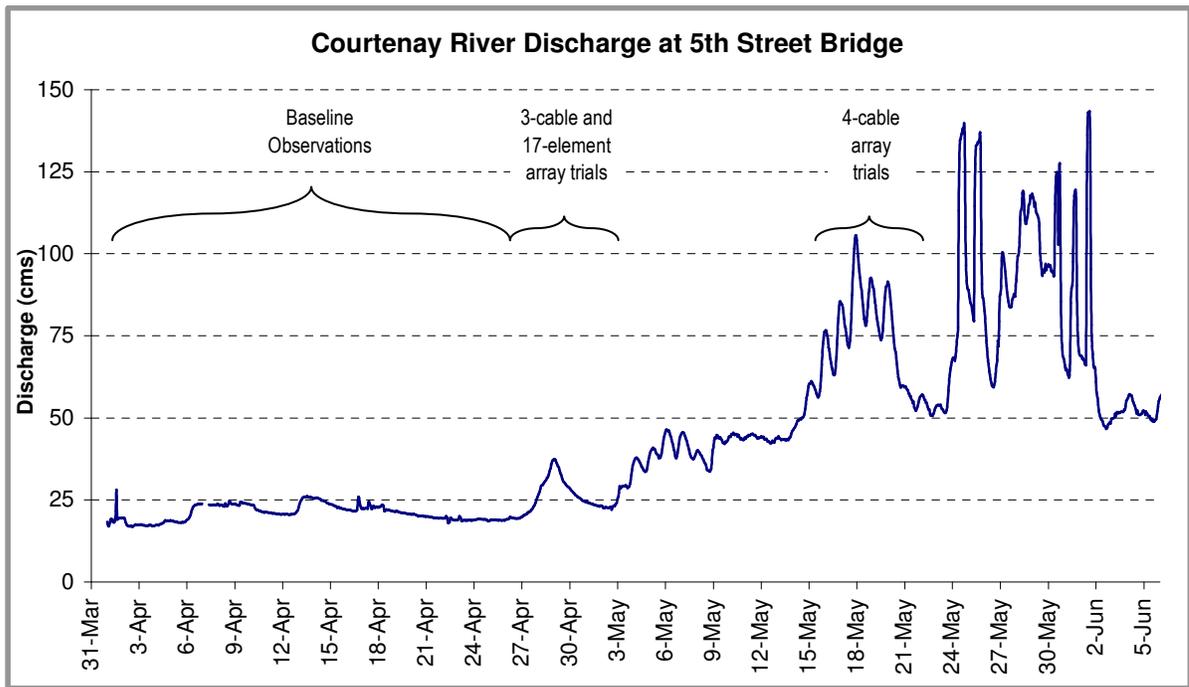
**Figure 8.** Hourly average discharge for the Puntledge (Courtenay) River (below the Puntledge/Tsolum River confluence) from April 1 - June 5, 2008, derived from the sum of Puntledge River discharge below the BC Hydro powerhouse and the Tsolum River discharge.

Puntledge/Tsolum River confluence) and the Tsolum River station (WSC Gauge No. 08HB011) located approximately 2 km upstream of the confluence. Discharge from these two stations were totalled to provide an estimate of the discharge observed at the 5<sup>th</sup> Street Bridge with no correction for lag time for distances between gauge locations and the bridge location (Figure 8). Discharge in the river below the confluence was highest during the testing period of the 4-cable array from May 14 to May 22, 2008 (average discharge = 68.8 cms) and lowest during the baseline observations (average discharge = 21cms).

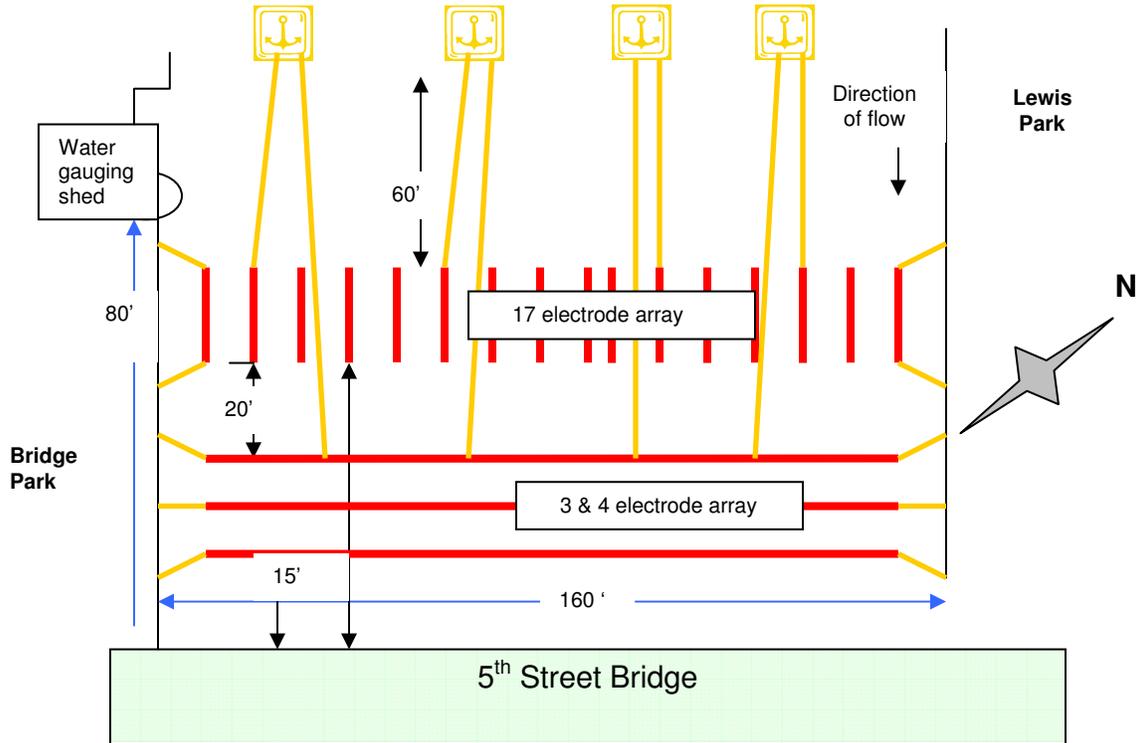
Appendix A. Schematic of anchor, signage, and DIDSON sonar camera locations.

**Courtenay River Seal Deterrent**  
**(As built - top view)**

**Anchoring set-up**

- 4 anchors (30# ground line / halibut) spaced across river approximately 80' above the top end of the upstream array (new design - 17 electrode).
- Each anchor had 2 lines attached. 1 line was attached to upstream array & 1 line was attached to downstream array.
- Arrays were also attached to shore locations directly adjacent.

Between April 27 and June 5, 2008 three different configurations of electrodes (i.e. arrays) were tested in the lower Puntledge River: a “**3-cable perpendicular**” array, a “**17-element parallel**” array and a “**4-cable perpendicular**” array. Each of the electrode arrays were installed just upstream of the 5<sup>th</sup> Street Bridge in an approximately 24 metre stretch of river between the upstream edge of the bridge and a metal retaining wall located on the west side of the river (Figure 2). Each array was securely anchored to both shorelines as well as in several locations in the river bottom. Anchors were also placed upstream with securing lines extending to the arrays to hold their position throughout the test period (Appendix A).

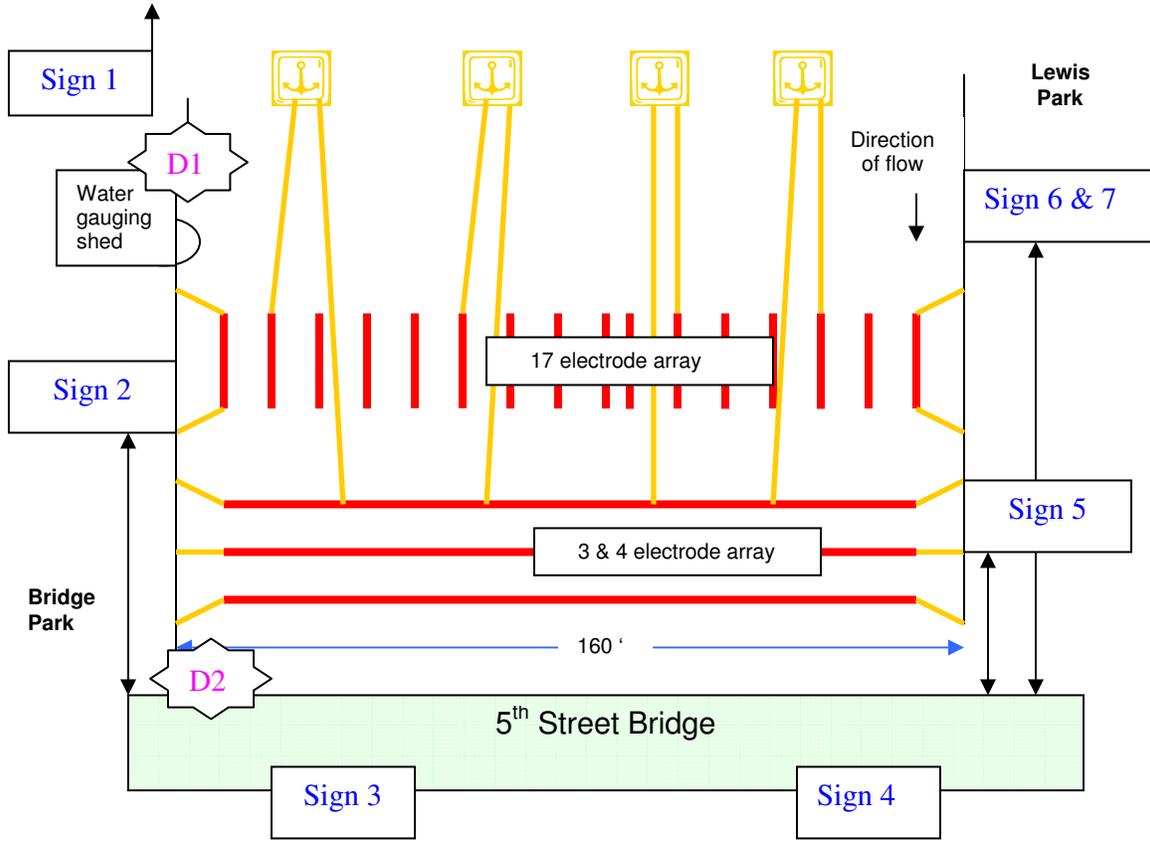
**Puntledge River Seal Deterrent**  
(Signage & DIDSON Sonar locations)

**Sign location:**

- 1) 125 ft. upstream from water gauging shed.
- 2) Immediately adjacent to arrays (river right)
- 3) Hanging from 5<sup>th</sup> St. Bridge walkway railing – river right.
- 4) Hanging from 5<sup>th</sup> St. Bridge walkway railing – river left.
- 5) Attached to railing adjacent to arrays.
- 6) Attached to stairway railing – downstream rail.
- 7) Attached to stairway railing – upstream rail.

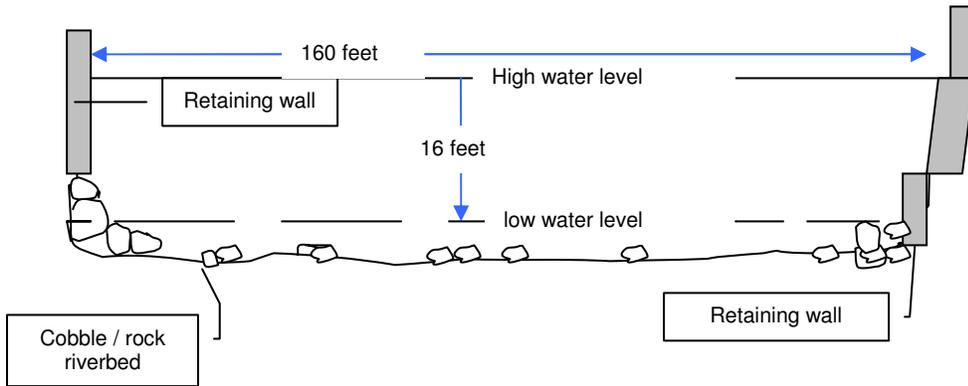
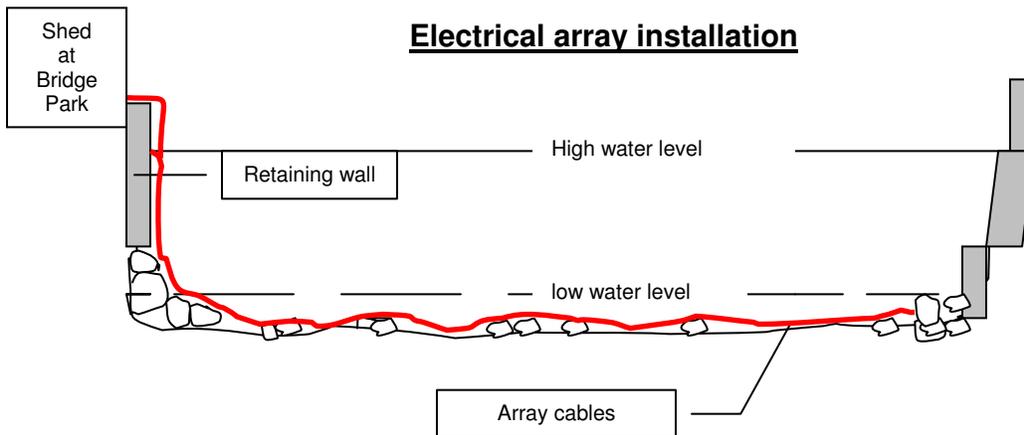
Appendix B. Cross-section view of the Puntledge River looking upstream from the 5<sup>th</sup> Street bridge at the electrode array location.

### Puntledge River at Bridge Park

### Electrical array installation

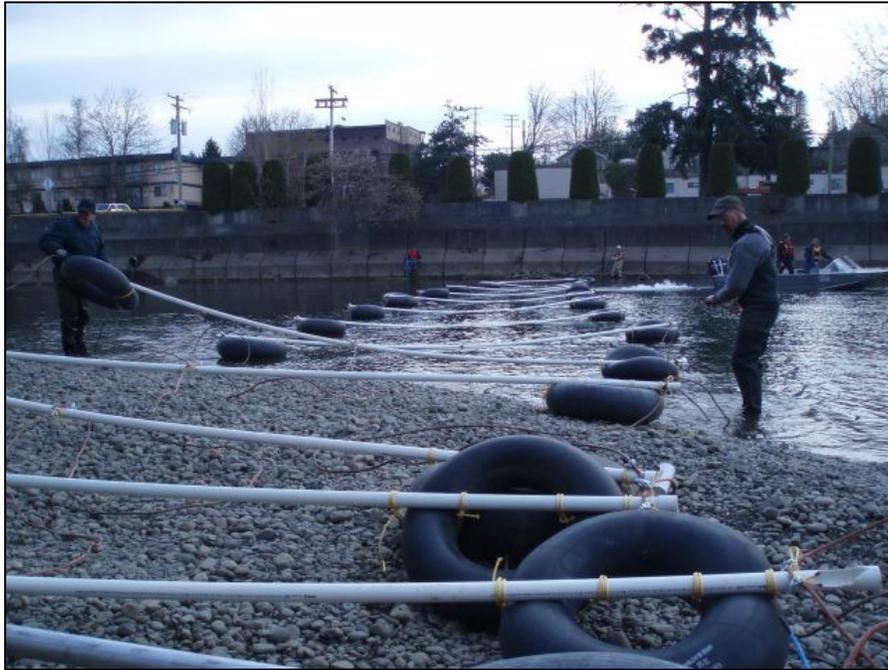
**Photo 1.** Assembling and installing the 3-cable array, April 2008. Photo looking from east to west shore (river left to river right) at low tide.

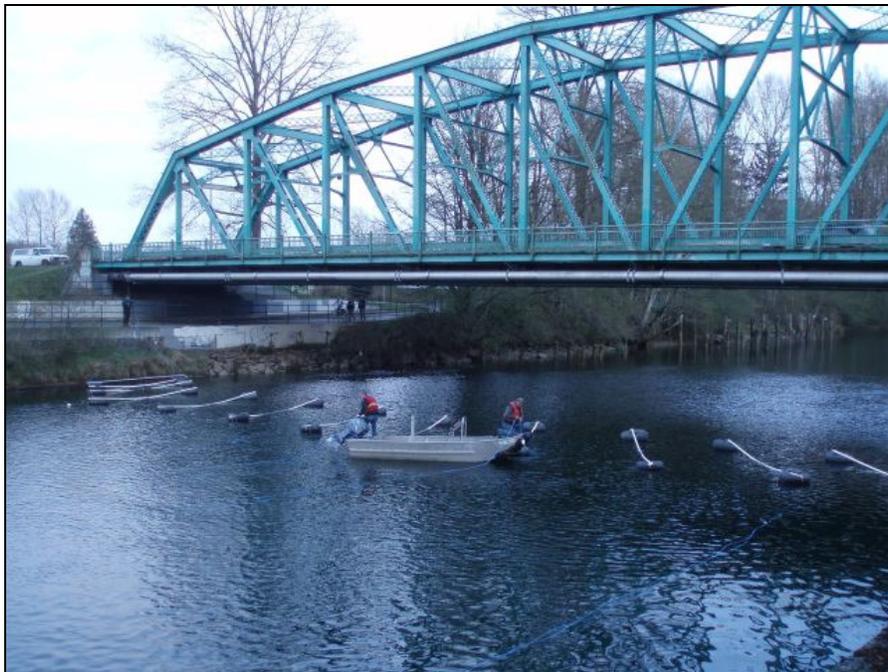
**Photo 2.** Placement of the 3-cable array upstream of the 5<sup>th</sup> Street bridge prior to anchoring, April 2008. Photo looking downstream from west to east shore (river right to river left).

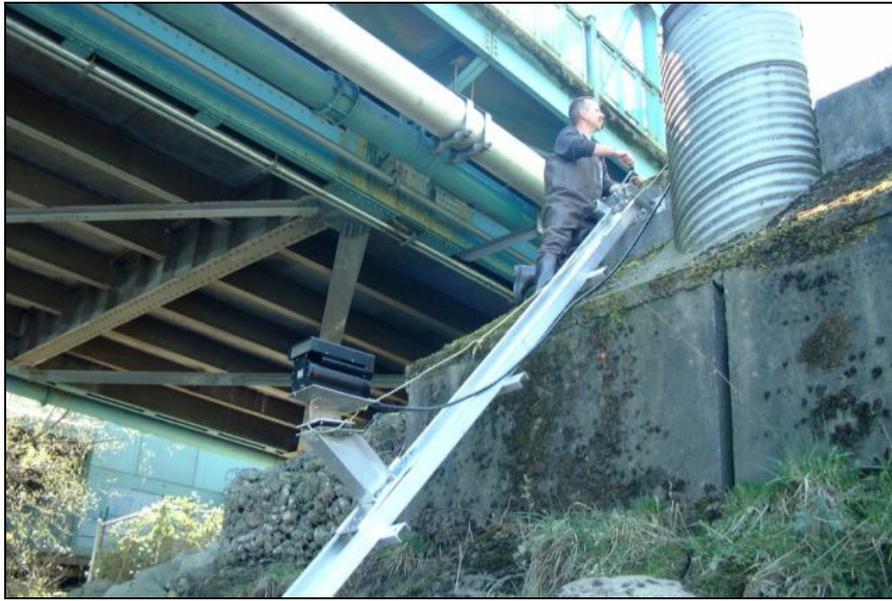
**Photo 3.** Placement of one of two DIDSON sonars and ramps for easy deployment and adjustment, upstream of the 5<sup>th</sup> Street bridge.

Two DIDSON acoustic cameras, a Short-range (30 m) and a Long-range (80 m), were used to record behaviour of seals and fish in the area of the active electrical array. Two ramps were fabricated and installed on the west shoreline to guide and position the DIDSON acoustic cameras in the water (Appendix C - Photo 3). This additionally allowed easy installation and removal, as the DIDSONs could not be left permanently in position due to security concerns. One was located downstream of the lower array and the other was located upstream of the upper array (Appendix A). The positioning of these ramps was not changed throughout the testing. The Long-range DIDSON initially was placed at the upstream ramp with the Short-range DIDSON at the downstream ramp, however the upstream ramp was located in water too shallow to allow continual operation of the DIDSON throughout the tidal cycle. As the Long-range DIDSON provided the best coverage of the interactions between seals and the electric array, it was moved to the downstream ramp after a few days. DIDSON imagery was collected during each evening the electric array was operated with the exception of the initial trial period of the 3-cable array.

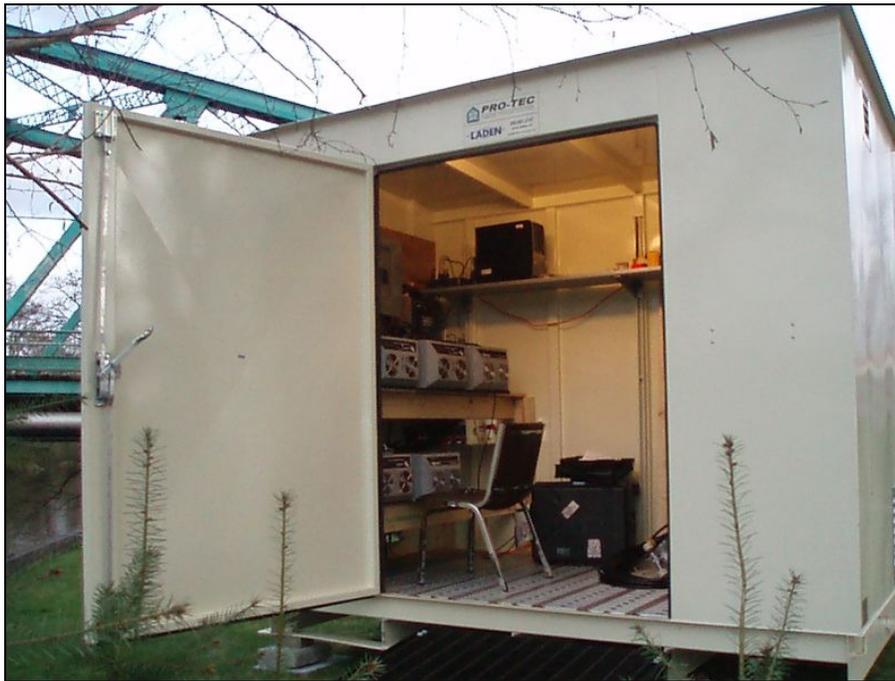
**Photo 4.** Secure metal building temporarily installed on the west side of the river to house all electronic and computer components necessary for the project.

All electronic and computer equipment necessary for the project was housed on the west side of the river in a secure metal building provided by DFO (Appendix C - Photo 4). This included a series of customized 1.5 Programmable Output Waveform (POW) pulsators (SRI), computer components needed to produce and control electrical output to the arrays, and computers to record DIDSON (Dual-frequency IDentification SONar, Sound Metrics, Inc.) images. The 1.5 POW barrier pulsators converted incoming alternating current (commercial 220V, 30 Amp) from a neighbouring apartment building to pulsed direct current (PDC), and served as the power supply for the electrode arrays. Heavy gauge wires encased in conduit transmitted power to the array cables at the water’s edge. The arrays laid flat on the river bottom and, when energized at a frequency of 2.25 Hz, created an electric field directly over the cables with a voltage gradient of 0.32 V/cm at the surface, and extended upstream and downstream of the array, quickly decreasing to undetectable levels within 2-3 meters of the array.

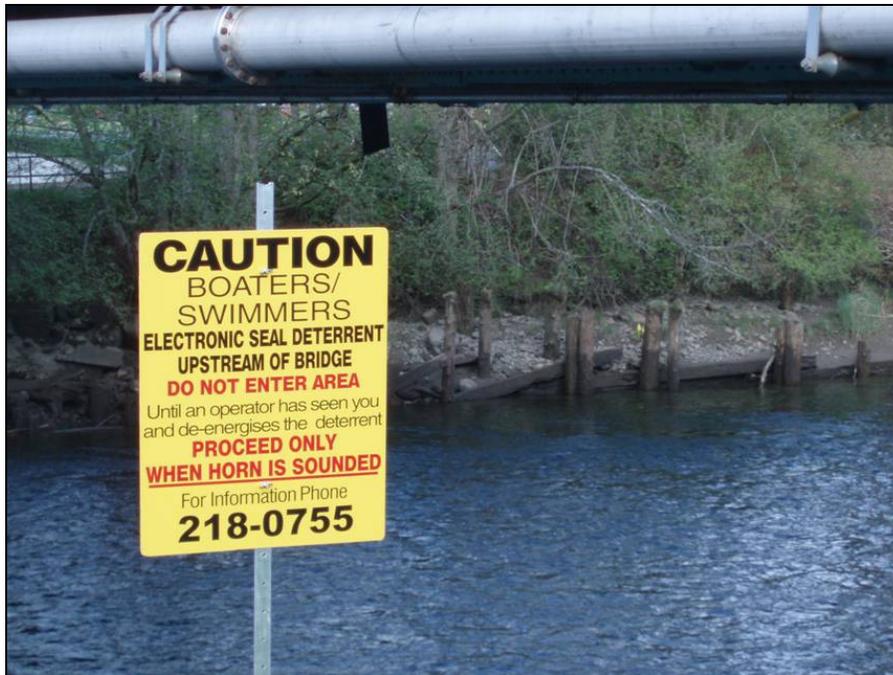
**Photo 5.** Example of signage posted upstream, downstream and within the testing area of the electric arrays in the Puntledge River from April – June 2008.

During the field trials, a minimum of two safety observers were on site stationed near shore where visibility of the electrified zone was unobstructed. The electrical system for operating the arrays was equipped with a kill switch which the safety observer could have next to them while at the shoreline. The observer could turn off power to the array at a moments notice if there was any potential for a human interaction with the electrical field in the water. Signs were placed above and below the electrical arrays to alert river users of the presence of electricity in the water during the trial periods (Appendix C - Photo 5) and information notices were also placed in the local newspapers. The observers were also equipped with an air horn to get the attention of humans wanting to pass through the array location. Power was always turned off whenever humans approached the array. The observers also made visual observations of numbers and behaviour of seals in the vicinity of the electrical barrier, and periodically made counts of seals upriver of the electrical array. These were particularly useful in evaluating the effectiveness of the electrical barrier early in the study, when DIDSON acoustic camera installation was being developed and they were not always available.
