**USACE Walla Walla District
QA/QC Evaluation of 2012 FMS TDG
Monitoring Data**

**USGS Washington Water Science Center
Dwight Copeland
Kevin Wright**

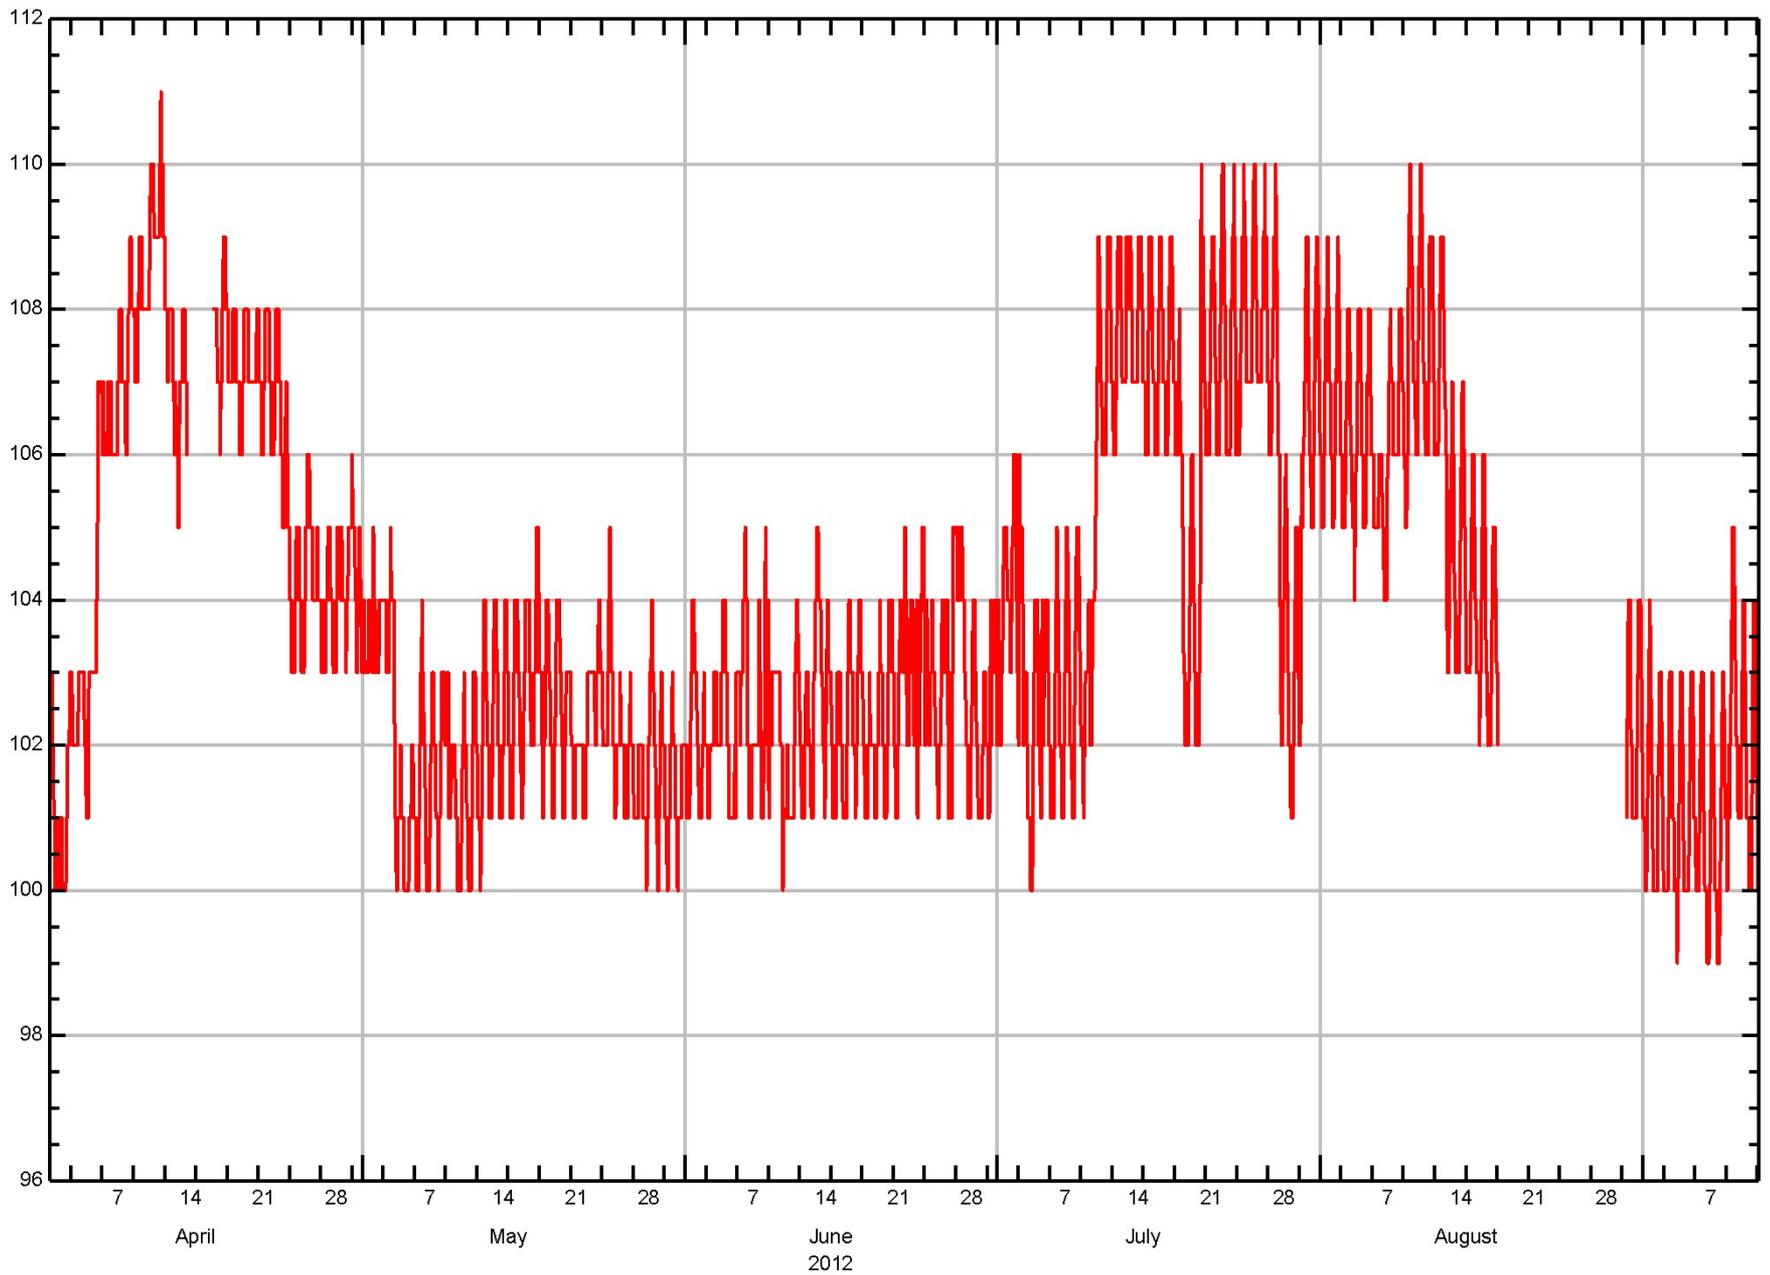
Peck

13341050 CLEARWATER RIVER NEAR PECK, ID (Pressure, diss gases PUBLISHED (%), COMPUTED) * 1

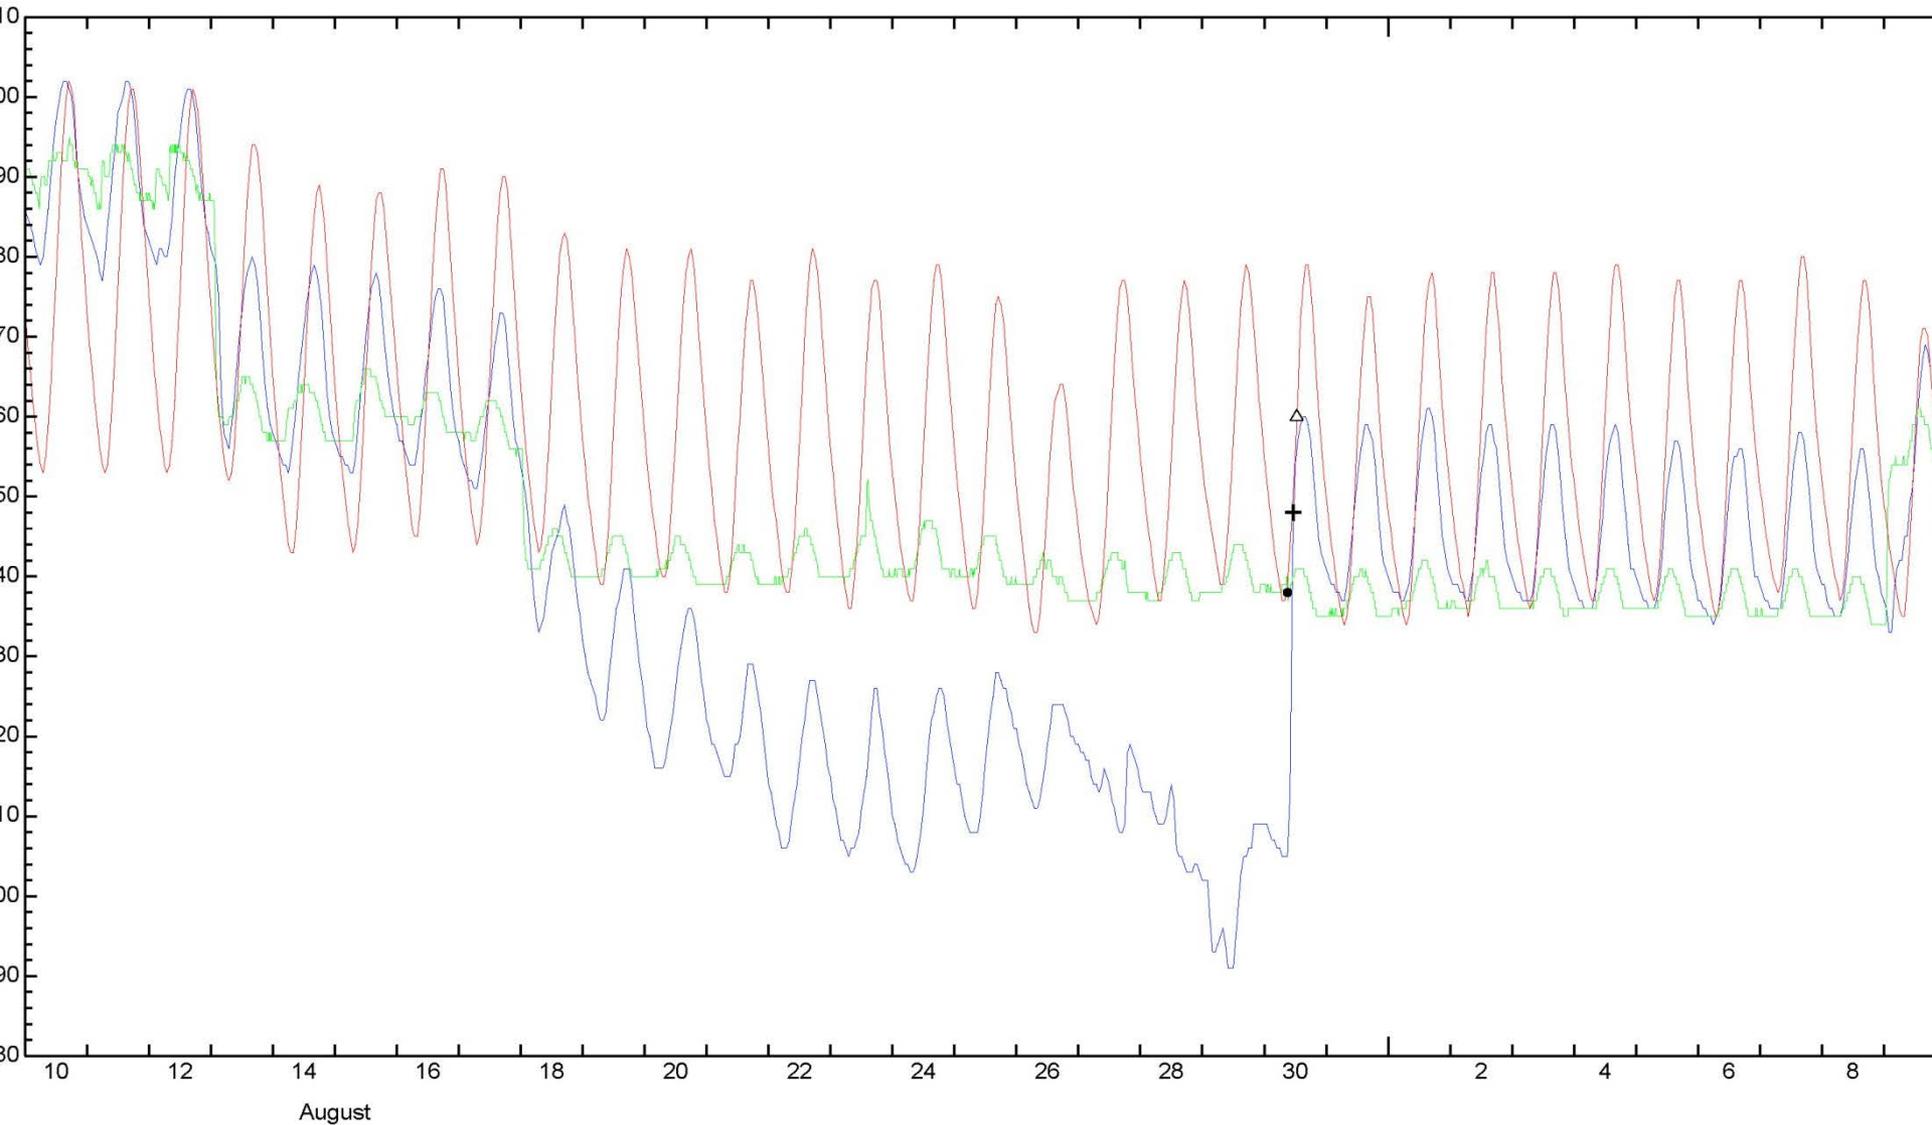
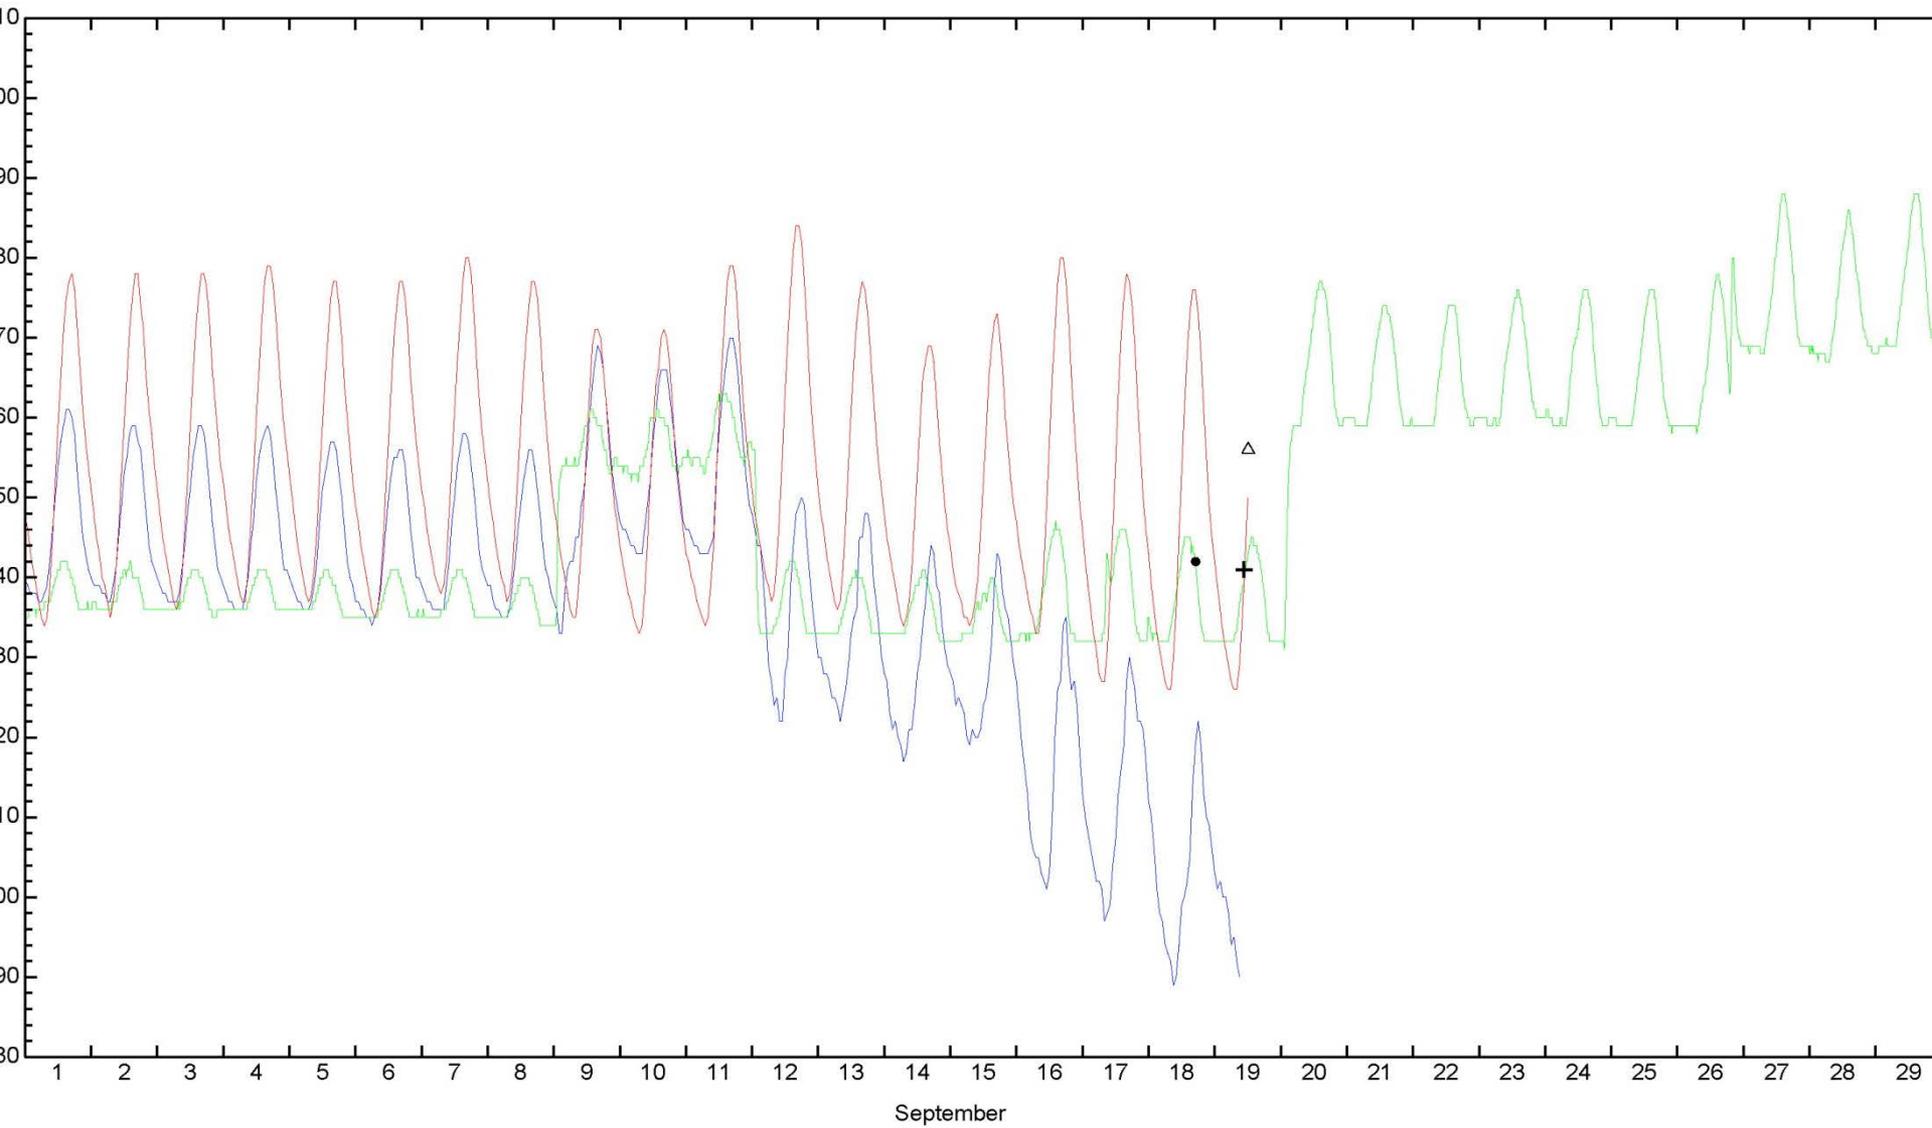
- 13341050 CLEARWATER RIVER NEAR PECK, ID (Pressure, diss gases FROM TDG DCP (mm/Hg), MEASURED METHOD) * 1
- 13341000 NORTH FORK CLEARWATER RIVER AT AHSAHKA, ID (Pressure, diss gases FROM DCP (mm/Hg), MEASURED METHOD) * 1
- 13343000 CLEARWATER RIVER NEAR LEWISTON, ID (Pressure, diss gases FROM DCP (mm/Hg), MEASURED METHOD, Trans. Code=S) * 1
- 13341050 CLEARWATER RIVER NEAR PECK, ID (All sensor readings, Pressure, diss gases)}
- 13341000 NORTH FORK CLEARWATER RIVER AT AHSAHKA, ID (All sensor readings, Pressure, diss gases)}
- △ 13343000 CLEARWATER RIVER NEAR LEWISTON, ID (All sensor readings, Pressure, diss gases)}

- 13341050 CLEARWATER RIVER NEAR PECK, ID (Pressure, diss gases FROM TDG DCP (mm/Hg), MEASURED METHOD) * 1
- 13341000 NORTH FORK CLEARWATER RIVER AT AHSAHKA, ID (Pressure, diss gases FROM DCP (mm/Hg), MEASURED METHOD) * 1
- 13343000 CLEARWATER RIVER NEAR LEWISTON, ID (Pressure, diss gases FROM DCP (mm/Hg), MEASURED METHOD, Trans. Code=S) * 1
- + 13341050 CLEARWATER RIVER NEAR PECK, ID (All sensor readings, Pressure, diss gases)}
- 13341000 NORTH FORK CLEARWATER RIVER AT AHSAHKA, ID (All sensor readings, Pressure, diss gases)}
- △ 13343000 CLEARWATER RIVER NEAR LEWISTON, ID (All sensor readings, Pressure, diss gases)}

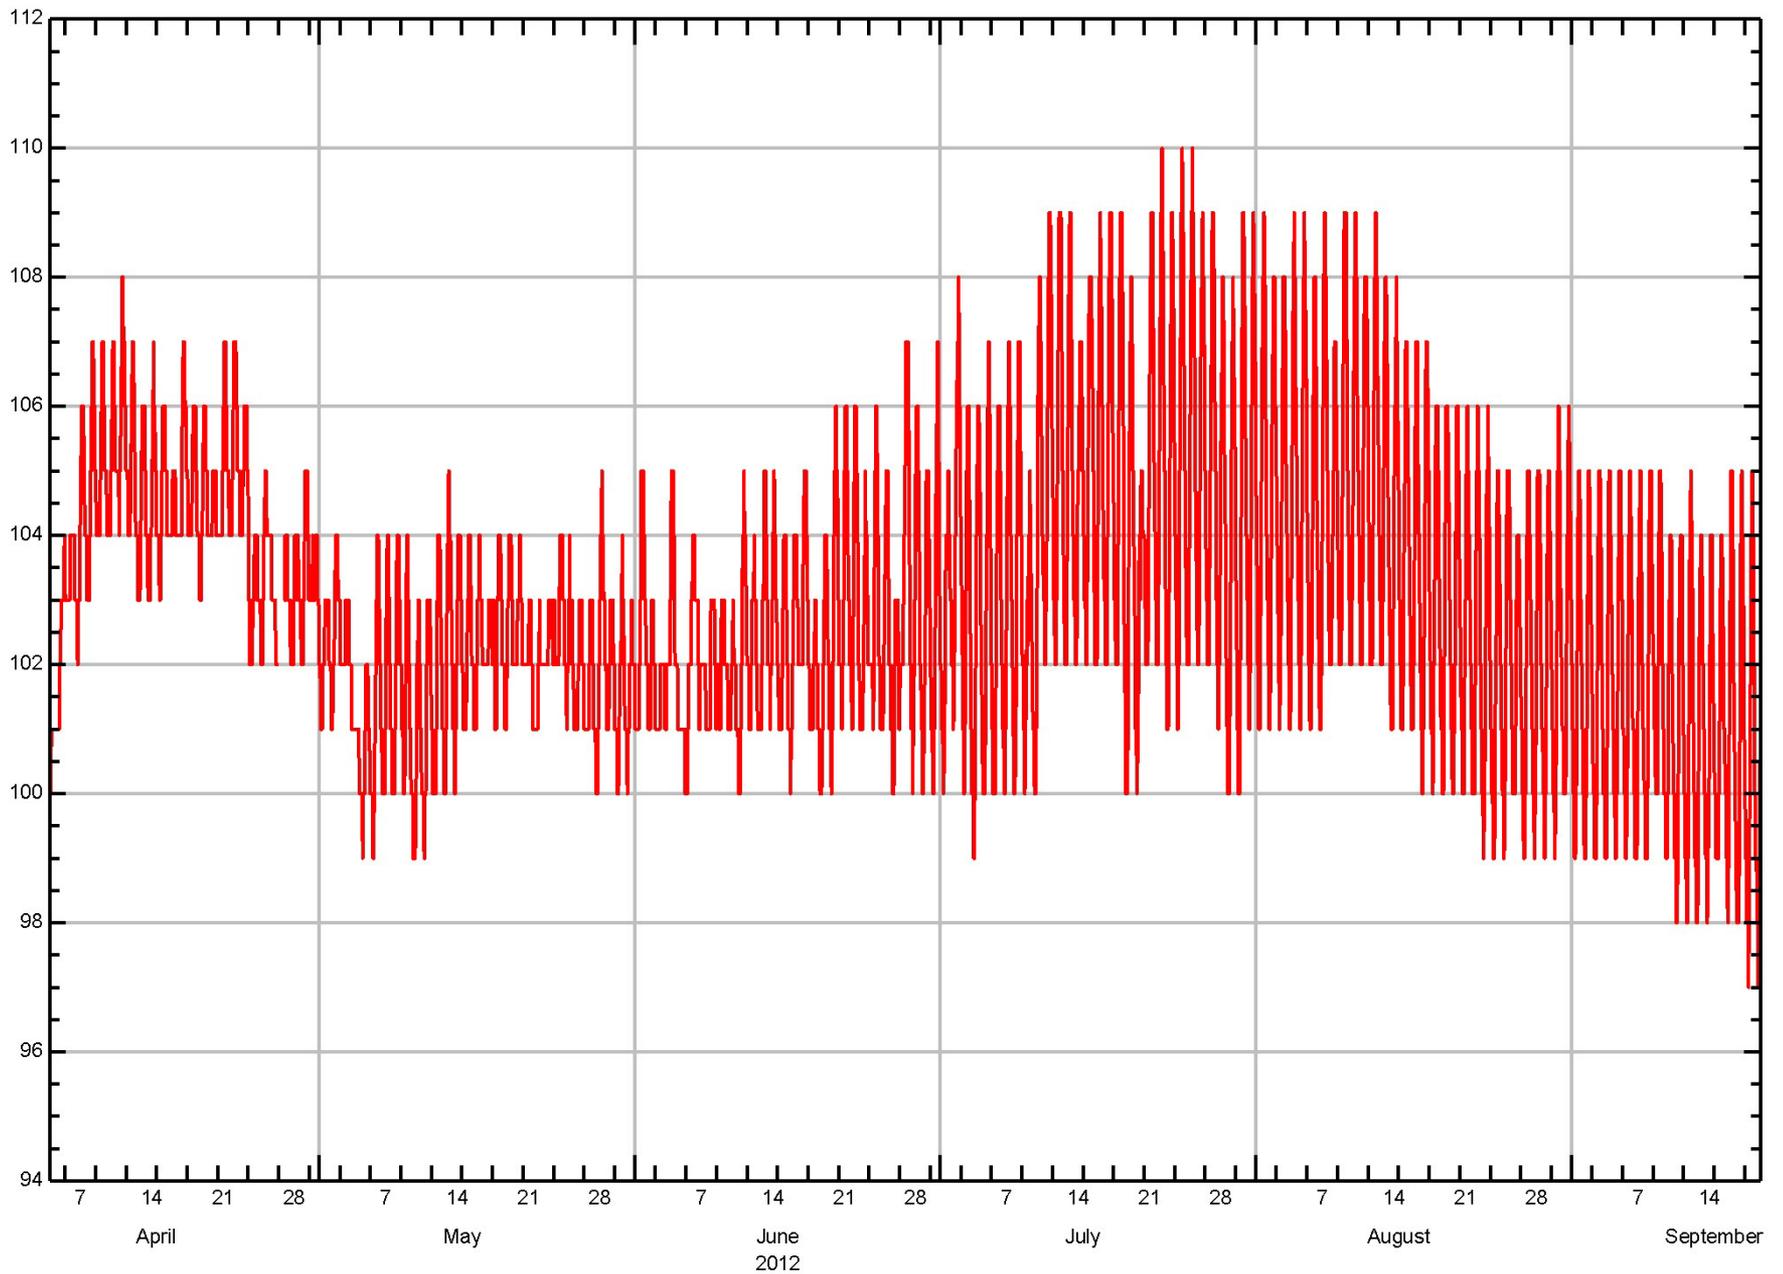
Lewiston

13343000 CLEARWATER RIVER NEAR LEWISTON, ID (Pressure, diss gases PUBLISHED (H), COMPUTED) * 1

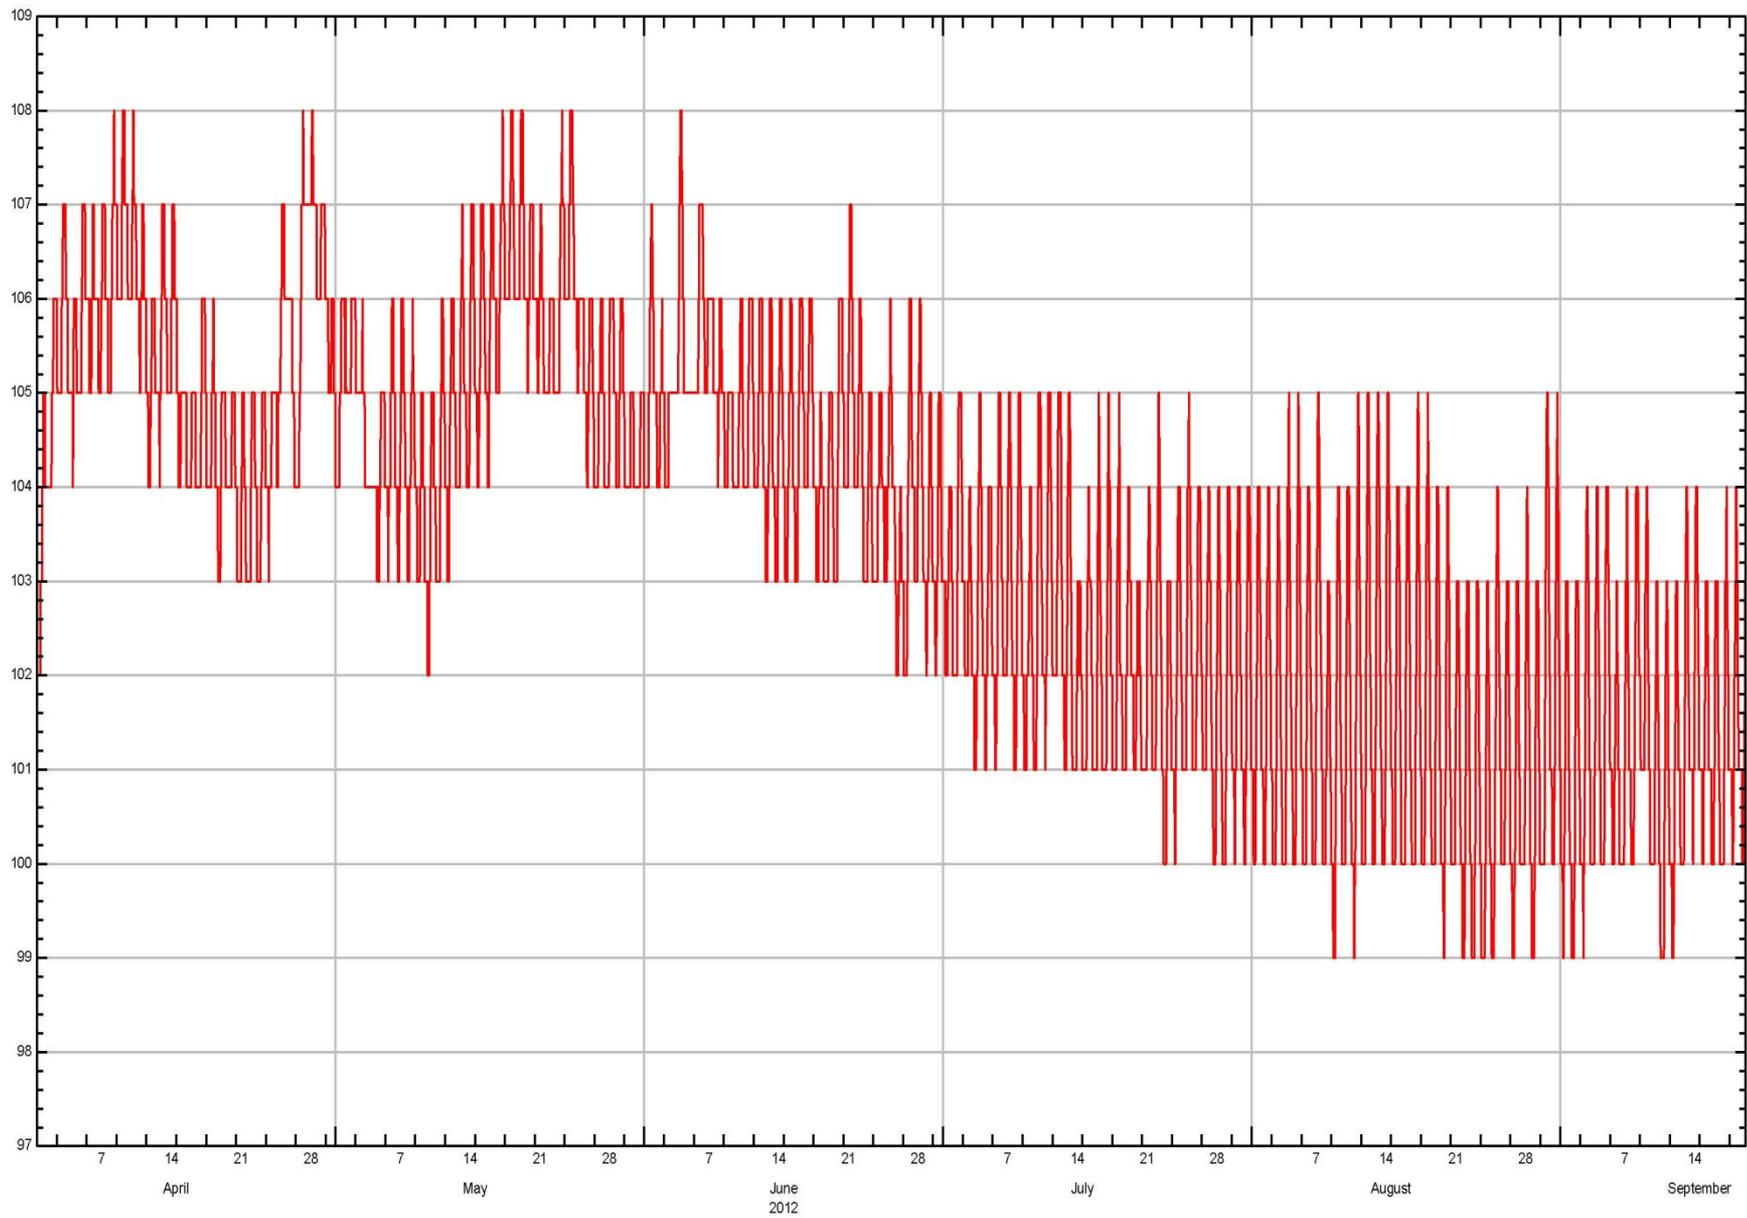
Anatone

13334300 SNAYE RIVER NEAR ANATONE, MA (Pressure, diss gases PUBLISHED (%), COMPUTED) * 1

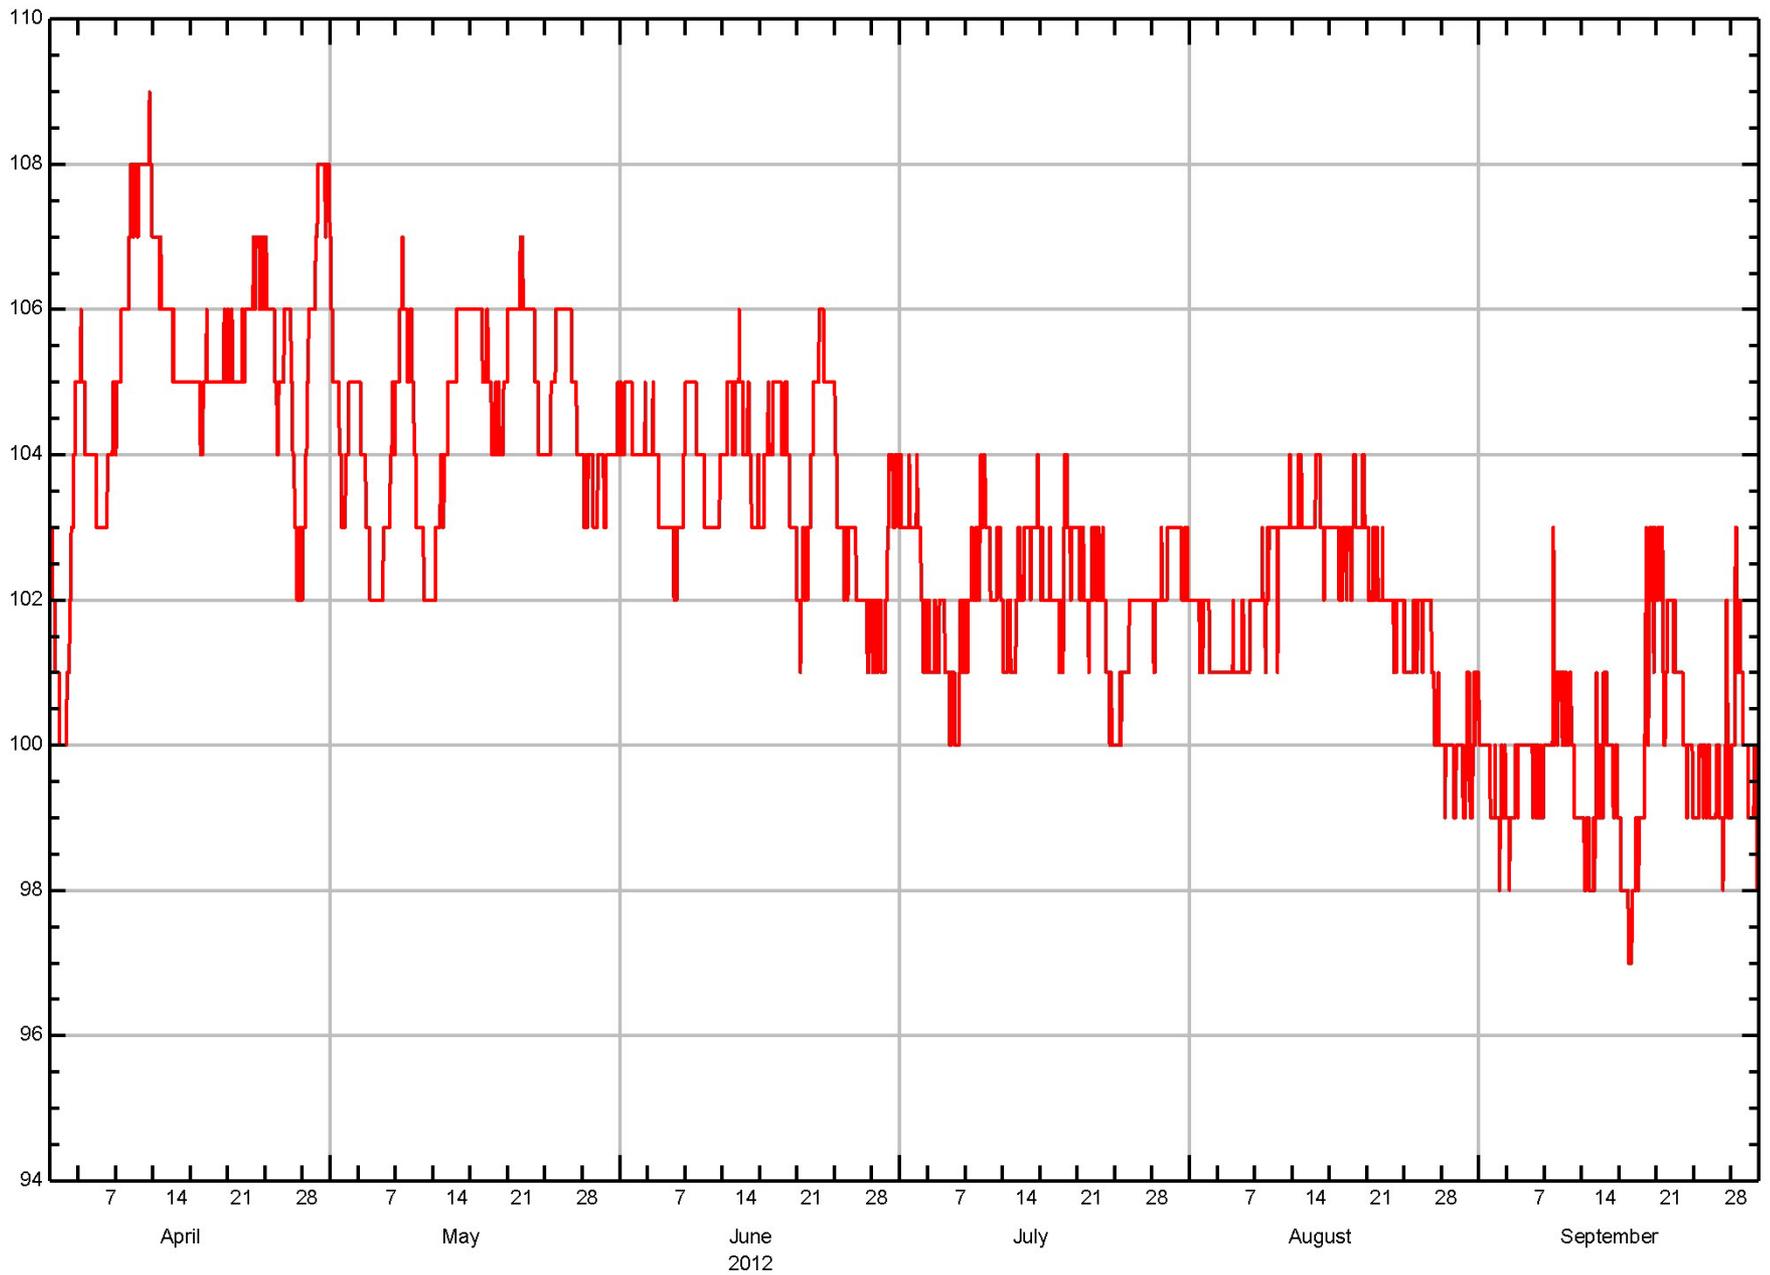
Lower Granite Forebay

13343590 LOWER GRANITE LK FOREBAY AT LOWER GRANITE DAM, WA (Pressure, diss gases PUBLISHED (%), COMPUTED) * 1

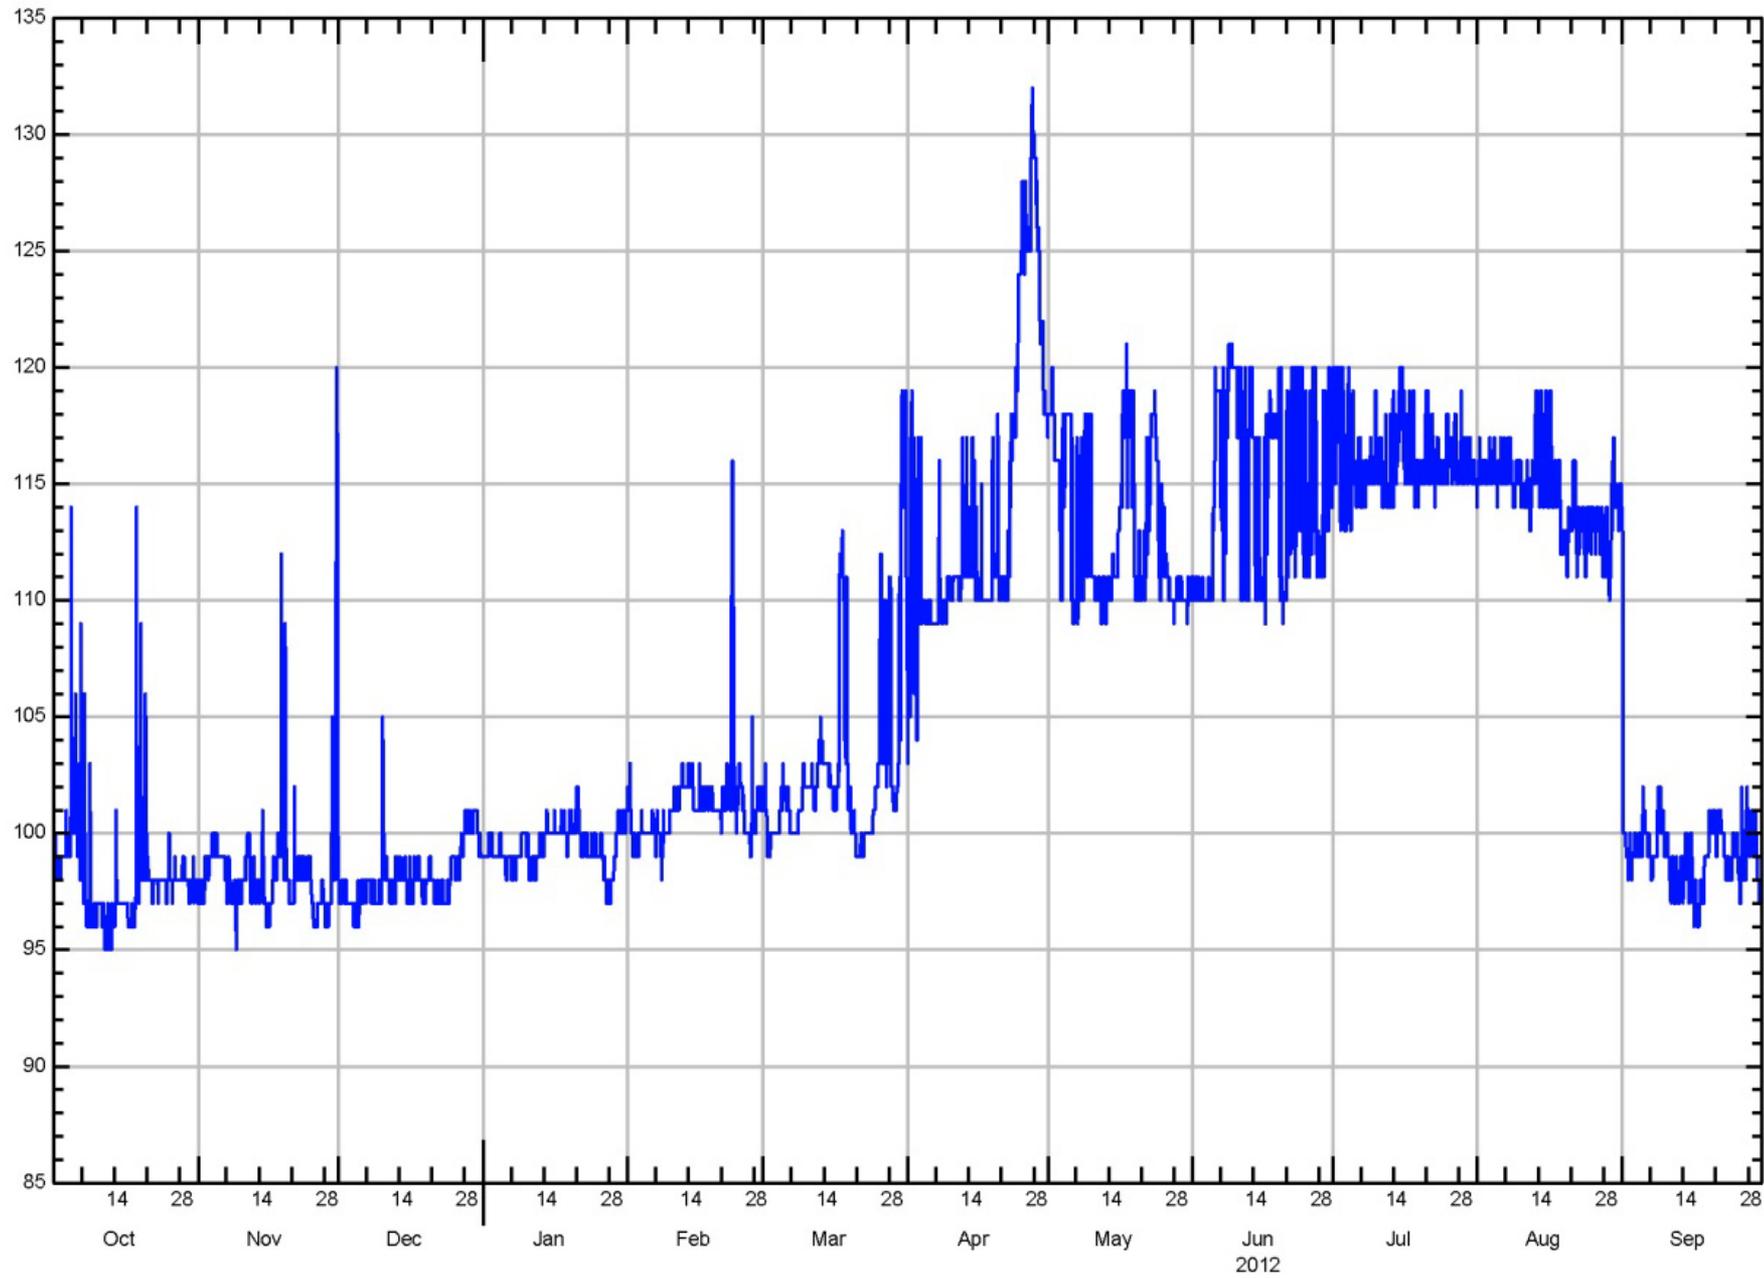
Lower Granite Tailwater

13343595 SNAKE RIVER (RIGHT BANK) EL LOWER GRANITE DAM, WA (Pressure, diss gases PUBLISHED (%), COMPUTED) * 1

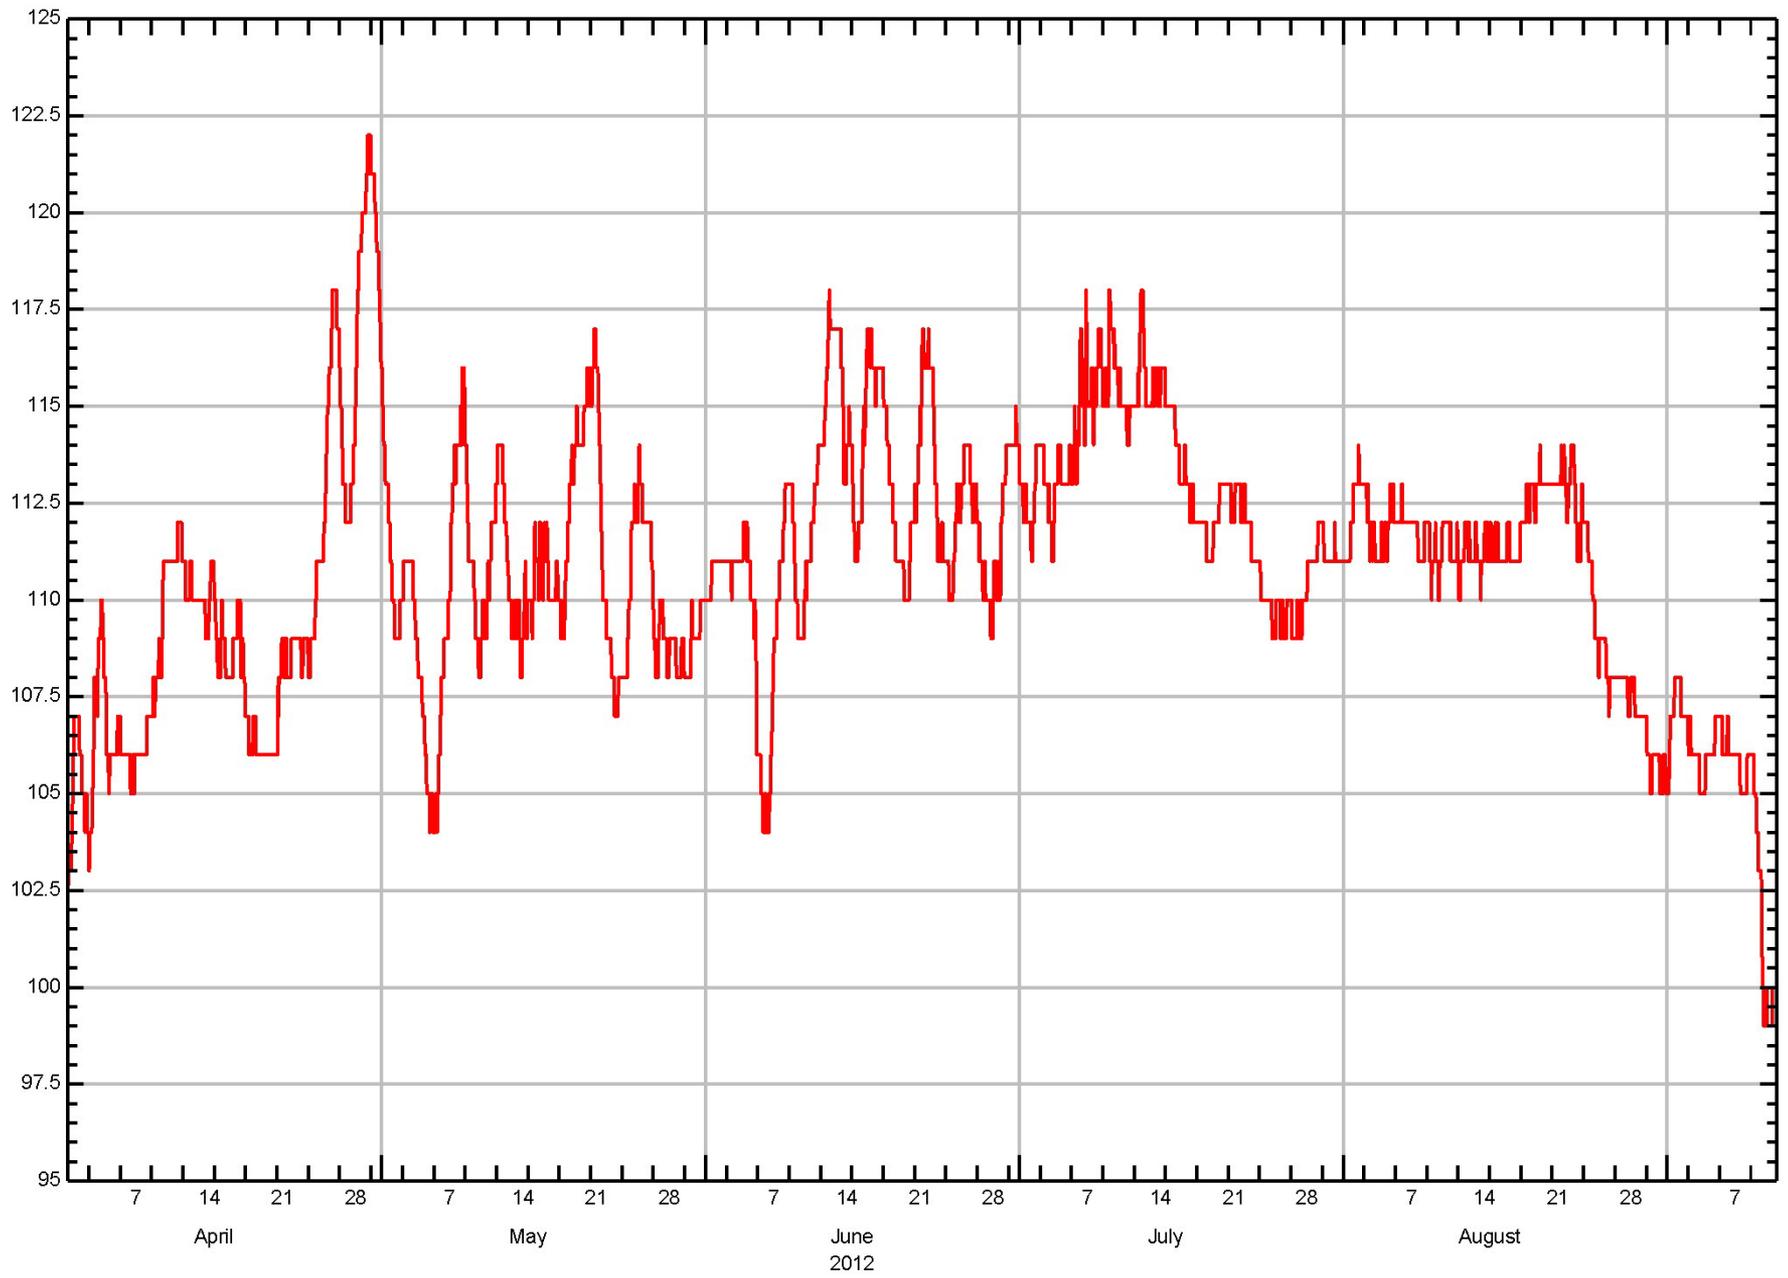
Little Goose Forebay

13343955 LAKE BRYAN FOREBAY AT LITTLE GOOSE DAM, WA (Pressure, diss gases PUBLISHED (%), COMPUTED) * 1

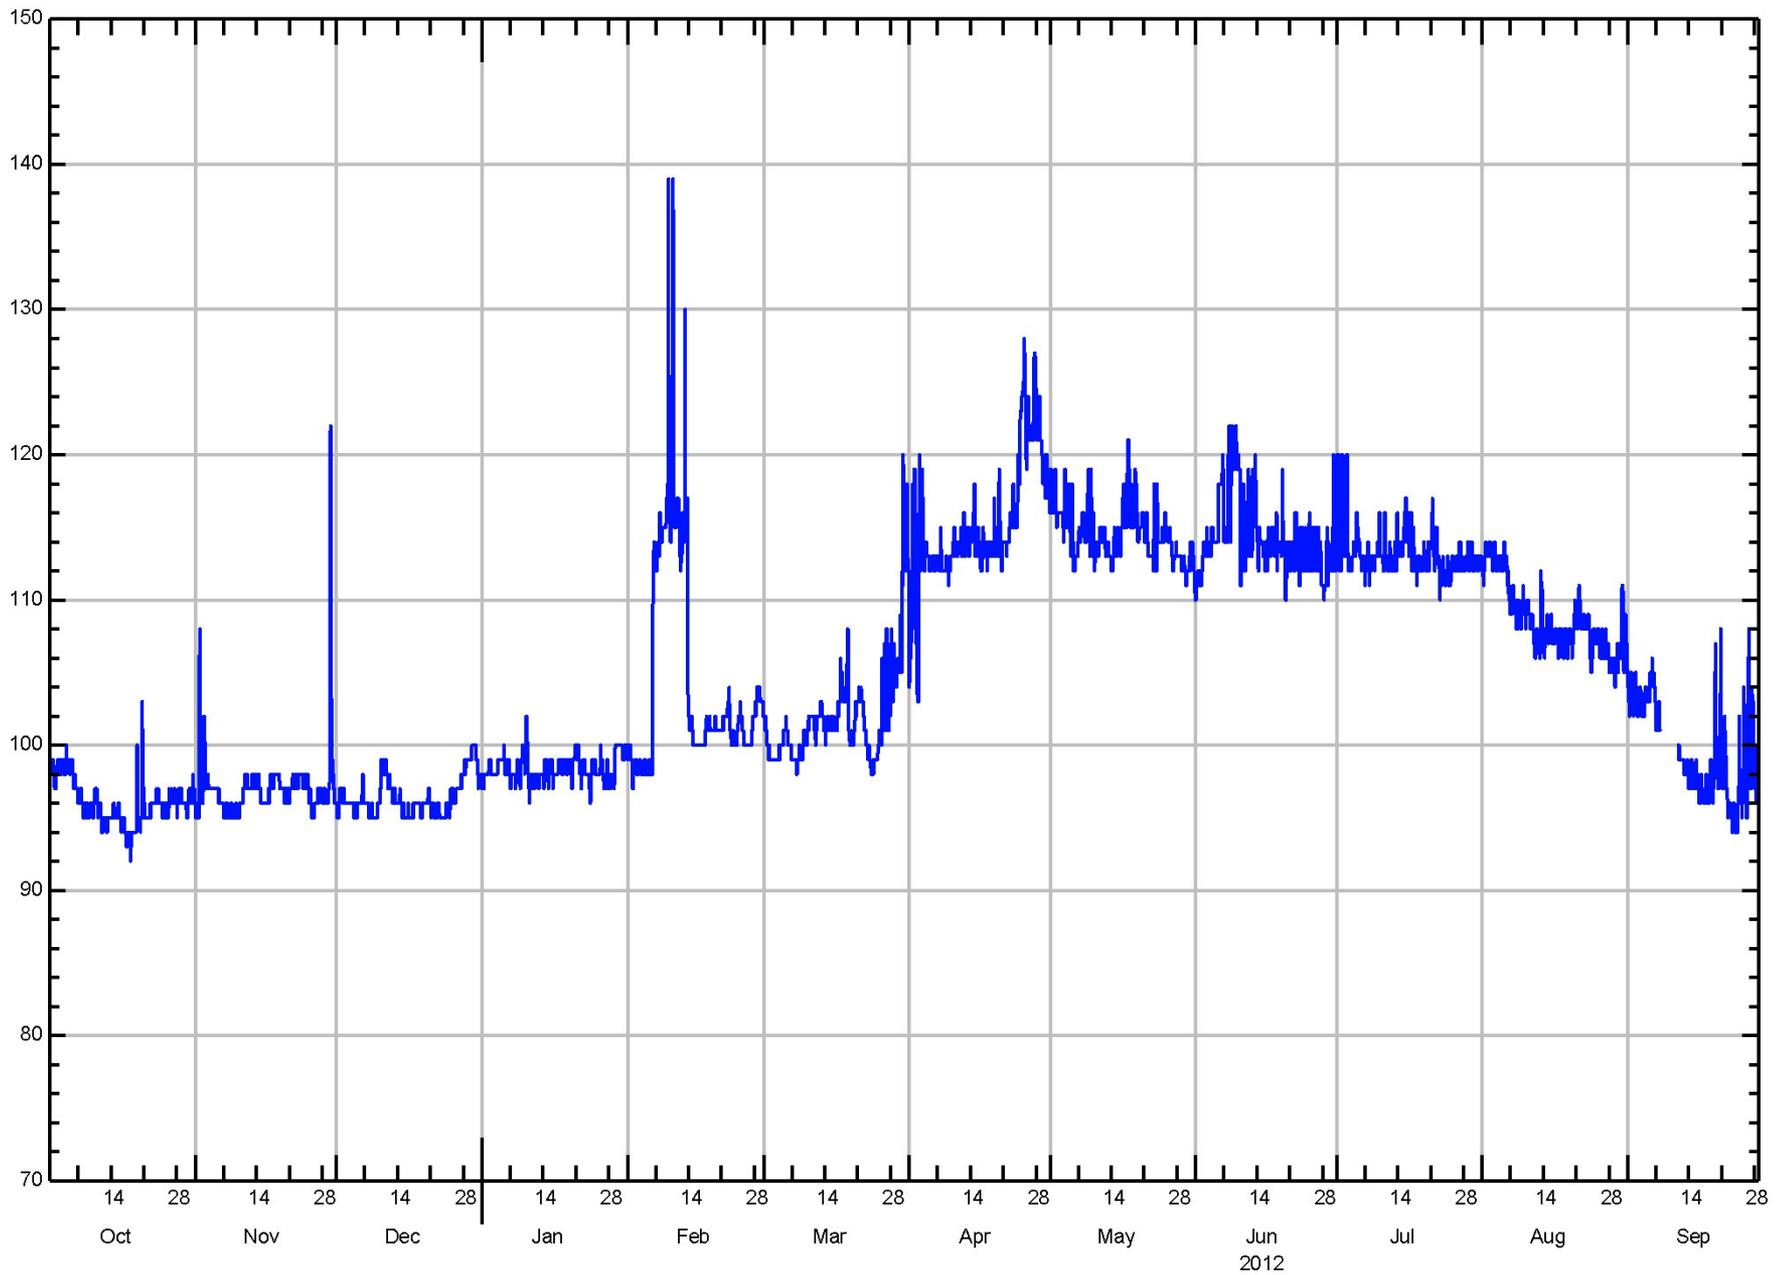
Little Goose Tailwater

13343960 SNAKE RIVER BELOW LITTLE GOOSE DAM, WA (Pressure, diss gases PUBLISHED (%), COMPUTED) * 1

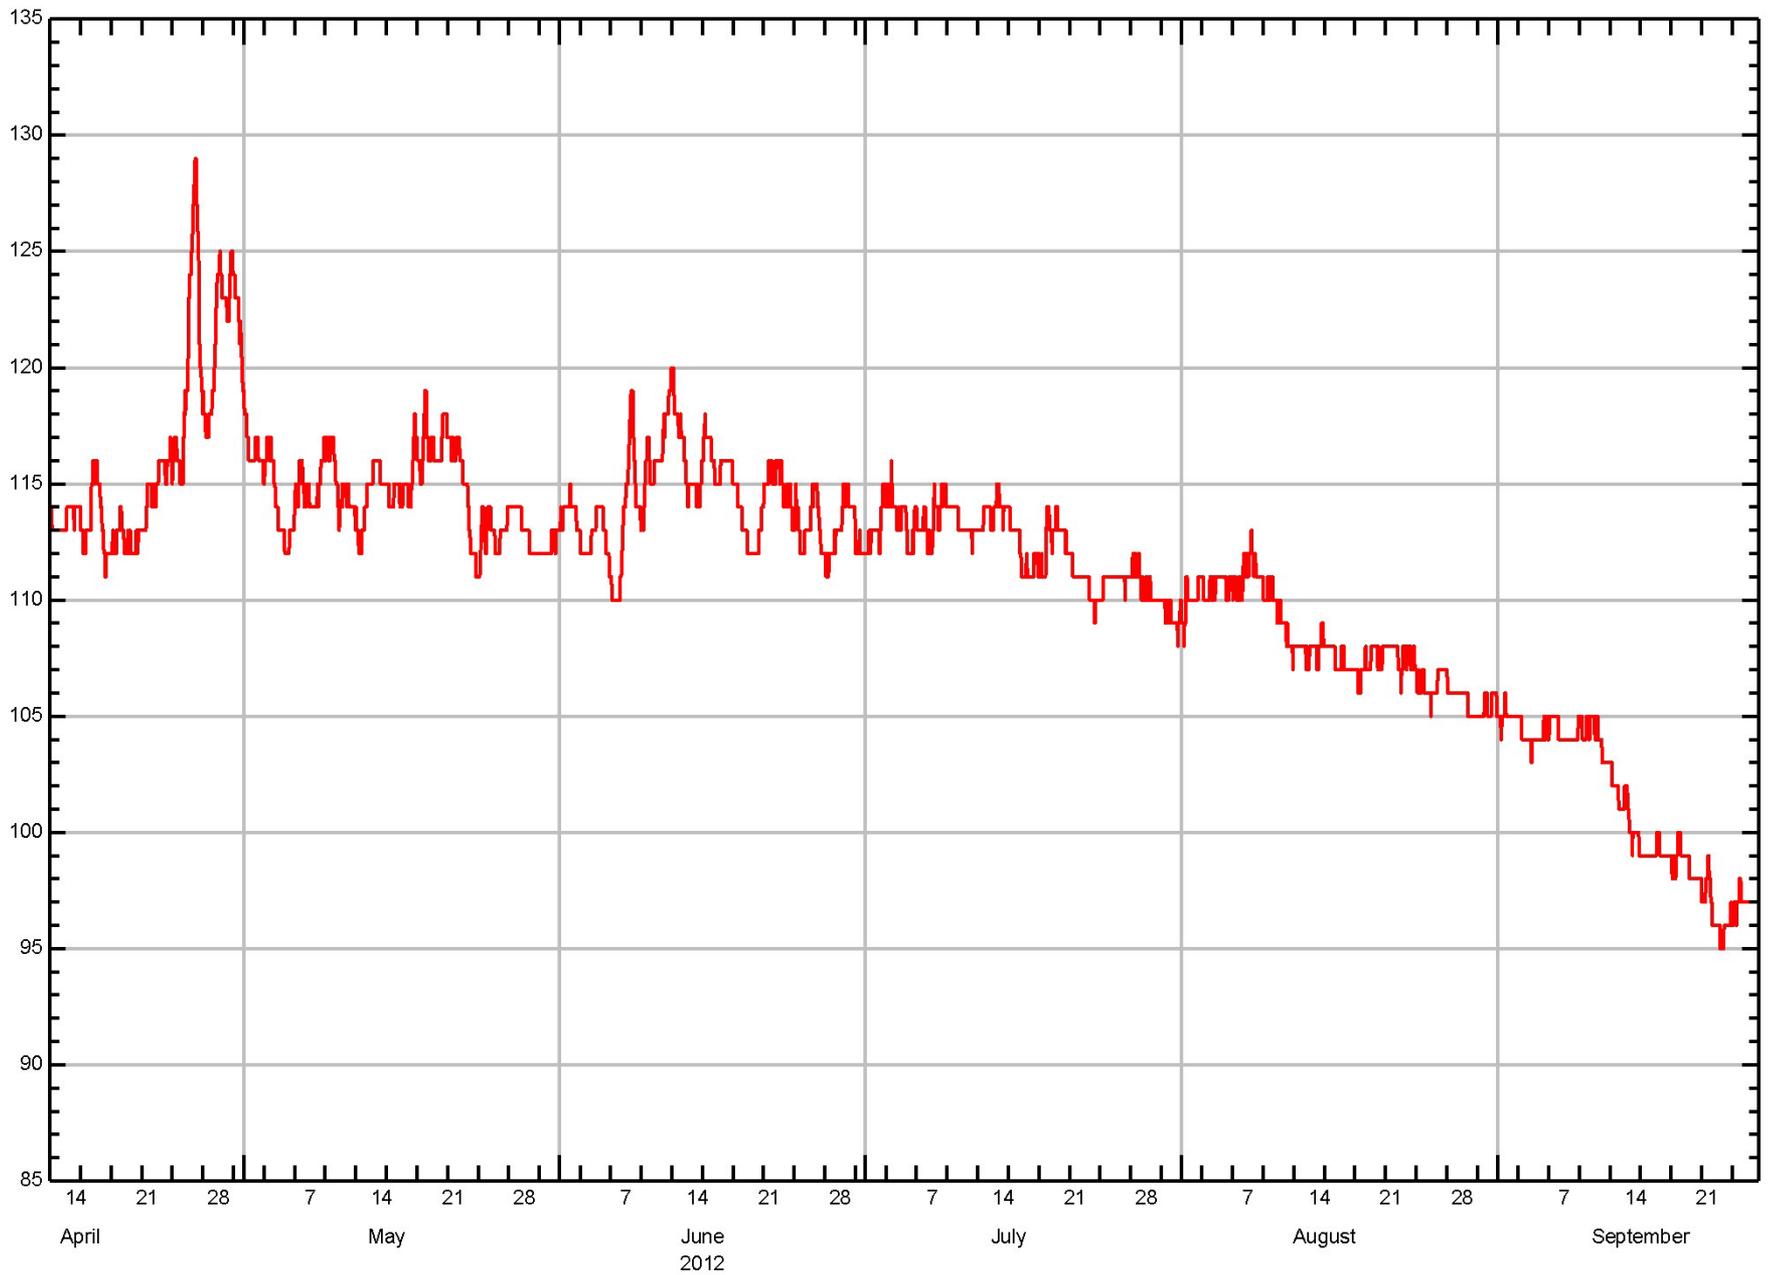
Lower Monumental Forebay

13352595 LAKE H G WEST FOREBAY AT LOWER MONUMENTAL DAM, WA (Pressure, diss gases PUBLISHED (%), COMPUTED) * 1
