**USACE Walla Walla District
QA/QC Evaluation of 2012 FMS TDG
Monitoring Data**

**USGS Washington Water Science Center
Dwight Copeland
Kevin Wright**

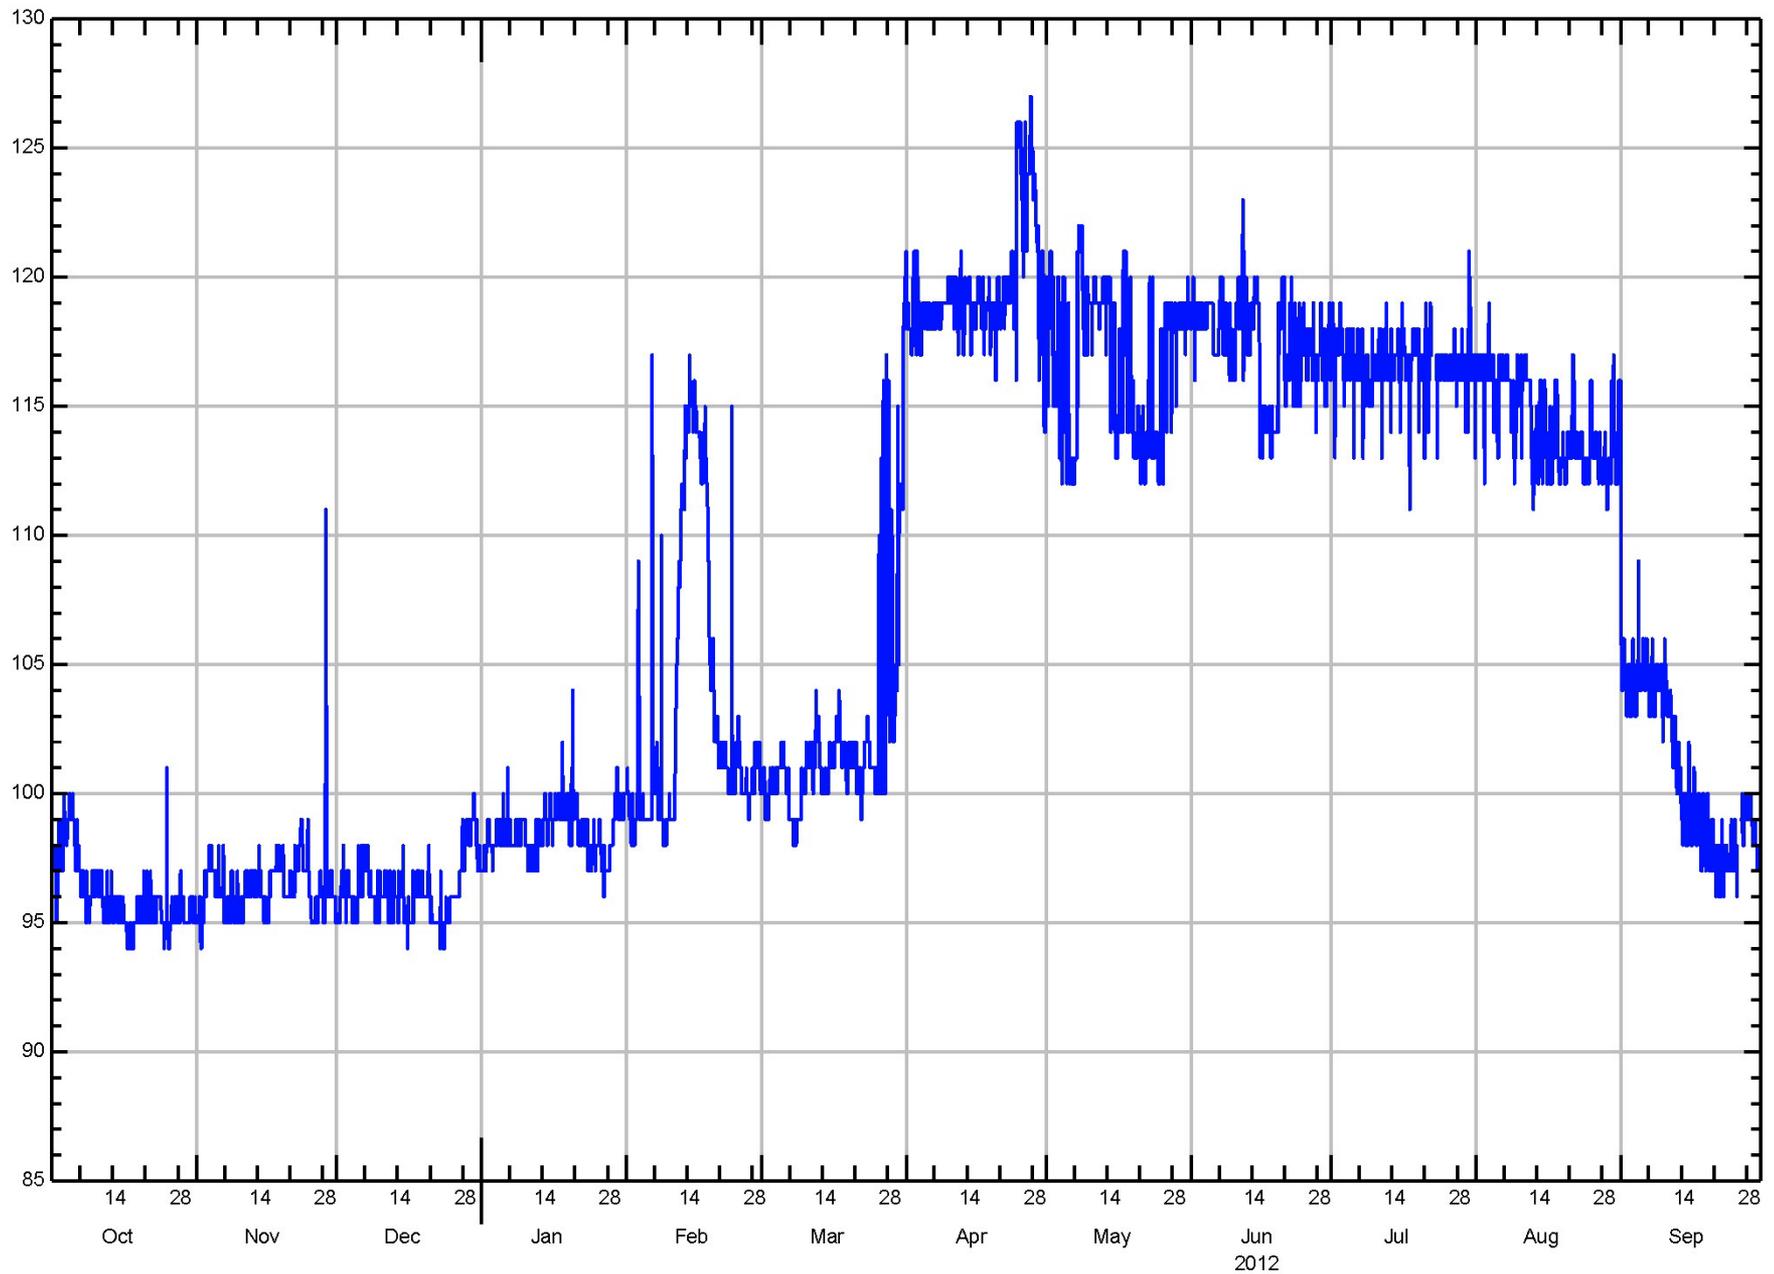
Lower Monumental Tailwater

13352600 SNAKE RIVER BELOW LOWER MONUMENTAL DAM, WA (Pressure, diss gases PUBLISHED (*), COMPUTED) * 1

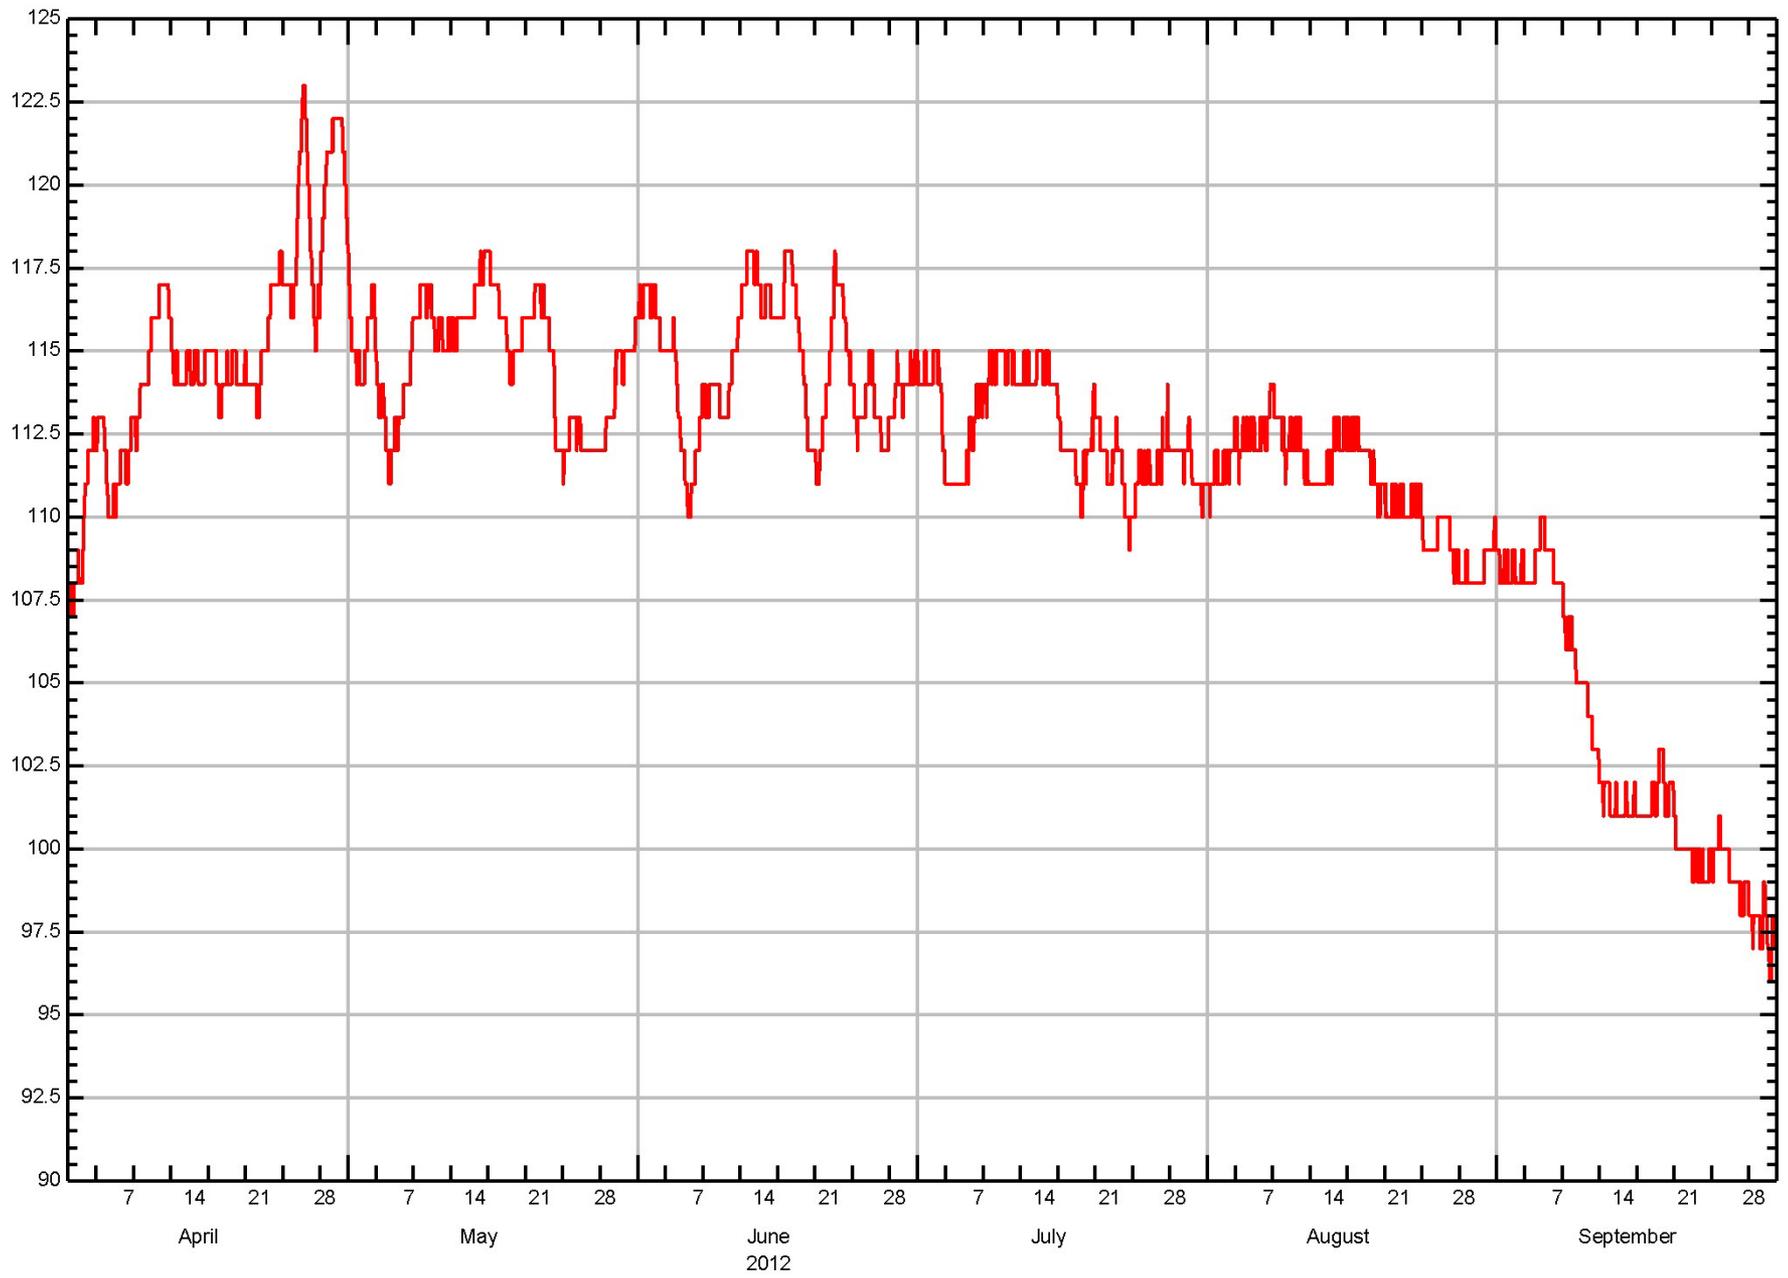
Ice Harbor Forebay

13352950 LAKE SACJAWEA FOREBAY AT ICE HARBOR DAM, WA (Pressure, diss gases PUBLISHED (%), COMPUTED) * 1

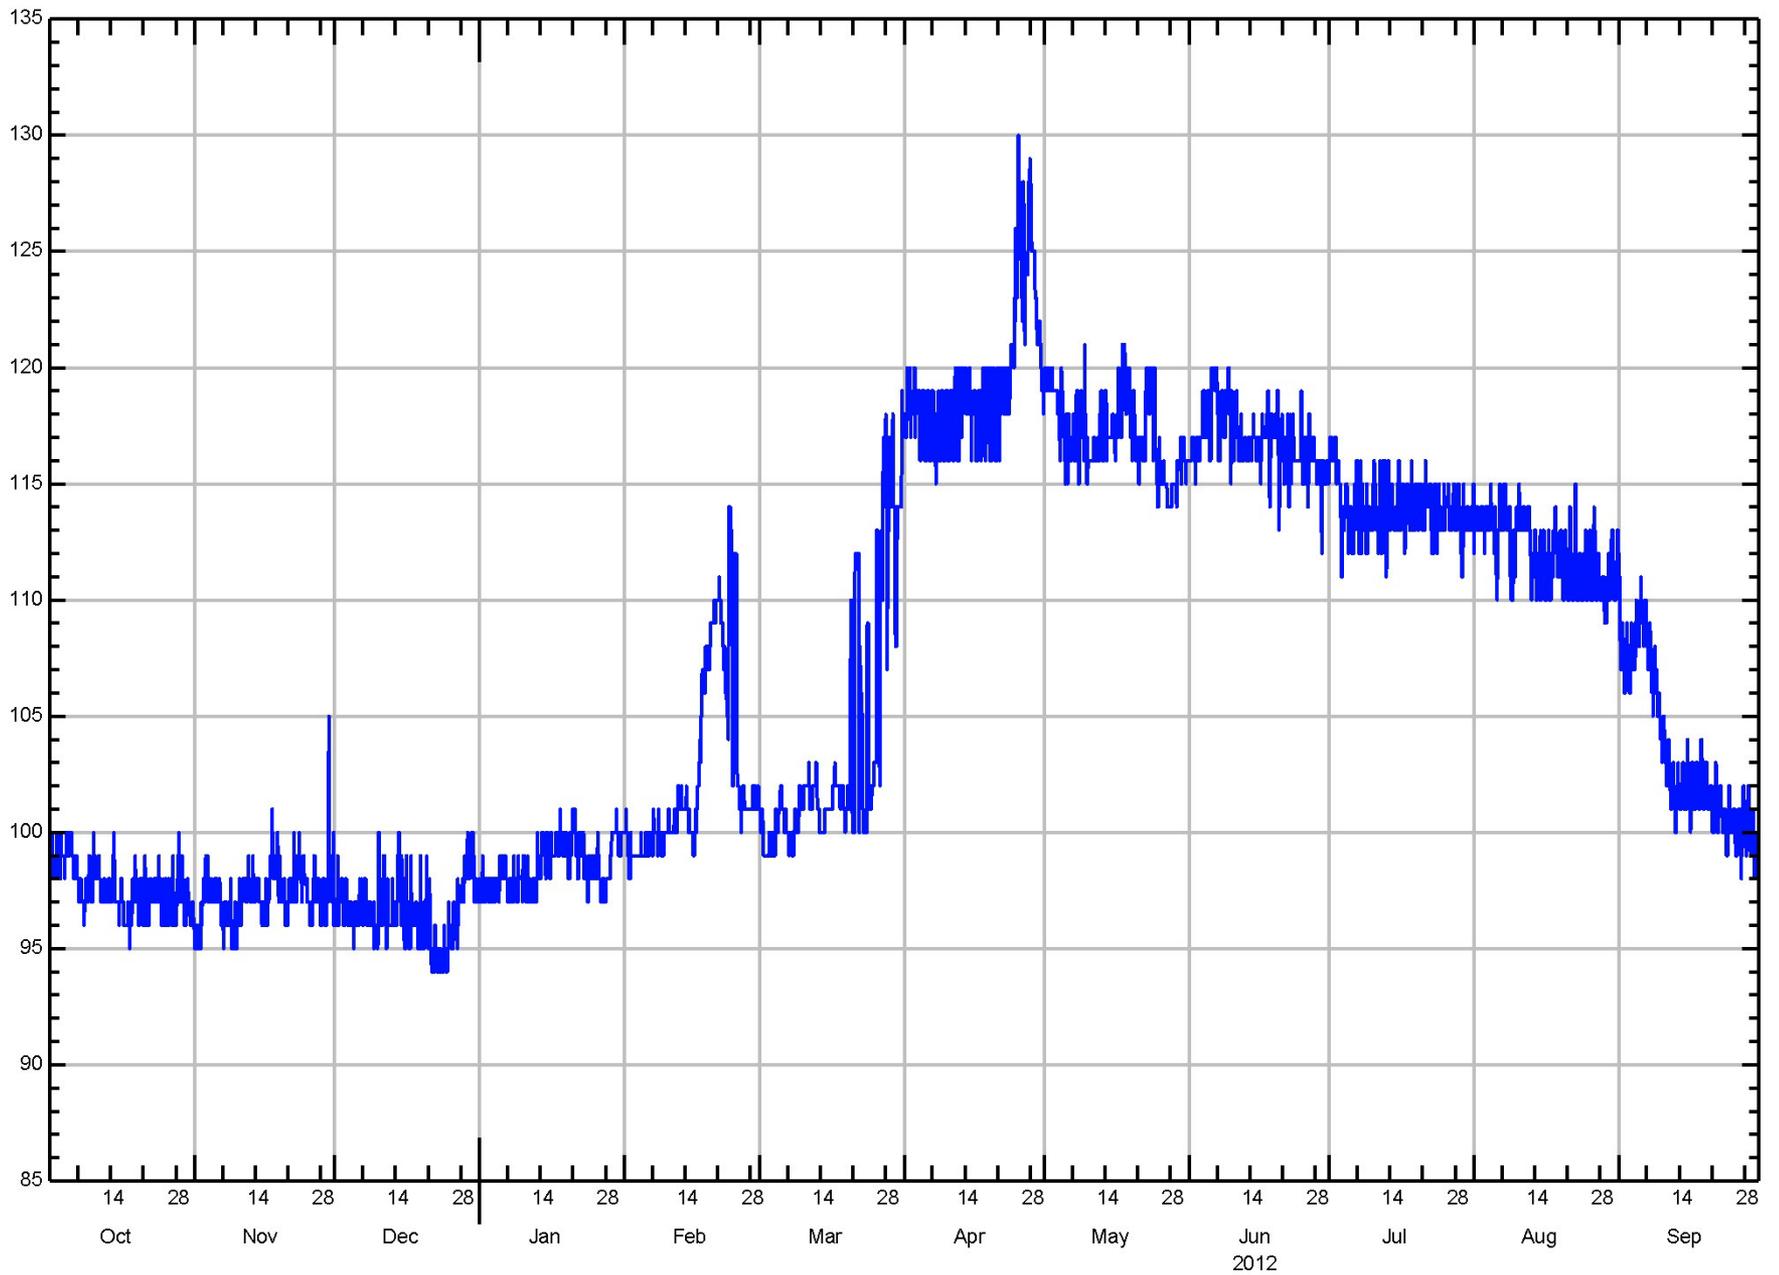
Ice Harbor Tailwater

13353010

SNAKE RIVER EL GOOSE ISLAND EL ICE HARBOR DAM, WA (Pressure, diss gases PUBLISHED (%), COMPUTED) * 1

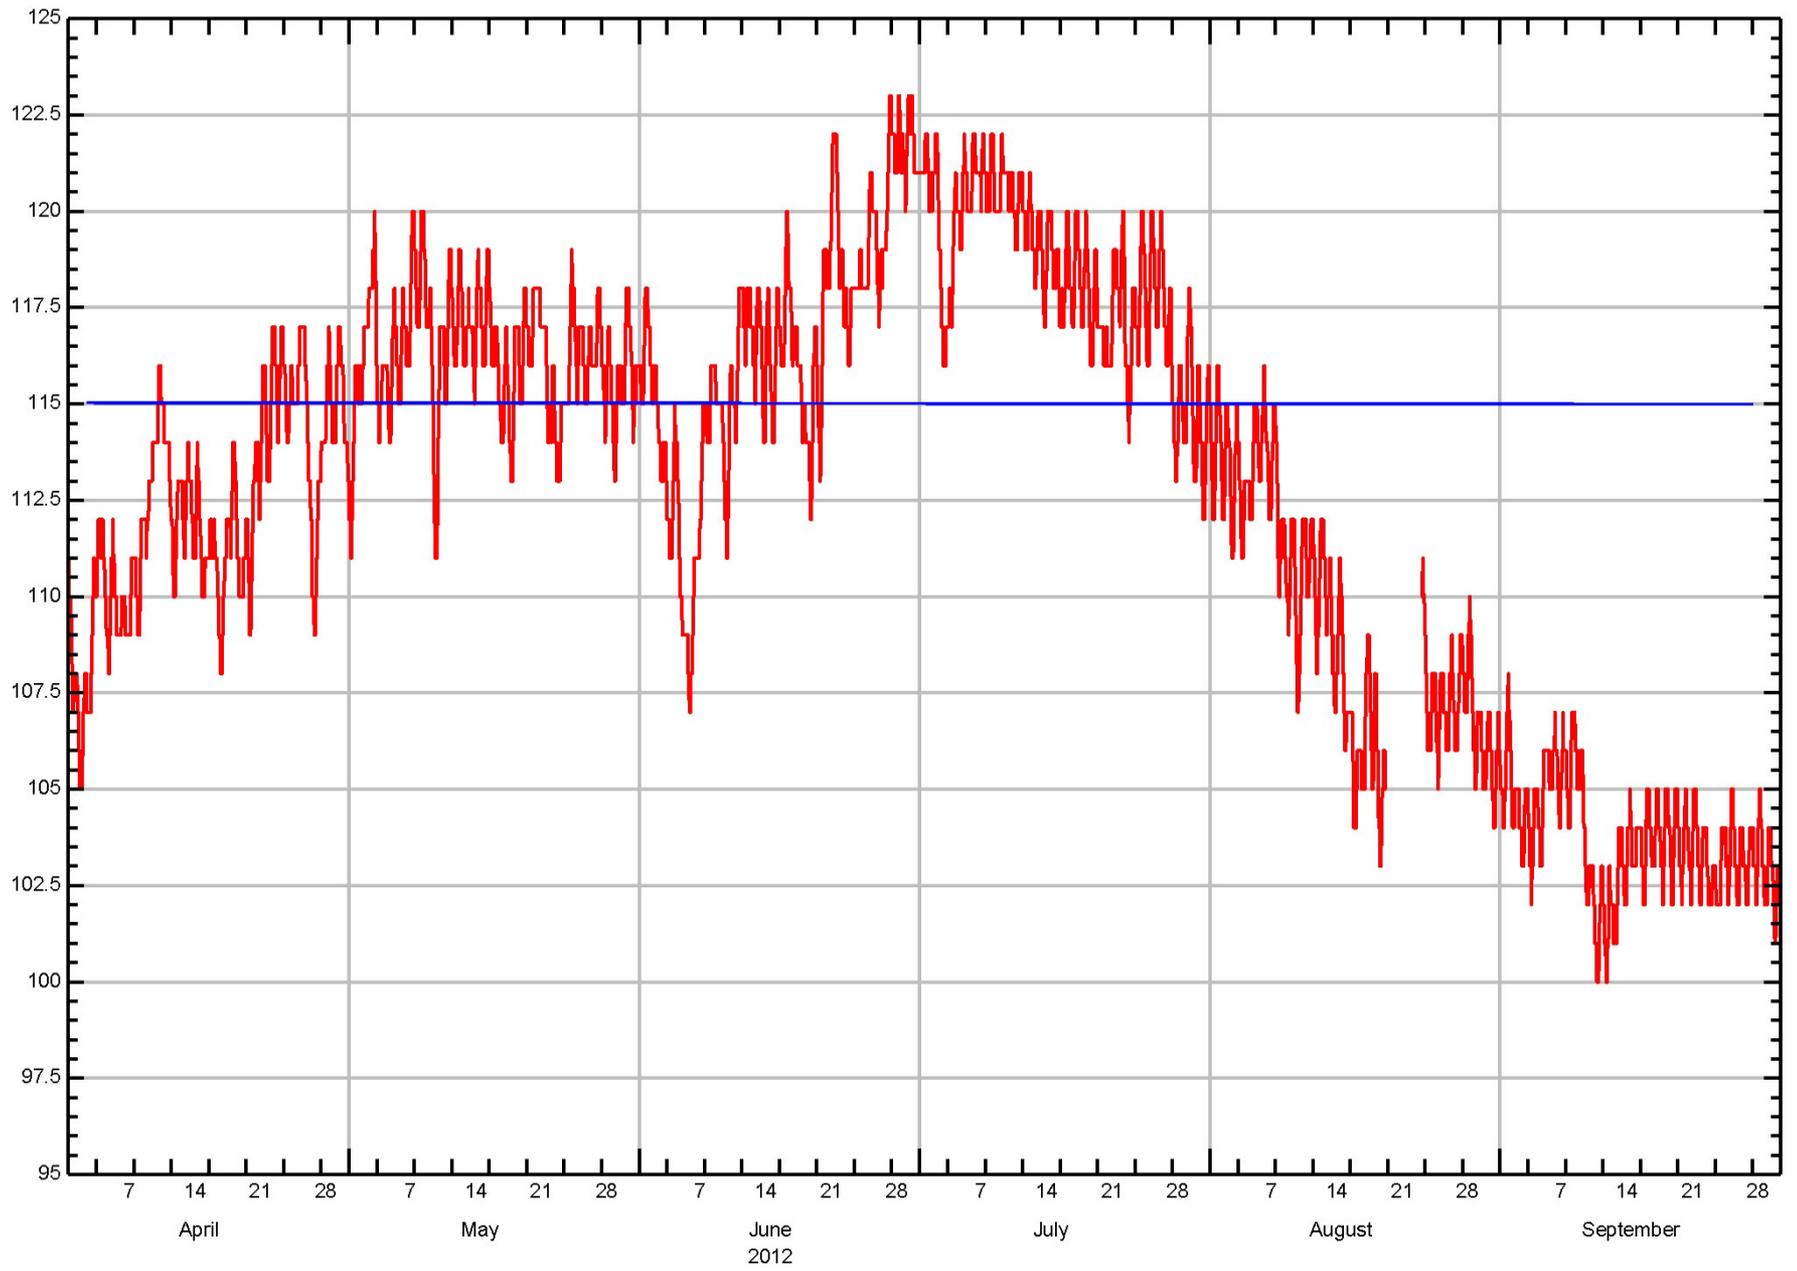
Pasco

12514400 COLUMBIA RIVER BELOW HWY 395 BRIDGE AT PASCO, WA (Pressure, diss gases PUBLISHED (%), COMPUTED) * 1

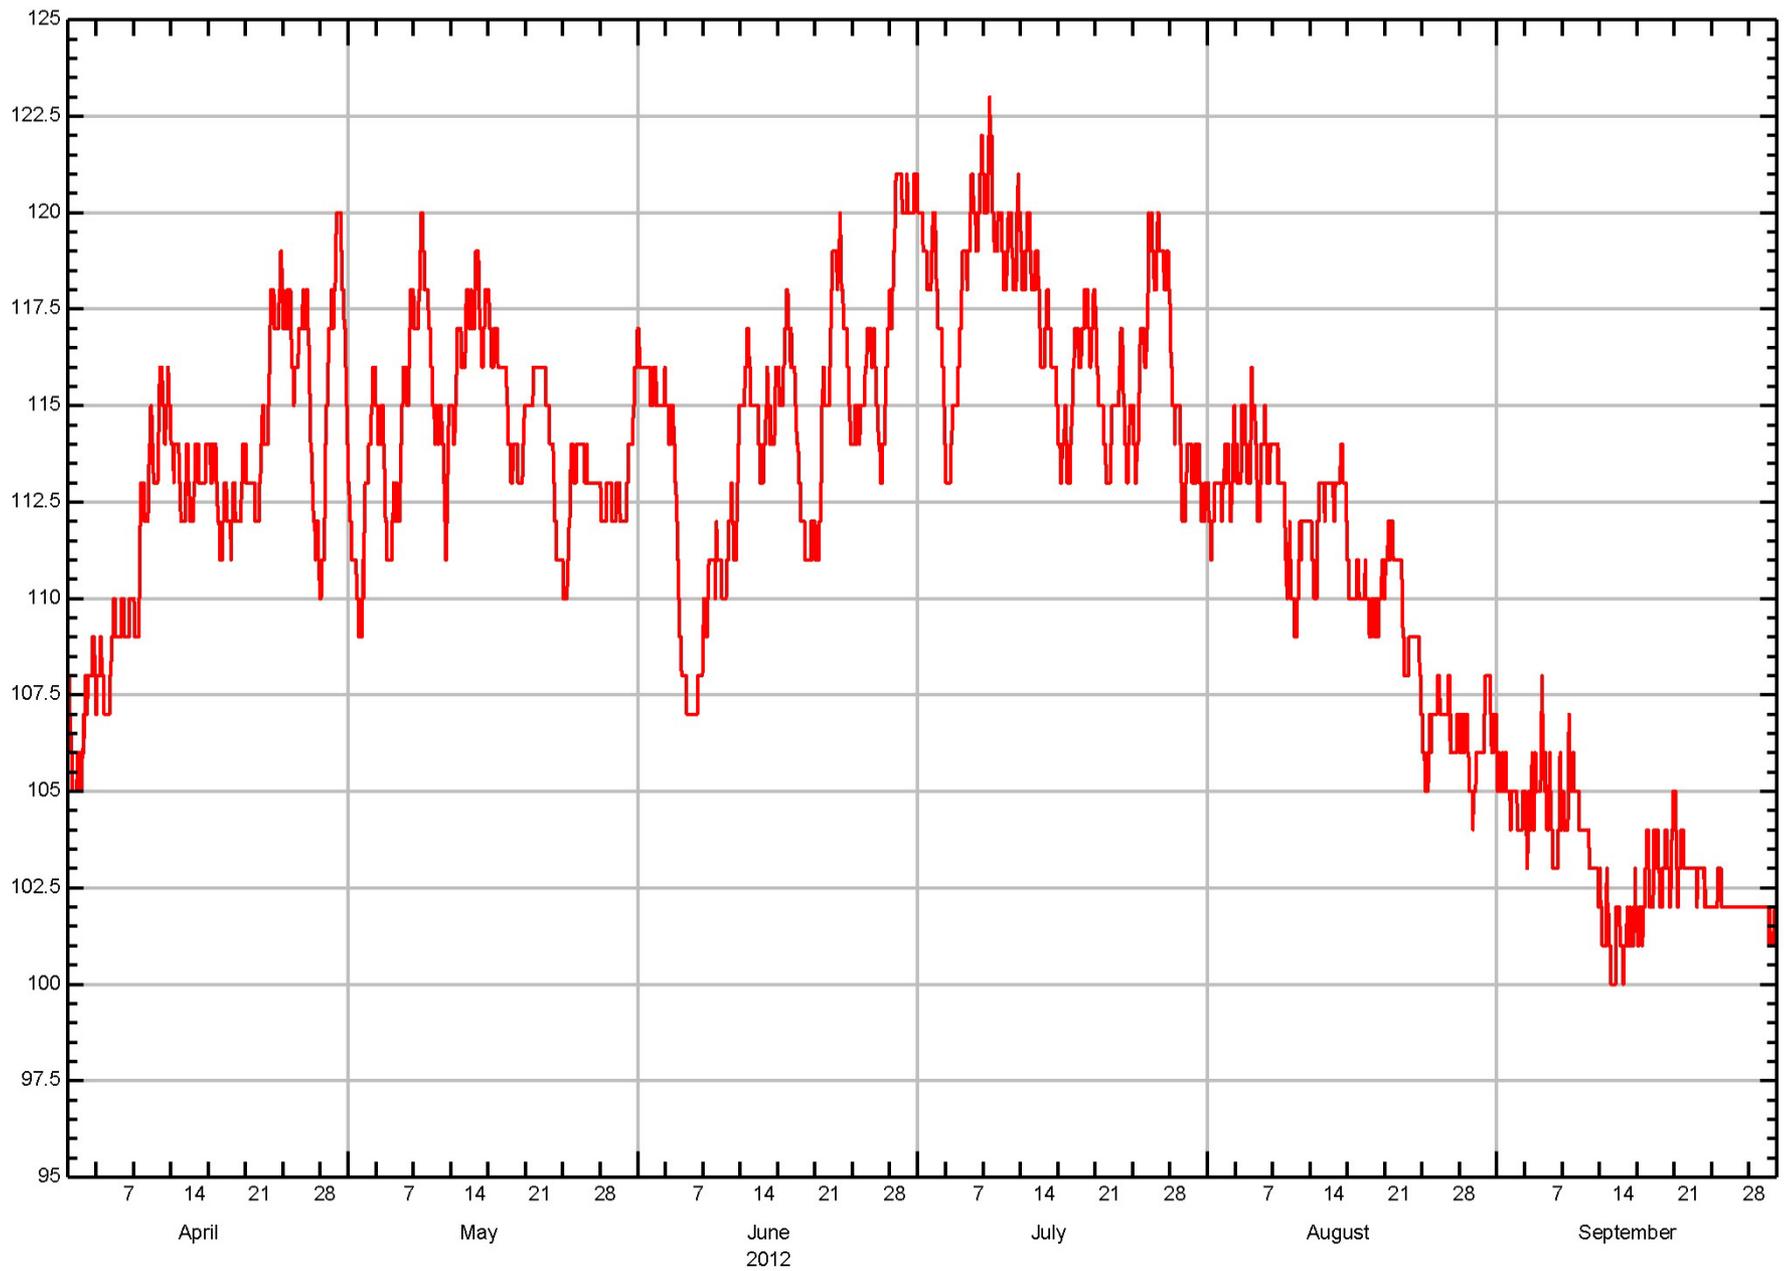
McNary Forebay

14019220 COLUMBIA RIVER AT McNARY DAM LOCK NR UMATILLA, OR (Pressure, diss gases PUBLISHED (%), COMPUTED) * 1

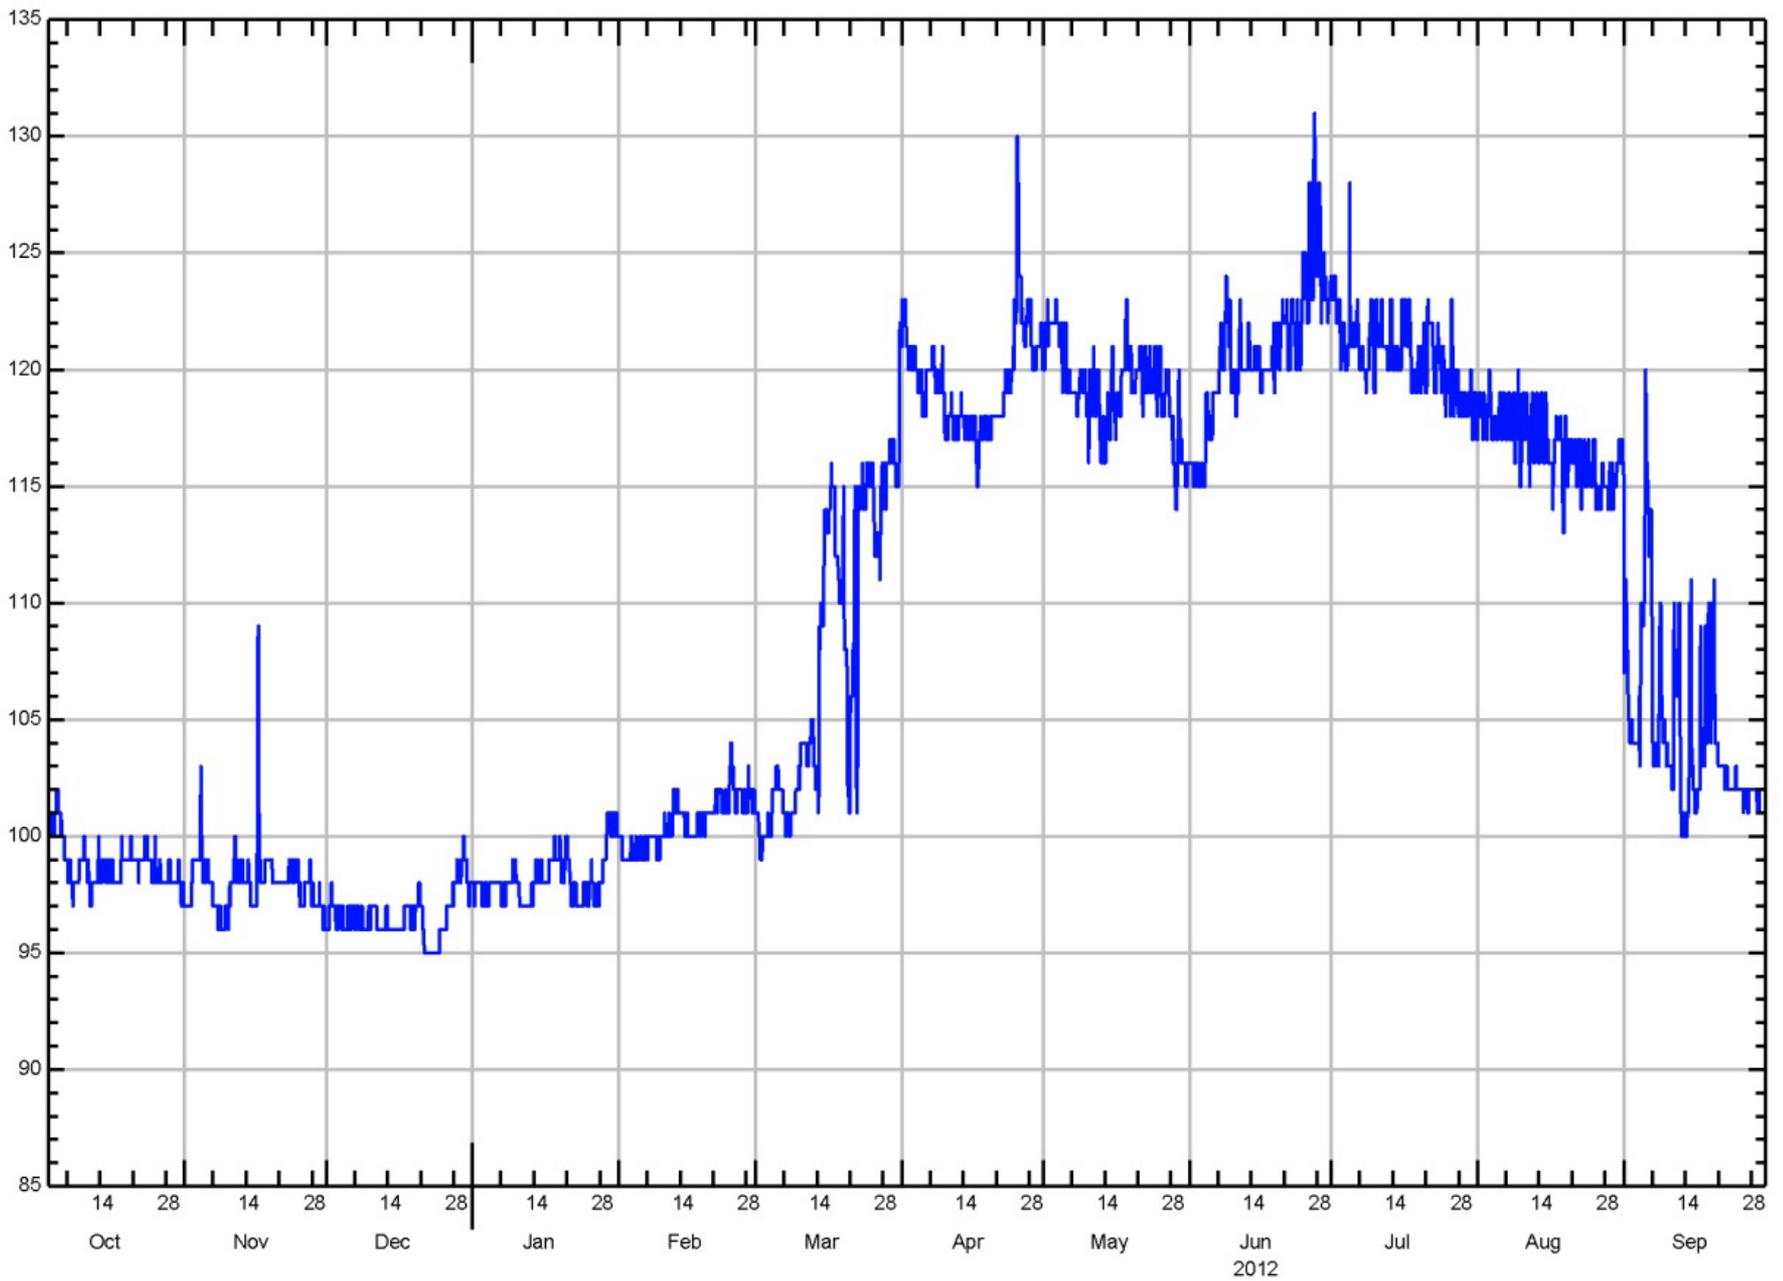
McNary Tailwater

14019240 COLUMBIA RIVER BELOW McNARY DAM NEAR UMATILLA, OR (Pressure, diss gases PUBLISHED (%), COMPUTED) * 1

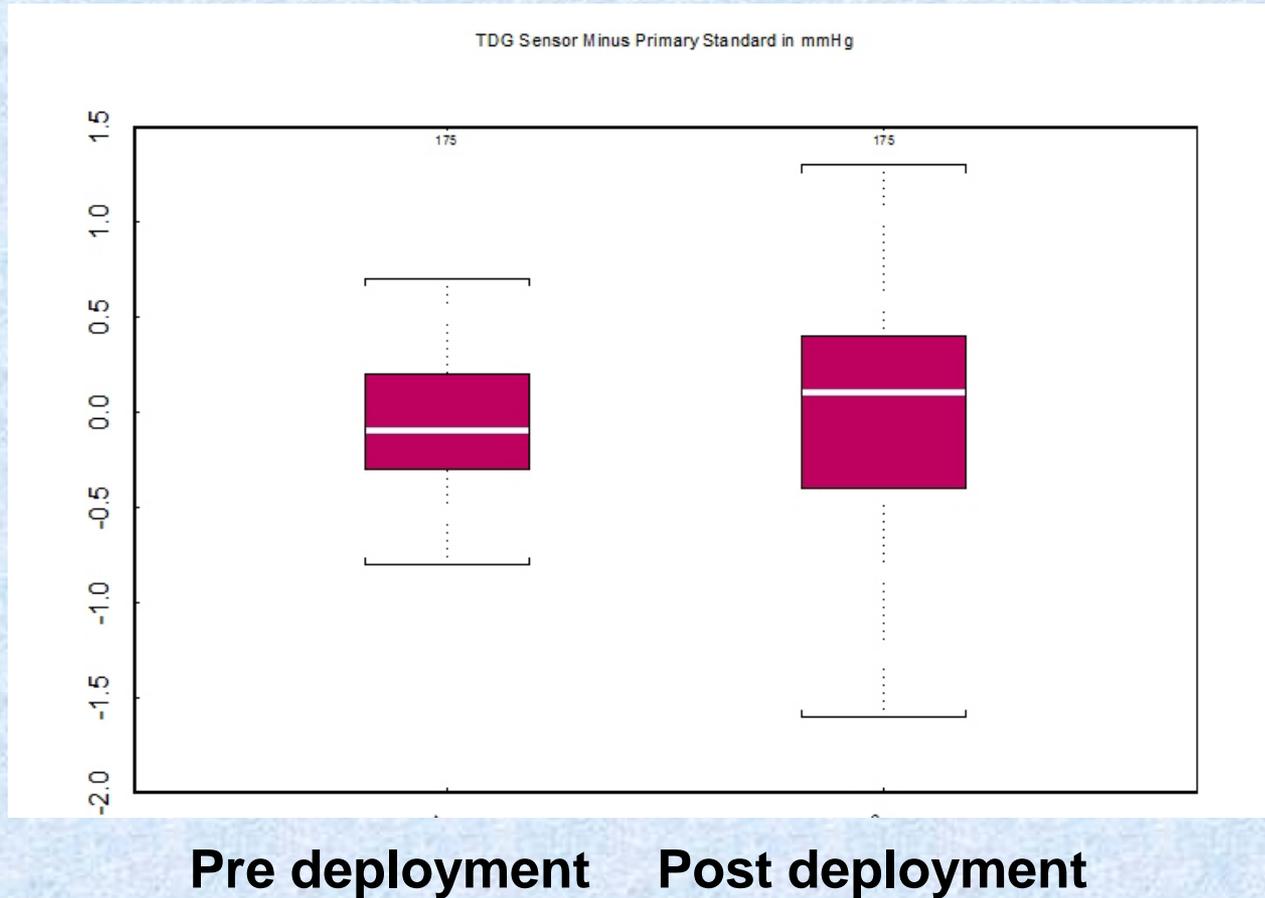
TDG Sensor vs Primary Standard Barometric Pressure

- **Barometric pressure**
 - Pre deployment: -0.1 mm Hg
 - Post deployment: 0.1 mm Hg
- **Water temperature**
 - Pre deployment: 0.02 °C
 - Post deployment: 0.01 °C

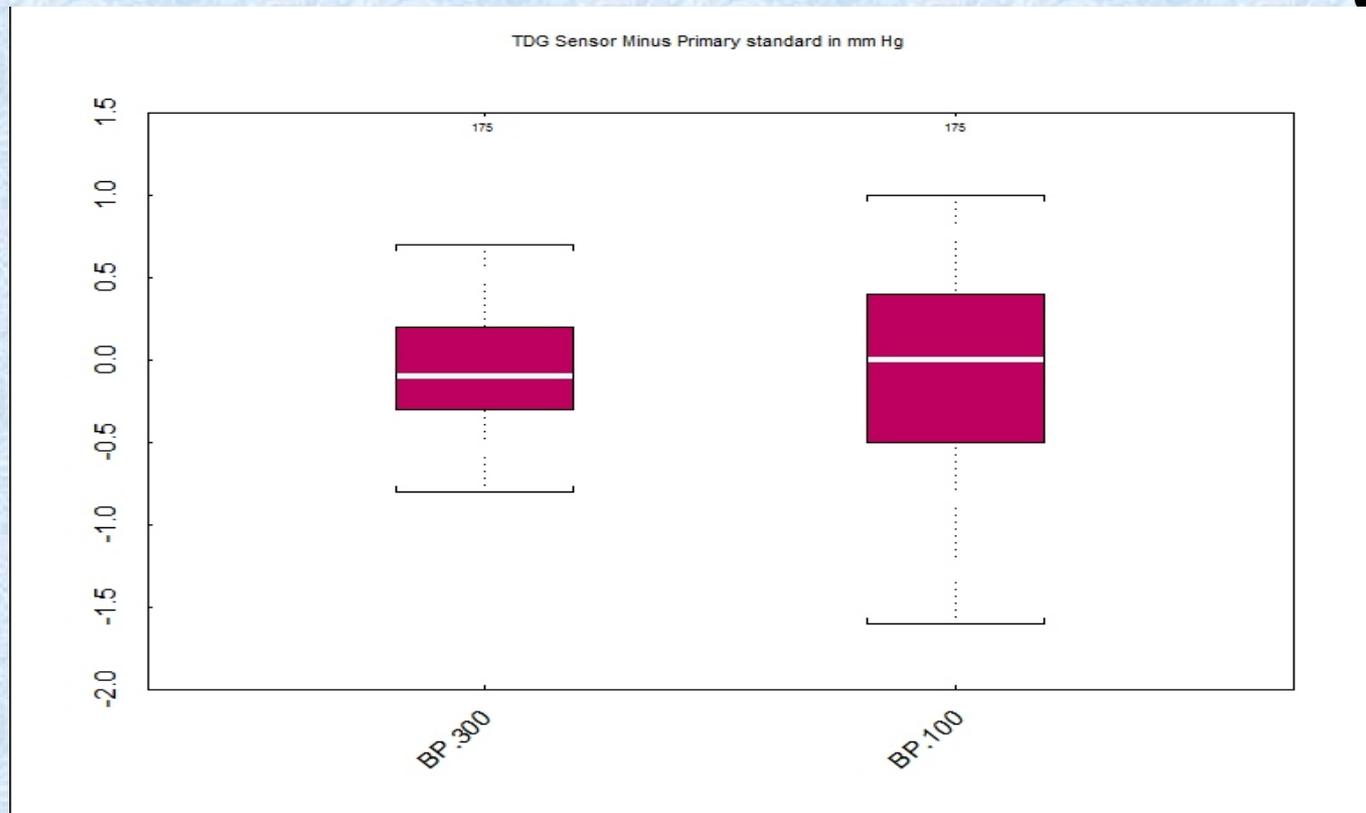
TDG Sensor vs Primary Standard

Barometric Pressure + 300 or 100 mm Hg

**Pre deployment
(+300 mmHg)**

**Post deployment
(+100 mg Hg)**

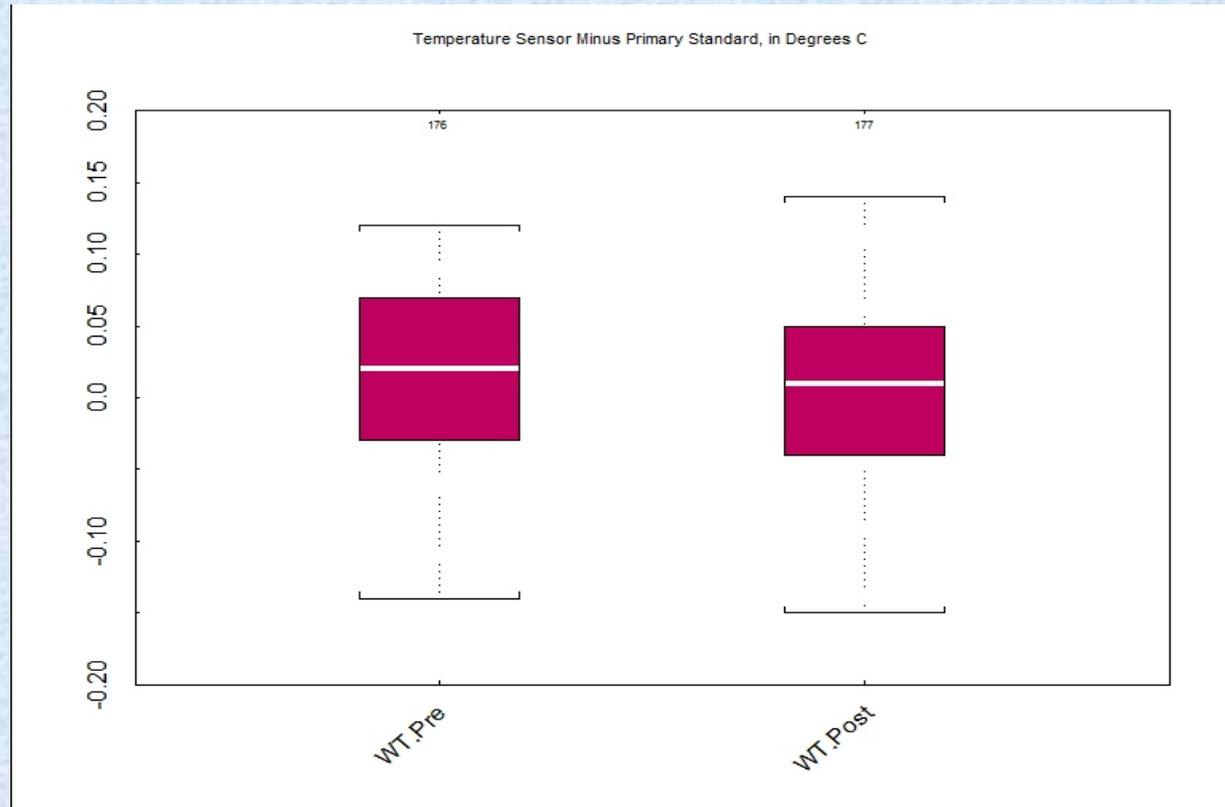
Temperature Sensor vs Primary Standard

Water temperature

Pre deployment Post deployment

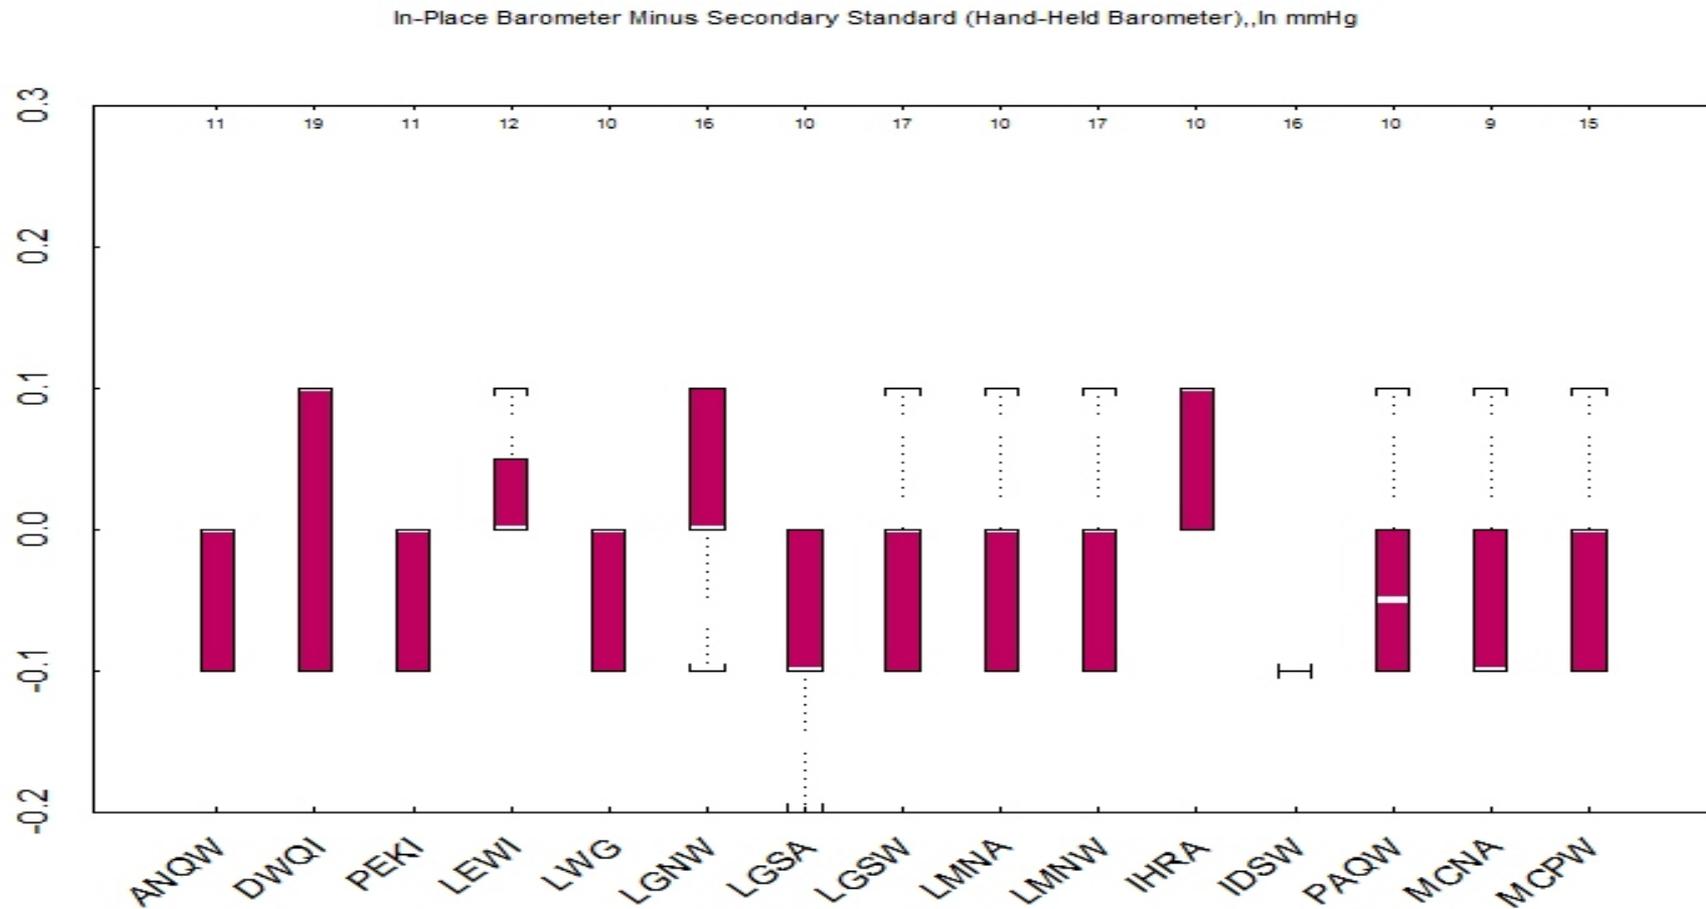
In-Place Barometer vs Secondary Standard

Barometric Pressure

Barometric pressure: 0.0 mm Hg

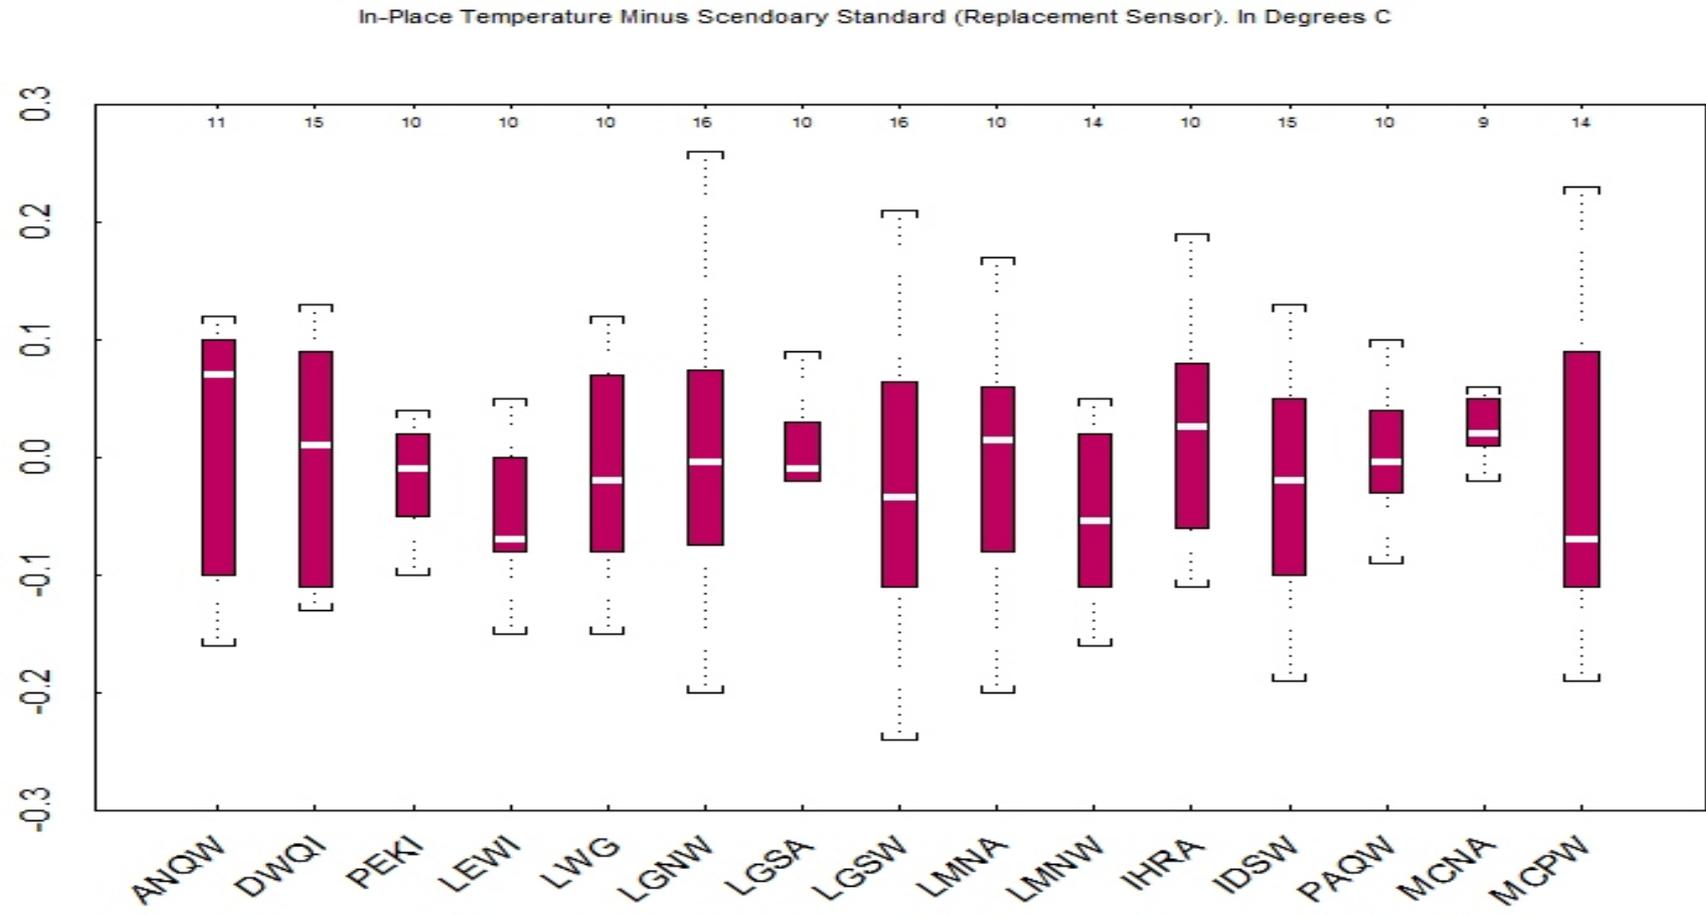
Temperature Sensor vs Secondary Standard

Water Temperature

Water temperature: -.01 °C

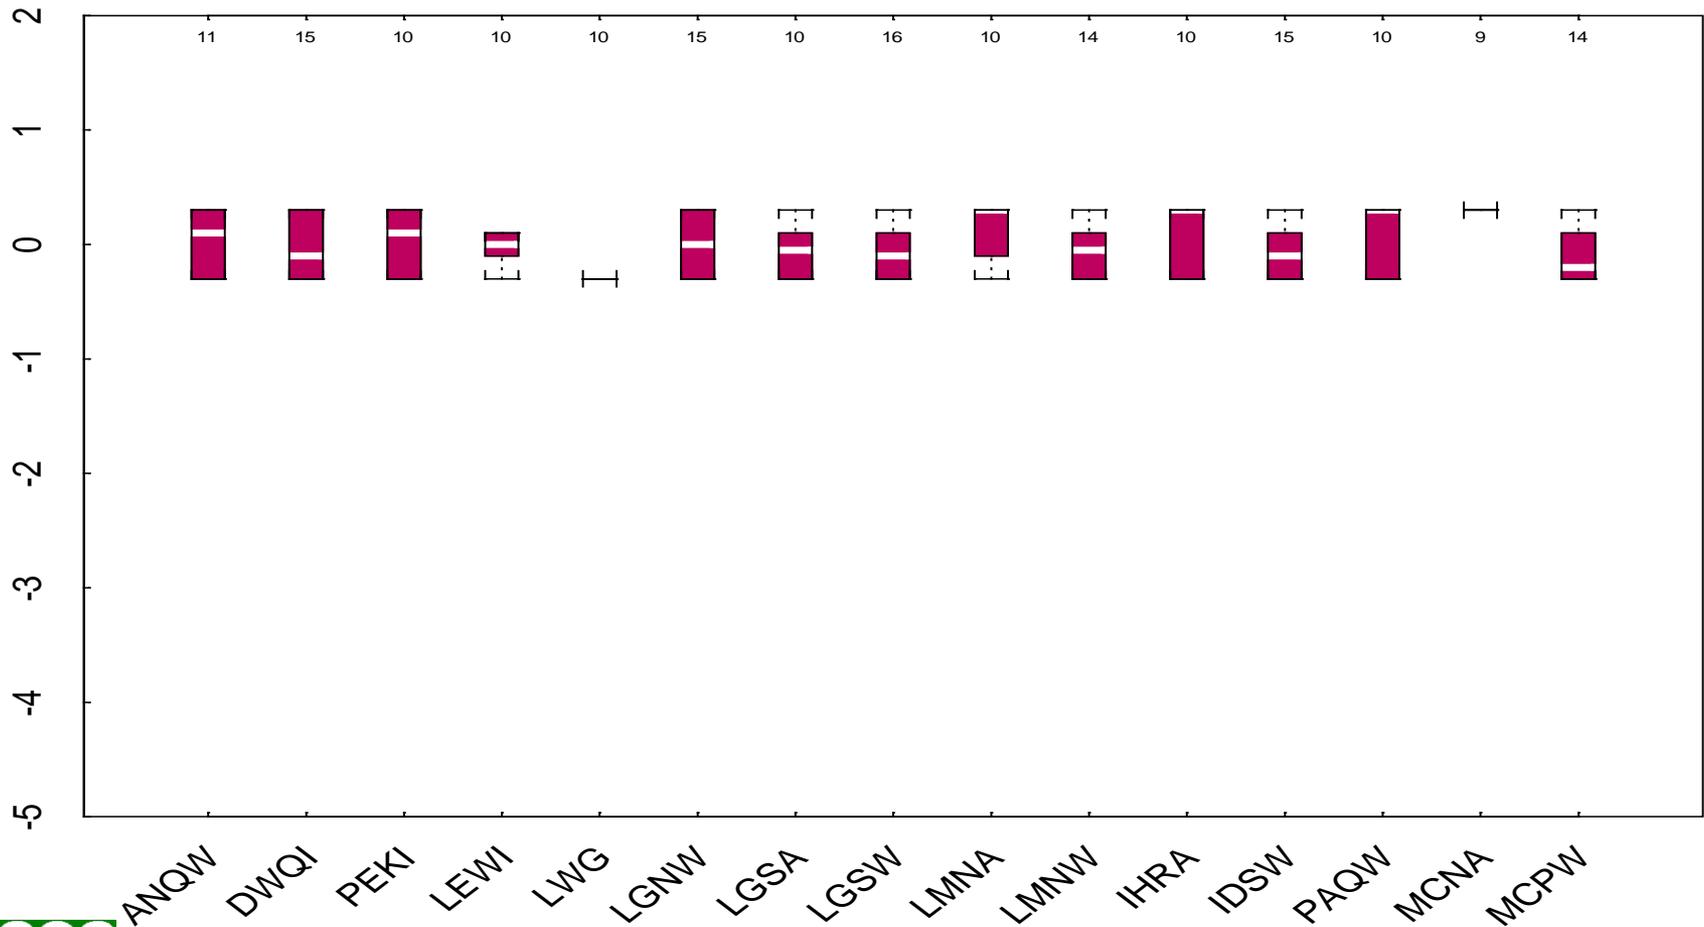
TDG Sensor vs Secondary Standard

Difference in TDG (Percent Saturation)

IN-PLACE TDG SENSOR MINUS SECONDARY STANDARD (REPLACEMENT SENSOR), IN PERCENT

TDG, in percent saturation: 0%
