**USACE Walla Walla District
QA/QC Evaluation of 2012 FMS TDG
Monitoring Data**

**USGS Washington Water Science Center
Dwight Copeland
Kevin Wright**

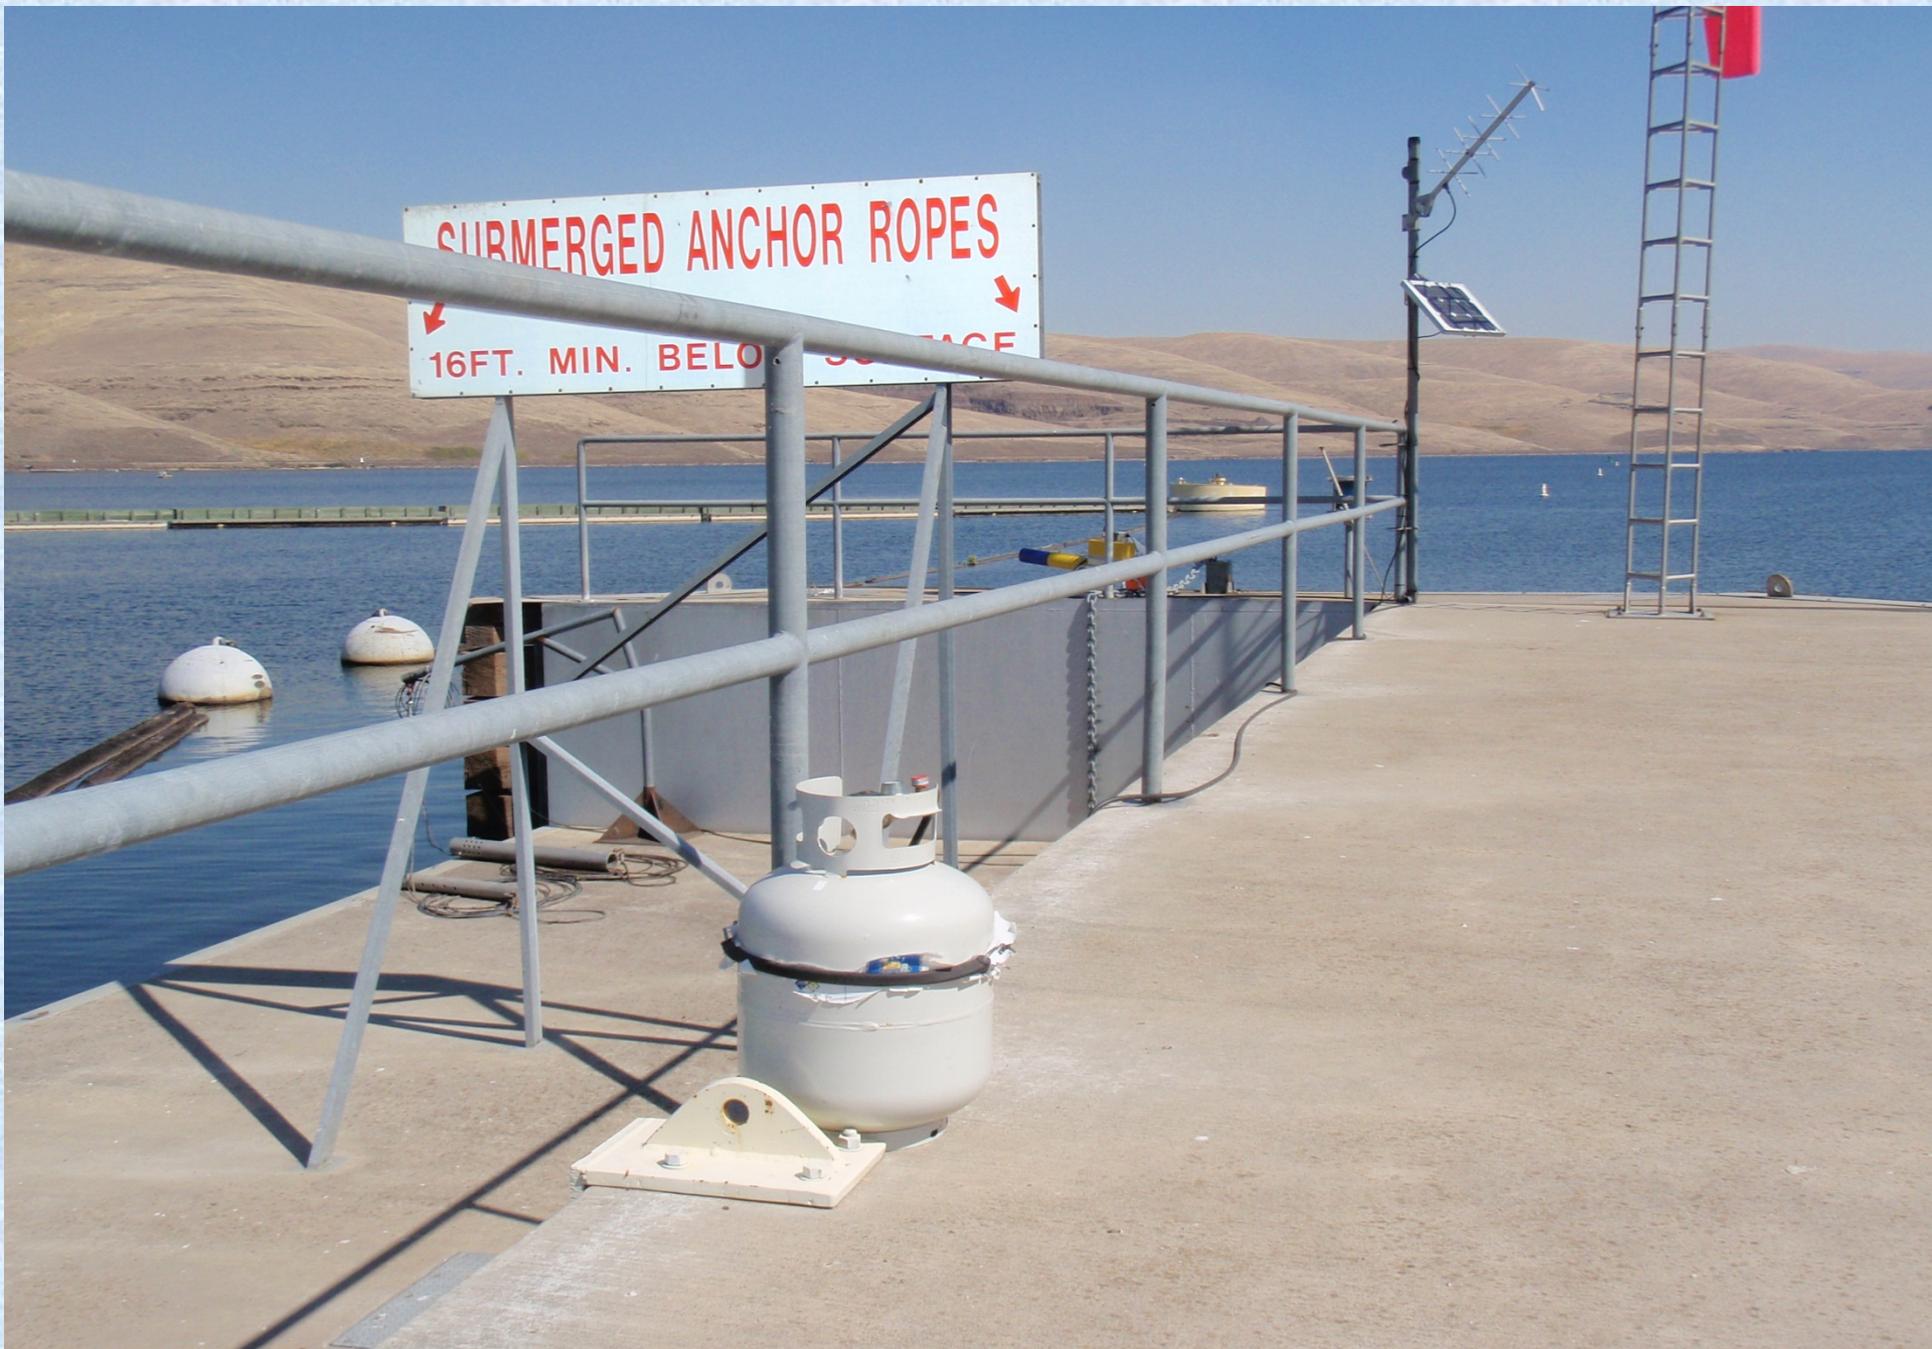
SUBMERGED ANCHOR ROPES
16FT. MIN. BELOW SURFACE
