Wells Hydroelectric Project Total Dissolved Gas Abatement Plan *2013 Annual Report*

USACE TDG
Performance Meeting

Dec. 11, 2013

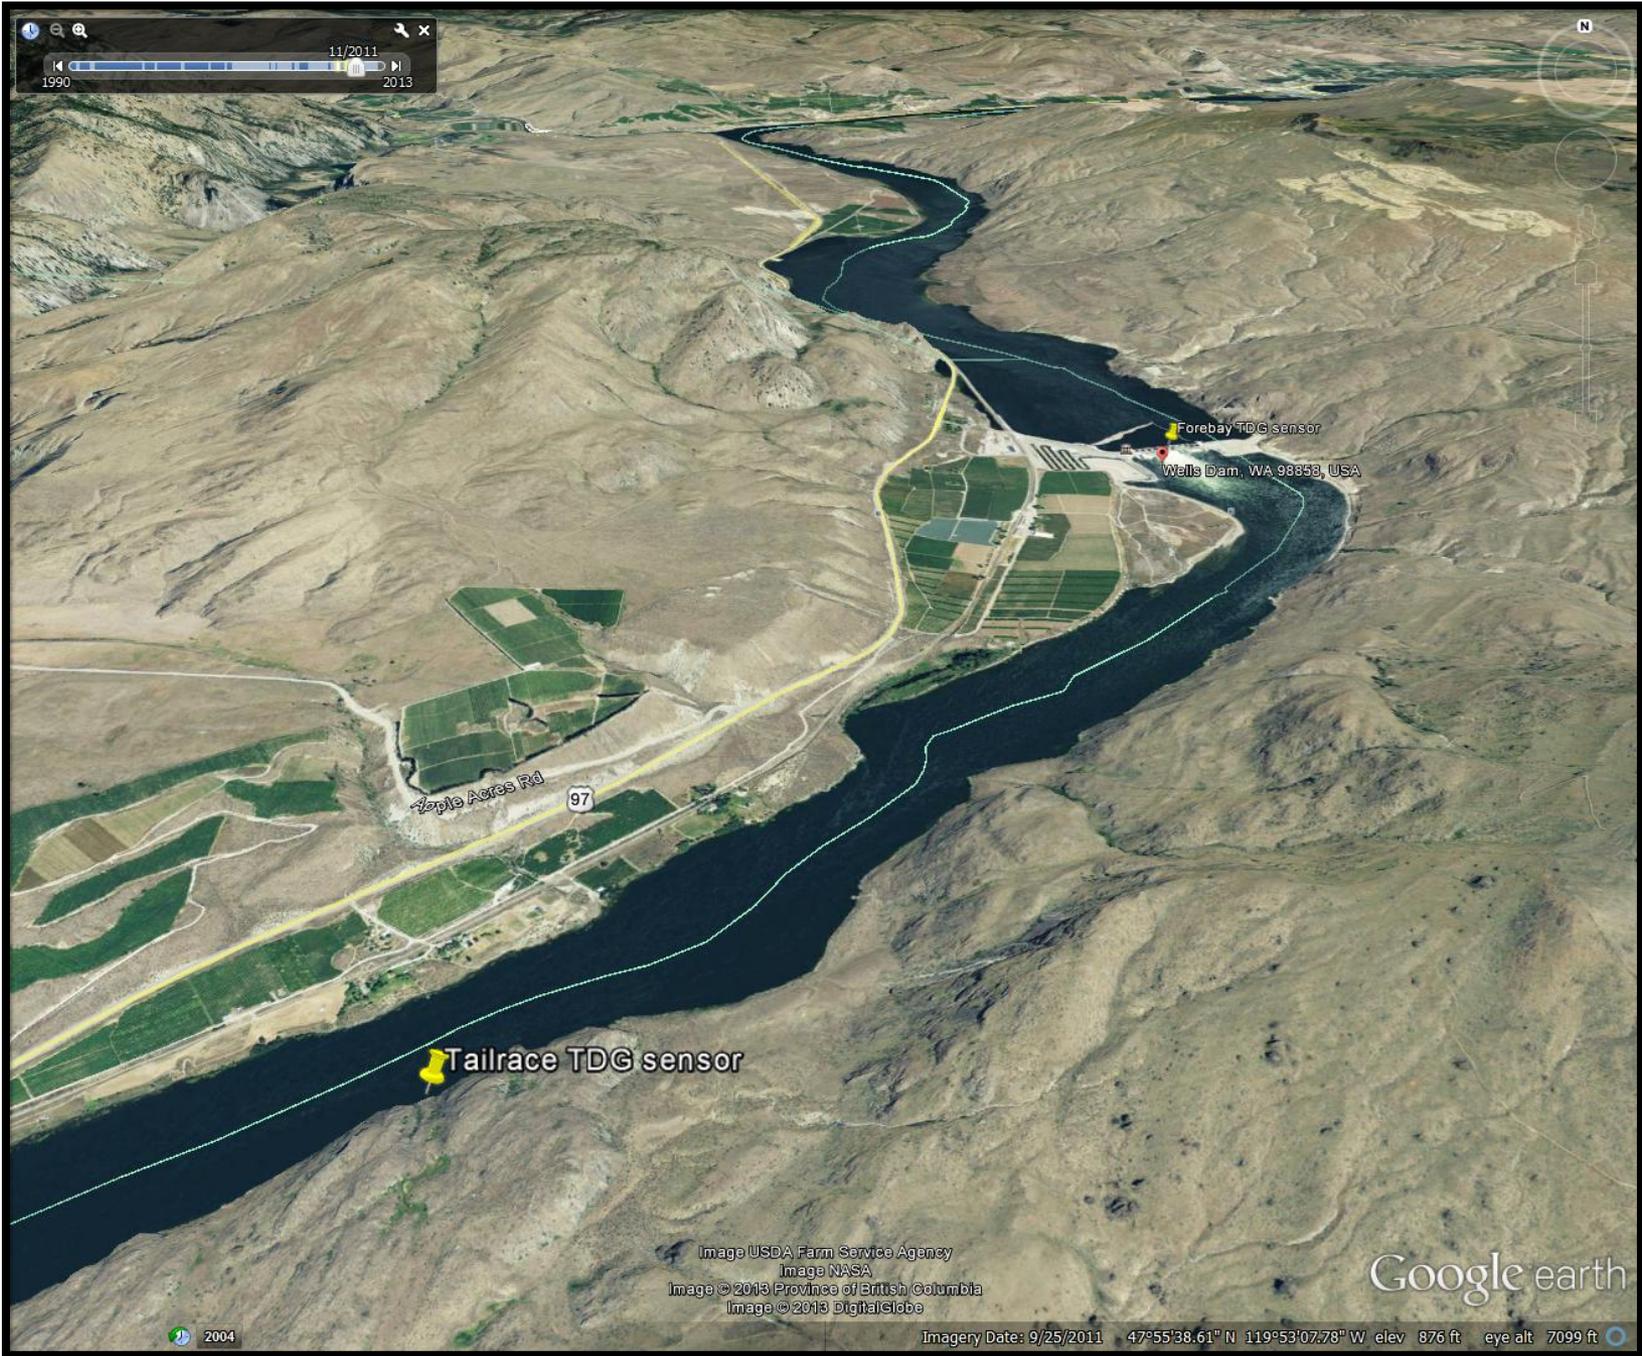
Forebay TDC sensor
Wells Dam, WA 98853, USA

Tailrace TDC sensor

- Minisonde MS5 in forebay (unit 6) and tailrace (2.5 km downstream).
- Calibrated monthly by John Lemons
- Data is sent using RF to Wells Dam
- Processed through SCADA system
- Data is uploaded to dcpud.org and USACE webpage for TDG data in real-time. (<http://www.dcpud.org/wells-project/total-dissolved-gas-and-temperature-monitoring>) and (<http://www.nwd-wc.usace.army.mil/tmt/wcd/tdg/months.html>)

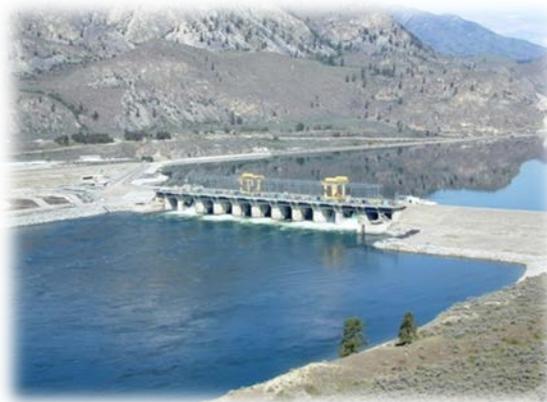
- 1. No hourly value above 125% in tailrace**
 - 2. 12-C high (rolling 12 hour average) during any hour of the day in the Wells tailrace of 120%**
 - 3. 12-C high (rolling 12 hour average) during any hour of the day in the Rocky Reach forebay of 115%**
- *If 7Q-10 flows are occurring violations not considered.
 - *Also unwritten rule: If TDG is out of compliance incoming - as long as the project doesn't add any TDG, still in compliance (Not in the WQS however).*
