# TDG Incident at Ruskin Dam

An update on follow-up studies,  
March 2011

## TDG Incident at Ruskin Dam

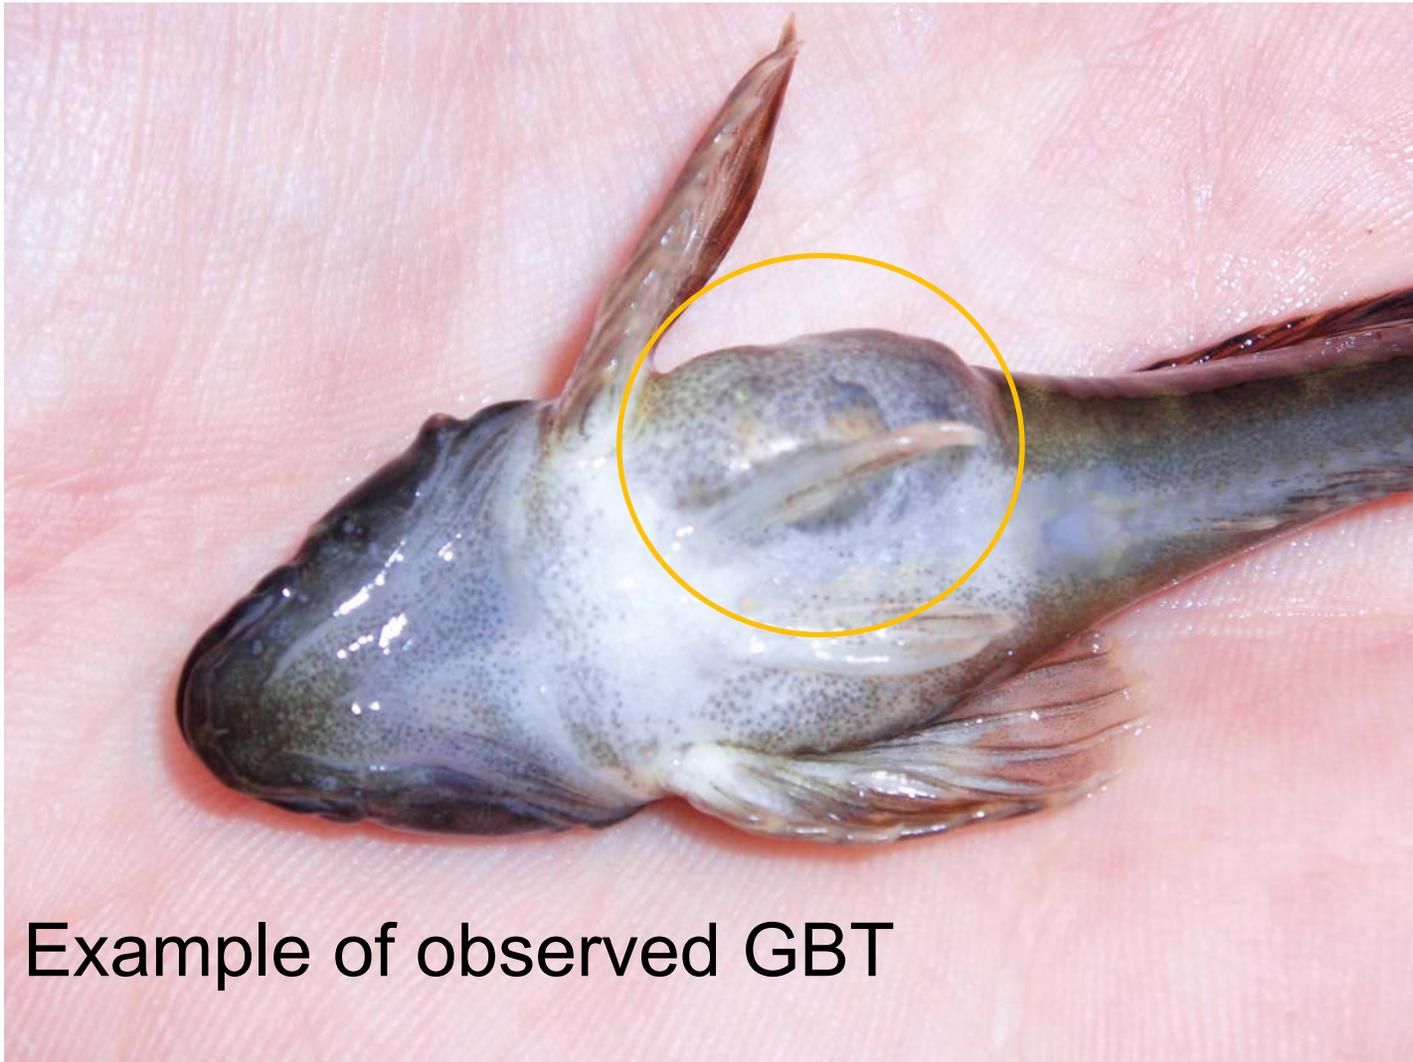
Example of observed GBT

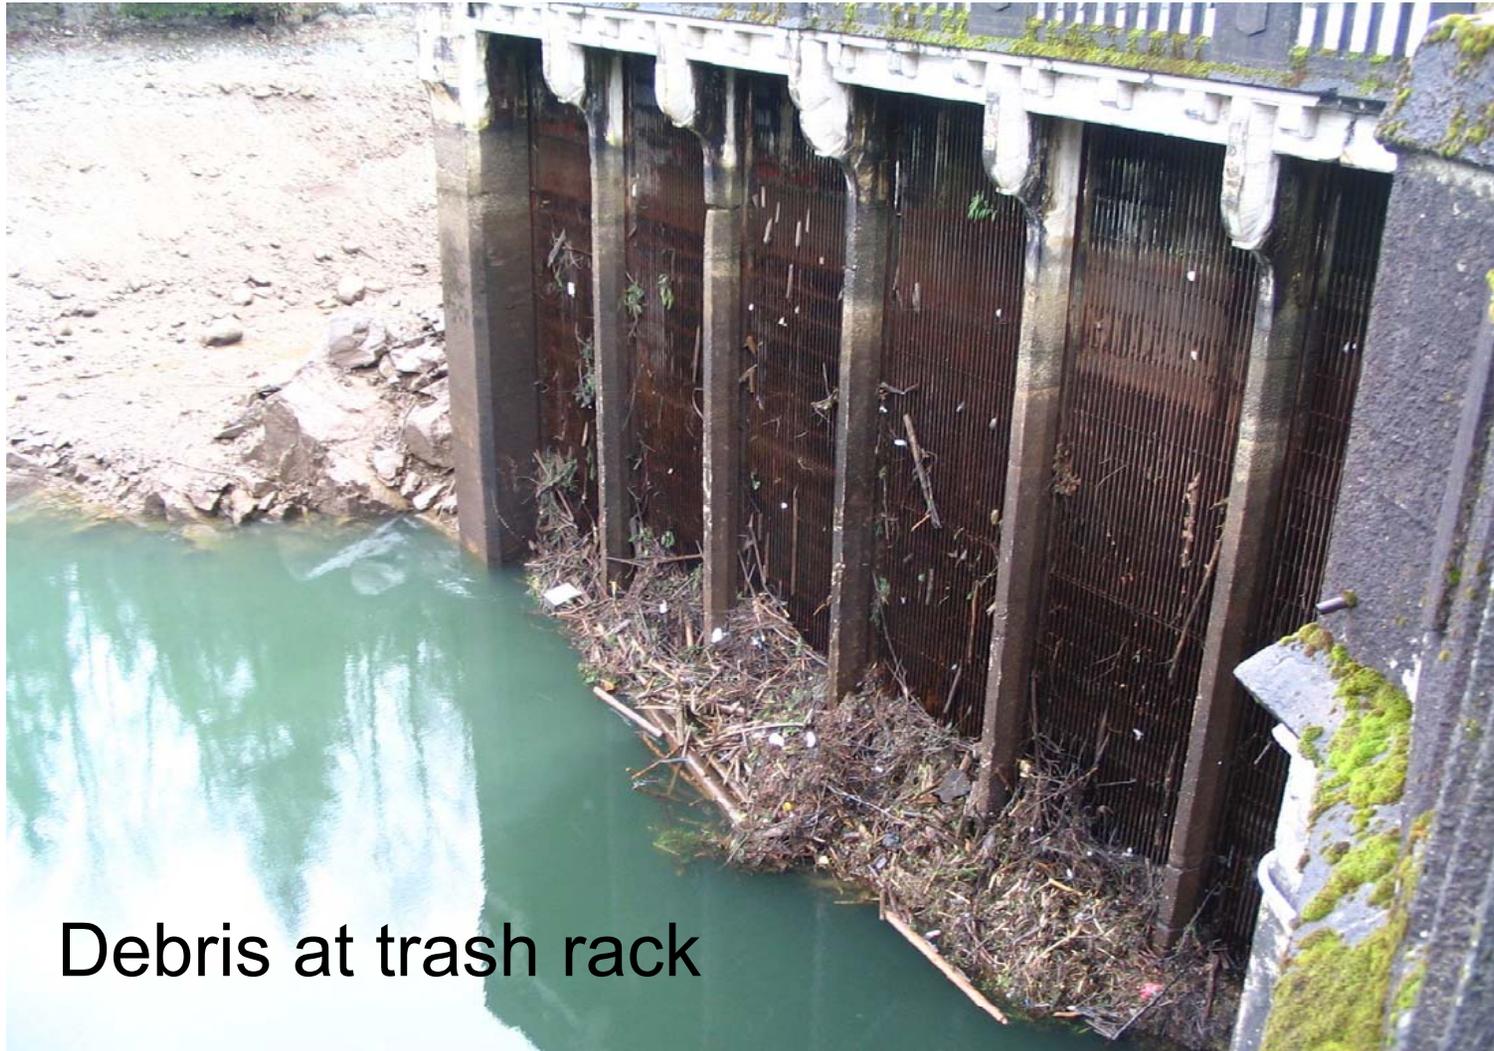
Debris at trash rack

1. On Feb 13, 2007, Hayward Reservoir was drawn down to ~ 34m for regular maintenance.
2. Two days later, local residents reported dead fish on river banks
  - most were cottids, 2 salmonids were found
  - most showed evidence of gas bubble trauma
3. Investigation found that debris on trash rack restricted flow to intakes
  - Caused a drop in head behind trash rack
  - Allowed entrainment of air into the unit turbines
  - TDG reached 135% supersaturation, no potential for dilution
  - Max exposure estimated to be roughly 4 days

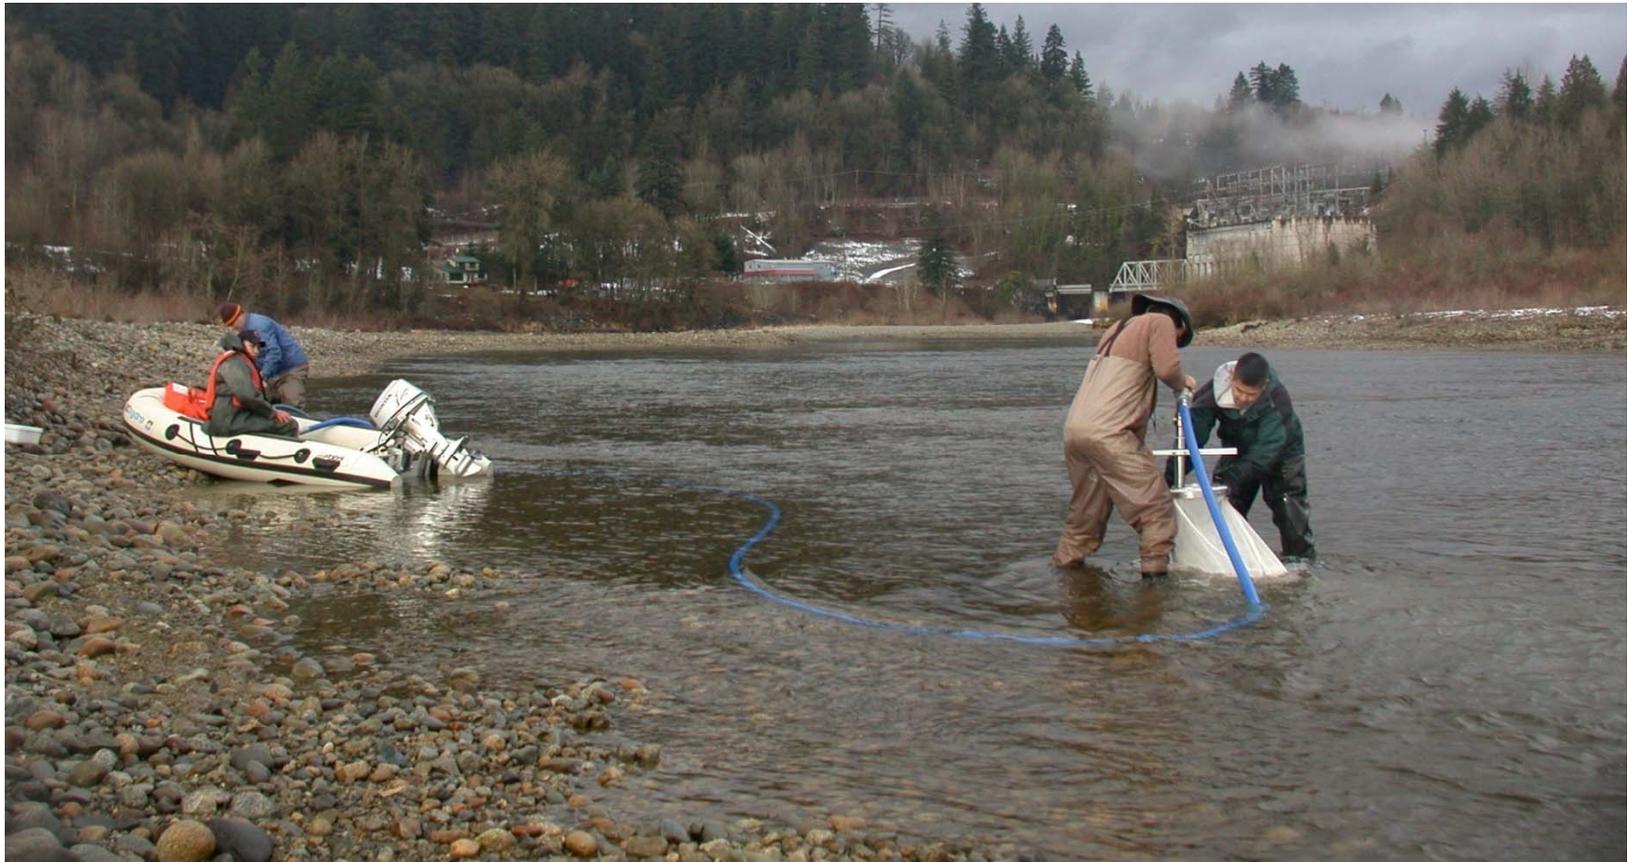
# Hydraulic Sampling

1. All alevins were captured using a hydraulic sampler
2. Sampling was concentrated in the 500 m of Stave River immediately below Ruskin Dam; spread from right to left bank
3. Samples were collected on 5 occasions roughly 2 weeks apart, but only alevins captured on:
  - February 21, 2008
  - March 8, 2008 and
  - March 20, 2008were used in our dose response trials.
4. All alevins were given at least 2 days recovery/acclimation prior to the start of dose response studies

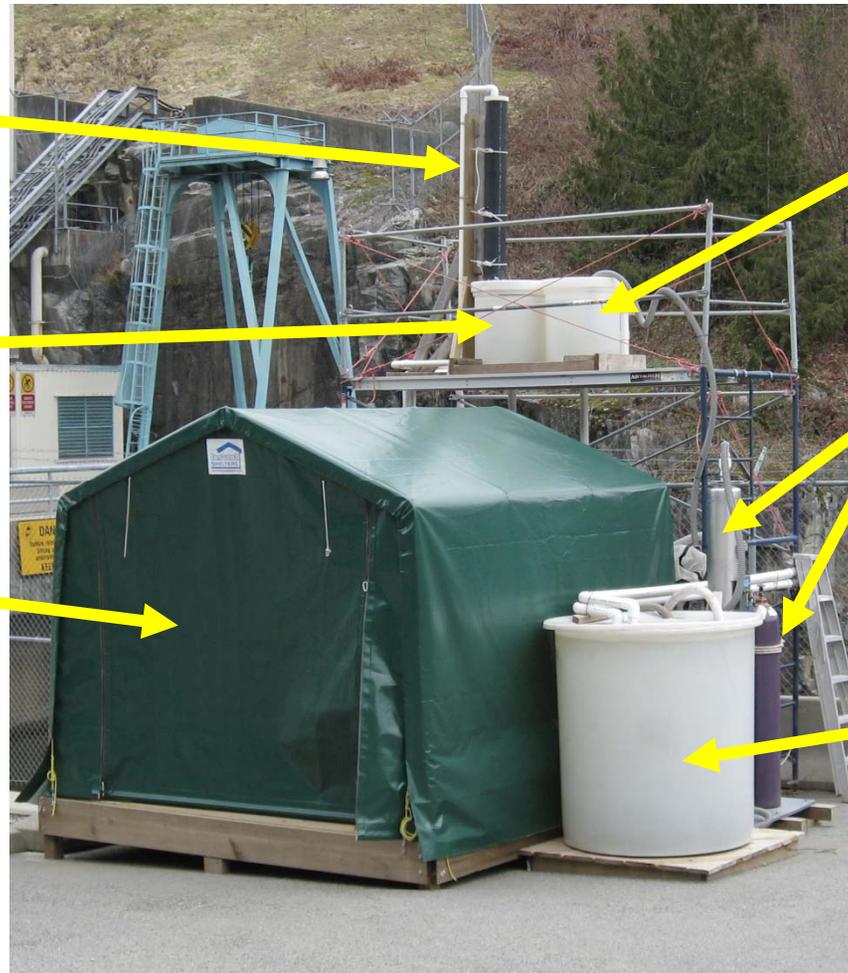
## Dose-Response Apparatus:

Degassing tower

Head tank of 100% Sat water supply

Tent housing experimental tanks

Head tank of 130% Sat water supply

Gas column and compressed air cylinder

Primary head tank receiving water pumped from Stave Falls Dam tailrace

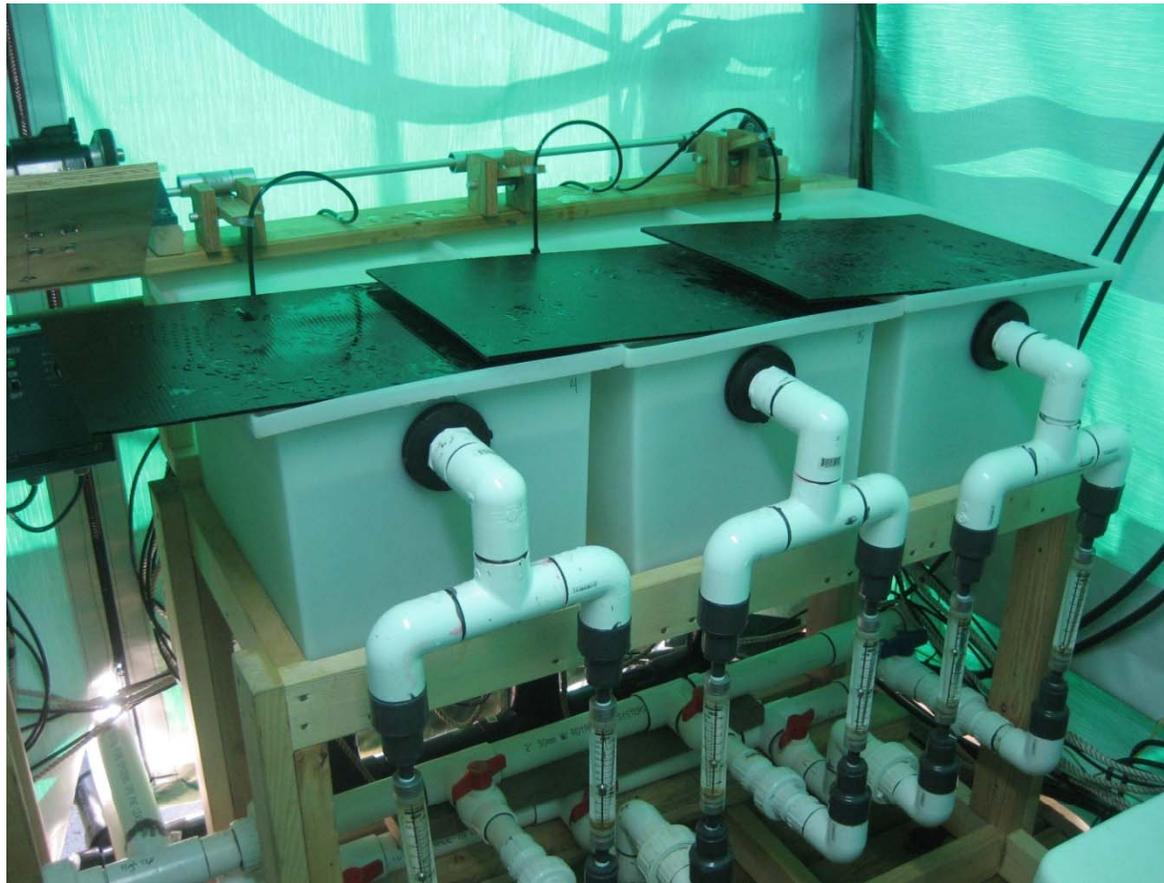
# Dose-Response Apparatus:

Second of 2 banks of 3 test tanks each

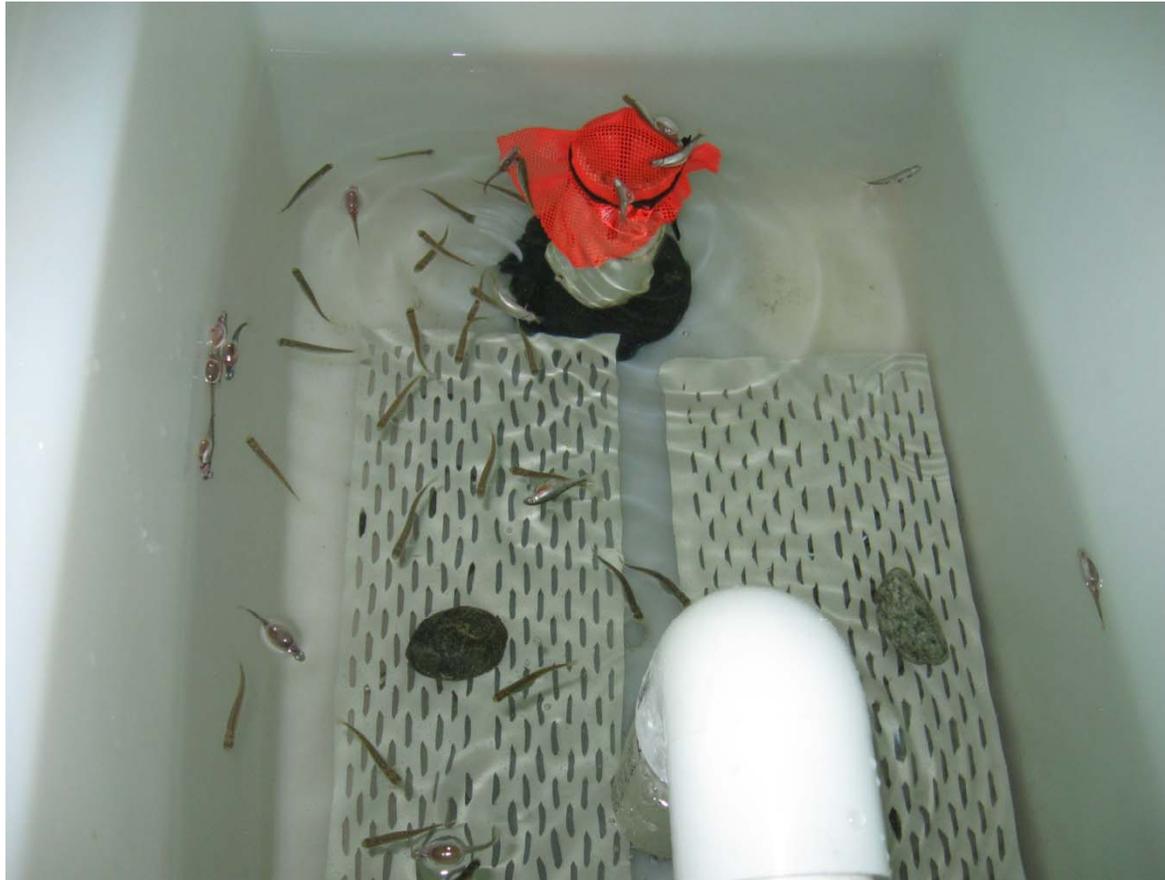
# Dose-Response Apparatus:

View inside the tank with incubation mats

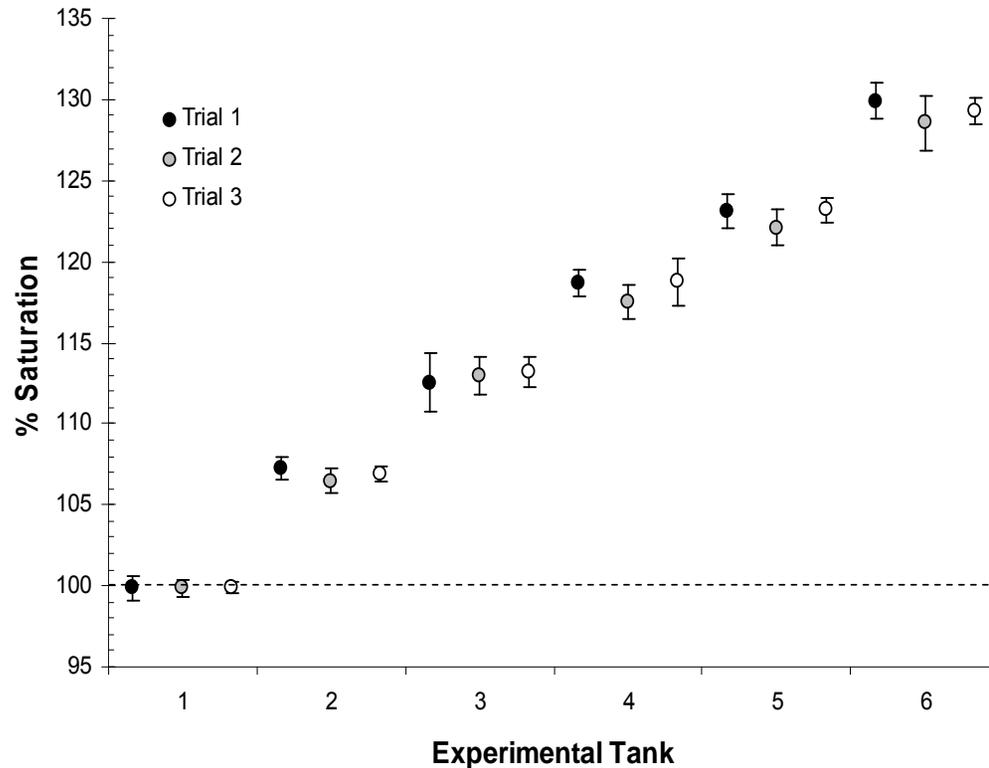
## Dose-Response Exposure Regime:

Total Dissolved Gas (TDG) for each test tank and trial

Average TDG for all experiments	
Tank	% Saturation
1	100
2	107
3	113
4	118
5	123
6	129

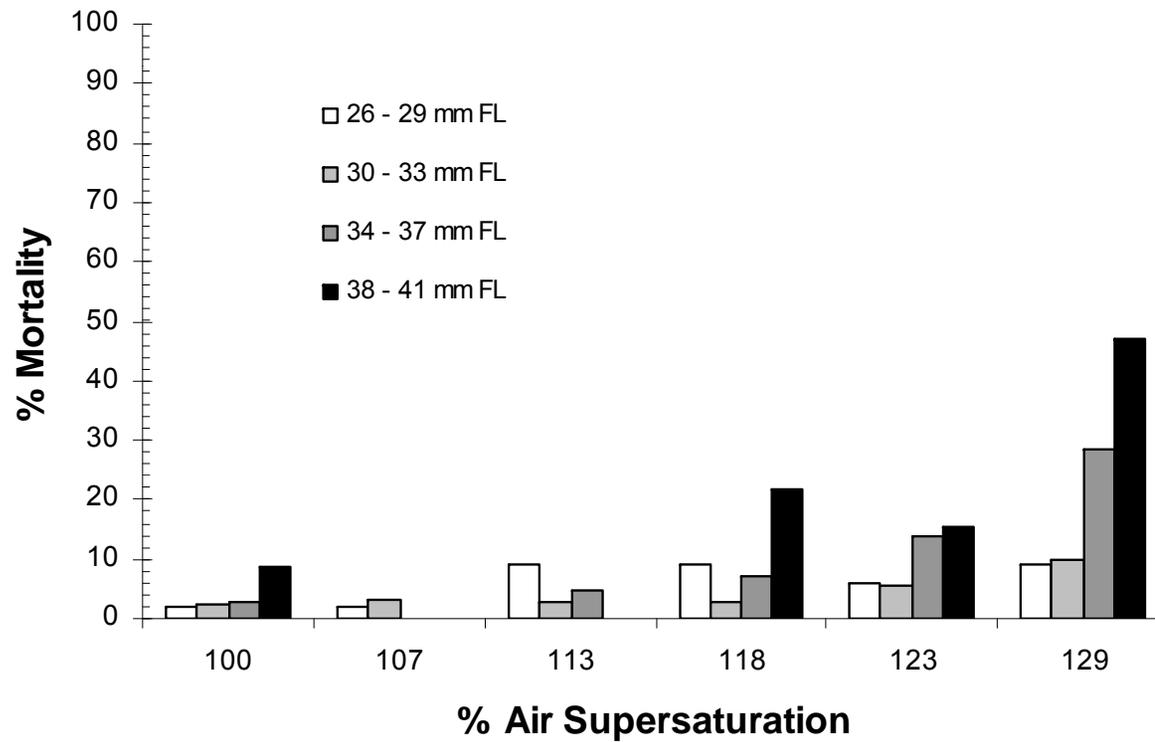
Percent mortality vs. Air supersaturation (96 hr exposure)

1. Chum alevins  $\leq 33$  mm FL tend to be tolerant of high TDG levels approaching 130% saturation (for periods of up to 4 days)
2. Chum alevin  $> 33$  mm FL tend to be more susceptible to high TDG levels  $\geq 118\%$  saturation; mortality tends to increase with size.
3. Given that most alevins at time of the Feb 2007 TDG incident were  $< 33$  mm fork length, natural tolerance to high TDG levels likely played a role minimizing mortality.

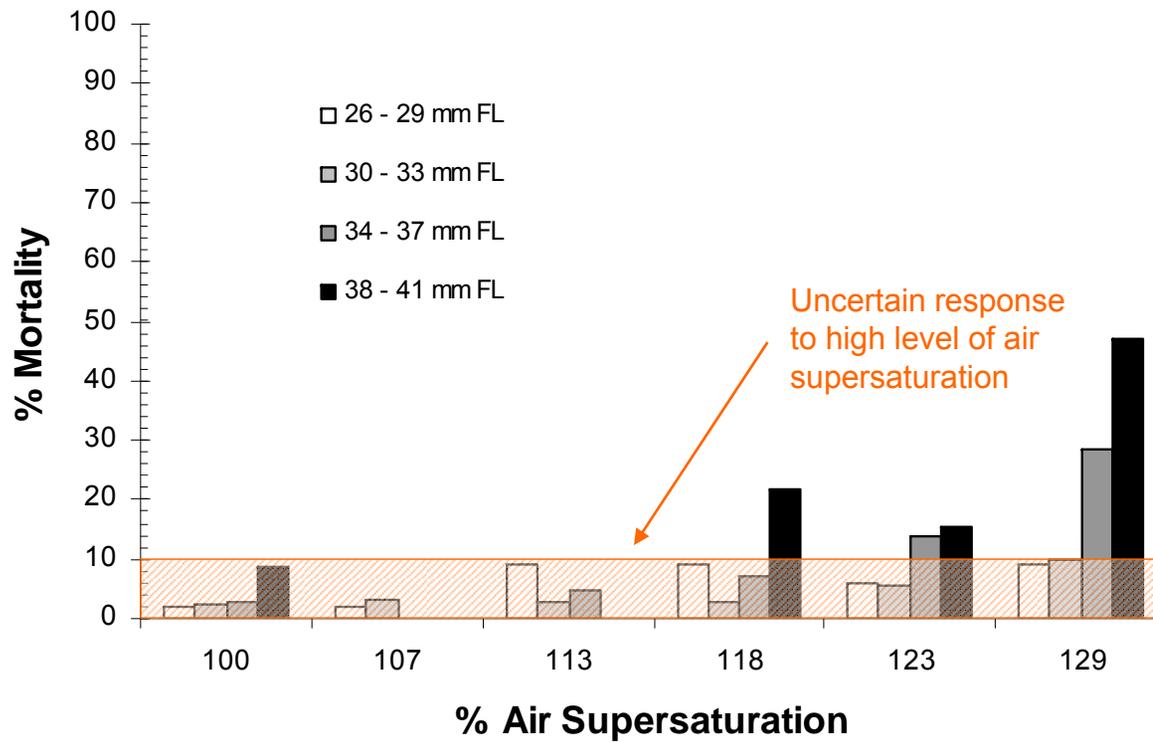
Percent mortality vs. Air supersaturation (96 hr exposure)
