Damage to the 9-ft Tunnel at Mud Mountain Dam

Northwest Regional Technical Forum
August 7, 2008

Presented by: CENWS-EC-TB-HH
Douglas D. Knapp, PE

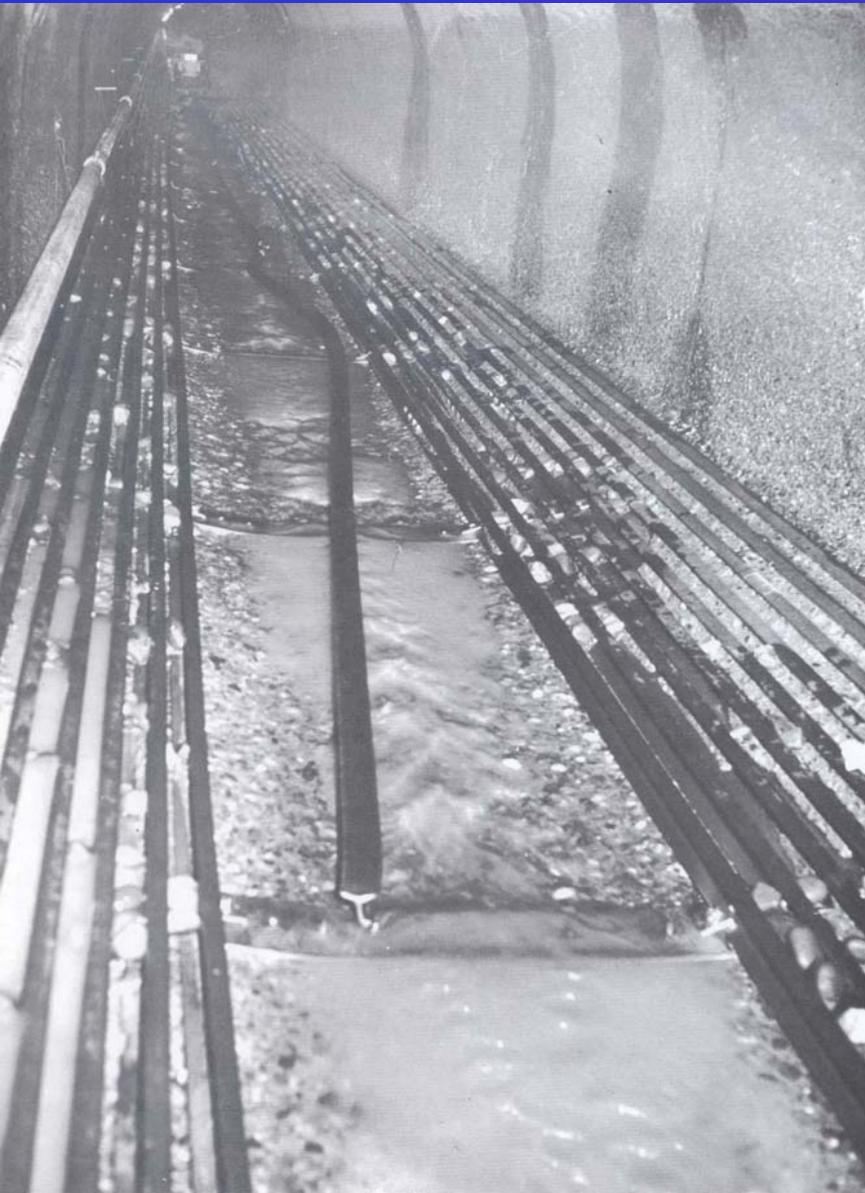
- Periodic Inspection No. 1 (1968)
- Damage due to abrasion starting at the rail interface

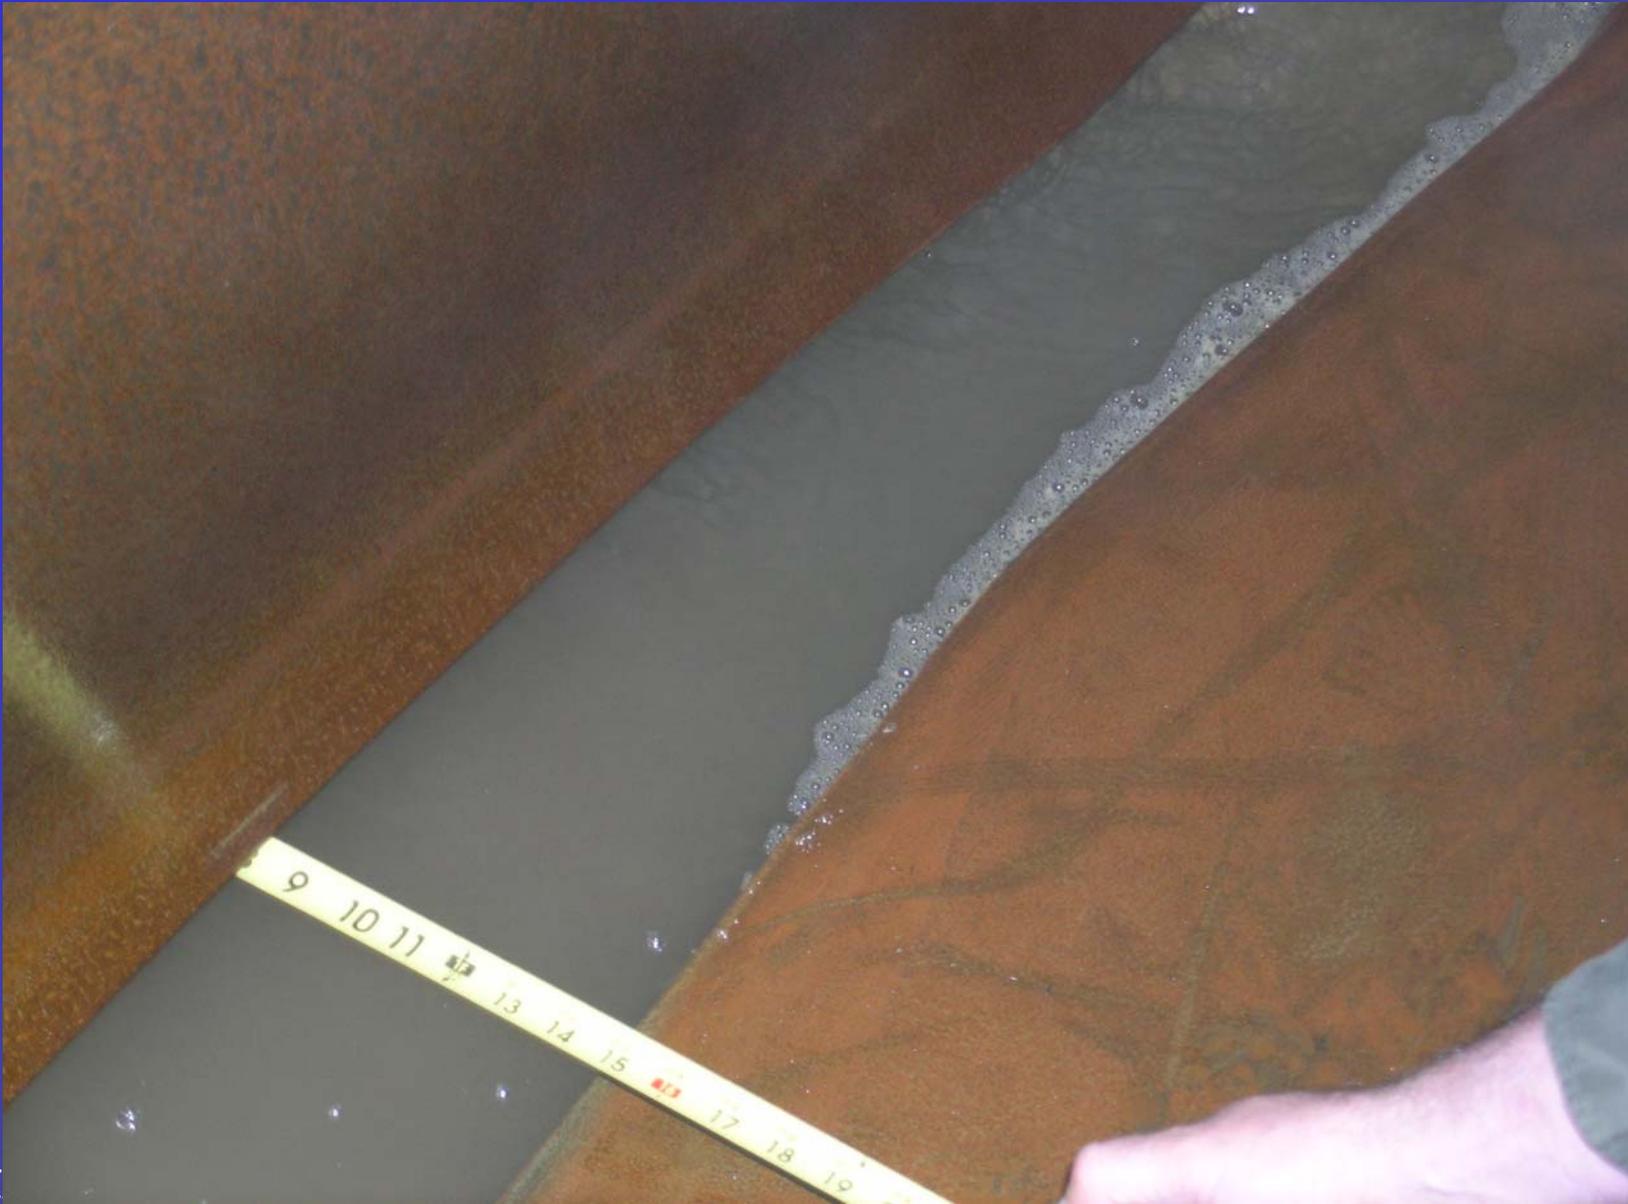
- d/s stoplog placed and 11 additional holes found
- Holes much larger than u/s
- NDT of tunnel takes place in October

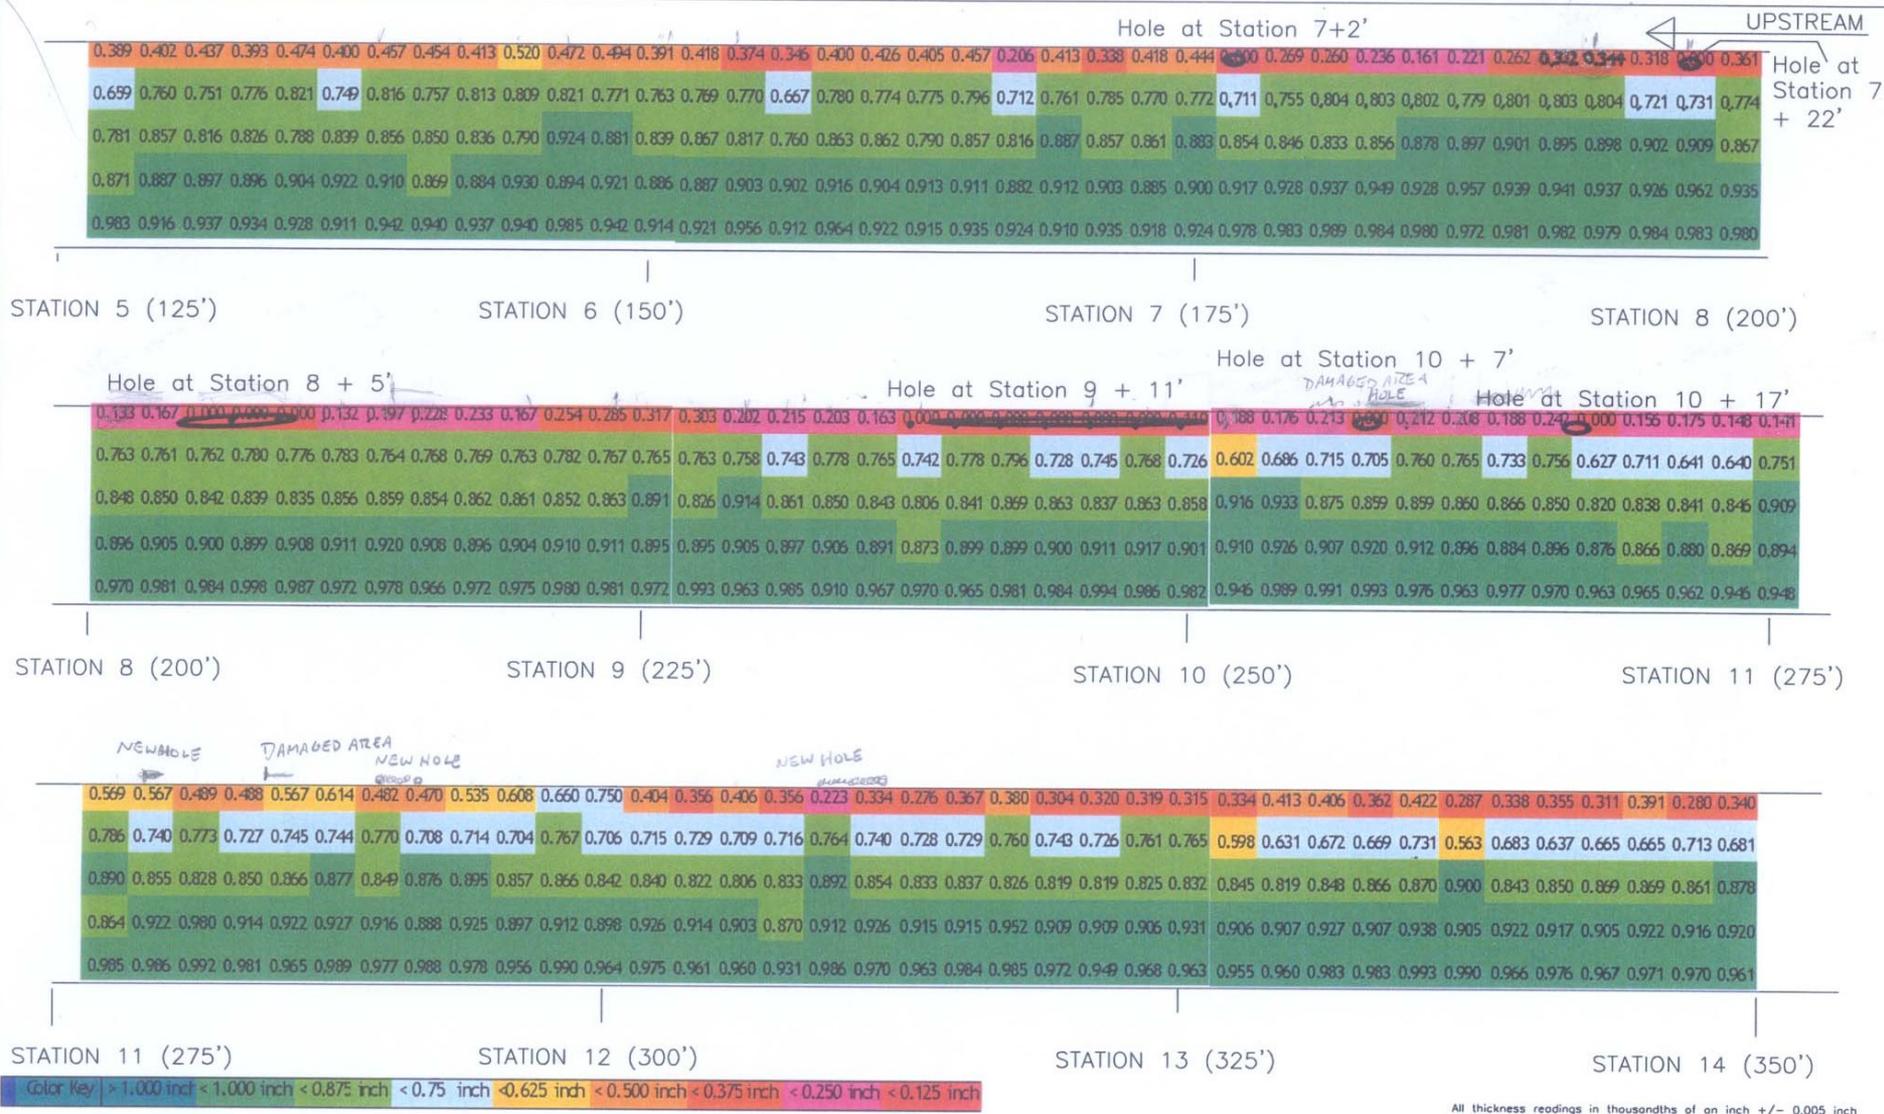
9-FOOT TUNNEL STEEL THICKNESS TESTING
 MUD MOUNTAIN DAM, WASHINGTON
 CONTRACT NO. W912DW-07-P-0825

INSPECTION DATE: 10/08/2007
 DRAWING NUMBER: 129920 REV. 0 Page: 2
 CAD DRAFTSMAN: Emery E. Roberts

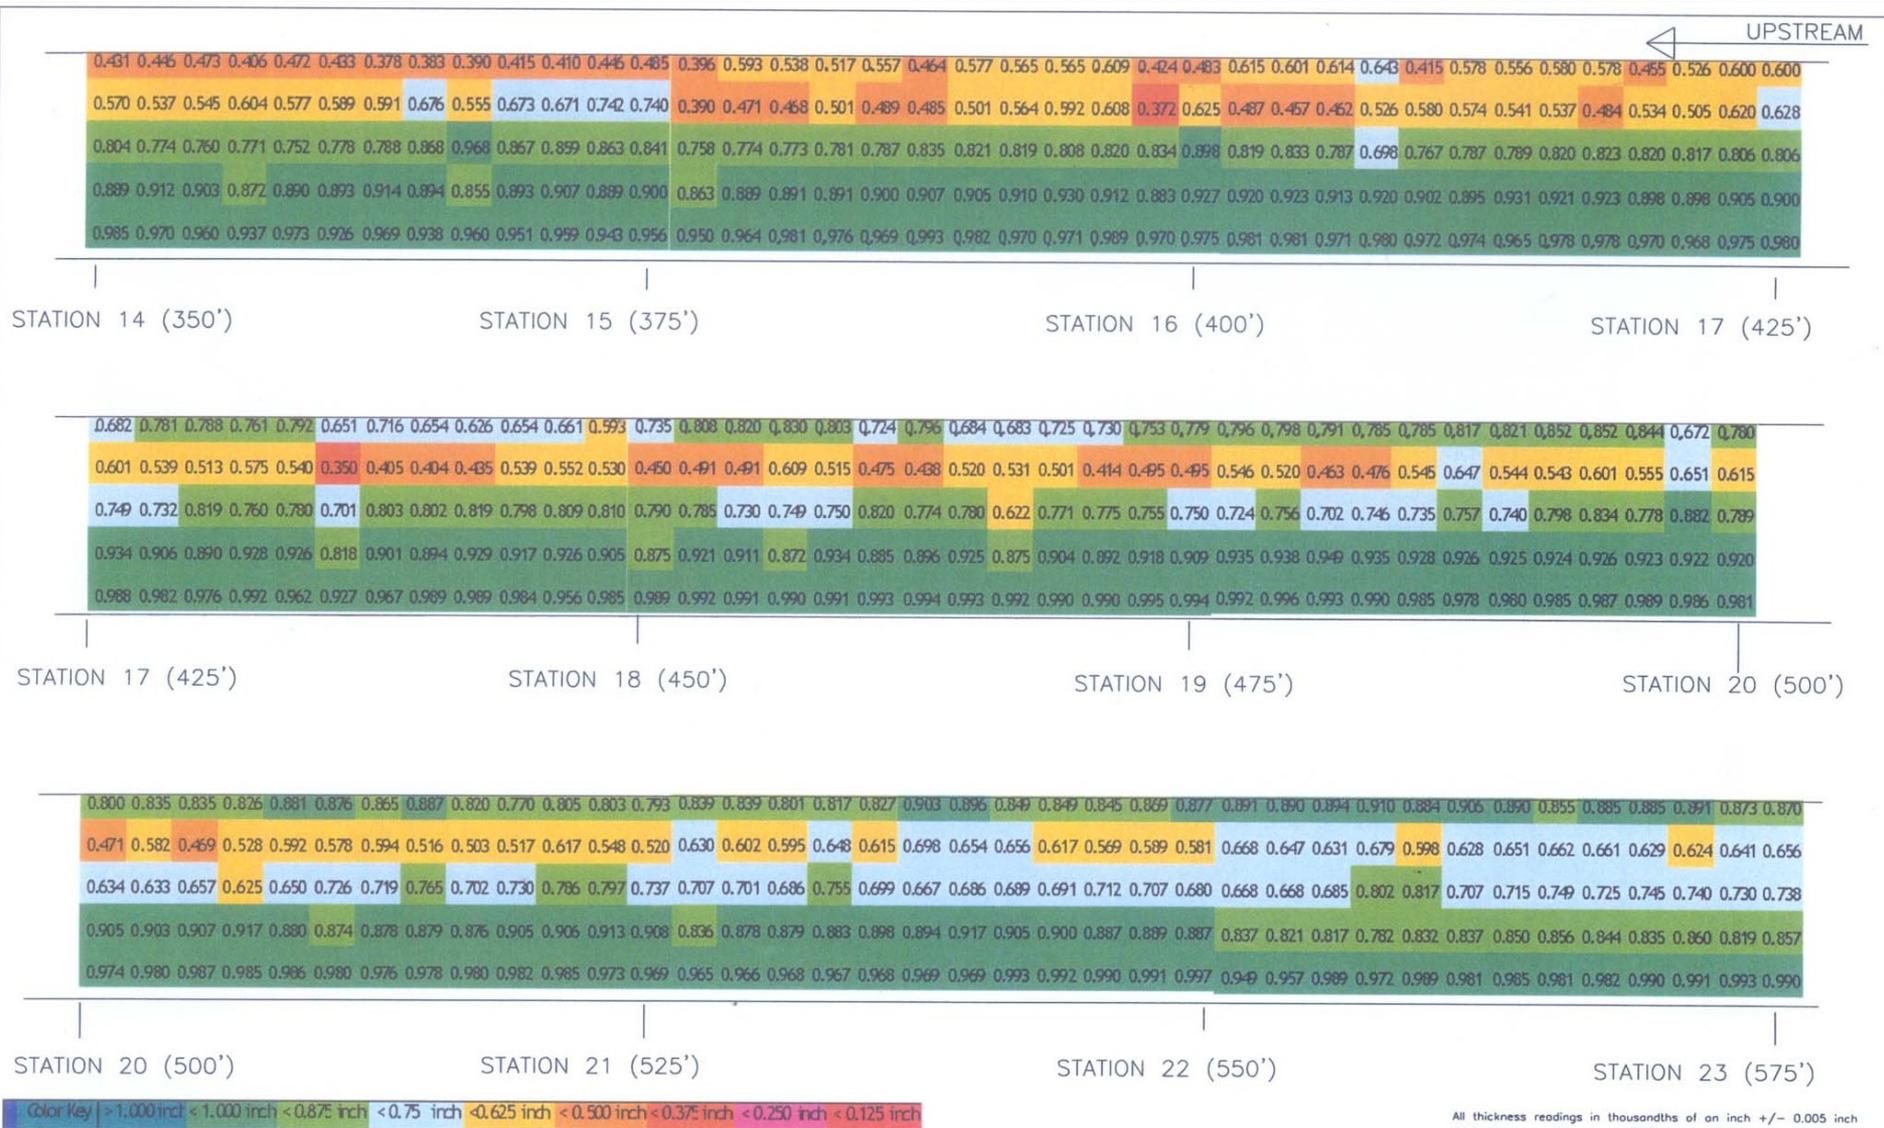
9-FOOT TUNNEL STEEL THICKNESS TESTING
 MUD MOUNTAIN DAM, WASHINGTON
 CONTRACT NO. W912DW-07-P-0825

INSPECTION DATE: 10/08/2007
 DRAWING NUMBER: 129920 REV. 0 Page: 3
 CAD DRAFTSMAN: Emery E. Roberts

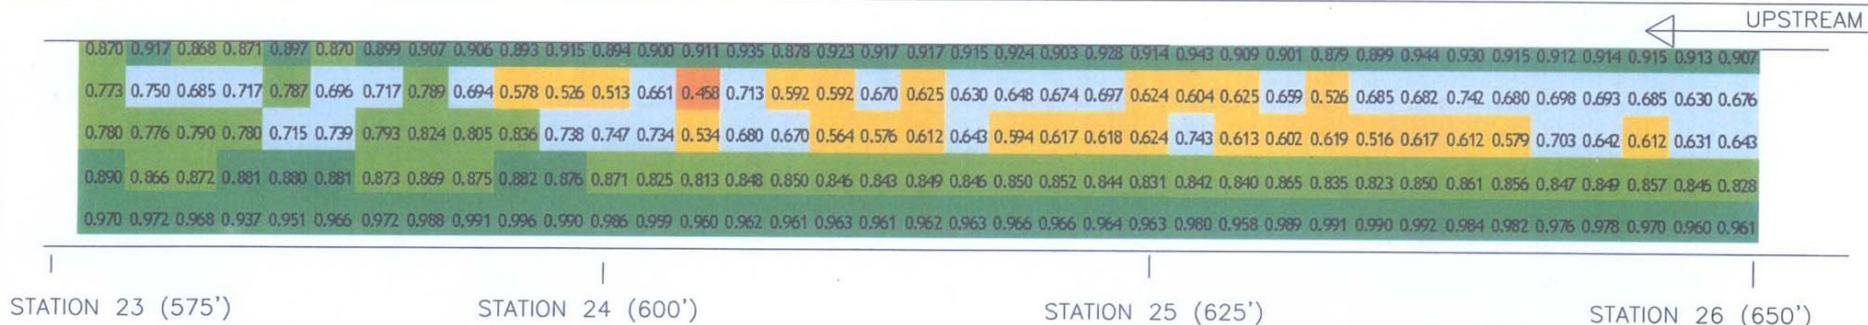
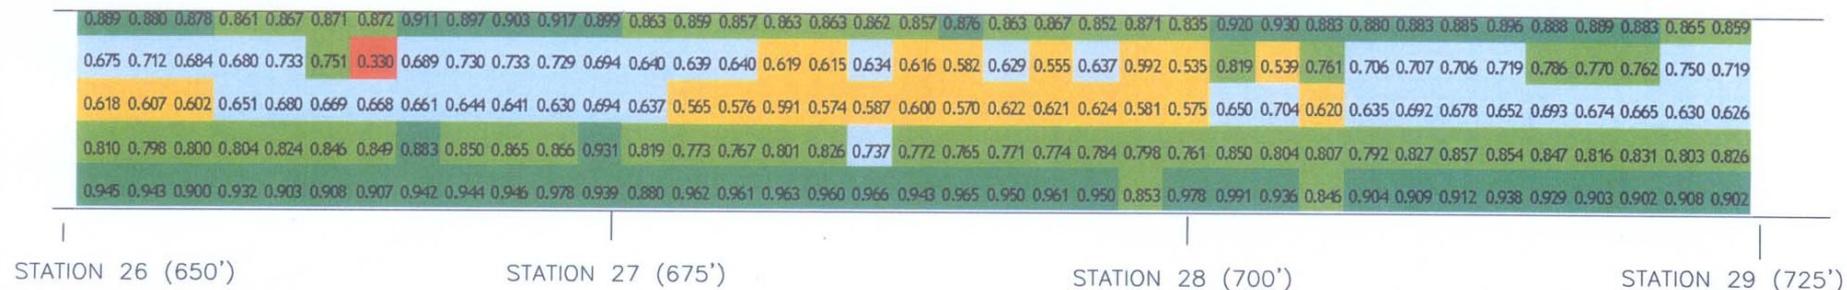
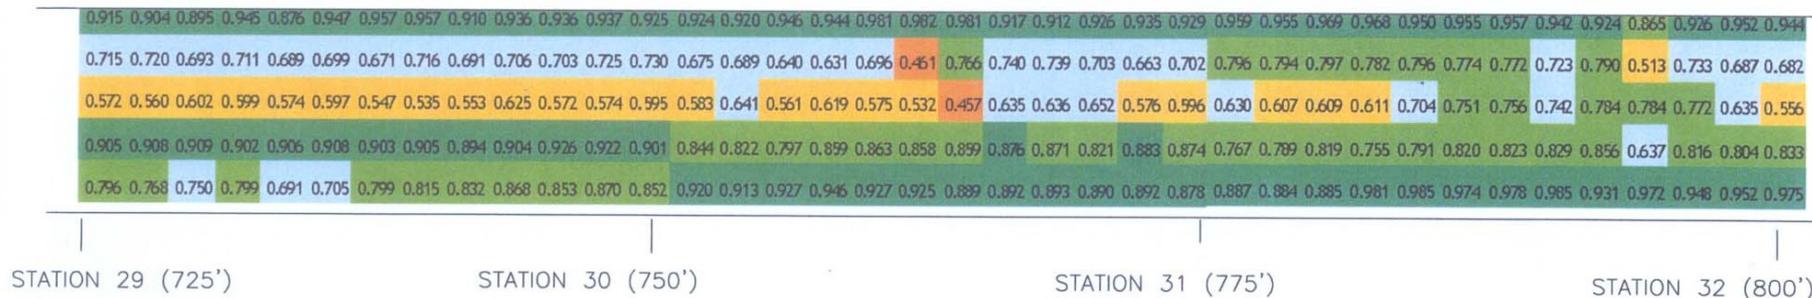
9-FOOT TUNNEL STEEL THICKNESS TESTING
MUD MOUNTAIN DAM, WASHINGTON
CONTRACT NO. W912DW-07-P-0825

INSPECTION DATE: 10/08/2007
DRAWING NUMBER: 129920 REV. 0 Page: 4
CAD DRAFTSMAN: Emery E. Roberts

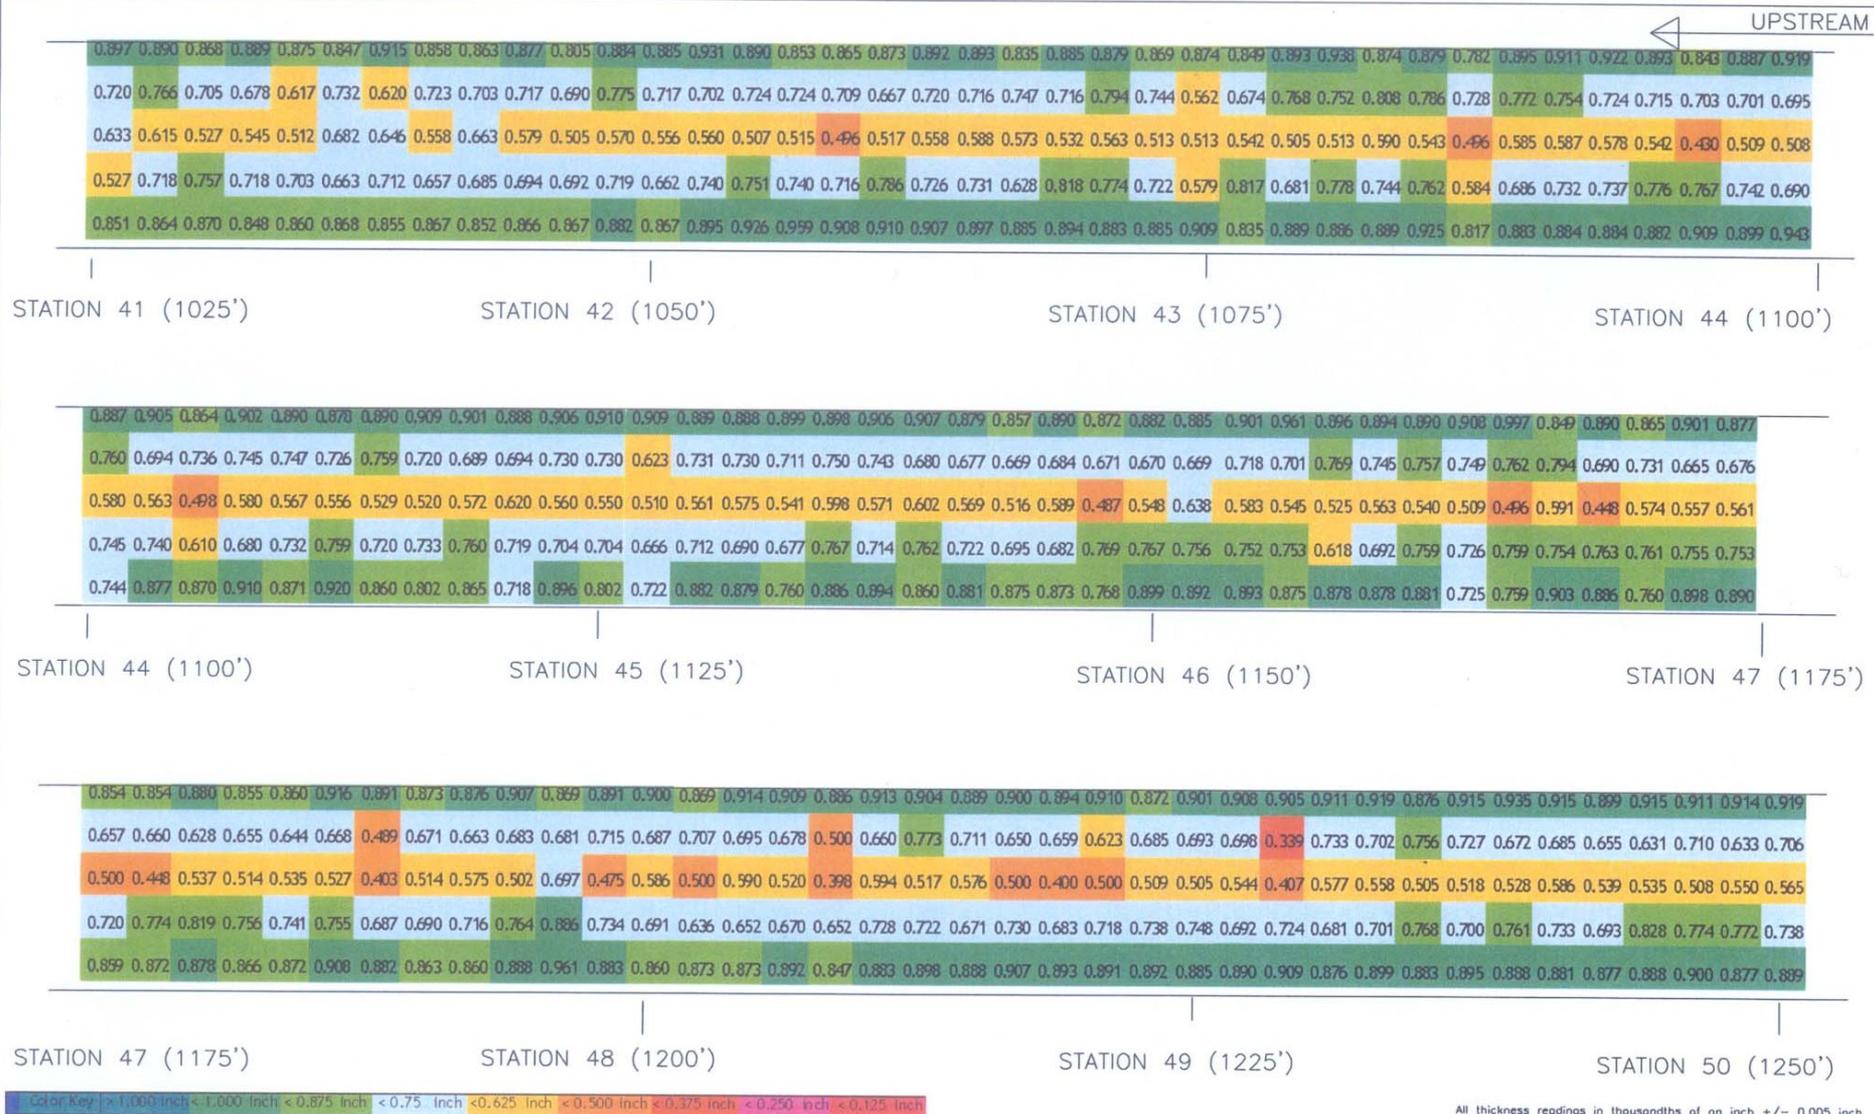
9-FOOT TUNNEL STEEL THICKNESS TESTING
 MUD MOUNTAIN DAM, WASHINGTON
 CONTRACT NO. W912DW-07-P-0825

INSPECTION DATE: 10/08/2007
 DRAWING NUMBER: 129920 REV. 0 Page: 6
 CAD DRAFTSMAN: Emery E. Roberts

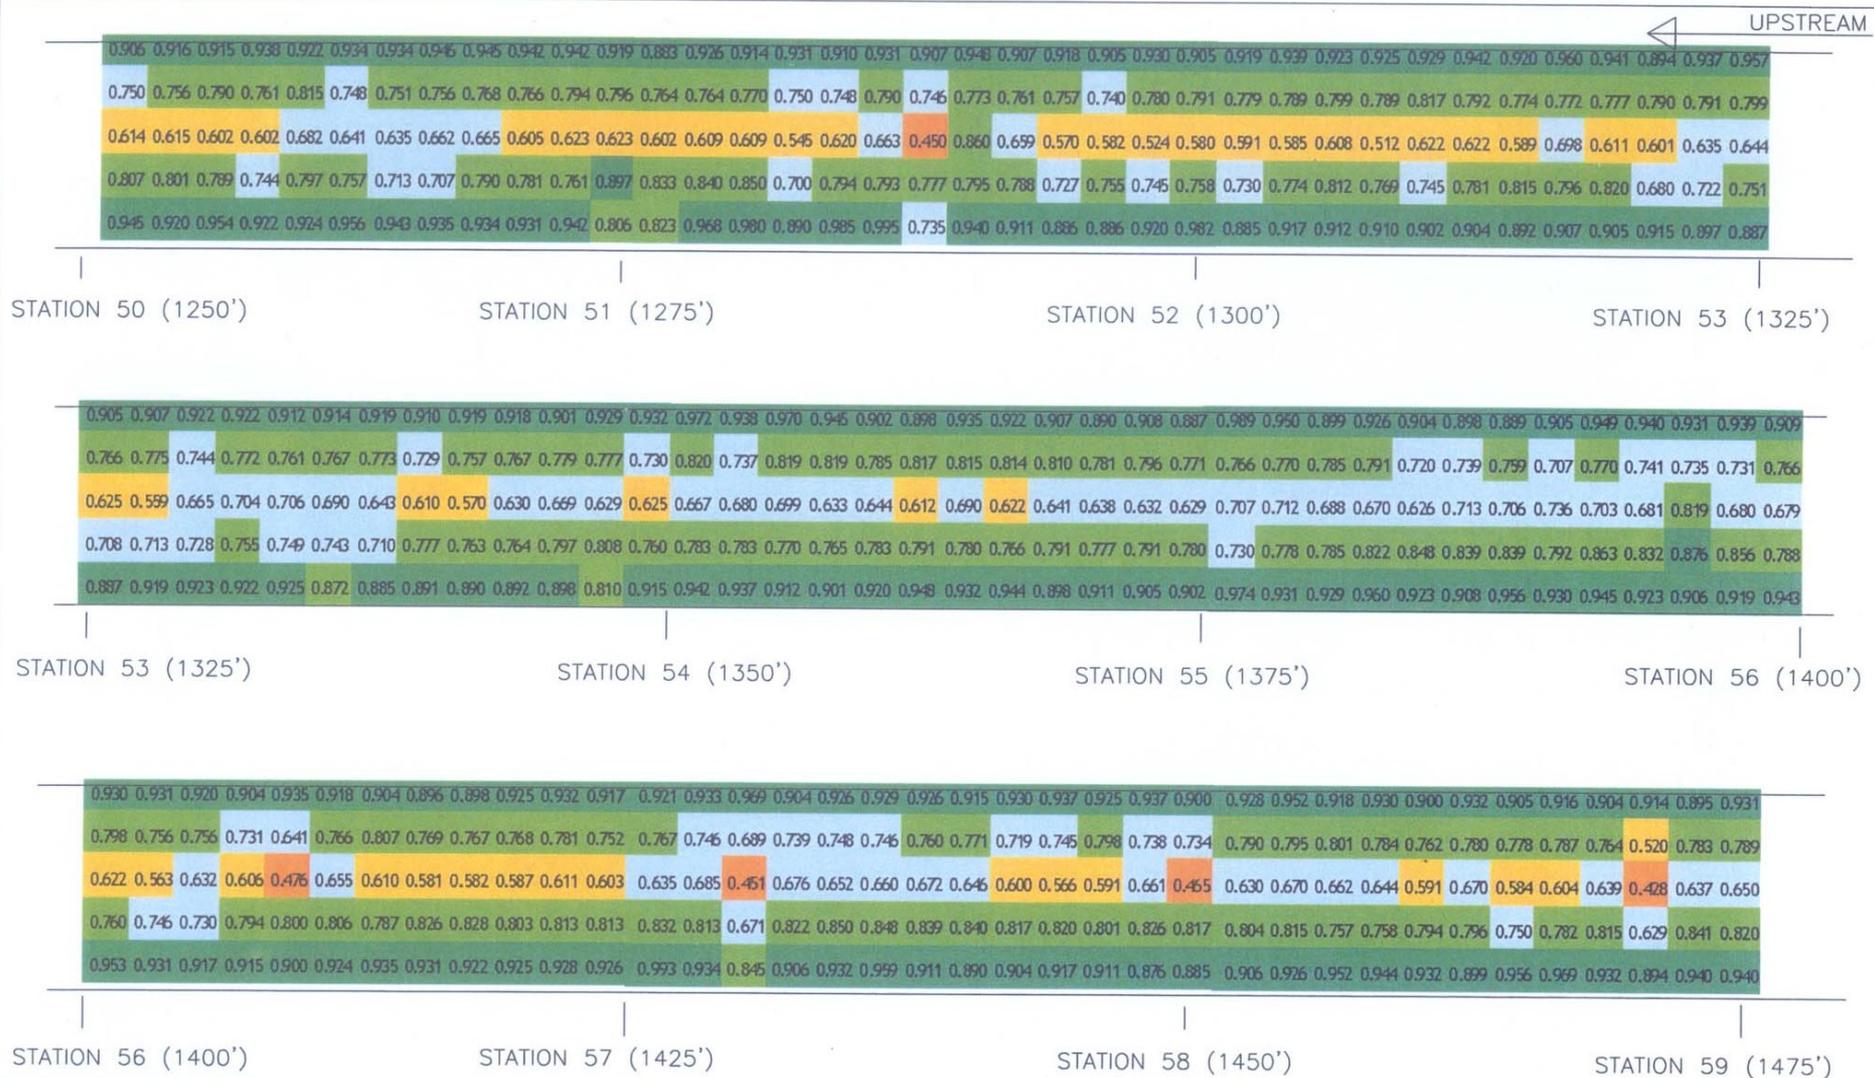
9-FOOT TUNNEL STEEL THICKNESS TESTING
MUD MOUNTAIN DAM, WASHINGTON
CONTRACT NO. W912DW-07-P-0825

INSPECTION DATE: 10/08/2007
DRAWING NUMBER: 129920 REV. 0 Page: 7
CAD DRAFTSMAN: Emery E. Roberts

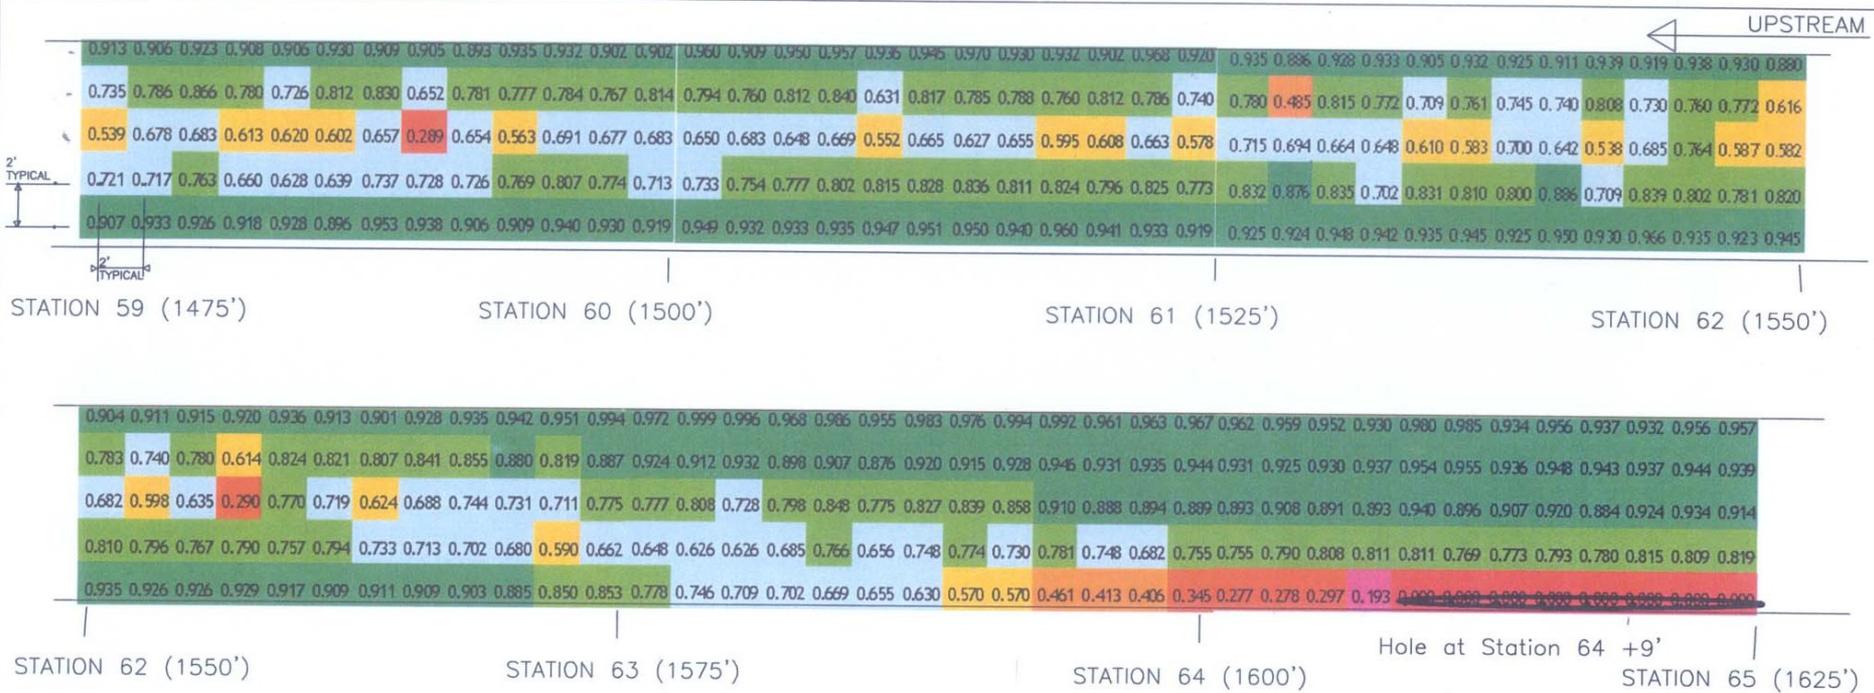
9-FOOT TUNNEL STEEL THICKNESS TESTING
MUD MOUNTAIN DAM, WASHINGTON
CONTRACT NO. W912DW-07-P-0825

INSPECTION DATE: 10/08/2007
DRAWING NUMBER: 129920 REV. 0 Page: 8
CAD DRAFTSMAN: Emery E. Roberts

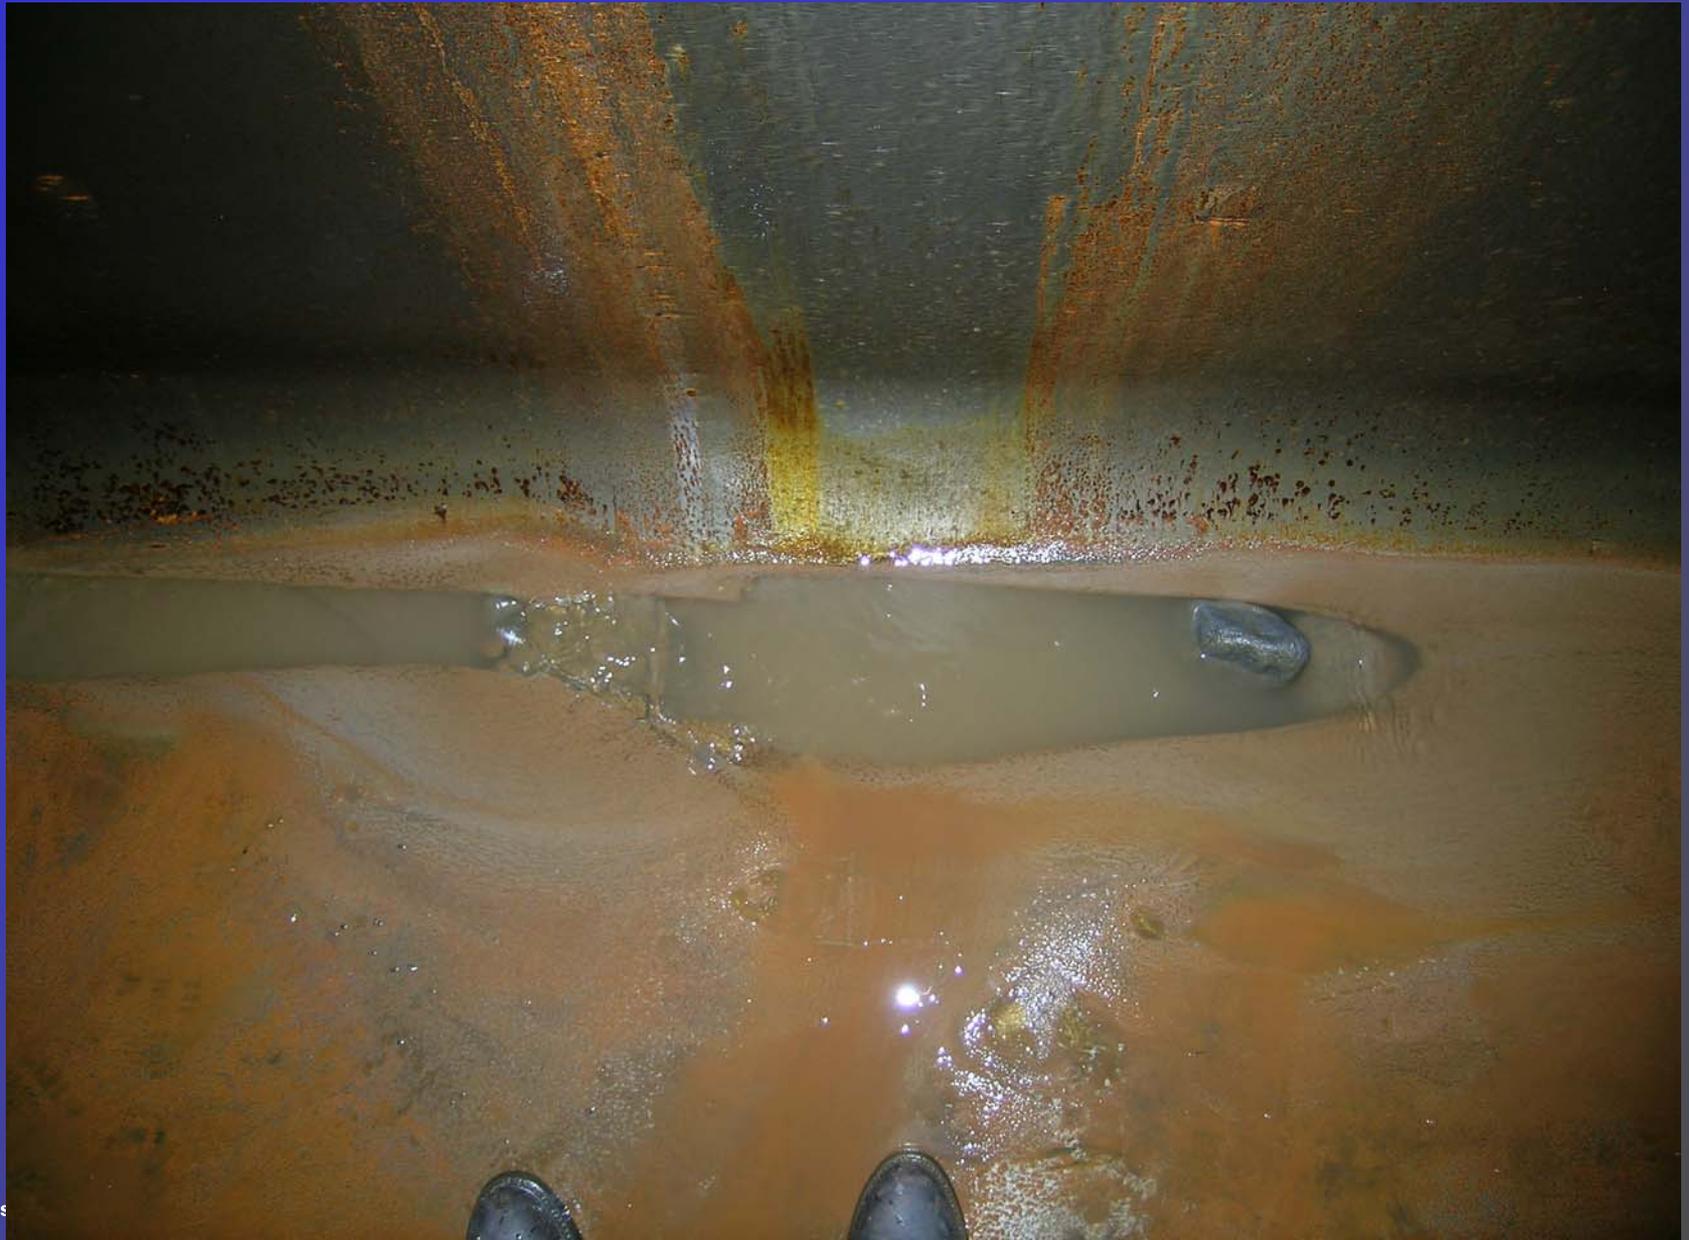
- October 2007 to February 2008
 - Max pool elevation = 950'
 - Additional hole formation
 - Lost ~75% of patch material
- February 2008 to June 2008
 - Max pool elevation = 920'
 - Average elevation during this time = 905'
 - Very little sediment transport
 - <5% increase in damage
- June 2008 to Present
 - Max pool elevation = 930'
 - Pool elevations near 930' for extended time
 - Expect that large amounts of sediment transported
 - Increased damage = 15% to 20%

- Current Plan
 - Fill holes with high-strength concrete
 - Cover with Belzona
 - Leave one hole open for monitoring
 - Continue operational restrictions
- Expect ~10 years of life left in liner
- Long Term Solutions
 - Continue regular temporary fixes
 - Replace steel liner
 - Tunnel Redesign / Realignment
