**John Day Dam  
South Fish Ladder  
Section 12  
Wall Leak**

**January 28, 2015**

## Inspection Report

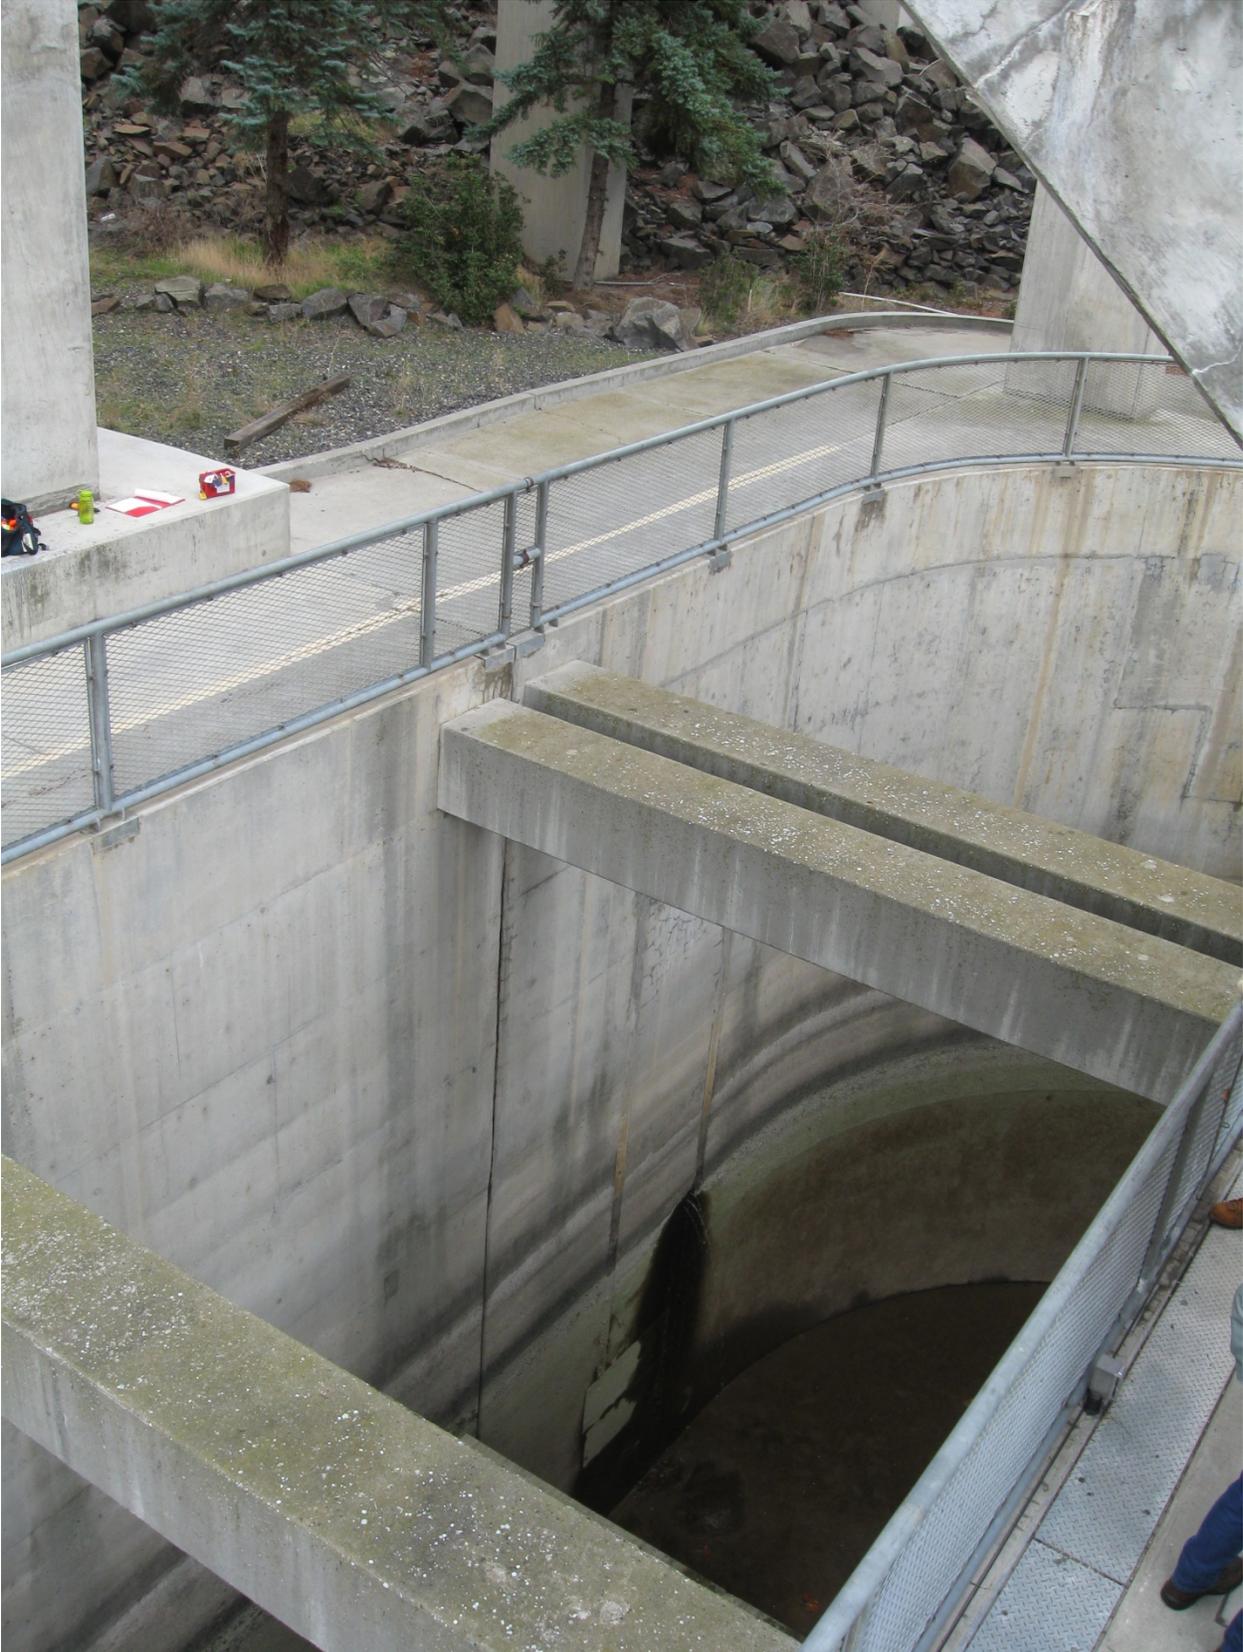
Figure 8 - Overview of Area

- c. Bags of Sakrete were mixed to a damp consistency and then packed into the hole while water was running out of it.
- d. Sheet metal plates were applied over the patched areas with expansion anchors. The anchors were noticed to be in 'soft' concrete as they were installed
- e. The sidewalk at grade level above the wall leak has subsided and cracked (Figure 7 and Figure 8).
