<b>DESIGN DOCUMENTATION REPORT</b> The Dalles Dam, Columbia River North Fish Ladder Rock Wall Stabilization	
	Issue/Revision No.: I1-R1
	Issue/Revision Date: August 25, 2015

**Design Documentation Report**

**THE DALLES DAM  
COLUMBIA RIVER**

**NORTH FISH LADDER ROCK WALL STABILIZATION**

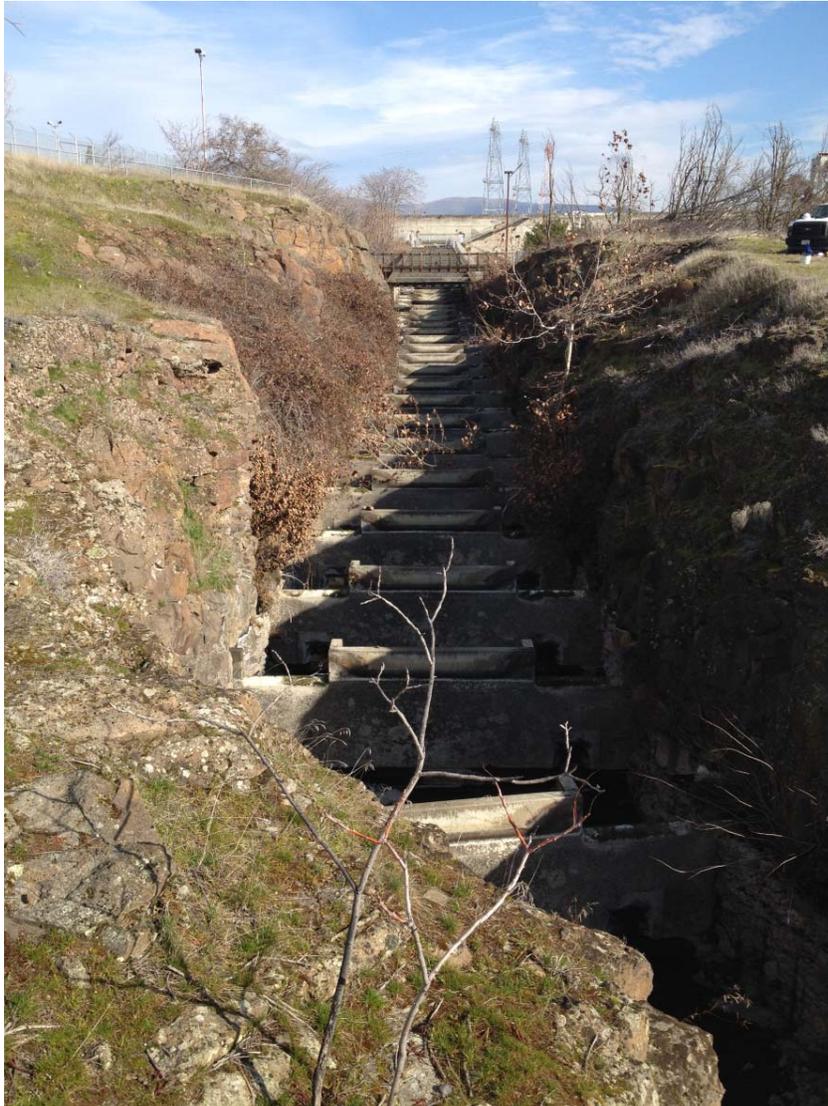
**Figure 5 – Photograph looking northwest towards the northern section of fish ladder.**

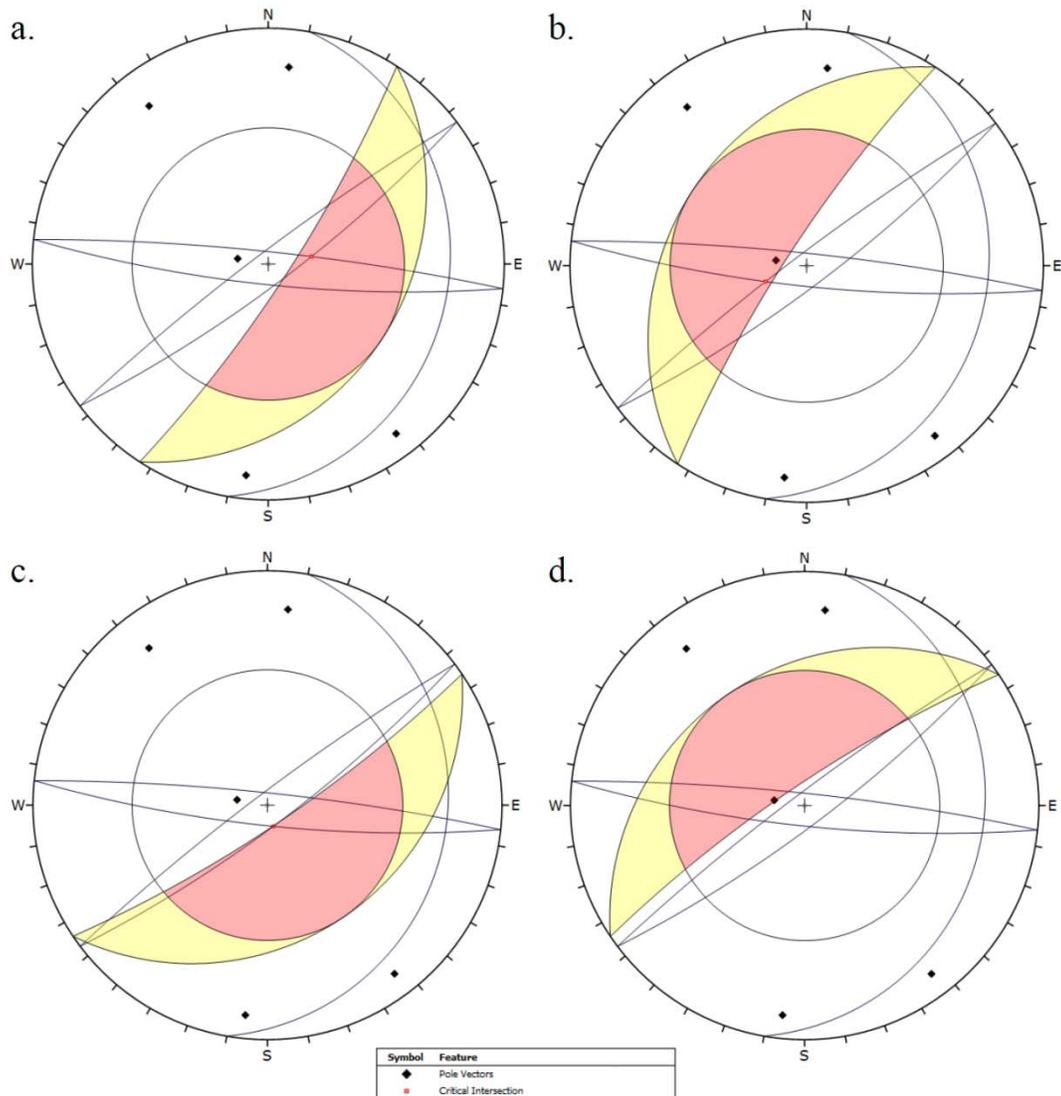
**Figure 14 – Stereographic plots showing requirements for wedge failures for the north (a, b) and south (c, d) fish ladder sections. Joint intersections within the red shaded areas indicate that wedge failures are possible. Central circle represents an assumed joint friction angle of 30 degrees.**

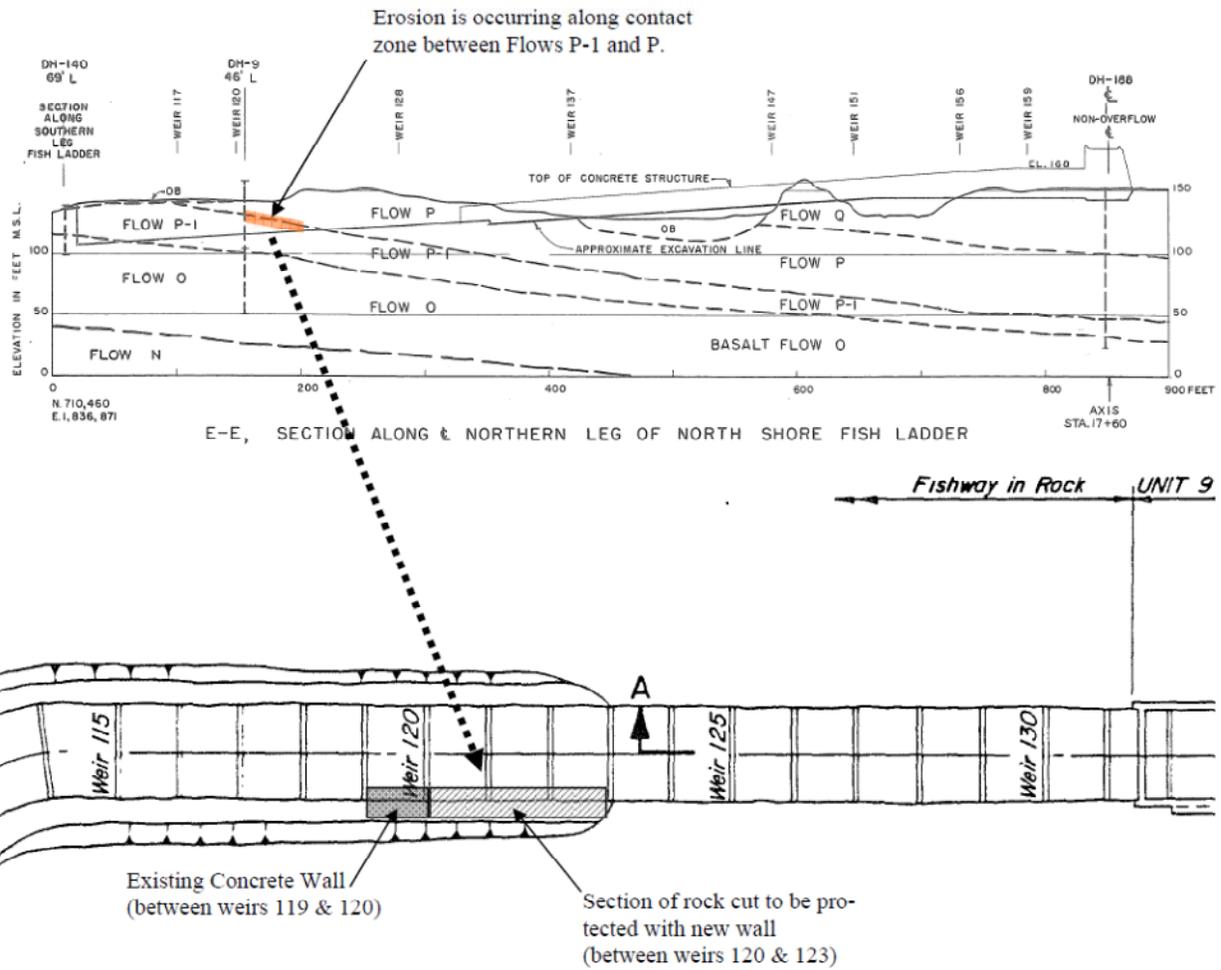
Although much of the fish ladder rock cuts are undergoing rockfall primarily as the result of weathering and gravitational forces, there is one section of ladder, between weirs 120 and 123 (south wall) where water flow has caused erosion of the lower rock cut, forming undercuts that could destabilize overlying rock masses (Figure 15; also see Figure 1 and Photos 6 & 7 of Appendix A). In this area, the contact between flows P-1 and P dip down below the waterline, and this weaker zone is more easily eroded by water. An existing concrete wall exists on the south side of the channel, between weirs 119 and 120, which appears to have been constructed in conjunction with fish ladder weir modifications completed in the 1980's. This existing wall was likely constructed to help protect the cut from water erosion along the same contact.

Figure 15 – Plan and section showing proposed shotcrete wall locations.

The walls should be designed assuming hydrostatic pore pressures to the top of the walls, with no water loading inside the channel. Lateral loads from the bedrock may be assumed to be zero.

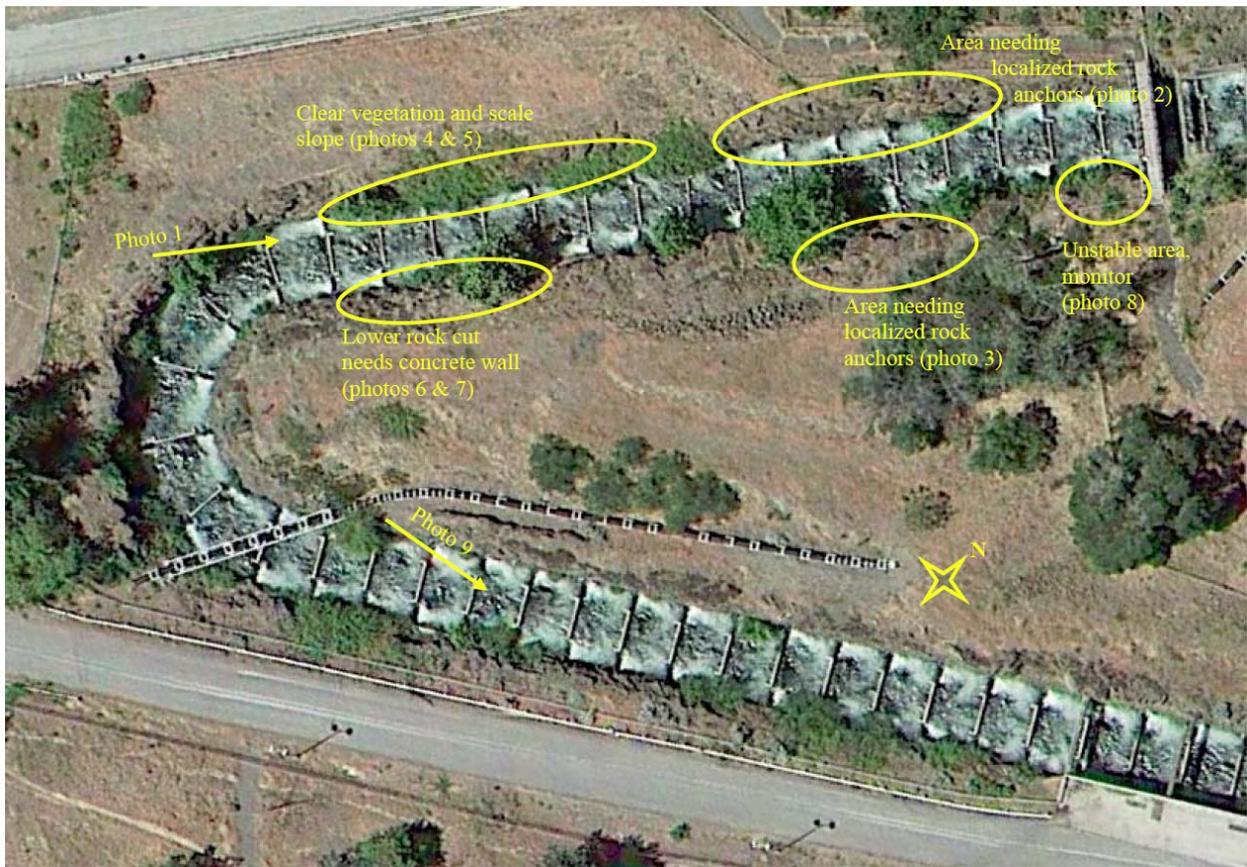
There is an area of the ladder, near the footbridge, that has unstable rock, including large unstable rock blocks (Figure 1 and photo 8). Unfortunately, it is likely that any scaling or rock anchor activity completed in this area could cause rock fall that could damage the fish ladder. Therefore, this area of the fish ladder could simply monitored, with special precautions given to personnel who work in this area of the ladder.

There is one section of the ladder where water flow has caused erosion of the lower rock cut, essentially undercutting the slope (See Figure 1 and photos 6 & 7). Continued erosion can result in larger rock fall that could damage the ladder. In this area of the ladder some kind of concrete wall will likely be required to protect the cut from on-going erosive forces. The wall could be supported by rock anchors.

Figure 1 - Aerial photo showing north fish ladder and areas of interest.

Prior to implementing any rock stabilization work, a qualified engineering geologist or geological engineer should be hired to evaluate the cuts in detail, and develop a stabilization design/plan.

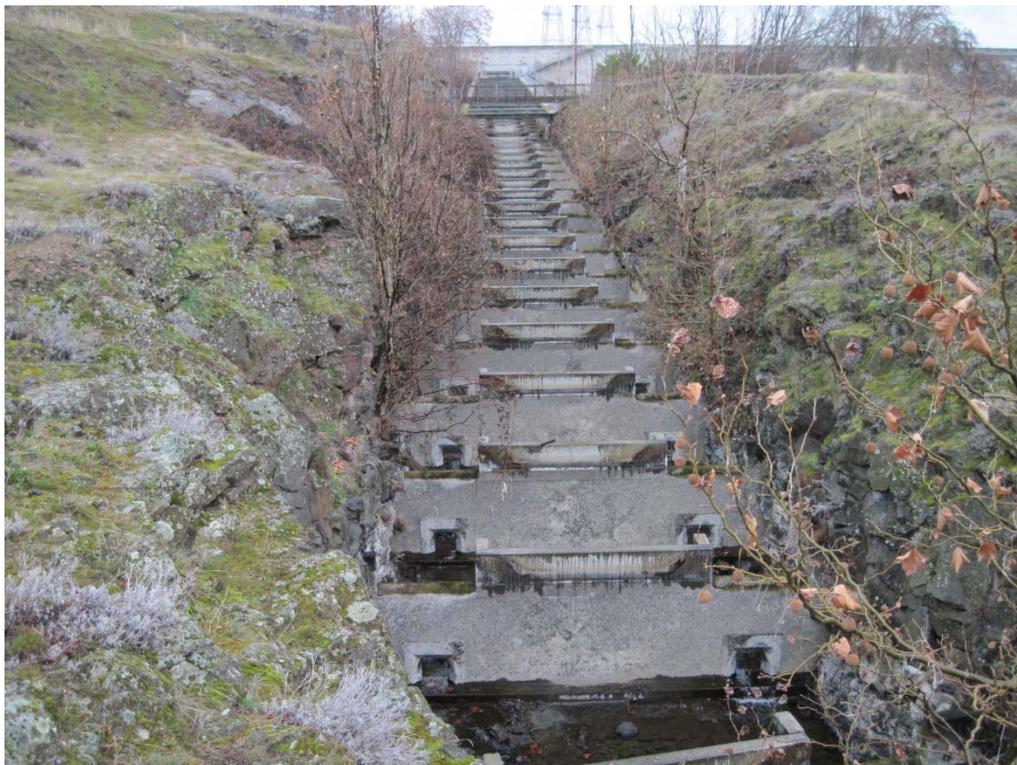
Photo 1 - looking north up fish ladder.

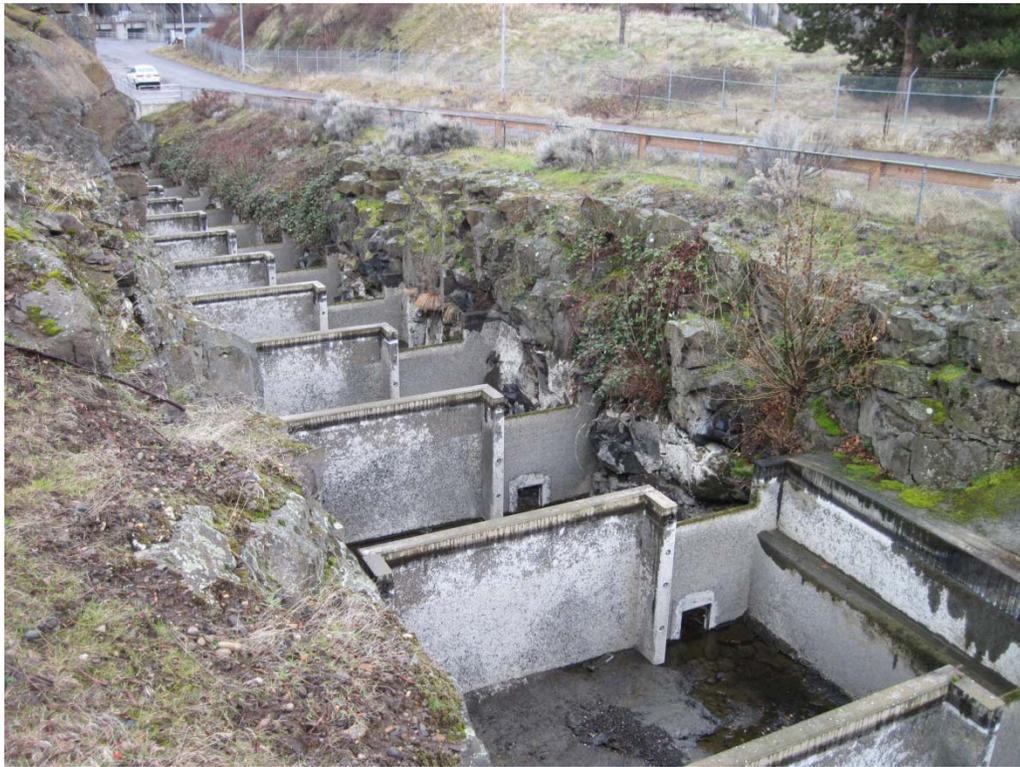
**Photo 9 – Looking towards the southern section of the fish ladder.**
