**John Day Dam  
South Fish Ladder  
Section 12  
Wall Leak**

**January 28, 2015**

## Inspection Report

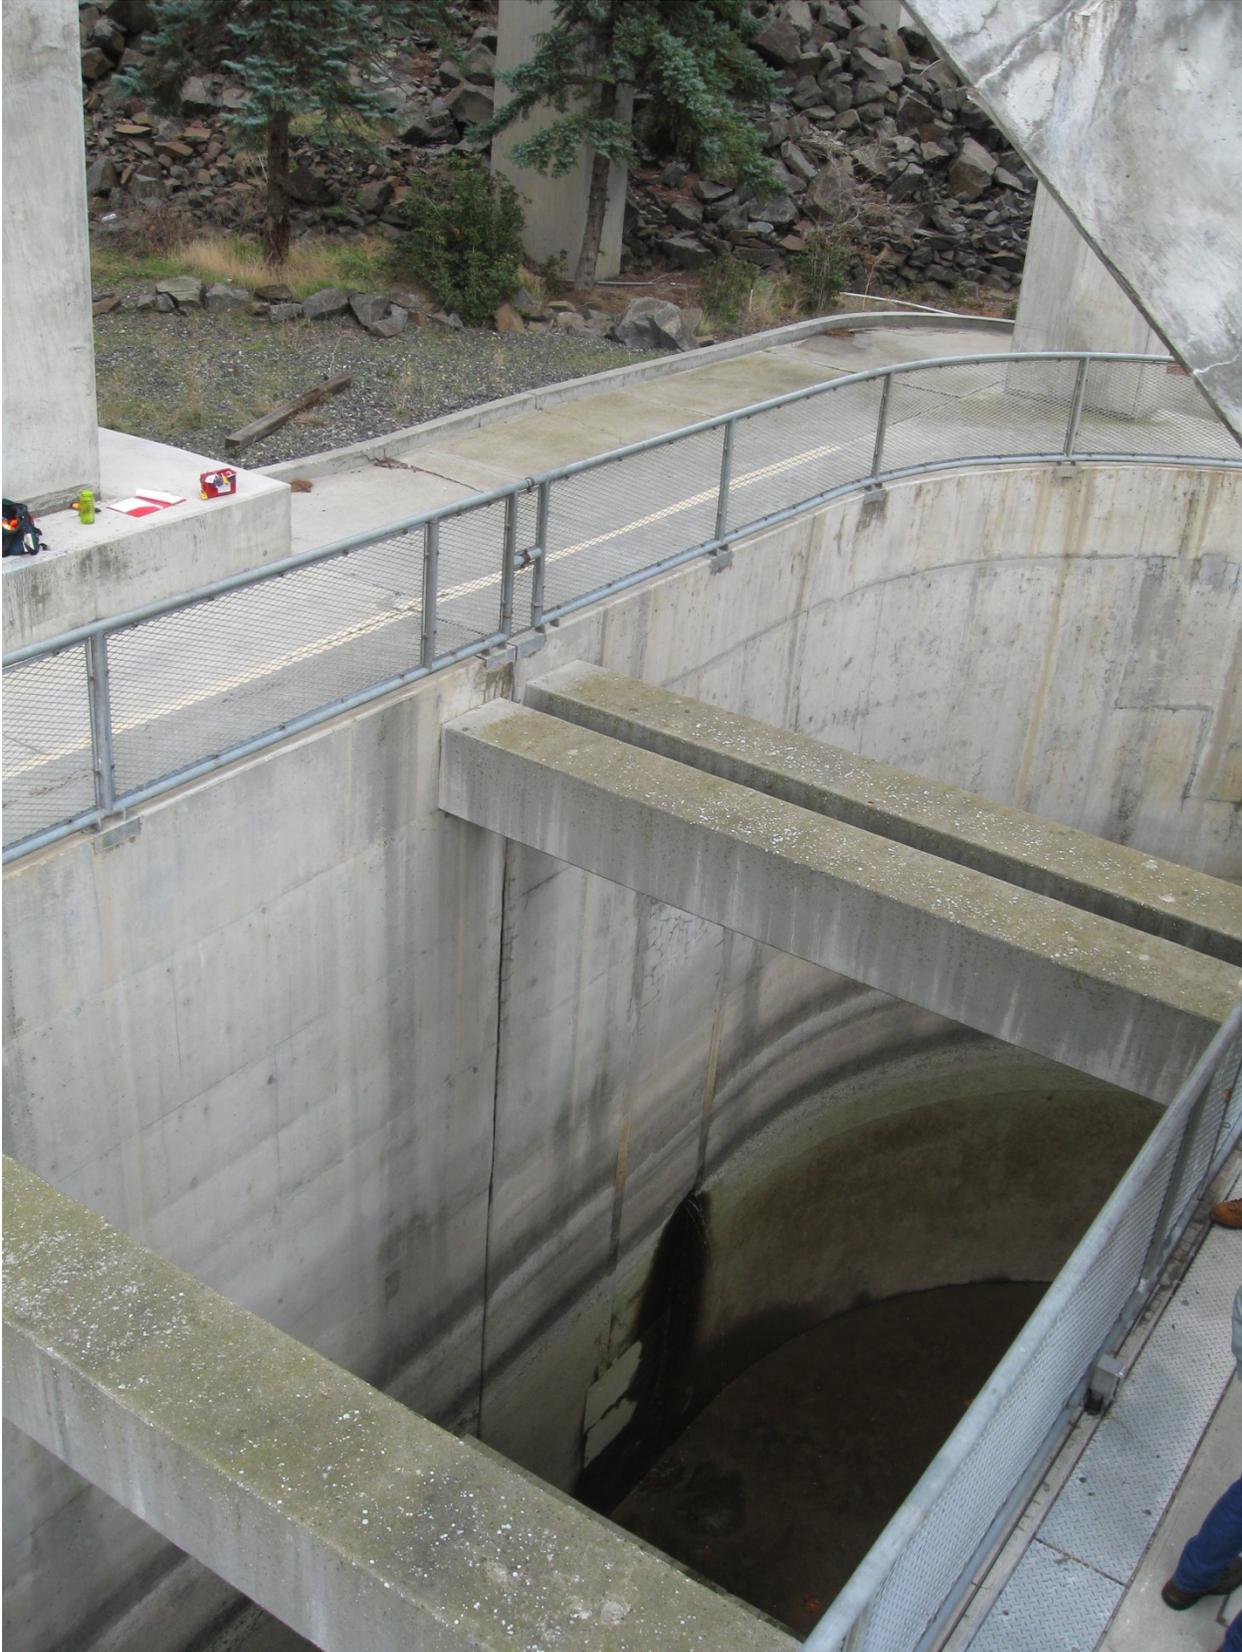
Figure 8 - Overview of Area

- c. Bags of Sakrete were mixed to a damp consistency and then packed into the hole while water was running out of it.
- d. Sheet metal plates were applied over the patched areas with expansion anchors. The anchors were noticed to be in 'soft' concrete as they were installed
- e. The sidewalk at grade level above the wall leak has subsided and cracked (Figure 7 and Figure 8).

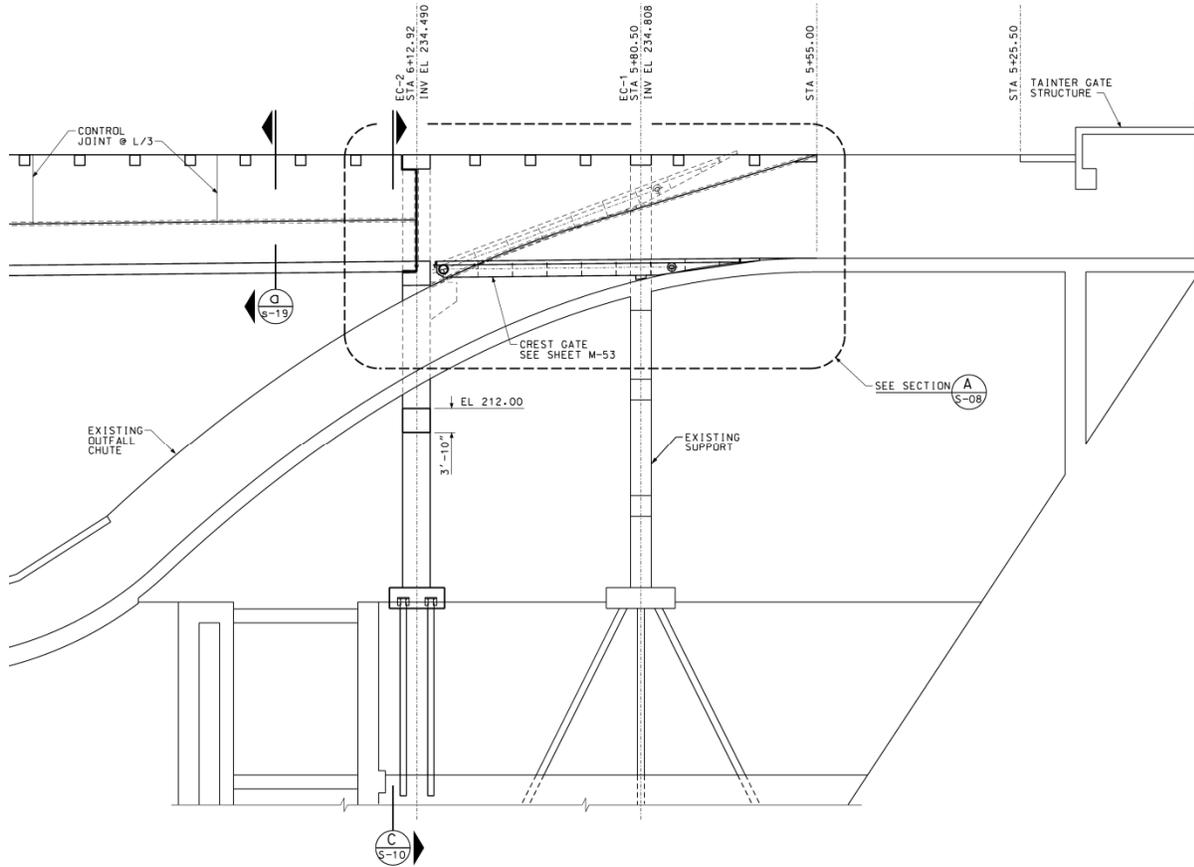
Figure 12 - Elevation of Chute Foundation System and SFL, JDF 2-10/17

The sidewalk immediately above the wall leak has cracked and sunk. Reference Figure 11. This is undoubtedly from the leak that has been carrying soil away from below the sidewalk into the fish ladder (internal erosion). At the time of the observation the water leaking through the wall was noted to be clear. It appears that at this time the sidewalk is the only structure that has been affected by internal erosion however, there is potential for other structures to experience settlement if this condition goes unchecked. The bottom of the spread footings supporting the columns of the elevated fish ladder (section 12 and 13) are above the leak elevation. The bottom of the leak is approximately at elevation 153'. The bottom of the footing in section 12 is at elevation 158' and the bottom of the footing in section 13 is at elevation 154'-6". The foundation for the juvenile bypass chute (immediately next to the subsided sidewalk) is pile supported. This foundation is labeled 'EC-2' in the Juvenile Fish Sampling and Monitoring Facility drawings from 1995 (Figure 12). The piles have a tip elevation of approximately 137'. The tip elevation is dependent upon the elevation of the top of sound, fresh, hard rock and should be verified with pile installation logs. Reference Figure 13 for pile embedment details and assumed top of rock elevations from the 1995 Juvenile Fish Sampling and Monitoring Facility contract drawings. It is unknown if any of these foundations have been undermined from internal erosion and should be monitored for future distress.

2. Monitor the ground area for future sink holes on a monthly basis.
3. Monitor the structures in the immediate area for signs of distress such as cracking, spalling and out of plumbness on a monthly basis.
