DEPARTMENT OF THE ARMY
SEATTLE DISTRICT, CORPS OF ENGINEERS
P.O. BOX 3755
SEATTLE, WASHINGTON 98124-3755

Subject: Plan of Study for 2008 Prototype Spill Test Uplift Investigation at Chief Joseph Dam

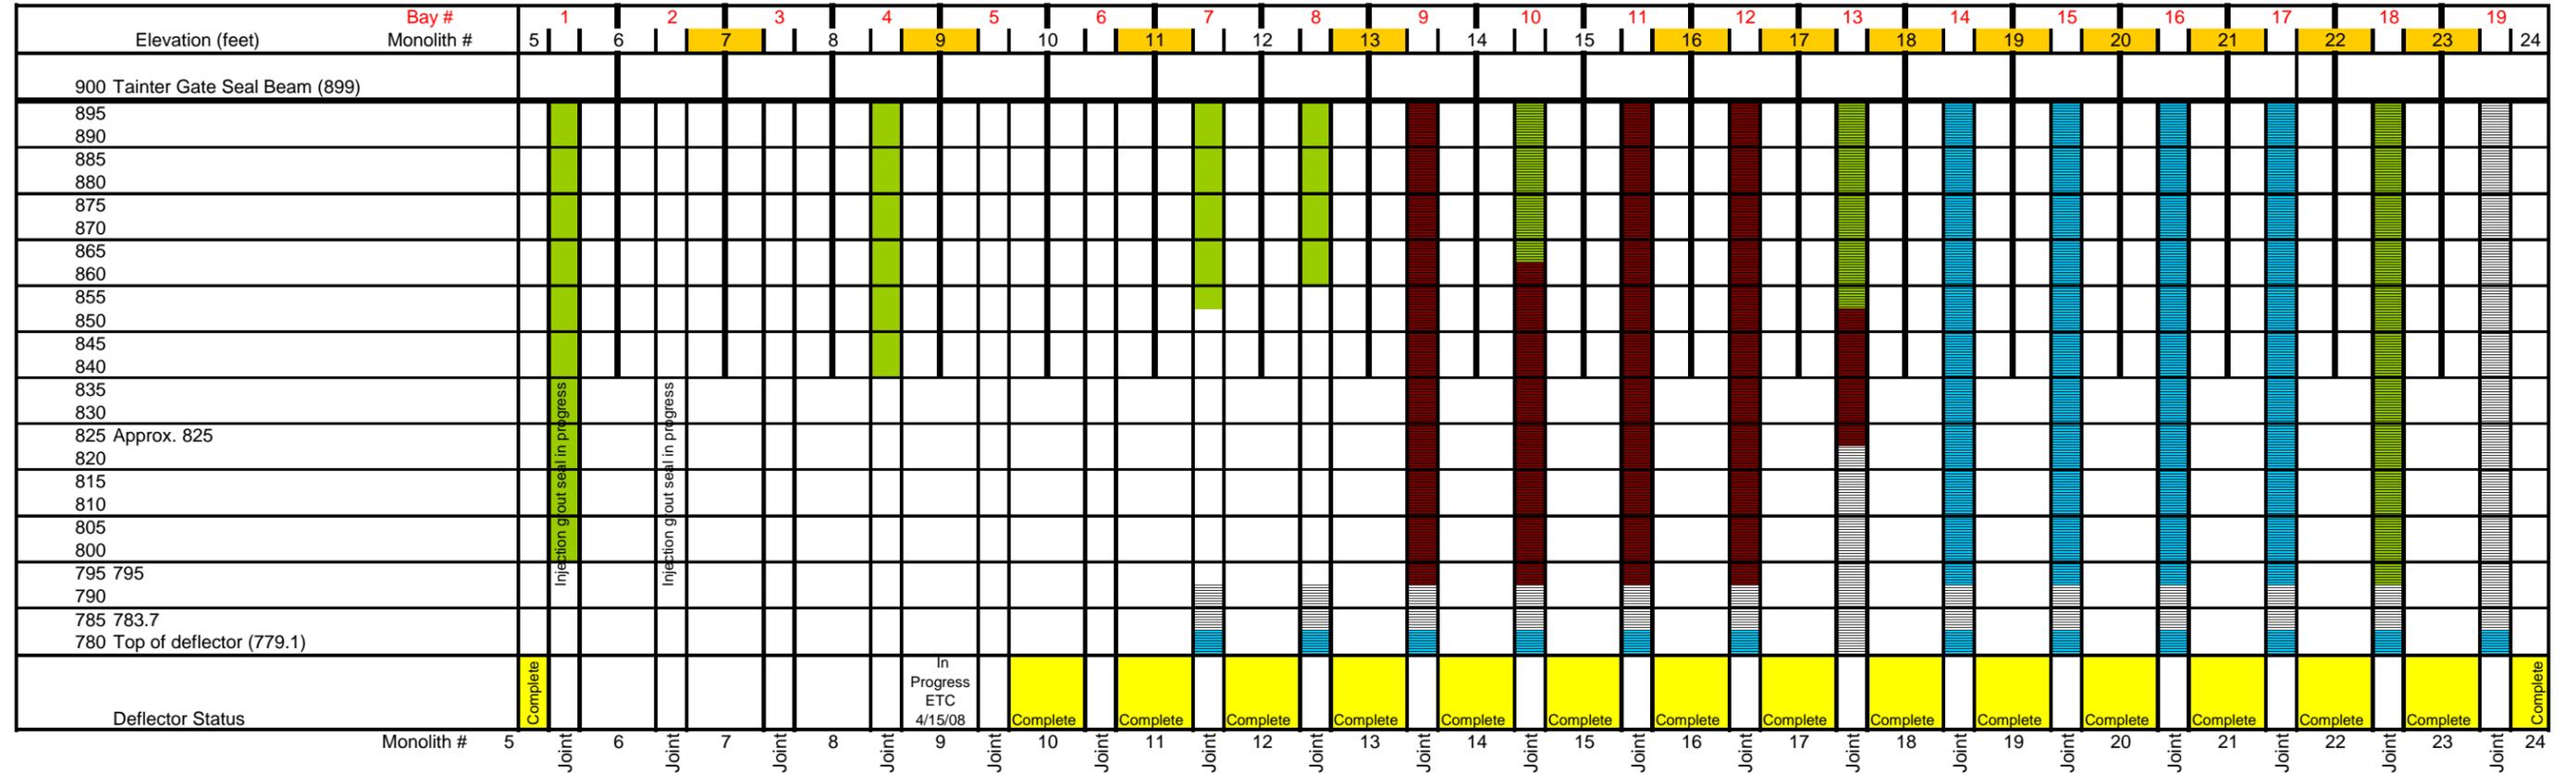
Monolith Joint Seal Condition Key

- = new surface seal in place (seal not shown if gap exists above seal in place)
 - = existing surface seal in place, varying condition (seal not shown if gap exists above seal in place)
 - = grout injection seal in place
 - = Surface seal missing (or discolored?) but injection grout present at surface (?) (seal not shown if gap exists above seal in place)
 - = old bituminous-cement seal present only
- =monoliths with uplift instrumentation other than beneath drainage and grouting gallery

6. Condition of Spillway in Monoliths 16, 17, and 18 under Gates 12 and 13.
