## 2002 TDG TMDL Load Allocation Compliance Locations

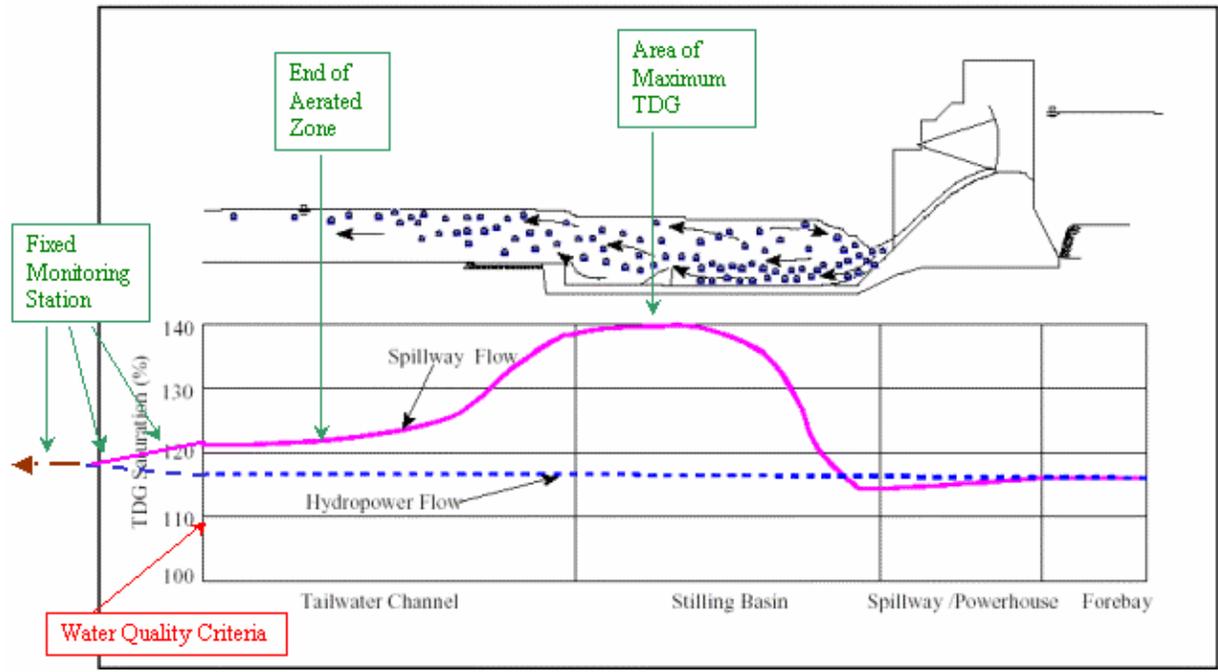
**Figure 21, 2002 TDG TMDL: Possible locations of Compliance Locations with Respect to TDG Levels**

1. Tailrace monitors are not reflective of their identified 2002 TDG TMDL load allocation locations at the edge of the aerated zone. Bonneville tailrace is located too close, while the other tailrace monitors are located to far downstream.
2. The method of measuring the tailrace monitor distance from the dam is inconsistent, for example Bonneville Dam tailrace monitor is 450 yards or. 200 yards downstream of the dam- depending on the source. There needs to be a consistent method of measuring the tailrace monitor distance from a dam. The 2002 TDG TMDL for the Lower Columbia River states: “The point of compliance for load allocations for the dams in this TMDL will be based on application of the mixing zone to the aerated zone immediately below the spillways of the dams.”
