**USACE Portland District (NWP) FFDRWG Update Form  
23 April 2015**

Project Title	B2 AWS Fish Unit Trash Rake Improvements
SCT Reference Number	
Project Manager (PM)	Eric Stricklin (NWP, 503-808-4757)
Technical Lead (TL)	Ben Filan (NWP, 503-808-4925)
Biologist/Coordination	Jon Rerecich (NWP, 503-808-4779)

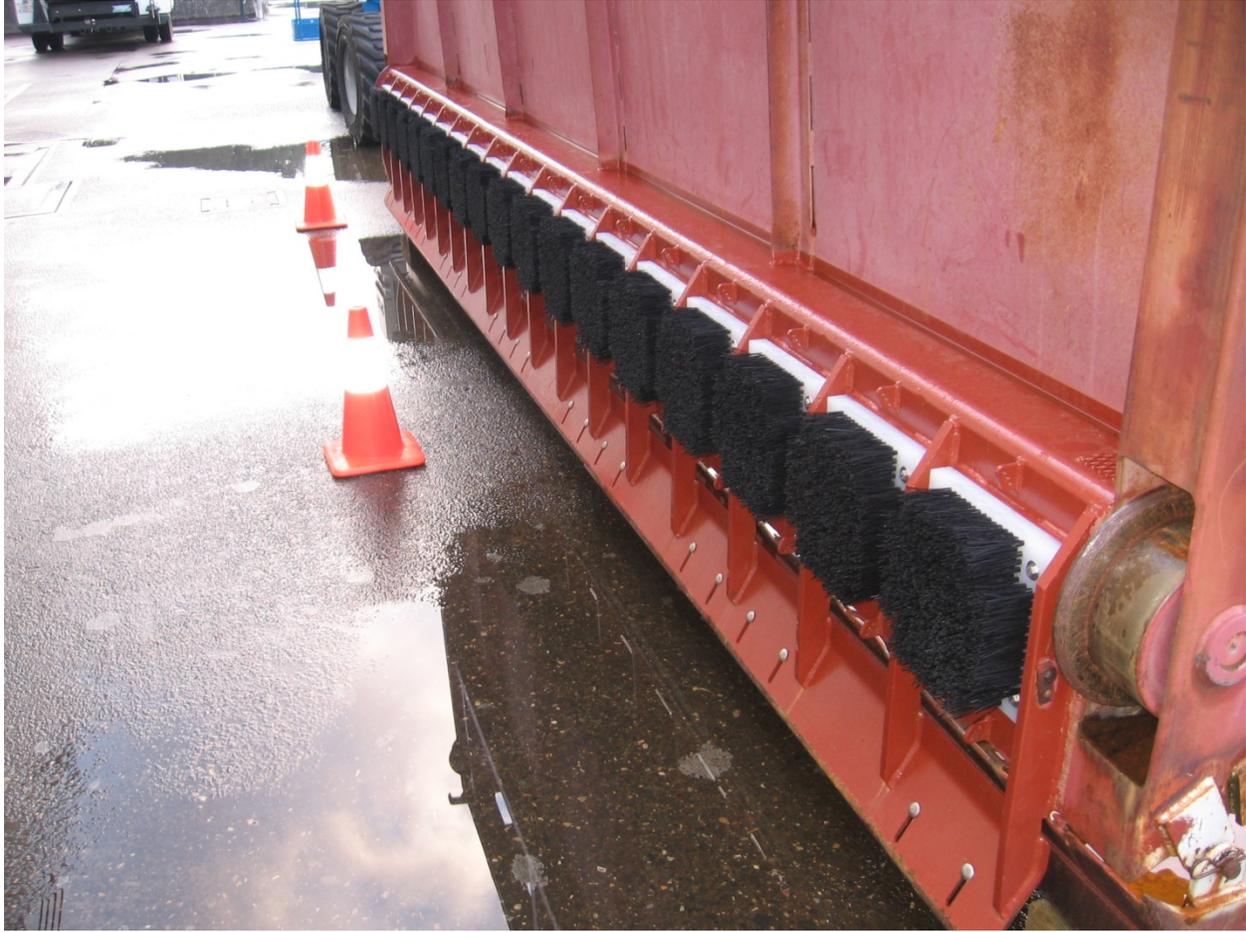
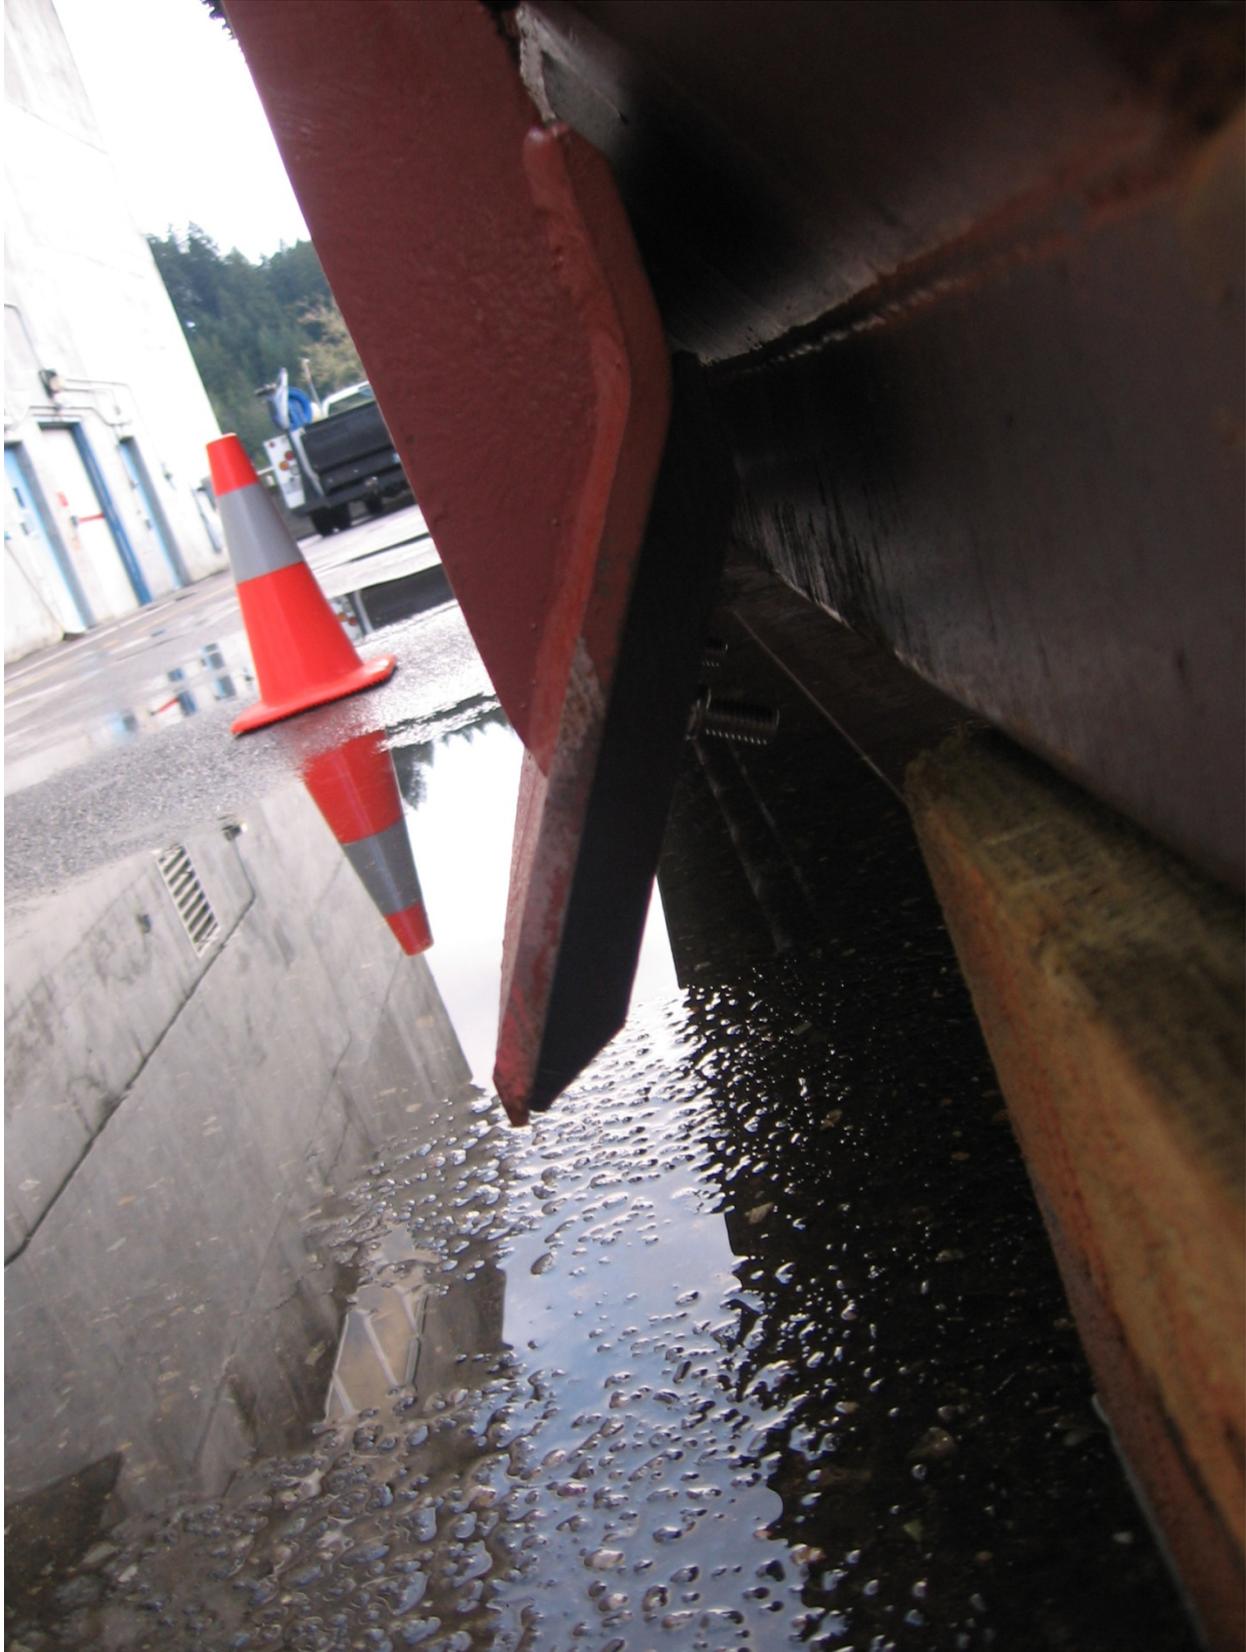
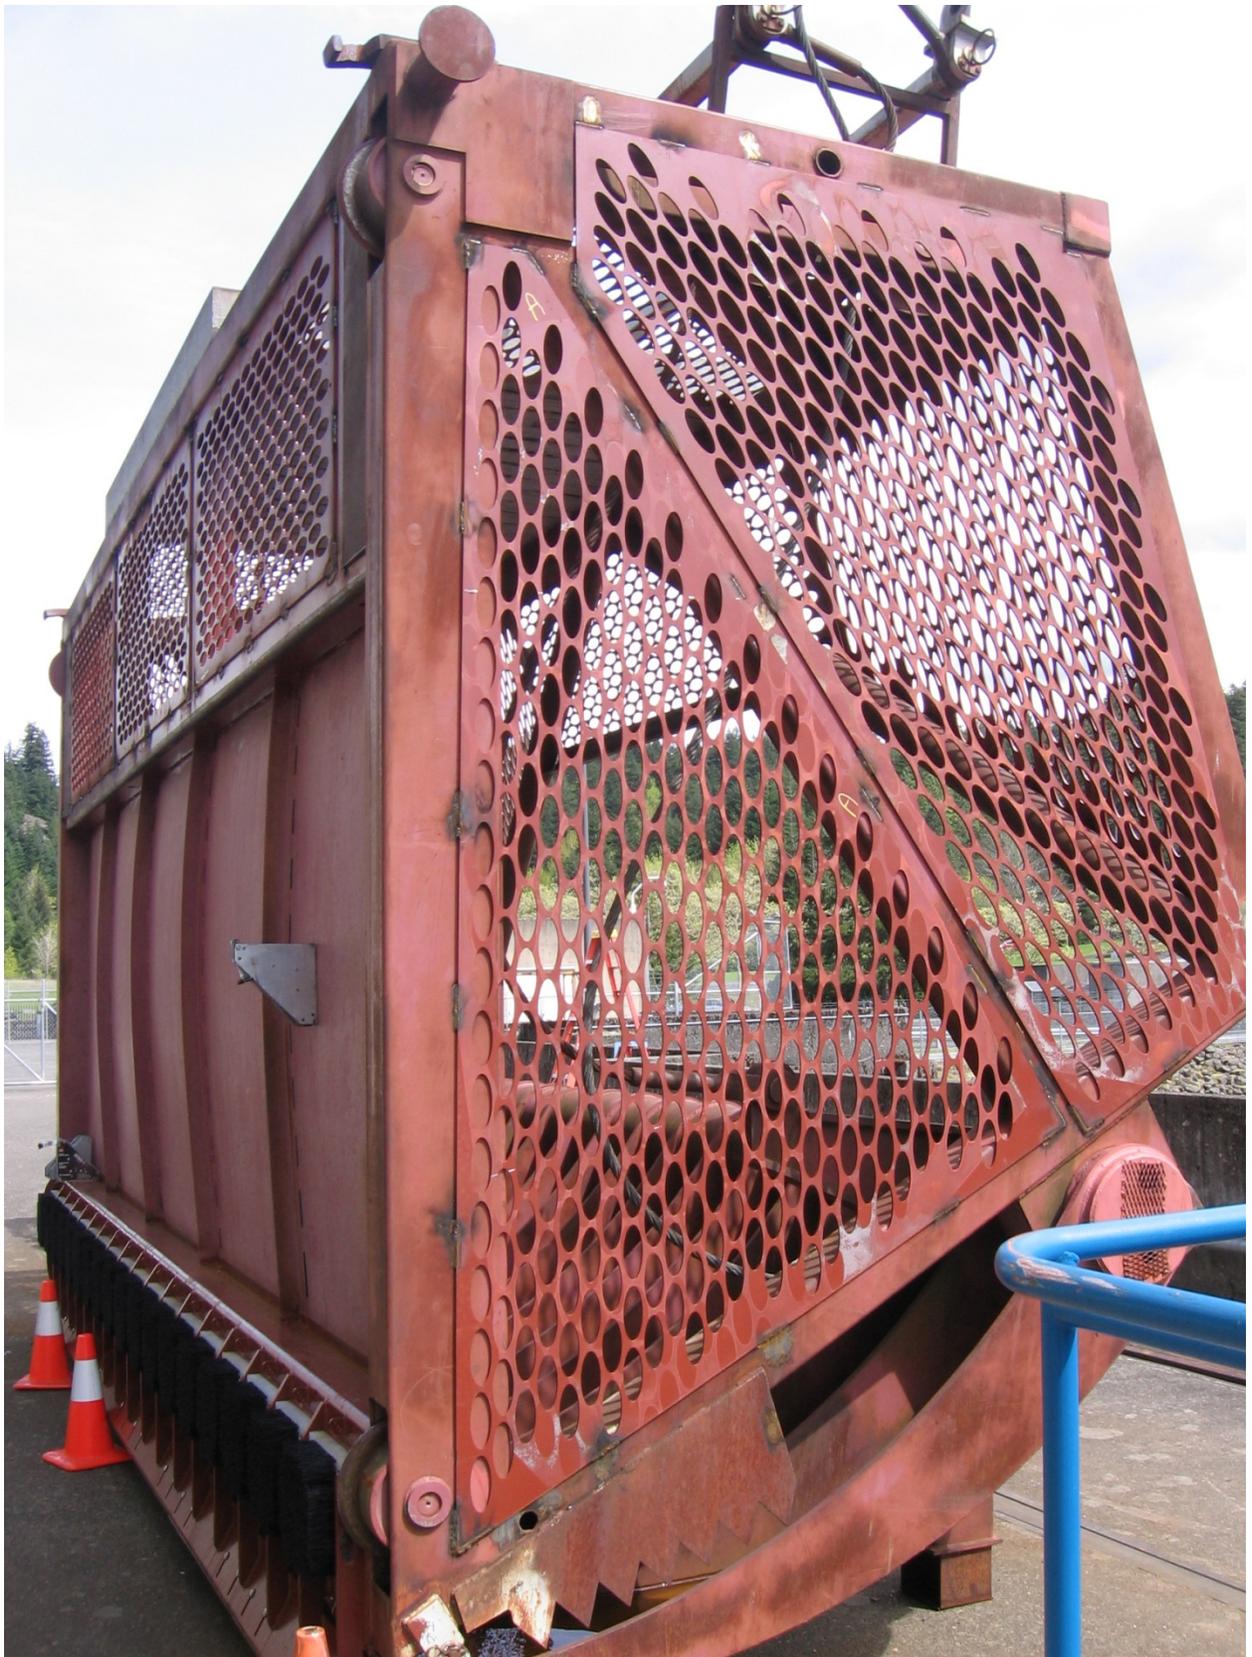
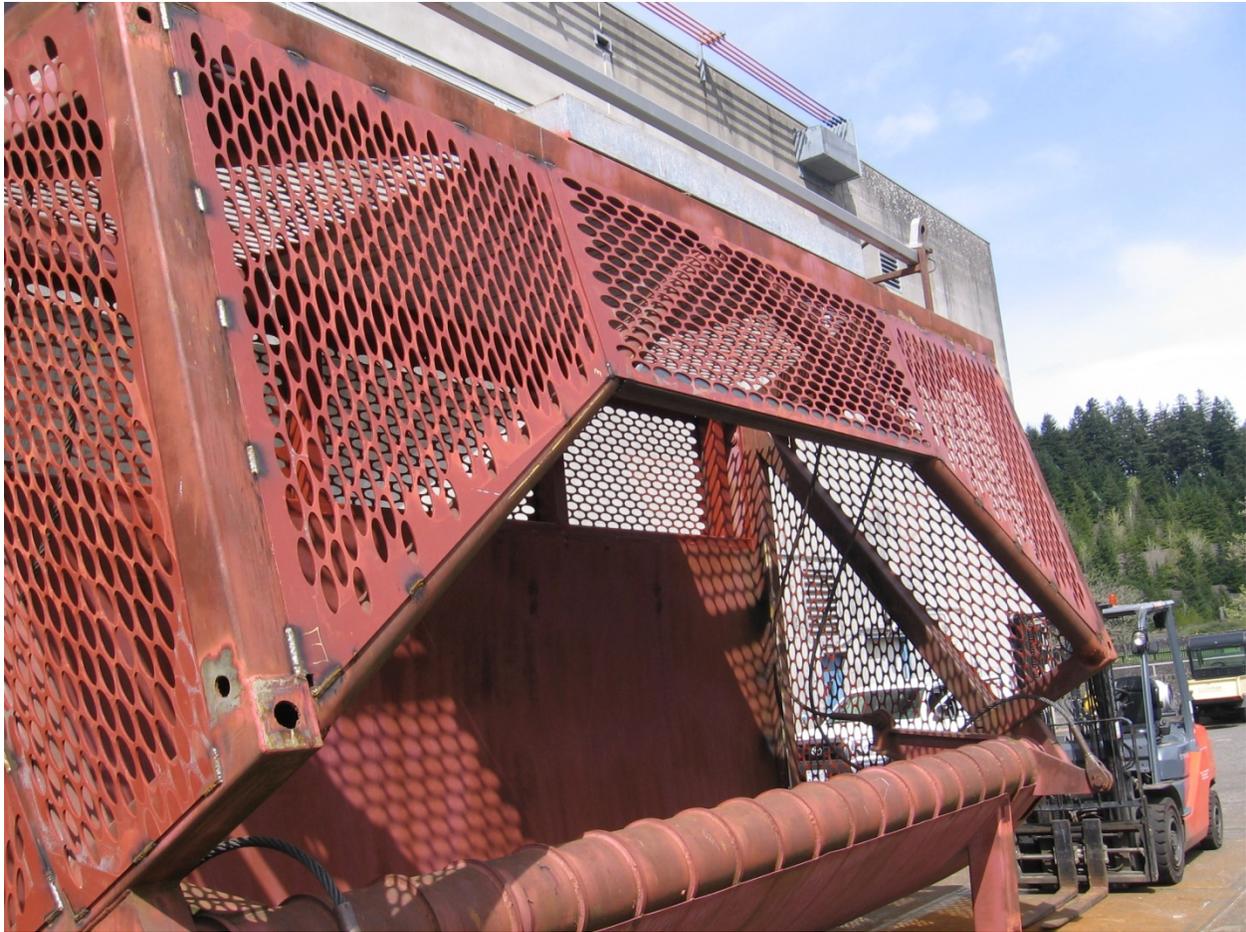
Photos of what the project has done to date.

Update from BON project – Brushes, cap plate, and UHMW plate, and perforated plate have been installed. ROV will be used to fine tune adjustments to the UHMW plate. Perforated plate to contain debris was installed on 9 April. Still needs a few stitch welds on the top mounted perforated plate and final touchup painting on welds. Rake should be completed and ready for use by 23 April 2015.
