MEMORANDUM FOR THE RECORD

SUBJECT: 14BON37 MFR – Sockeye Salmon and Pacific Lamprey mortalities at Bonneville's Cascades Island picket leads.

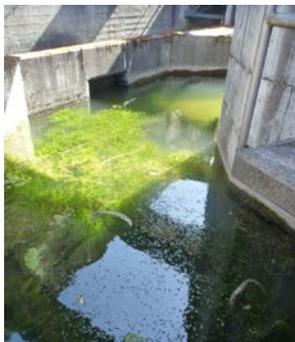
Picture 1:

On 17 July 2014, a U of I researcher alerted Bonneville Project Fisheries that there were Pacific Lamprey mortalities in the Cascades Island exit section. Upon inspection, four lamprey mortalities were found floating in the Cascades Island exit section (picture 1), all severely decomposed; roughly two dozen lamprey mortalities of varying decomposition were found on the picket leads, the majority on the lower (downstream) leads (picture 2); and one decomposed sockeye salmon was recovered from the upstream picket leads (picture 3).

- A. Species – Pacific Lamprey (*Entosphenus tridentatus*) and sockeye salmon (*Oncorhynchus nerka*)
- B. Origin – Unknown
- C. Length – PL : unknown, SOC: 31 cm.
- D. Marks and tags – PL: unknown, SOC: no tags.
- E. Marks and Injuries found on carcass – Unknown.
- F. Cause and Time of Death – Lamprey mortalities likely occurred over an extended period of time, collecting on the lower picket leads. Sockeye mortality was probably due to an overhead picket lead gap discovered on 26 June.
- G. Future and Preventative Measures – During winter maintenance, the lower picket leads will be further modified to completely exclude lamprey from the upper Cascades Island exit section. The overhead picket lead gap has been screened.

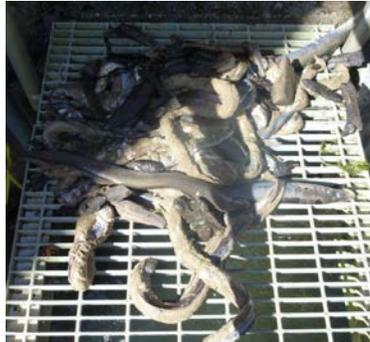
Picture 2:

Project Biologists believe that the lamprey mortalities have occurred throughout the season and collect on the lower picket leads, which have not been recently checked by project personnel. Additionally, these lower set of leads were recently modified to reduce the spacing between the pickets from ~1" down to ¾" to exclude lamprey from the upper Cascades Island section. During a recent dewatering it was discovered that gaps remain on the bottom and some sides of the new leads, still allowing lamprey to egress above the leads, but the reduced spacing likely makes it more efficient at collecting mortalities. Also, after the middle section of new picket leads was placed, an overhead gap allowed several adult salmonids to jump over that lead and into the upper exit section of Cascades Island; the ladder exit was opened, the gap was screened, and an emergency dewatering of the Cascades Island exit section occurred on 01 July. The sockeye mortality is likely a holdover from that incident.
