# **Appendix A**

## **2014 Total Dissolved Gas Fixed Monitoring Stations**

**Updated November 2014**

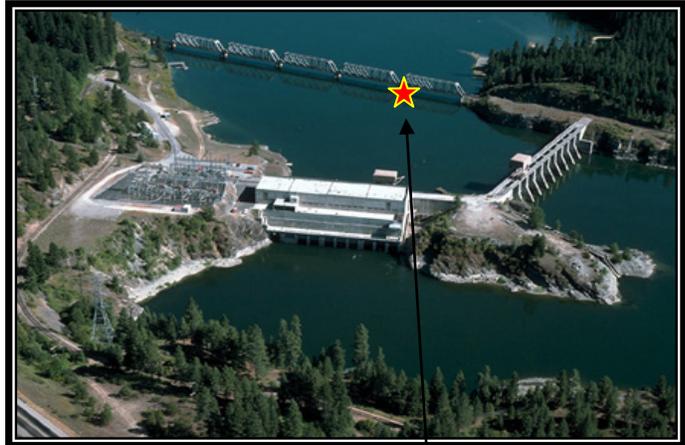
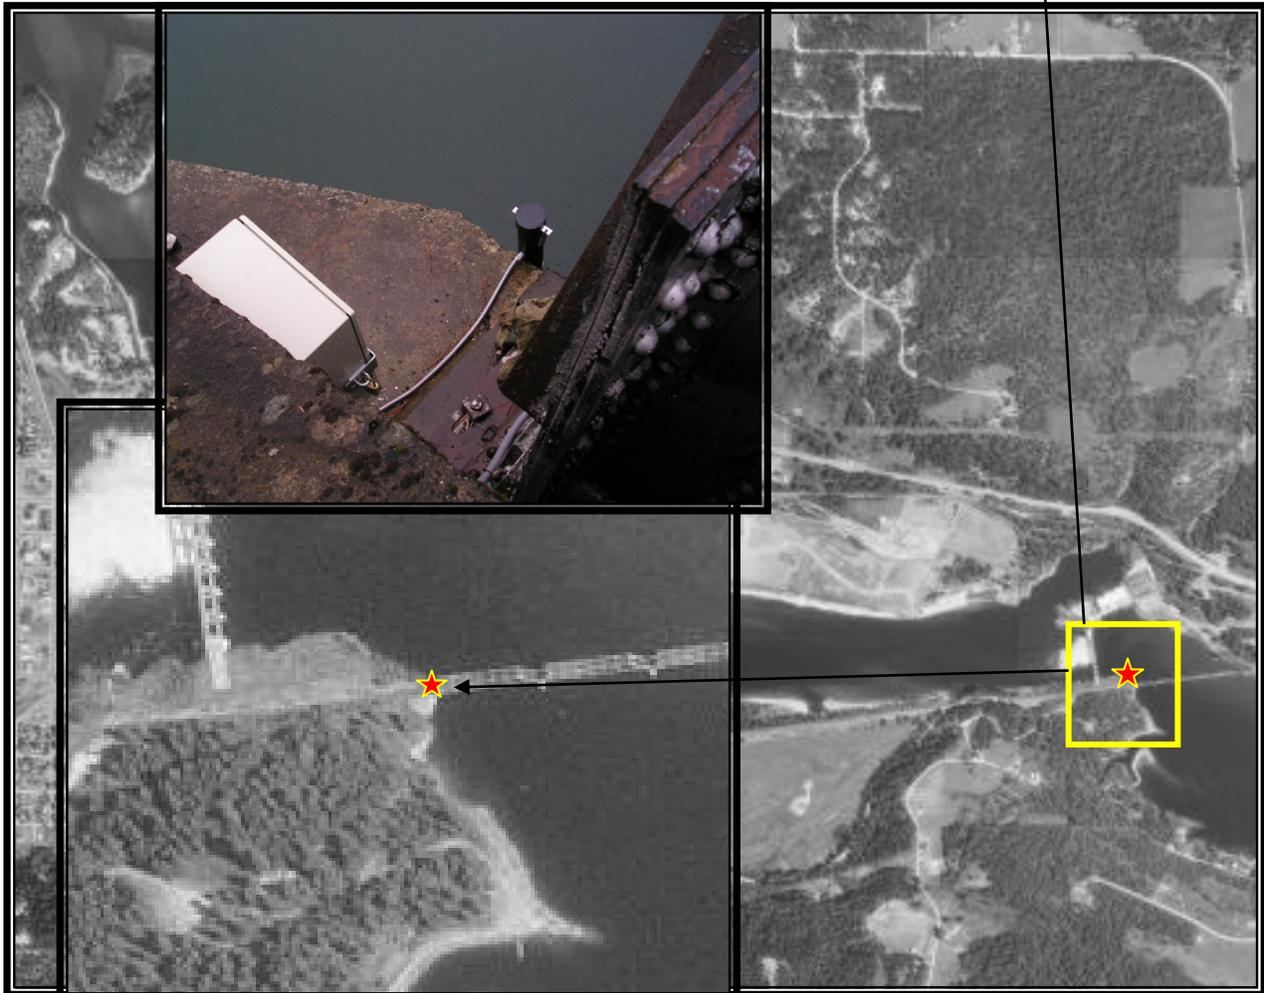
## 1. Albeni Falls Forebay TDG Monitoring Station (ALFI)

**Gauge Elevation:** Fixed  
**Latitude:** 48° 10' 40.2" N  
**Longitude:** 116° 59' 52.3" W  
**Distance from Dam:** --  
**Datum:** NAD83  
**River:** Pend Oreille  
**River Mile:** 87.0  
**USGS-ID:** --  
**Owner:** U.S. Army Corps of Engineers-NWS  
**Gauge Type:** Hydrosonde  
**Data Transmission:** Radio Transmission  
**Dates of Operation:** April 1– August 31\*  
**Years of Operation:** 2004 – Present  
**Water Conditions:** Mixed  
**Location:** Attached to the railroad bridge pier on the southern shoreline of the Pend Oreille River  
**This gauge replaced:** N/A  
**Reasons for replacement:** N/A  
**Comments:** \* The seasonal gauges may go in several weeks before April 1 and remain in operation several weeks after August 31.

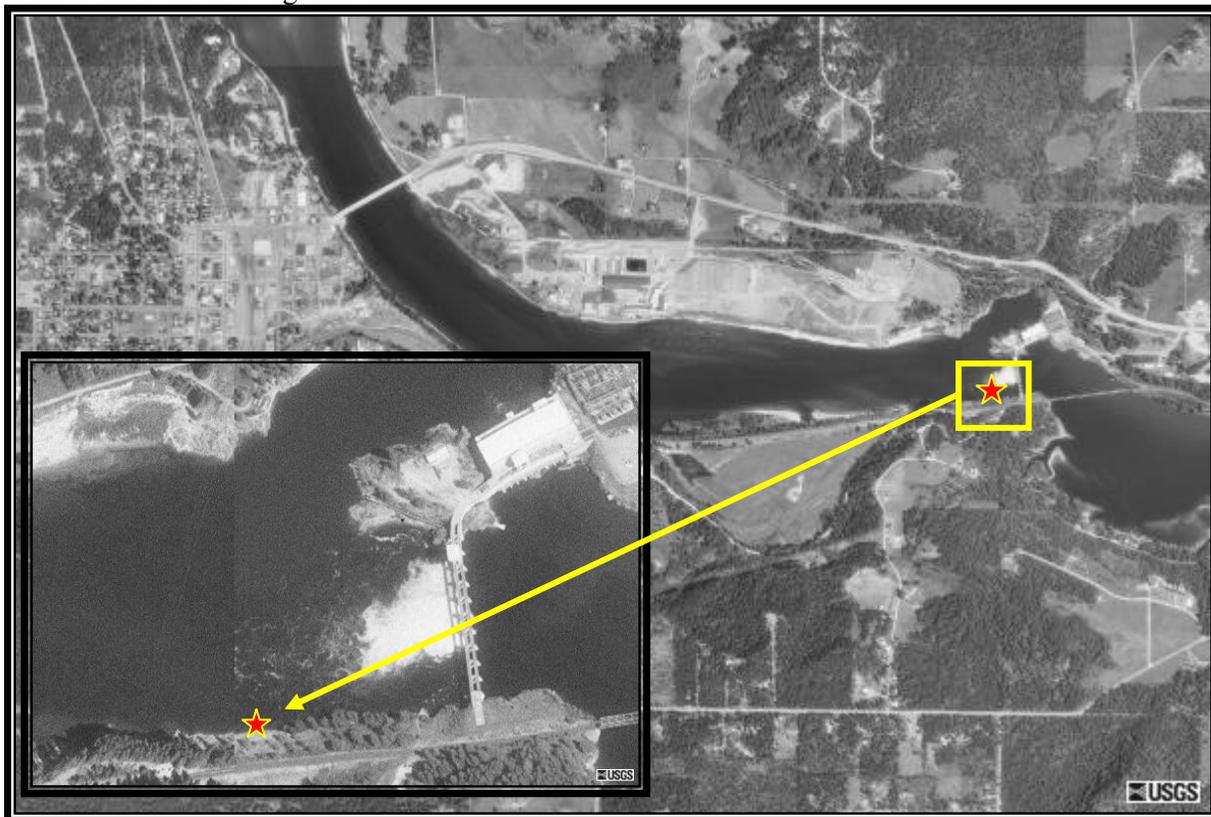
## 2. Albeni Falls Tailwater TDG Monitoring Station (ALQI)

**Location:** On the southern shoreline of the Pend Oreille River.

**Reasons for replacement:** This gauge was initiated at this site on July 28, 2005 due to sediment burying the previous site several times. This newer location is immediately below the spillway aerated zone in deeper water which should minimize sedimentation problems.

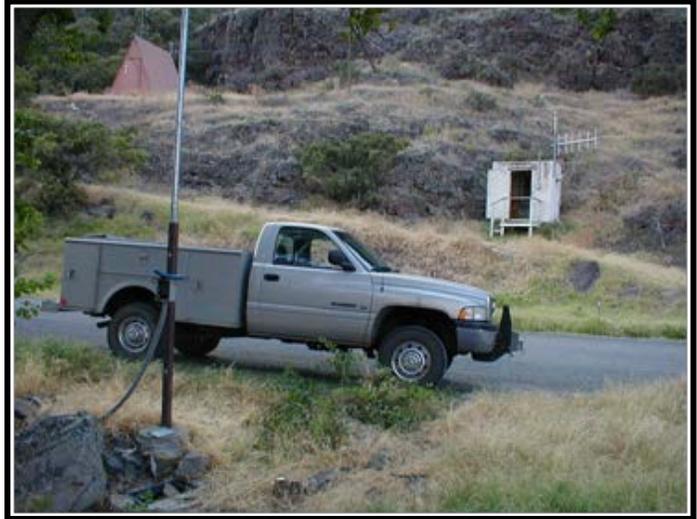
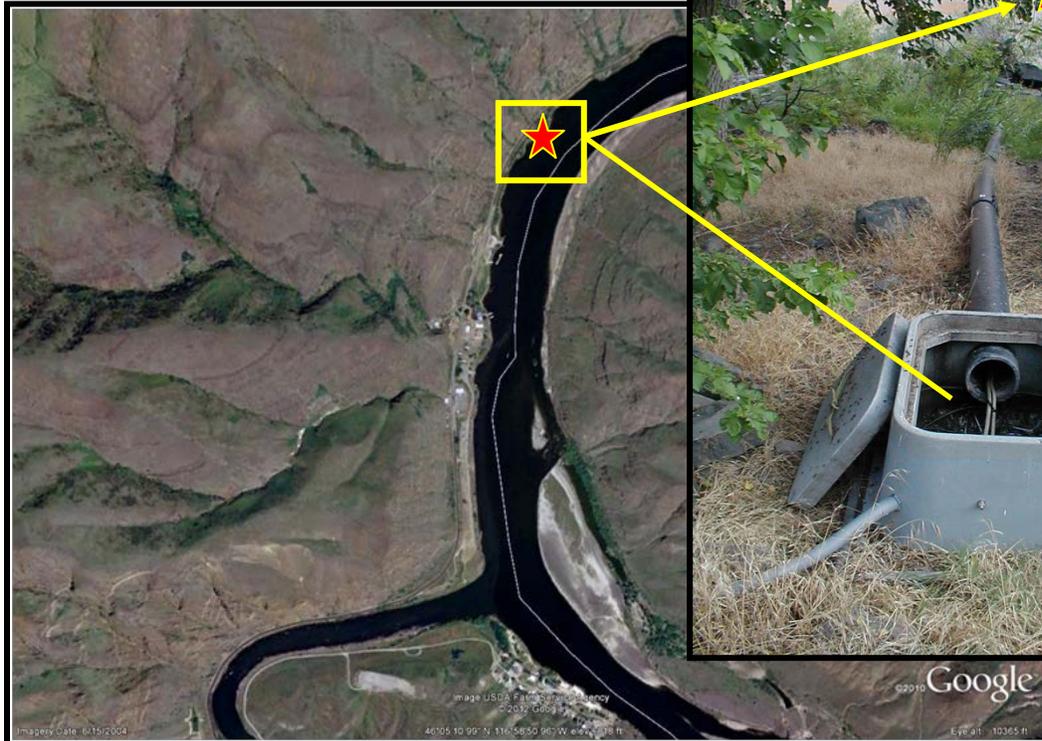
### 3. Anatone TDG Monitoring Station on the Snake River (ANQW)

**Location:** This gauge is located on the Washington shoreline of the Snake River approximately 1.3 miles downstream of the Grande Ronde River confluence. It is co-located with the USGS Anatone Stream gauge (ANAW).

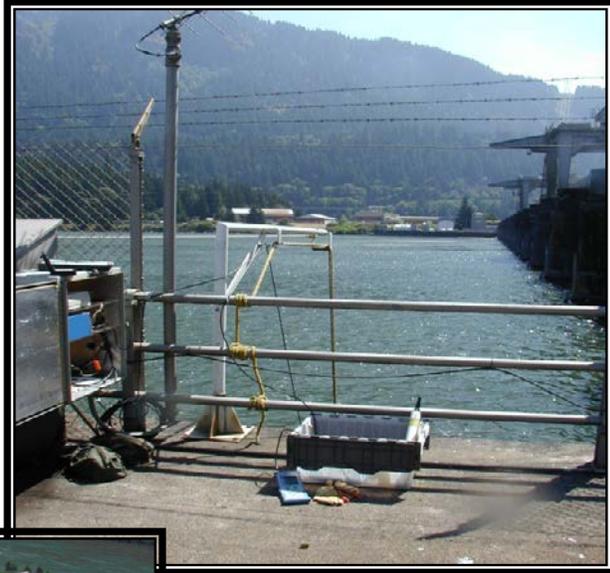
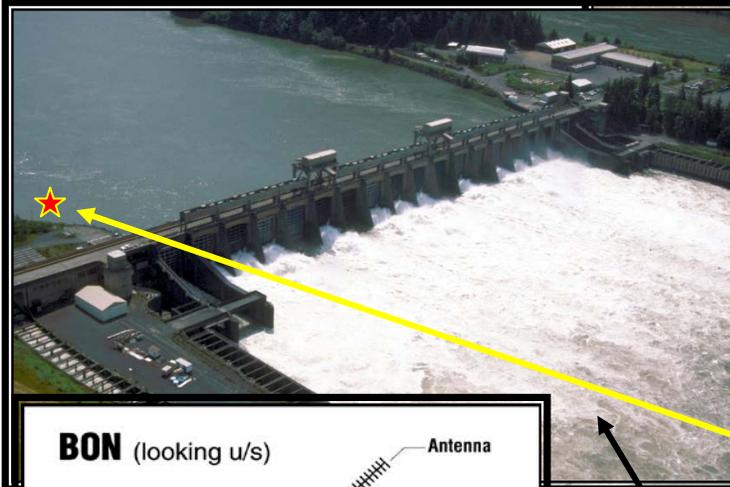
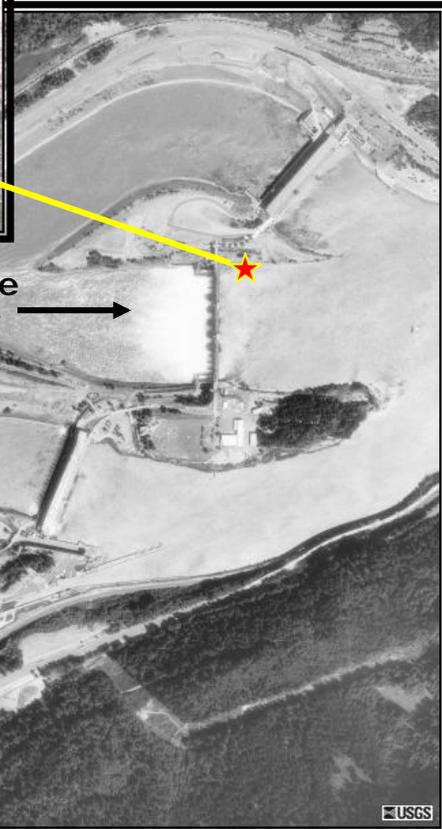
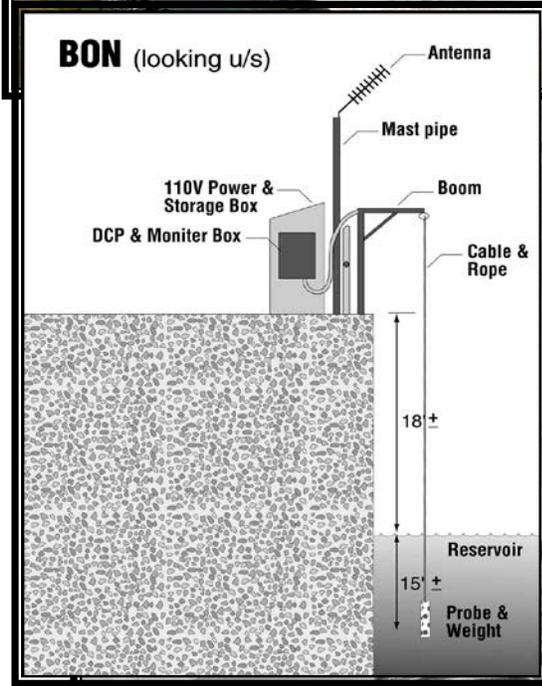
#### 4. Bonneville Forebay TDG Monitoring Station (BON)

**Gauge Elevation:** Fixed  
**Latitude:** 45° 38' 44.42147" N  
**Longitude:** 121° 56' 24.29279" W  
**Distance from Dam:** On face of dam  
**Datum:** NAD83  
**River:** Columbia  
**River Mile:** 146.1  
**USGS-ID:** 453845121562000  
**Owner:** U.S. Army Corps of Engineers-NWP  
**Gauge Type:** Hydrosonde  
**Data Transmission:** GOES Satellite  
**Dates of Operation:** April 1 – August 31\*  
**Years of Operation:** 1986 – Present  
**Water Conditions:** Mixed  
**Location:** On the northern side of the spillway channel on Cascade Island just upstream of Spillbay #1.  
**This gauge replaced:** N/A  
**Reason for replacement:** N/A  
**Comments:** \*The seasonal gauges may go in several weeks before April 1 and remain in operation several weeks after August 31.

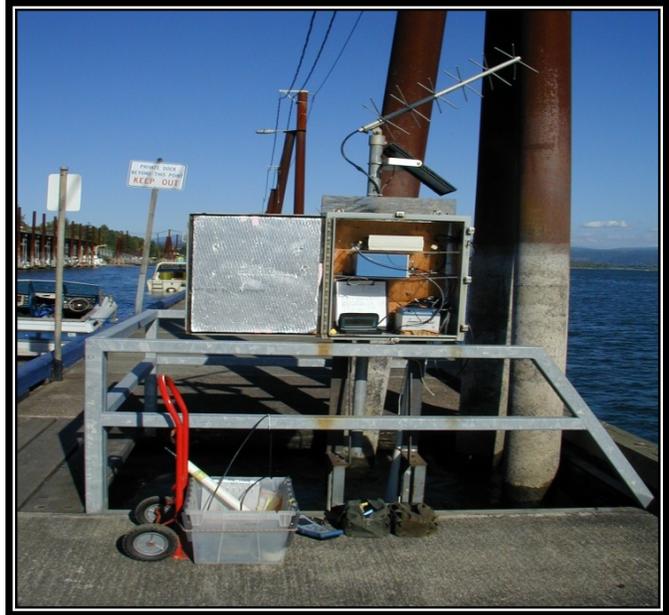
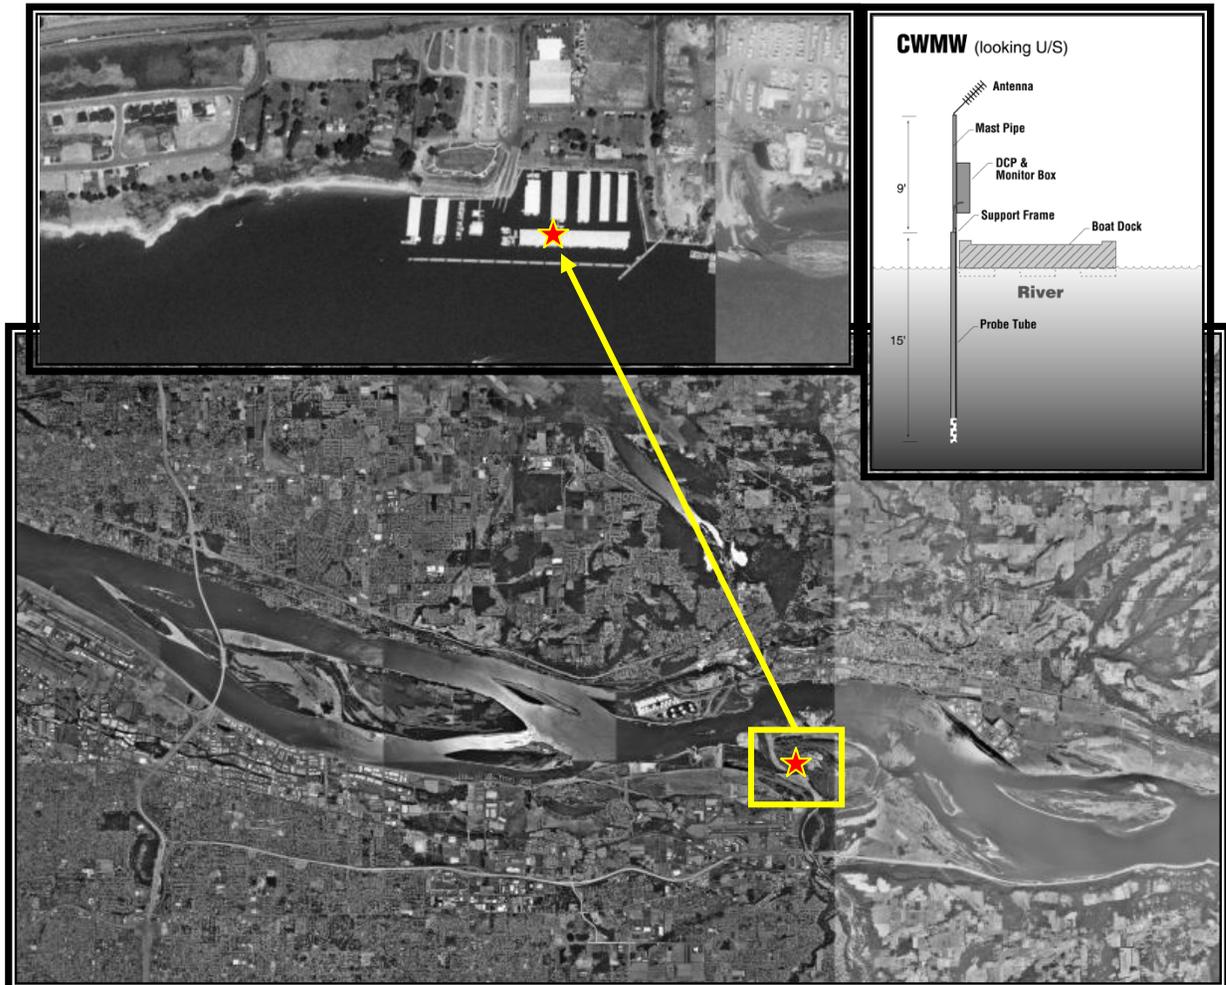
## 5. Camas-Washougal TDG Monitoring Station (CWMW)

**Gauge Elevation:** Variable  
**Latitude:** 45° 34' 38.42788" N  
**Longitude:** 122° 22' 43.32961" W  
**Distance from Dam:** 24 miles downstream from Bonneville  
**Datum:** NAD83  
**River:** Columbia  
**River Mile:** 121.7  
**USGS-ID:** 453439122223900  
**Owner:** U.S. Army Corps of Engineers-NWP  
**Gauge Type:** Hydrosonde  
**Data Transmission:** GOES Satellite  
**Dates of Operation:** April 1 – August 31\*  
**Years of Operation:** 1993 – Present  
**Water Conditions:** Mixed  
**Location:** Attached to the boat dock at the outer edge of the harbor at the Port of Camas/Washougal, WA  
**This gauge replaced:** N/A  
**Reason for replacement:** N/A  
**Comments:** This gauge is currently being utilized as a surrogate forebay gauge for the management of spill at Bonneville Dam.

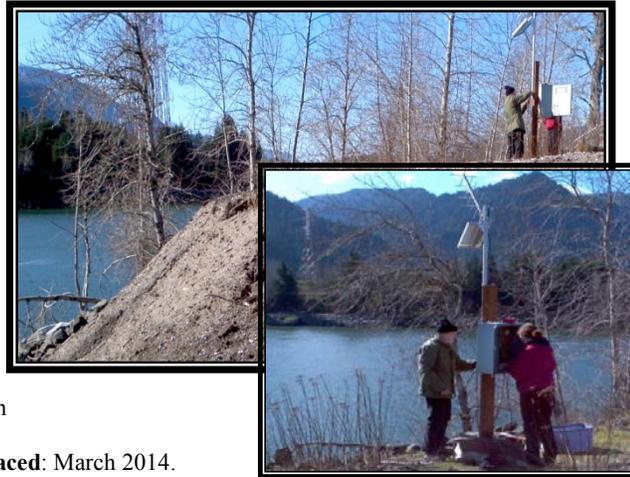
## 6. Cascades Island TDG Monitoring Station (CCIW)

**Gauge Elevation:** Fixed  
**Latitude:** 45° 38' 44.42143" N  
**Longitude:** 121° 56' 44.29340" W  
**Distance from Dam:** 0.27 miles (1400 ft)  
**Datum:** NAD83  
**River:** Columbia  
**River Mile:** 145.9  
**USGS-ID:** 453845121564001  
**Owner:** U.S. Army Corps of Engineers-NWP  
**Gauge Type:** Hydrosonde  
**Data Transmission:** GOES Satellite  
**Dates of Operation:** April 1 – August 31\*  
**Years of Operation:** 2004 – Present  
**Water Conditions:** Spillway  
**Location:** Within the Bonneville Dam spillway channel on Cascade Island.

**Reason for replacement:** Old gauge destroyed due to high velocity flows.

**Comments:** Became the spill management gauge as of 2004. Location of station moved to higher elevation.

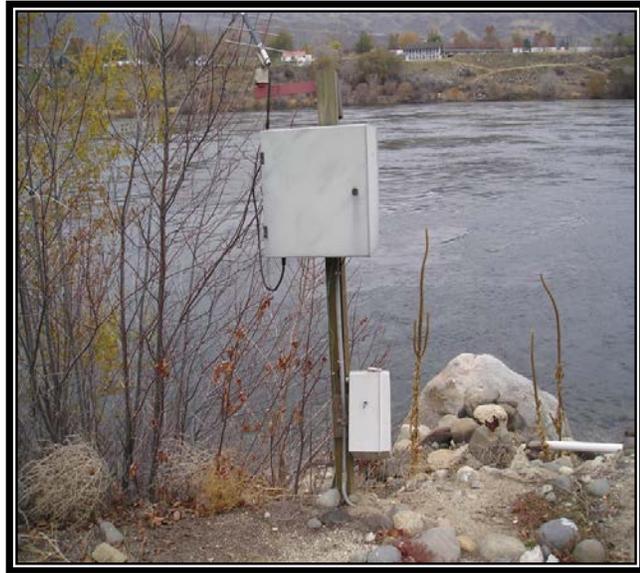
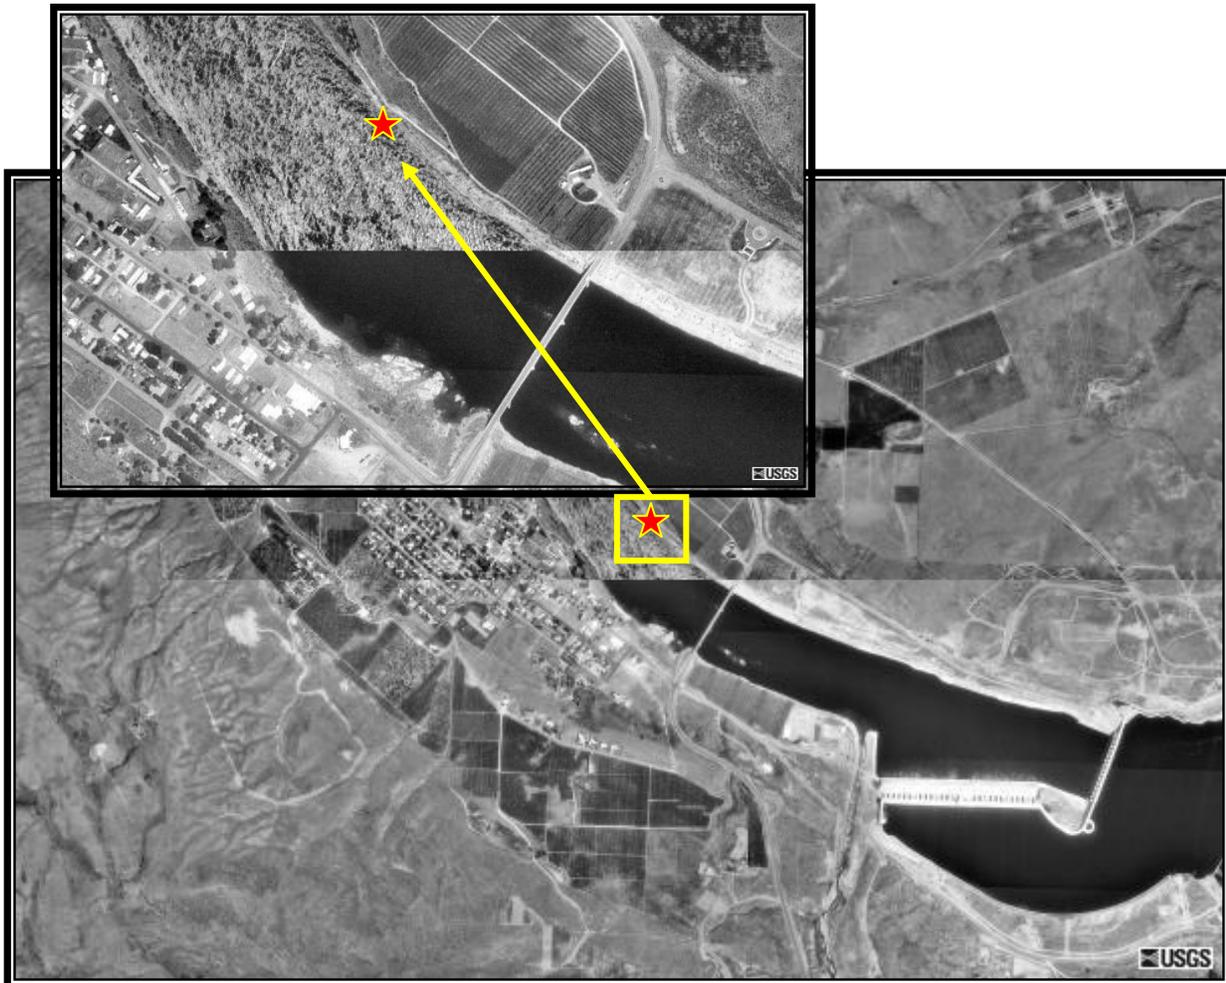
## 8. Chief Joseph Tailwater TDG Monitoring Station (CHQW)

**Gauge Elevation:** Fixed  
**Latitude:** 48° 00' 17.2" N  
**Longitude:** 119° 39' 30.3" W  
**Distance from Dam:** 1 mile  
**Datum:** NAD83  
**River:** Columbia  
**River Mile:** 543.8  
**USGS-ID:** --  
**Owner:** U.S. Army Corps of Engineers-NWS  
**Gauge Type:** Hydrosonde  
**Data Transmission:** GOES Satellite  
**Dates of Operation:** April 1 – Aug 31\*  
**Years of Operation:** 1985 – Present  
**Water Conditions:** Spillway  
**Location:** North bank of the river, just downstream of the Highway 17 Bridge.  
**This gauge replaced:** N/A  
**Reason for gauge replacement:** N/A  
**Comments:** \*The seasonal gauges may go in several weeks before April 1 and remain in operation several weeks after August 31.

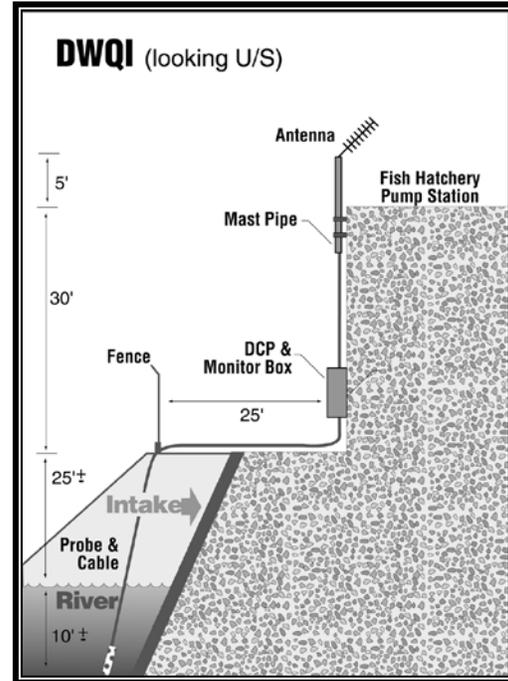
## 9. Dworshak TDG Monitoring Station (DWQI)

**Gauge Elevation:** Fixed  
**Latitude:** 46° 30' 11.6464" N  
**Longitude:** 116° 19' 16.4090" W  
**Distance from Dam:** 1.5 miles  
**Datum:** NAD83  
**River:** North Fork, Clearwater River  
**River Mile:** 0.5  
**USGS-ID:** 13341000  
**Owner:** U.S. Army Corps of Engineers-NWW  
**Gauge Type:** Hydrosonde  
**Data Transmission:** GOES Satellite  
**Dates of Operation:** Year round  
**Years of Operation:** 1993 - Present  
**Water Conditions:** Mixed  
**Location:** On the southern bank of the North Fork, Clearwater River between the bridge and the U.S. Fish and Wildlife Service Fish Hatchery outflow pipe.  
**This gauge replaced:** N/A  
**Reason for replacement:** N/A  
**Comments:** --

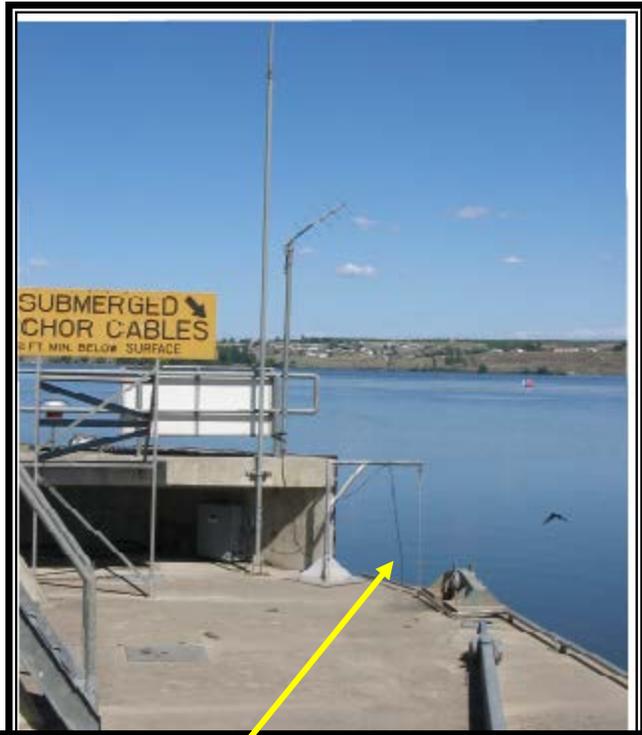
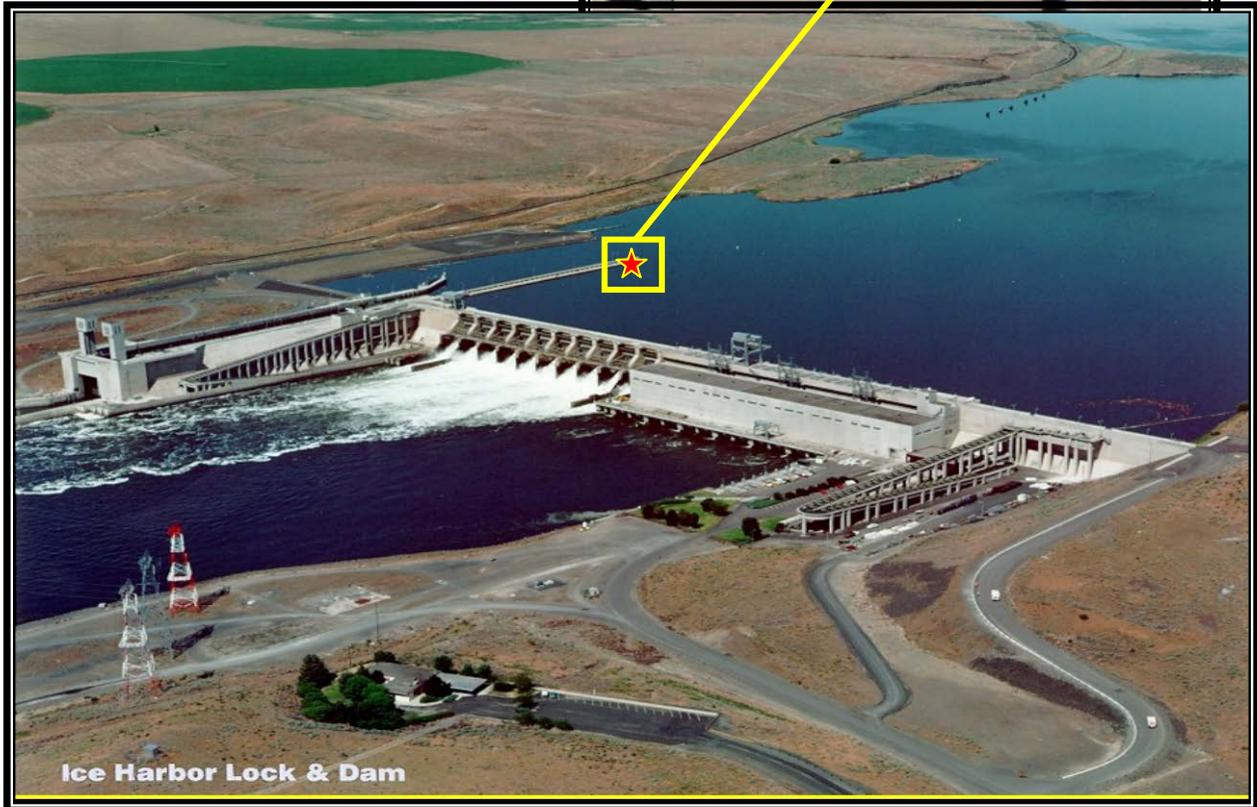
## 10. Ice Harbor Forebay TDG Monitoring Station (IHRA)

**Gauge Elevation:** Fixed  
**Latitude:** 46° 15' 5.2792" N  
**Longitude:** 118° 52' 43.0096" W  
**Distance from Dam:** 695 ft  
**Datum:** NAD83  
**River:** Snake  
**River Mile:** 10.2  
**USGS-ID:** 13352950  
**Owner:** U.S. Army Corps of Engineers-NWW  
**Gauge Type:** Hydrosonde  
**Data Transmission:** GOES Satellite  
**Dates of Operation:** Was year round prior to 2006, now seasonal (April 1 – Aug. 31\*).  
**Years of Operation:** 2005 – Present.  
**Water Conditions:** Mixed  
**Location:** At the upstream end of the navigation lock guidewall.  
**This gauge replaced:** IHR  
**Reason for replacement:** Moved due to thermal influences and lowered from 15 ft to 45 ft.  
**Comments:** \*The seasonal gauges may go in several weeks before April 1 and remain in operation several weeks after August 31.

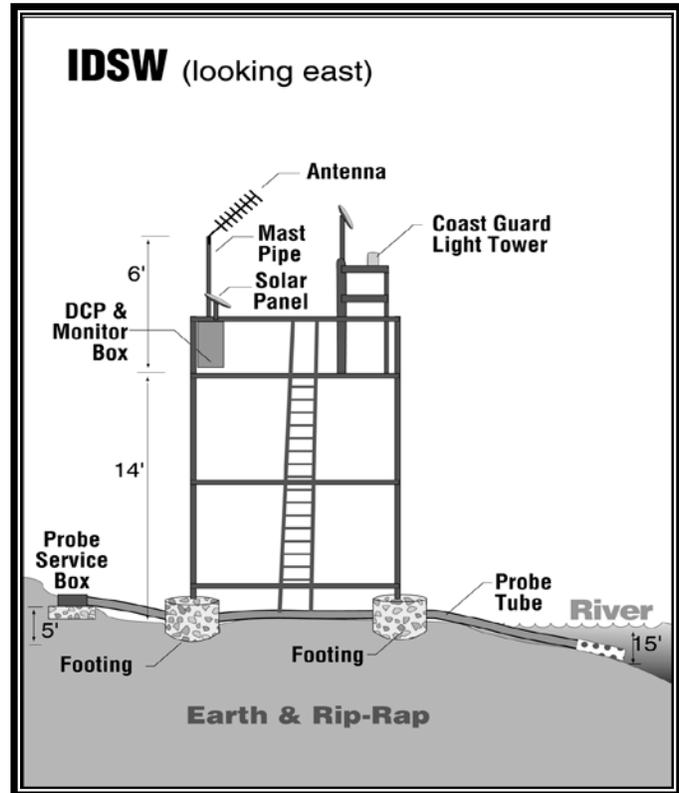
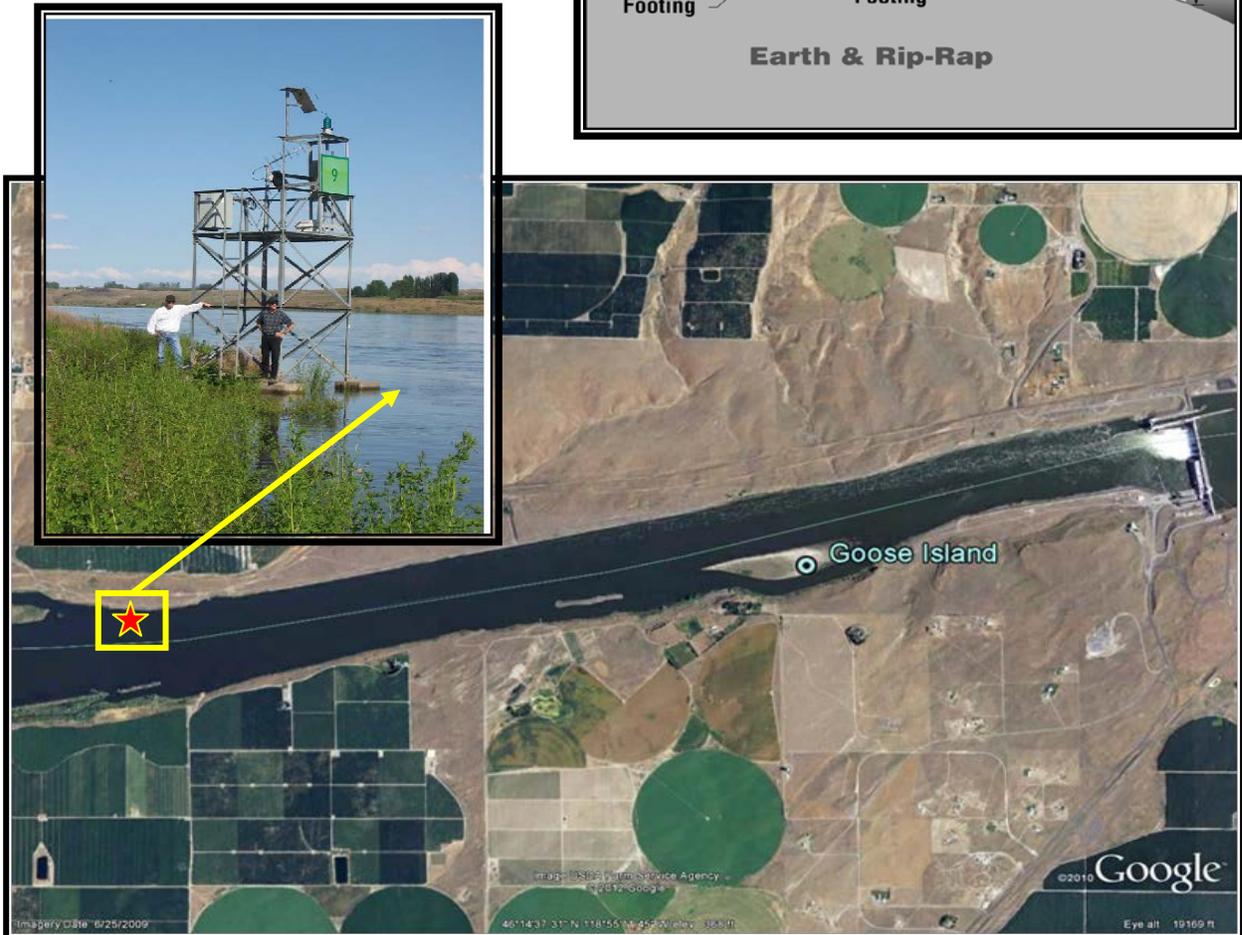
## 11. Ice Harbor Tailwater TDG Monitoring Station (IDSW)

**Gauge Elevation:** Fixed  
**Latitude:** 46° 14' 27.5868" N  
**Longitude:** 118° 57' 13.7130" W  
**Distance from Dam:** 3.6 miles  
**Datum:** NAD83  
**River:** Snake  
**River Mile:** 6.1  
**USGS-ID:** 13353010  
**Owner:** U.S. Army Corps of Engineers-NWW  
**Gauge Type:** Hydrosonde  
**Data Transmission:** GOES Satellite  
**Dates of Operation:** Was seasonal prior to 2006, now year round.  
**Years of Operation:** 1994 – Present.  
**Water Conditions:** Mixed & spillway  
**Location:** On the northern shore of the Snake River  
**This gauge replaced:** N/A  
**Reason for replacement:** N/A  
**Comments:** --

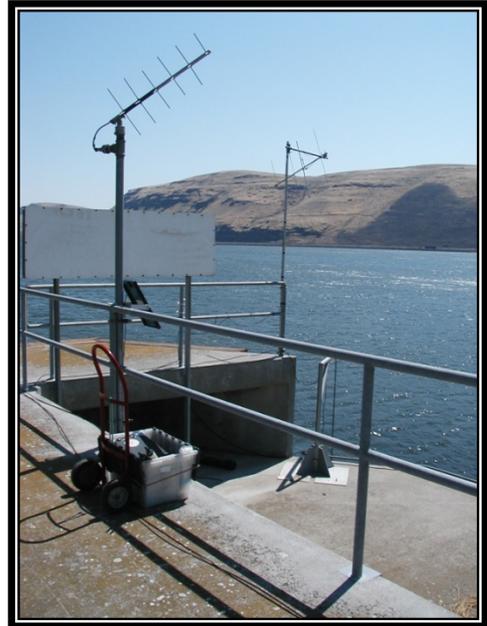
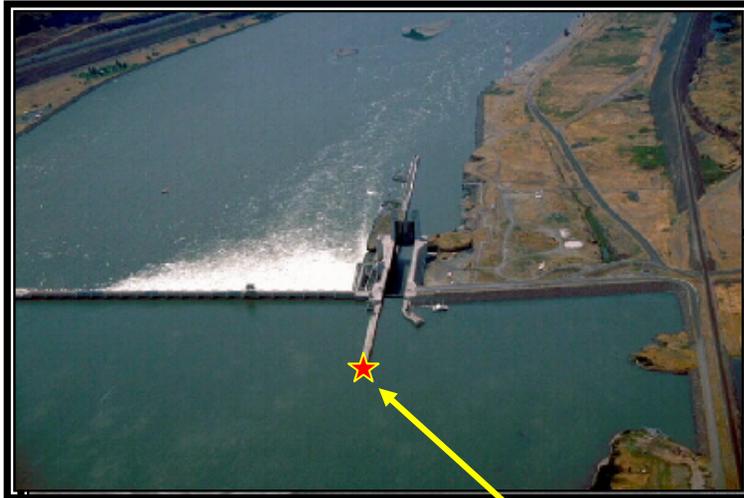
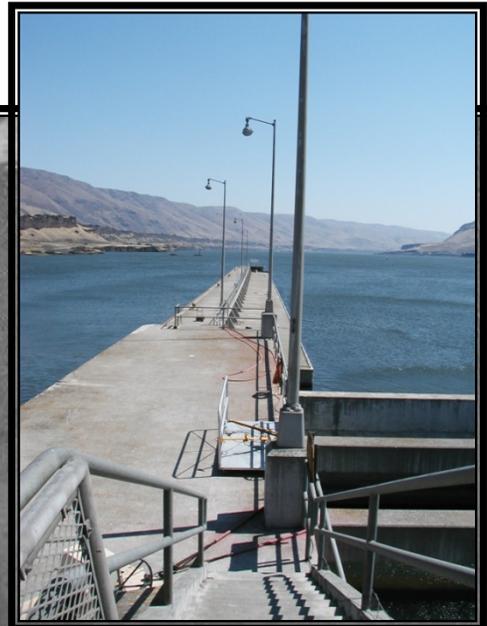
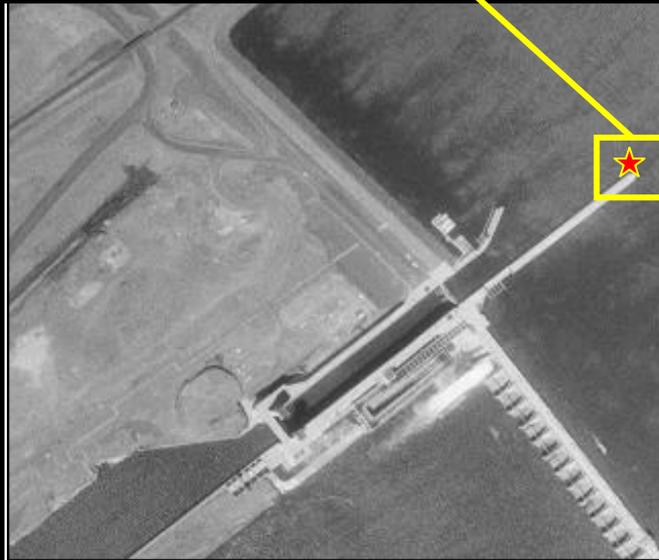
## 12. John Day Forebay TDG Monitoring Station (JDY)

**Gauge Elevation:** Variable  
**Latitude:** 45° 43' 13.44908" N  
**Longitude:** 120° 41' 41.21307" W  
**Distance from Dam:** On extended guidewall from dam  
**Datum:** NAD83  
**River:** Columbia  
**River Mile:** 215.7  
**USGS-ID:** 453439122223900  
**Owner:** U.S. Army Corps of Engineers-NWP  
**Gauge Type:** Hydrosonde  
**Data Transmission:** GOES Satellite  
**Dates of Operation:** April 1 – August 31\*  
**Years of Operation:** 2004 – Present  
**Water Conditions:** Mixed  
**Location:** At upstream end of the navigation lock guidewall.  
**This gauge replaced:** JDA  
**Reason for replacement:** Moved due to thermal influences and lowered from 15 ft to 45 ft.  
**Comments:** \*The seasonal gauges may go in several weeks before April 1 and remain in operation several weeks after August 31.

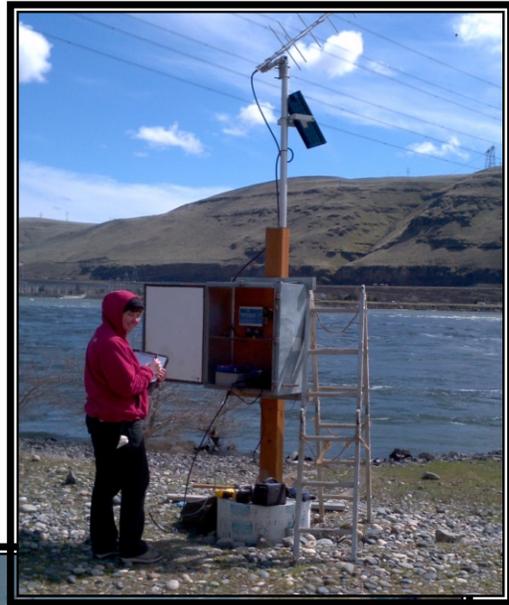
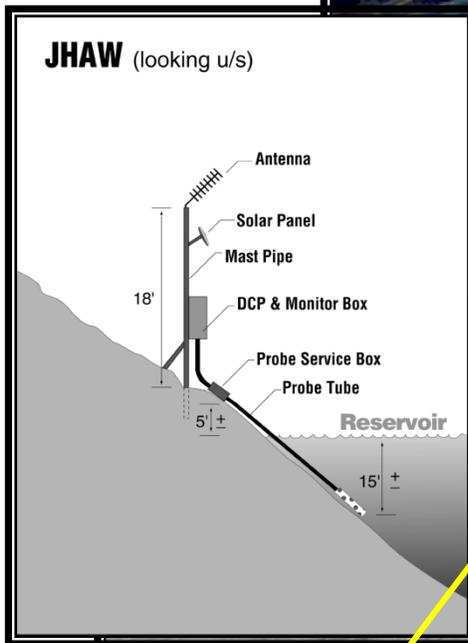
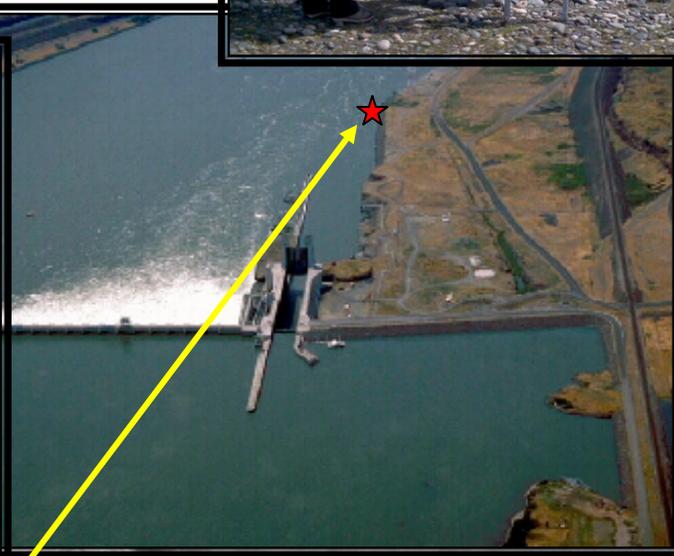
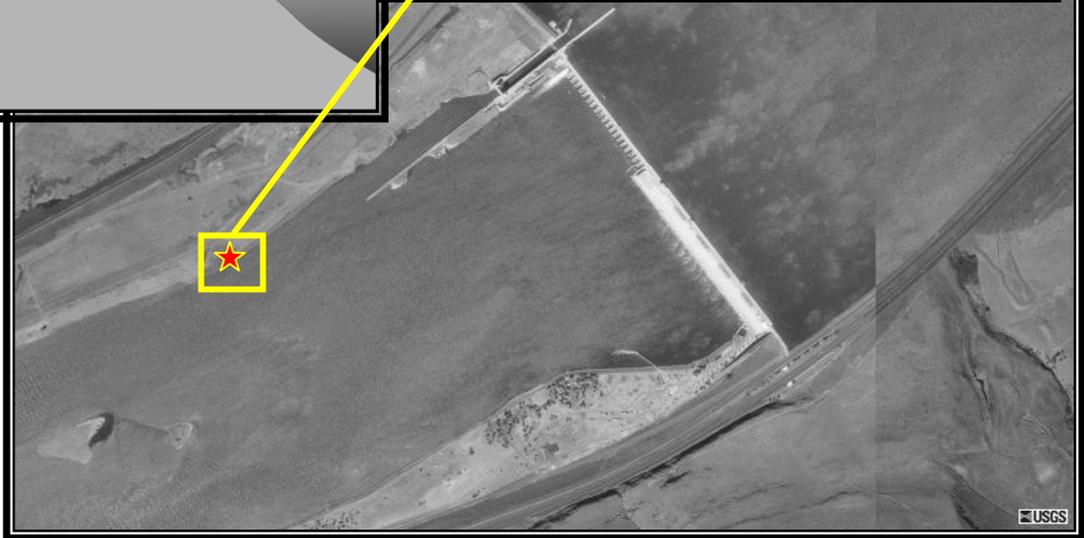
### 13. John Day Tailwater TDG Monitoring Station (JHAW)

**Gauge Elevation:** Fixed  
**Latitude:** 45° 42' 48.44859" N  
**Longitude:** 120° 42' 39.21477" W  
**Distance from Dam:** 0.8 miles  
**Datum:** NAD83  
**River:** Columbia  
**River Mile:** 214.8  
**USGS-ID:** 454249120423500  
**Owner:** U.S. Army Corps of Engineers-NWP  
**Gauge Type:** Hydrosonde  
**Data Transmission:** GOES Satellite  
**Dates of Operation:** Was seasonal prior to 2006, now year round.  
**Years of Operation:** 1995 – Present  
**Water Conditions:** Spillway  
**Location:** Other Washington shore.  
**This gauge replaced:** September 2011  
**Reason for replacement:** Rising flows  
**Comments:** Location of station moved about 12 feet higher elevation from shore, further up the hill.

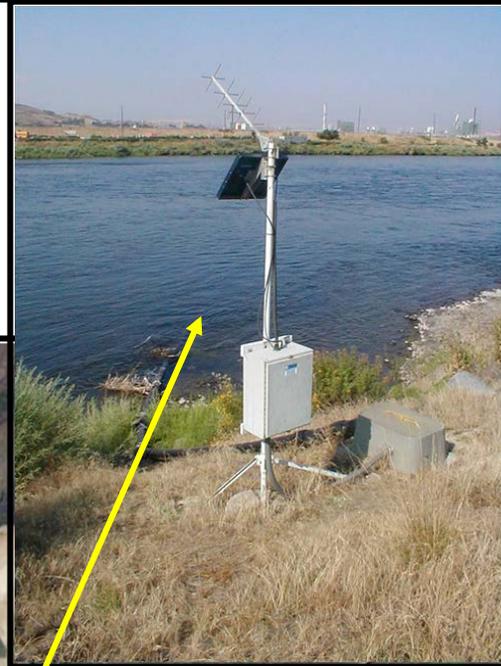
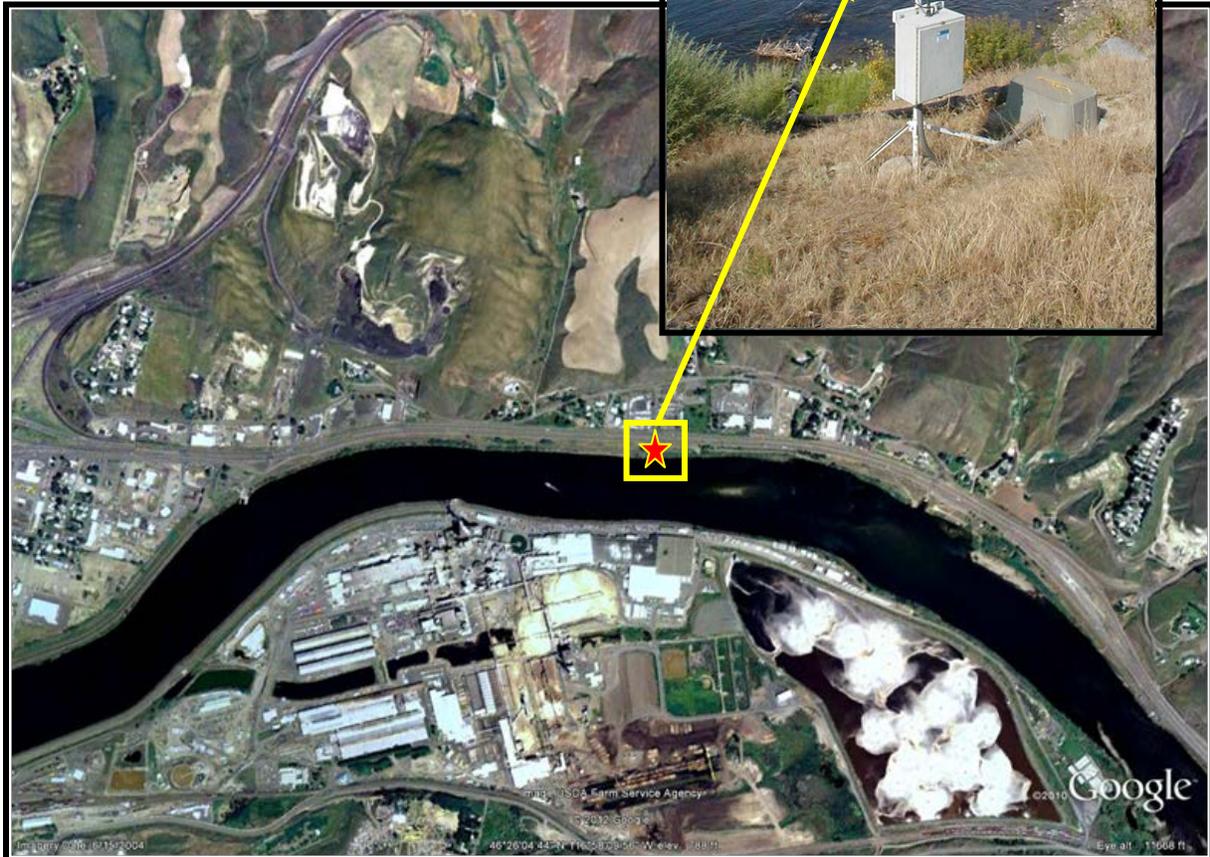
#### 14. Lewiston TDG Monitoring Station (LEWI)

**Gauge Elevation:** Fixed  
**Latitude:** 46° 25' 52.0867" N  
**Longitude:** 116° 56' 43.9589" W  
**Distance from Dam:** N/A  
**Datum:** NAD83  
**River:** Columbia  
**River Mile:** 5.0  
**USGS-ID:** 13343000  
**Owner:** U.S. Army Corps of Engineers-NWW  
**Gauge Type:** Hydrosonde  
**Data Transmission:** GOES Satellite  
**Dates of Operation:** April 1 – Aug. 31\*  
**Years of Operation:** 1996 – Present  
**Water Conditions:** Open River  
**Location:** On the northern shore of the Clearwater River just east of the City of Lewiston, Idaho near the junction of Hatwai Road and Central Grade Road.  
**This gauge replaced:** N/A  
**Reason for replacement:** N/A  
**Comments:** --

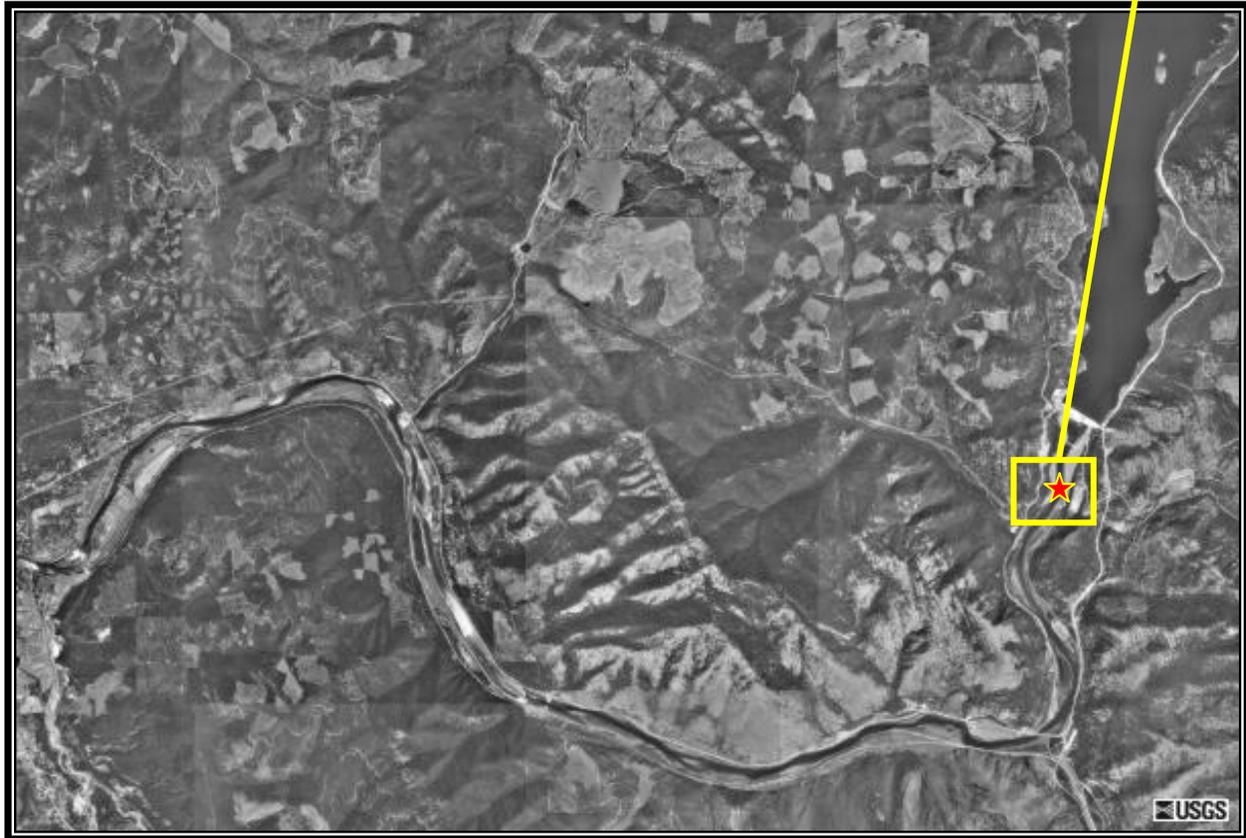
### 15. Libby Tailwater TDG Monitoring Station (LBQM)

**Gauge Elevation:** Fixed  
**Latitude:** 48° 24' 2.4" N  
**Longitude:** 115° 19' 7.0" W  
**Distance from Dam:** --  
**Datum:** NAD83  
**River:** Kootenai  
**River Mile:** 221.5  
**USGS-ID:**  
**Owner:** U.S. Army Corps of Engineers-NWS  
**Gauge Type:** Hydrosonde  
**Data Transmission:** GOES Satellite and Radio Transmission  
**Dates of Operation:** April 1 – Aug 31\*  
**Years of Operation:** 2004 – Present  
**Water Conditions:** Open River  
**Location:** This gauge is located on the eastern shore of the Kootenai River approximately 750 feet downstream of the Libby Dam access road bridge.  
**This gauge replaced:** N/A  
**Reason for replacement:** N/A  
**Comments:** \*The seasonal gauges may go in several weeks before April 1 and remain in operation several weeks after August 31.

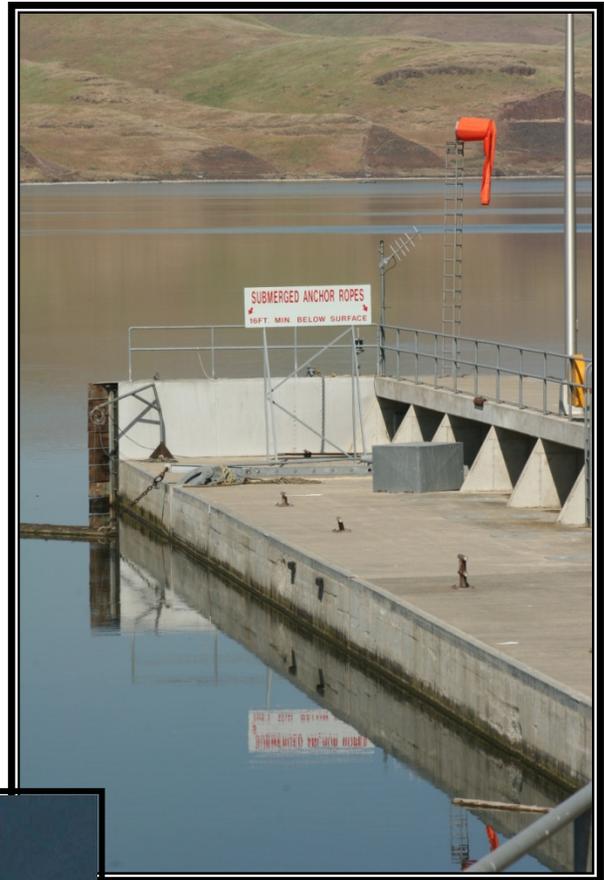
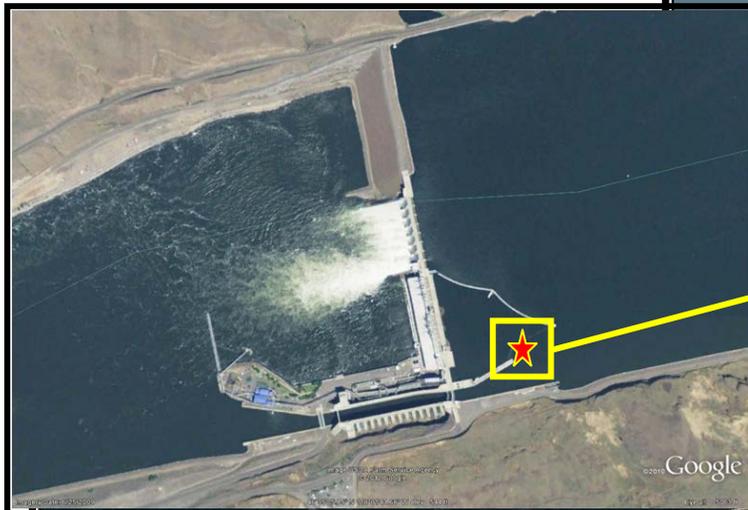
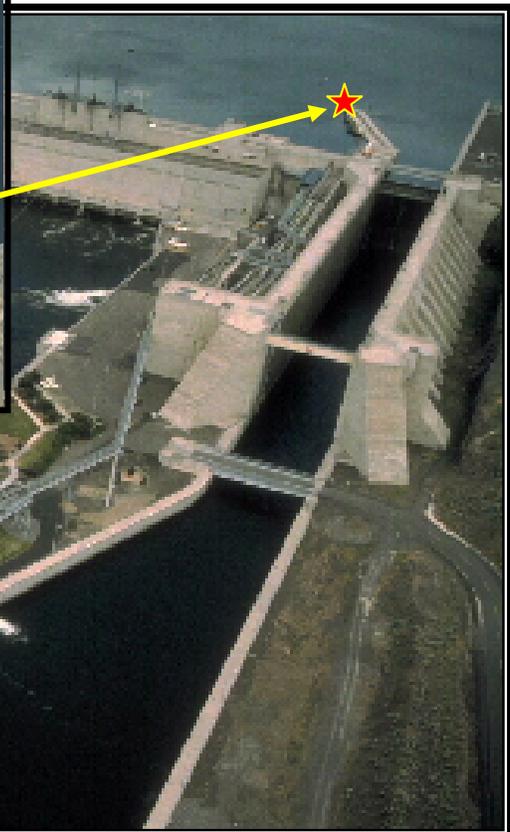
## 16. Little Goose Forebay TDG Monitoring Station (LGSA)

**Location:** At the upstream end of the navigation lock guidewall.

**Reason for replacement:** Move due to thermal influences and lowered from 15 ft to 45 ft.
