# **Appendix A**

## **2014 Total Dissolved Gas Fixed Monitoring Stations**

**Updated November 2014**

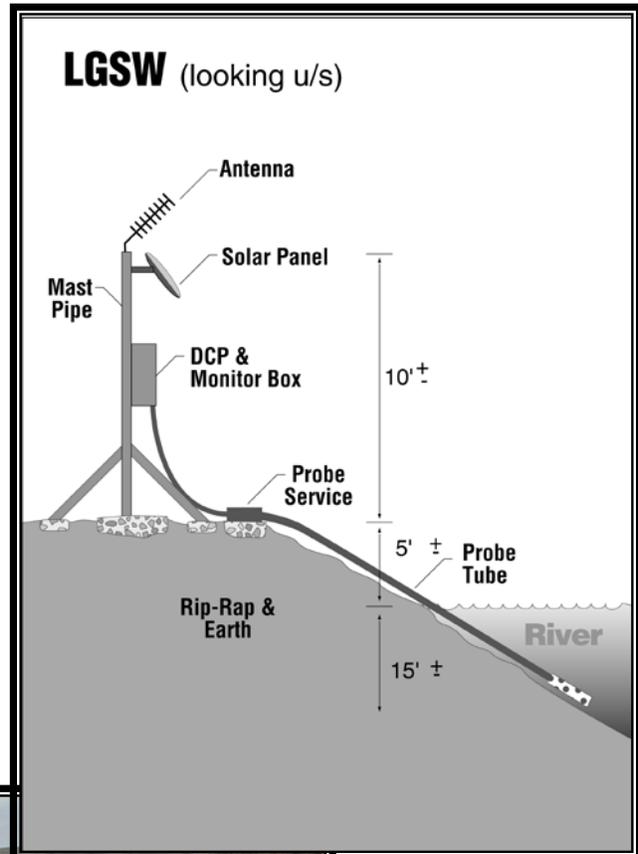
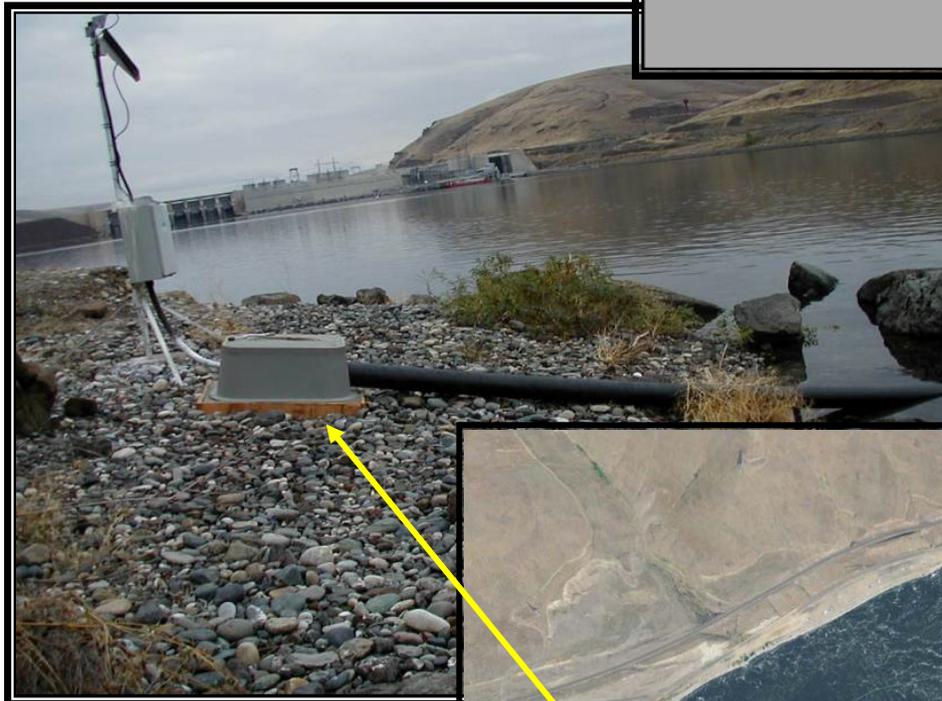
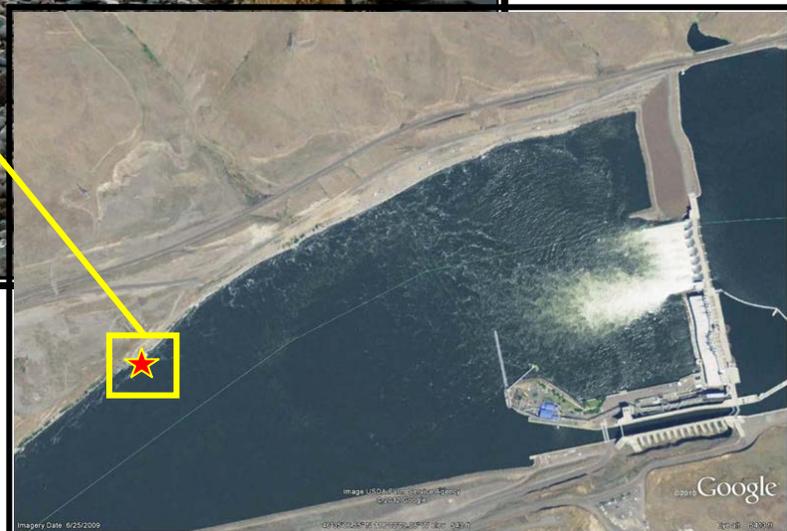
## 17. Little Goose Tailwater TDG Monitoring Station (LGSW)

**Gauge Elevation:** Fixed  
**Latitude:** 46° 35' 00.5280" N  
**Longitude:** 118° 02' 37.4186" W  
**Distance from Dam:** 0.7 miles  
**Datum:** NAD83  
**River:** Snake  
**River Mile:** 69.6  
**USGS-ID:** 13343860  
**Owner:** U.S. Army Corps of Engineers-NWW  
**Gauge Type:** Hydrosonde  
**Data Transmission:** GOES Satellite  
**Dates of Operation:** Was seasonal prior to 2006, now year round.  
**Years of Operation:** 1995 – Present.  
**Water Conditions:** Switches between mixed & spillway  
**Location:** On the northern shore of the Snake River  
**This gauge replaced:** N/A  
**Reason for replacement:** N/A  
**Comments:** --

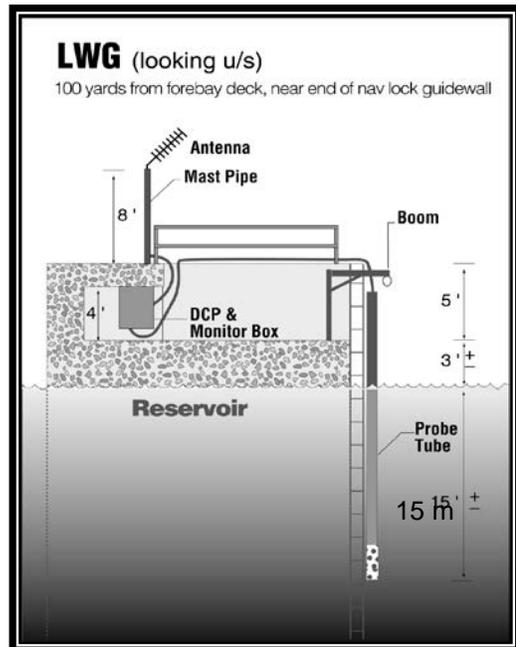
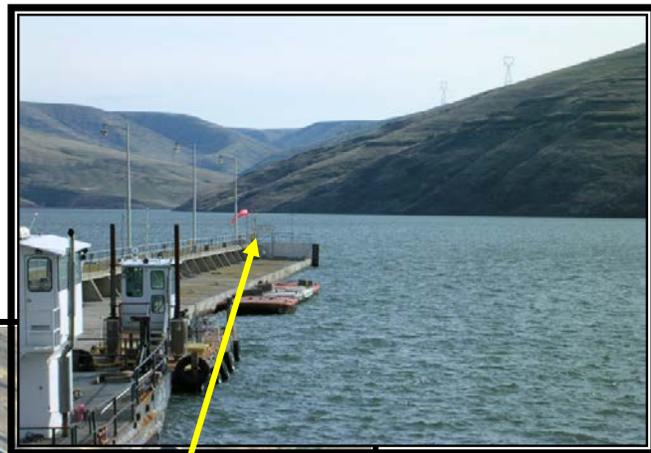
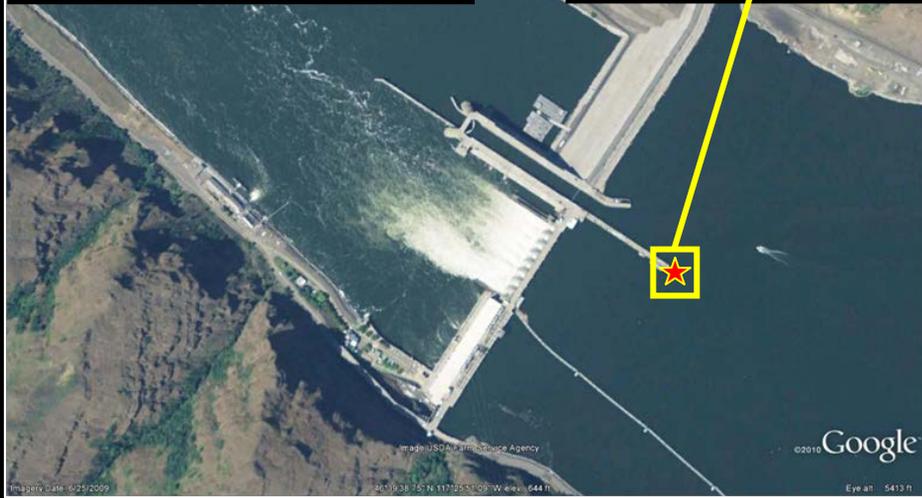
## 18. Lower Granite Forebay TDG Monitoring Station (LWG)

**Location:** At the upstream end of the navigation lock guidewall.  
**This gauge replaced:** N/A  
**Reason for replacement:** In March, 2005, this gauge was moved from a depth of 15 ft to 45 ft to avoid thermal influences. The geographic location of the gauge was not changed.

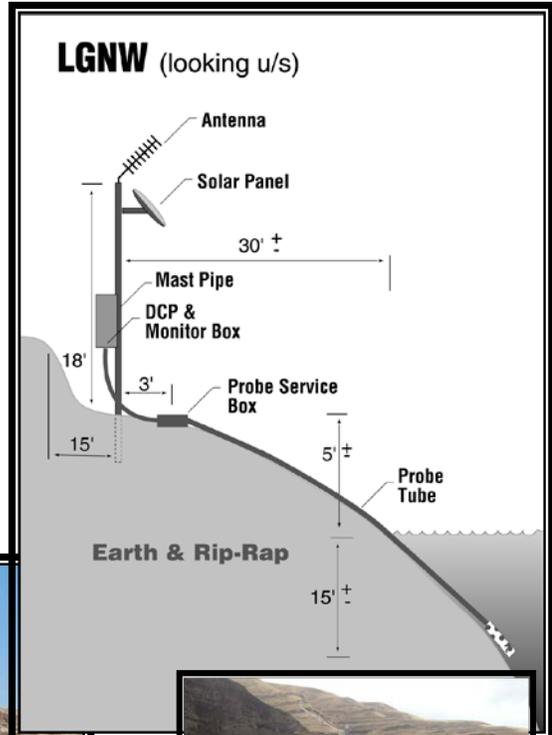
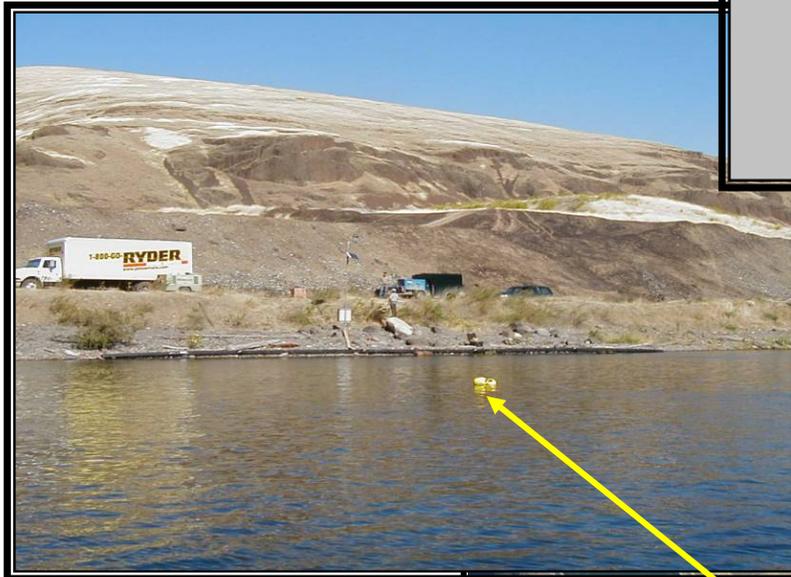
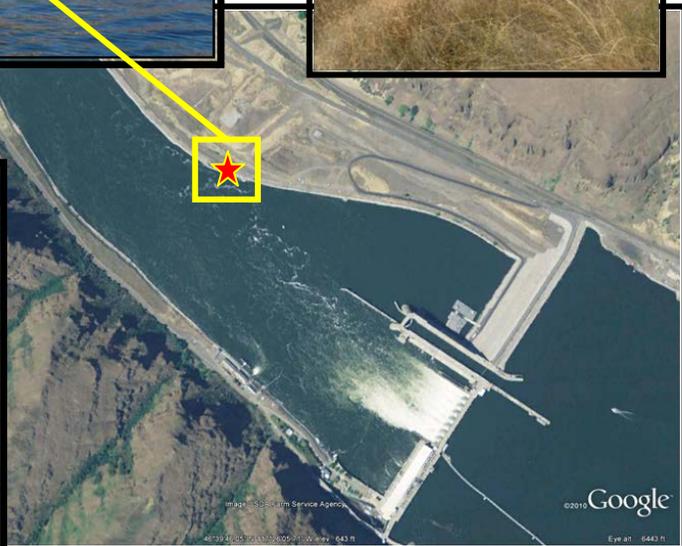
**19. Lower Granite Tailwater TDG Monitoring Station (LGNW)**

**Gauge Elevation:** Fixed  
**Latitude:** 46° 39' 58.0726" N  
**Longitude:** 117° 26' 19.2595" W  
**Distance from Dam:** 0.8 miles  
**Datum:** NAD83  
**River:** Snake  
**River Mile:** 106.7  
**USGS-ID:** 13343595  
**Owner:** U.S. Army Corps of Engineers-NWW  
**Gauge Type:** Hydrosonde  
**Data Transmission:** GOES Satellite  
**Dates of Operation:** Year around  
**Years of Operation:** 1995 – Present.  
**Water Conditions:** Switches between mixed & spillway  
**Location:** On the northeastern shore of the Snake River.  
**This gauge replaced:** N/A  
**Reason for replacement:** N/A  
**Comments:** --

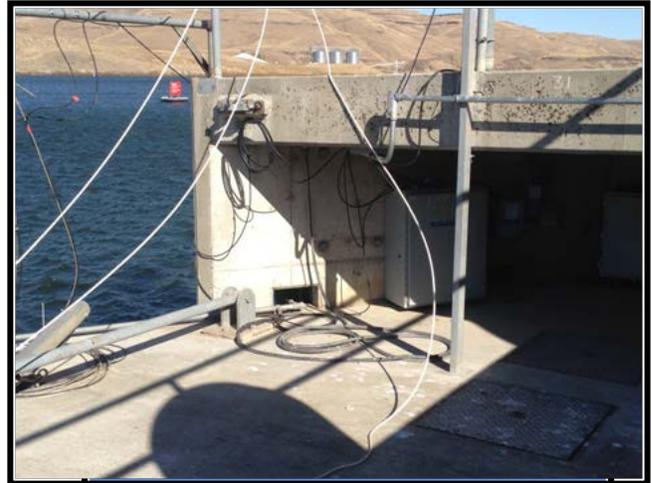
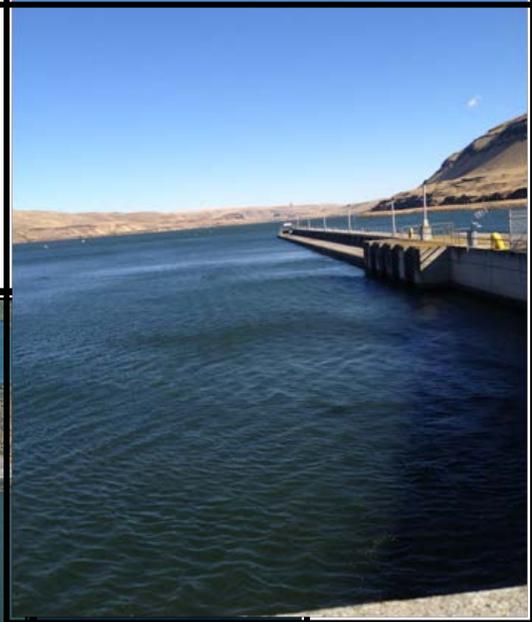
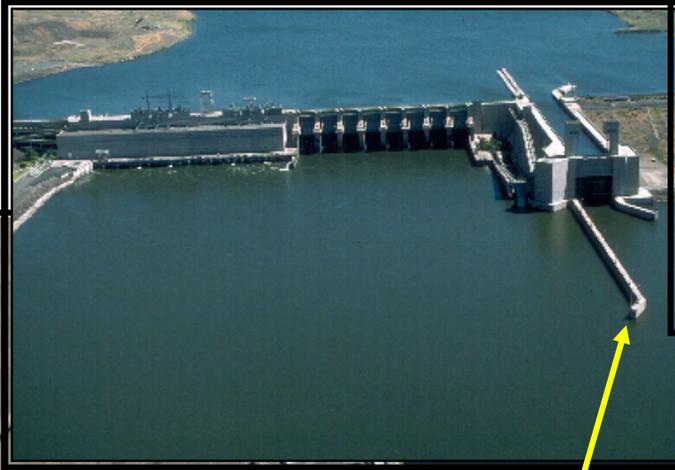
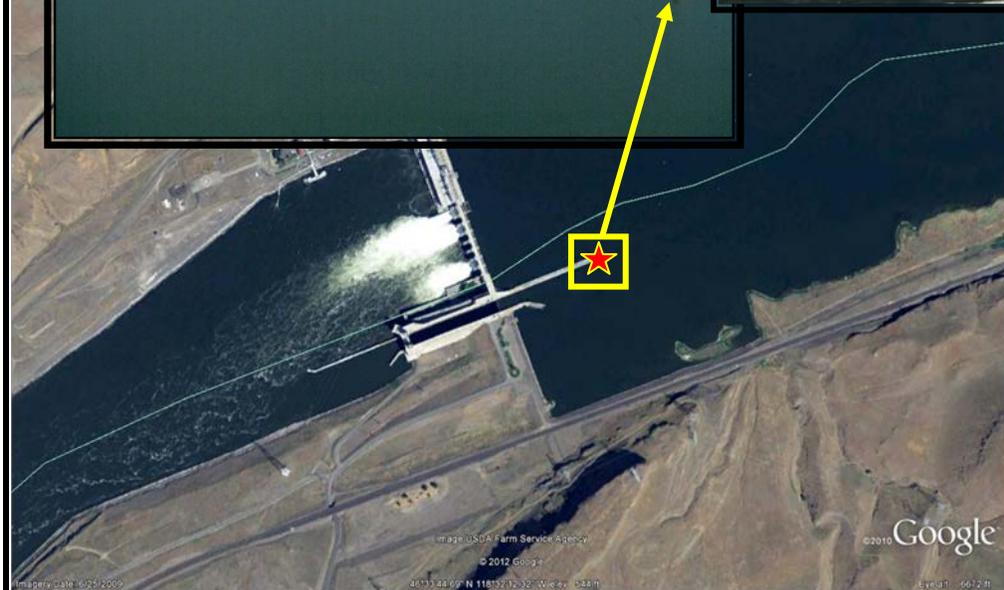
## 20. Lower Monumental Forebay TDG Monitoring Station (LMNA)

**Gauge Elevation:** Fixed  
**Latitude:** 46° 33' 44.6559" N  
**Longitude:** 118° 32' 08.3477" W  
**Distance from Dam:** 700 ft  
**Datum:** NAD83  
**River:** Snake  
**River Mile:** 41.7  
**USGS-ID:** 13352595  
**Owner:** U.S. Army Corps of Engineers-NWW  
**Gauge Type:** Hydrosonde  
**Data Transmission:** GOES Satellite  
**Dates of Operation:** April 1-Aug. 31\*  
**Years of Operation:** 2005 – Present  
**Water Conditions:** Mixed  
**Location:** At the upstream end of the navigation lock guidewall.  
**This gauge replaced:** Replaced LMN in 2005  
**Reason for replacement:** Moved due to thermal influences and lowered from 15 ft to 45 ft.  
**Comments:** \* The seasonal gauges may go in several weeks before April 1 and remain in operation several weeks after August 31.

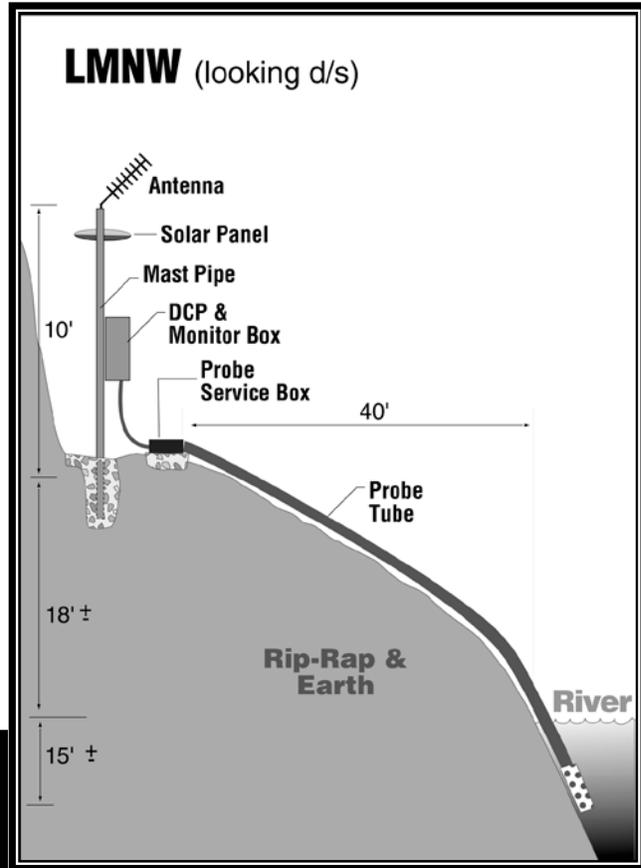
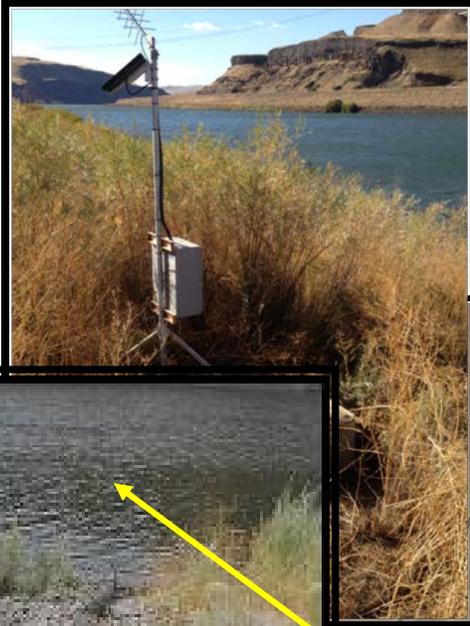
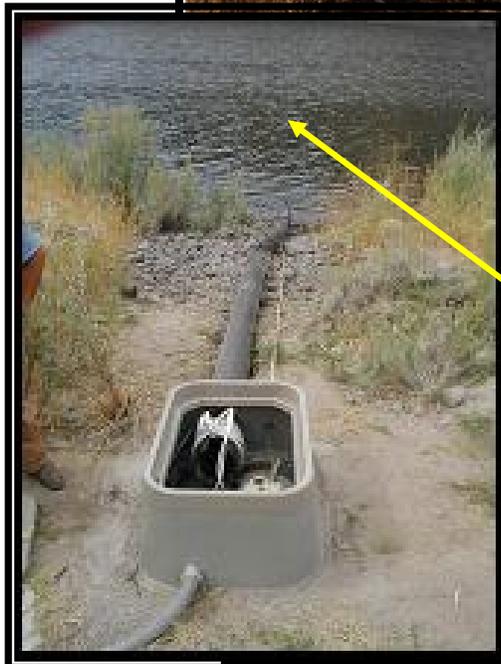
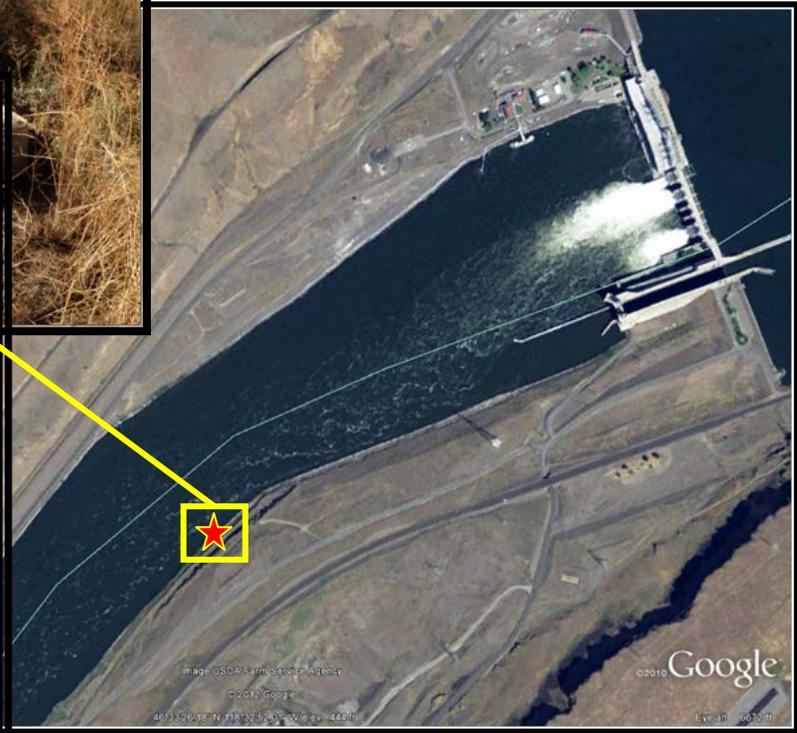
## 21. Lower Monumental Tailwater TDG Monitoring Station (LMNW)

**Gauge Elevation:** Fixed  
**Latitude:** 46° 33' 04.5051" N  
**Longitude:** 118° 32' 58.9500" W  
**Distance from Dam:** 1 mile  
**Datum:** NAD83  
**River:** Snake  
**River Mile:** 40.4  
**USGS-ID:** 13352600  
**Owner:** U.S. Army Corps of Engineers-NWW  
**Gauge Type:** Hydrosonde  
**Data Transmission:** GOES Satellite  
**Dates of Operation:** Was seasonal prior to 2006, now year around.  
**Years of Operation:** 1995 – Present  
**Water Conditions:** Switches between mixed & spillway.  
**Location:** On the southeastern shore of the Snake River.  
**This gauge replaced:** N/A  
**Reason for replacement:** N/A  
**Comments:** --

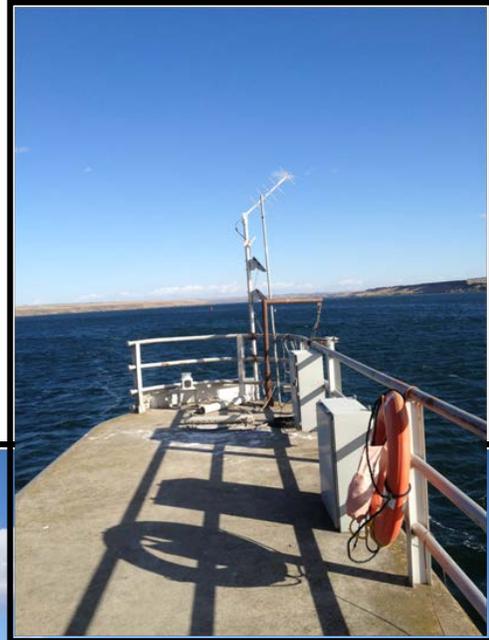
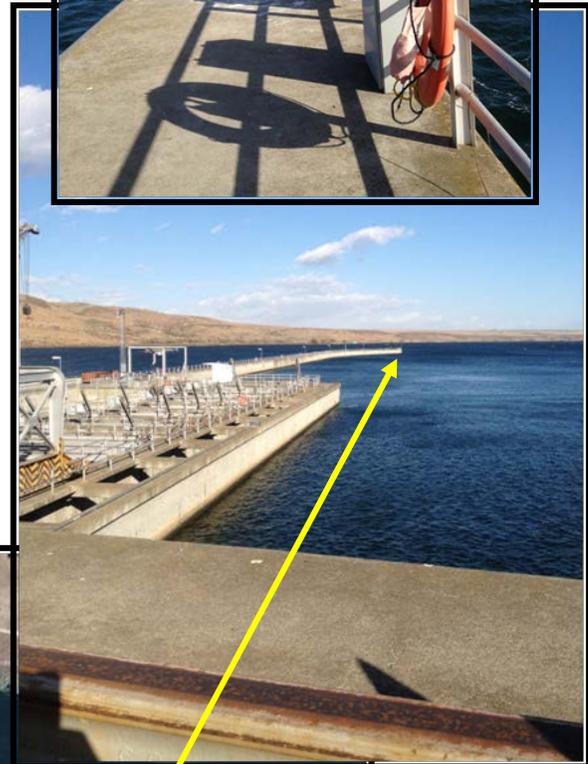
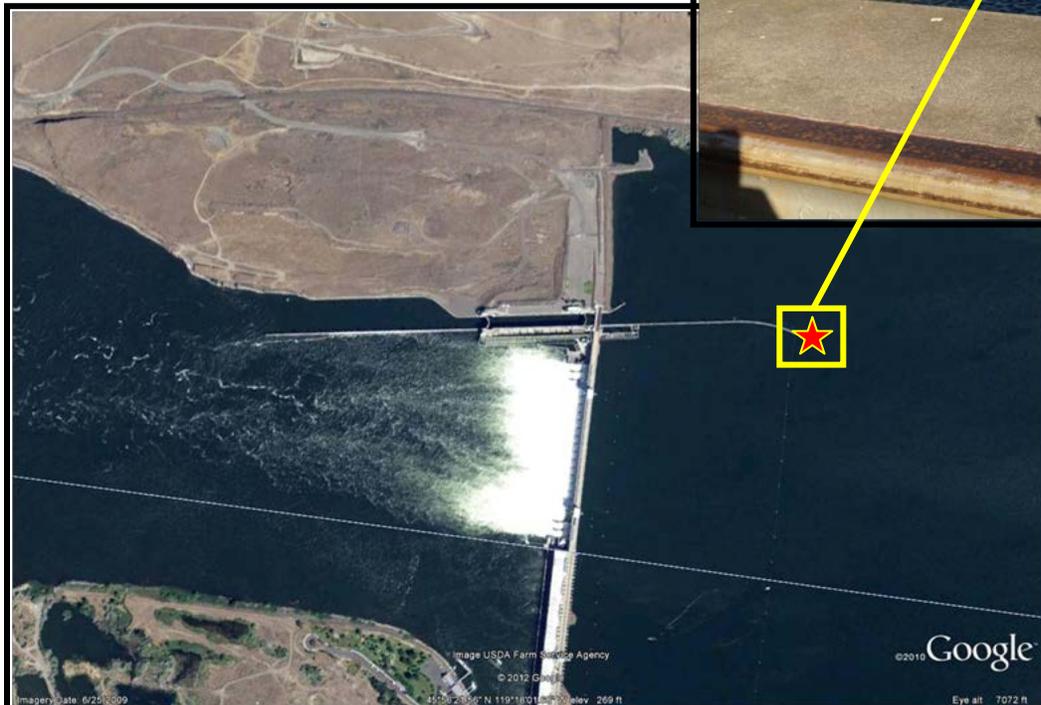
## 22. McNary Forebay TDG Monitoring Station (MCNA)

**Location:** At the end of the navigation lock guidewall near the Washington shoreline.

**Reason for replacement:** Moved due to thermal influences and lowered from 15 ft to 45 ft.

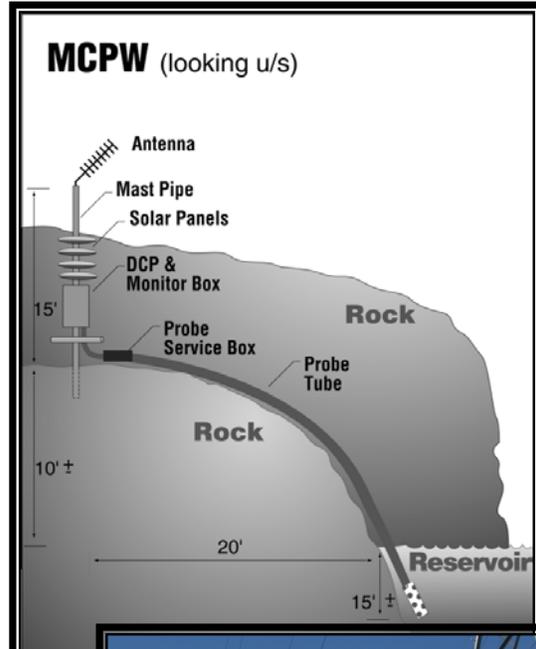
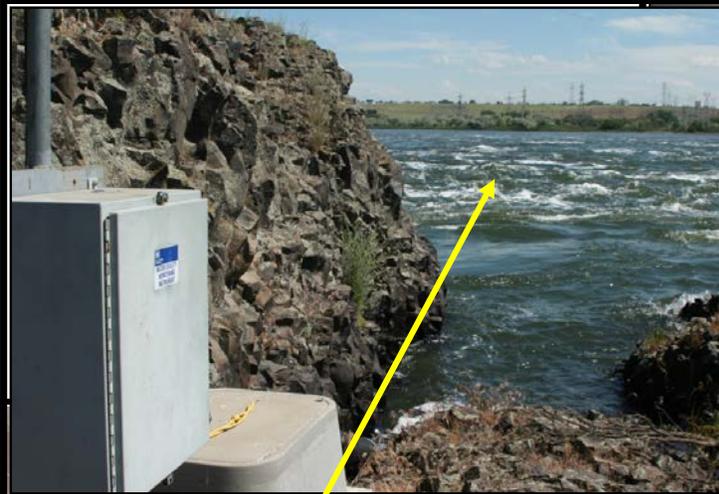
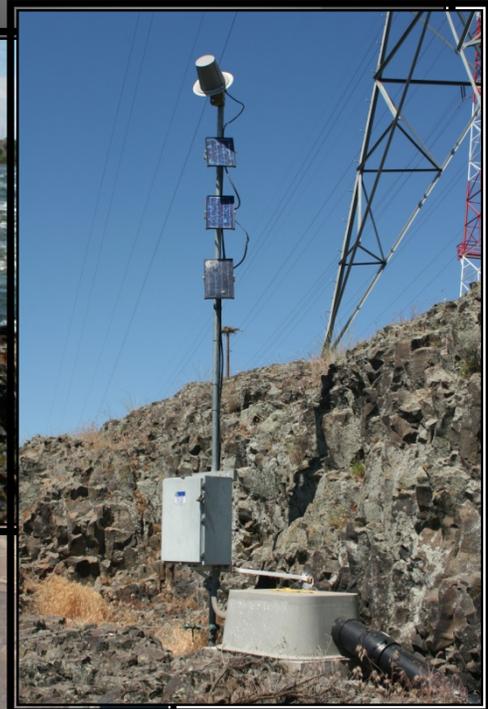
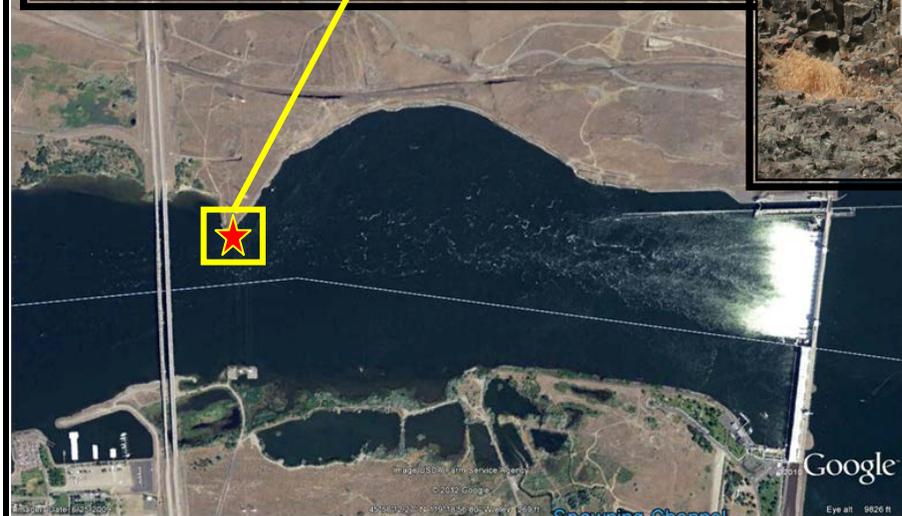
### 23. McNary Tailwater TDG Monitoring Station (MCPW)

**Gauge Elevation:** Fixed  
**Latitude:** 45° 56' 02.7775" N  
**Longitude:** 119° 19' 35.4628" W  
**Distance from Dam:** 1.3 miles  
**Datum:** NAD83  
**River:** Columbia  
**River Mile:** 290.7  
**USGS-ID:** 14019240  
**Owner:** U.S. Army Corps of Engineers-NWW  
**Gauge Type:** Hydrosonde  
**Data Transmission:** GOES Satellite  
**Dates of Operation:** Year around  
**Years of Operation:** 1995 - Present  
**Water Conditions:** Spillway  
**Location:** On a rocky outcrop on the Washington shore and just upstream of the Highway 395 Bridge.  
**This gauge replaced:** N/A  
**Reason for replacement:** N/A  
**Comments:** --

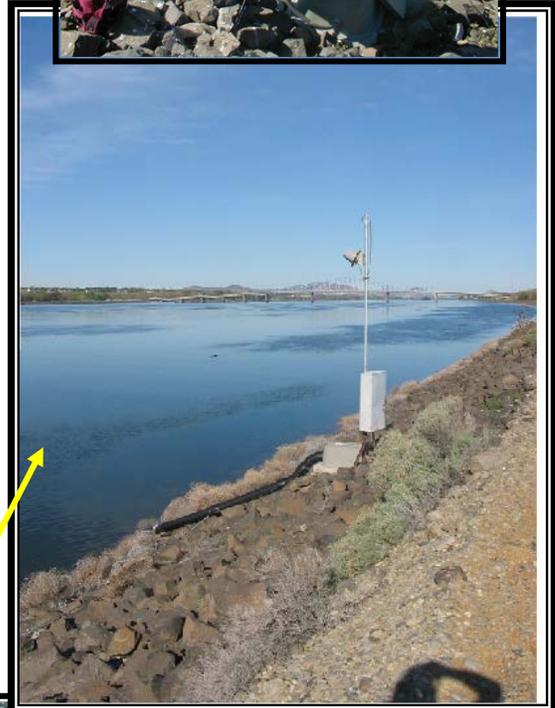
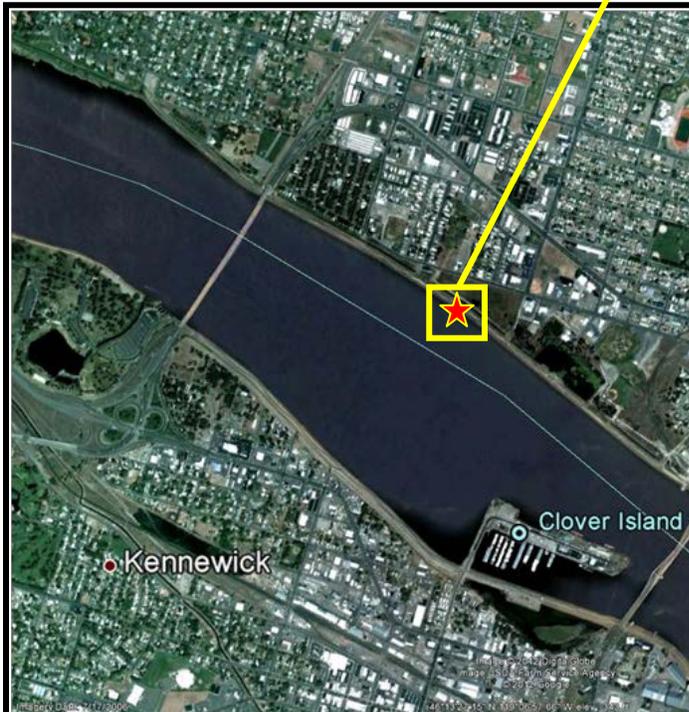
**PAQW (Looking Downstream)**

**Location:** On the northern shore of the Columbia River between the S. 10<sup>th</sup> Avenue Bridge and the Highway 395 Bridge in Pasco, WA. It is on the levee adjacent to a wetland area near the Pasco Youth Baseball Complex. The site is within Lake Wallula approximately 5 miles upstream of the Snake River confluence.

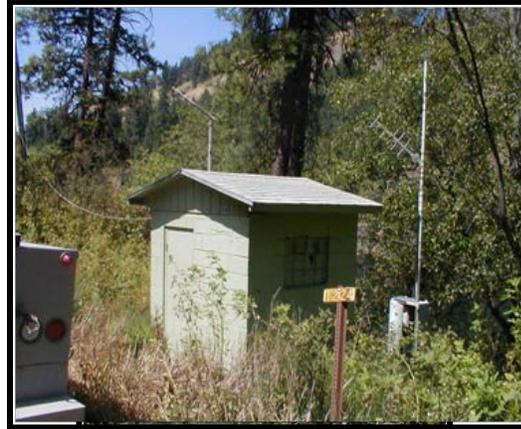
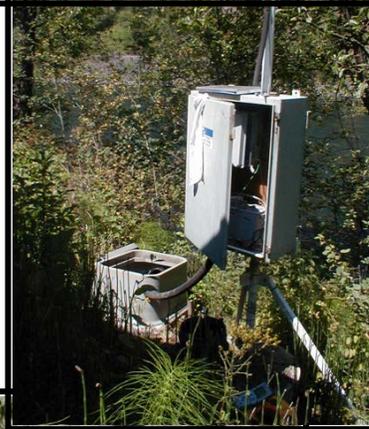
**26. The Dalles Forebay TDG Monitoring Station (TDA)**

**Gauge Elevation:** Fixed  
**Latitude:** 45° 37' 11.43618" N  
**Longitude:** 121° 07' 16.25220" W  
**Distance from Dam:** On part of dam  
**Datum:** NAD83  
**River:** Columbia  
**River Mile:** 192.4  
**USGS-ID:** 453712121071200  
**Owner:** U.S. Army Corps of Engineers-NWP  
**Gauge Type:** Hydrosonde  
**Data Transmission:** GOES Satellite  
**Dates of Operation:** April 1 – August 31\*  
**Years of Operation:** 1985 – Present  
**Water Conditions:** Mixed  
**Location:** In forebay of dam near the end of Powerhouse Unit 22.  
**This gauge replaced:** N/A  
**Reason for replacement:** N/A  
**Comments:** \* The seasonal gauges may go in several weeks before April 1 and remain in operation several weeks after August 31.

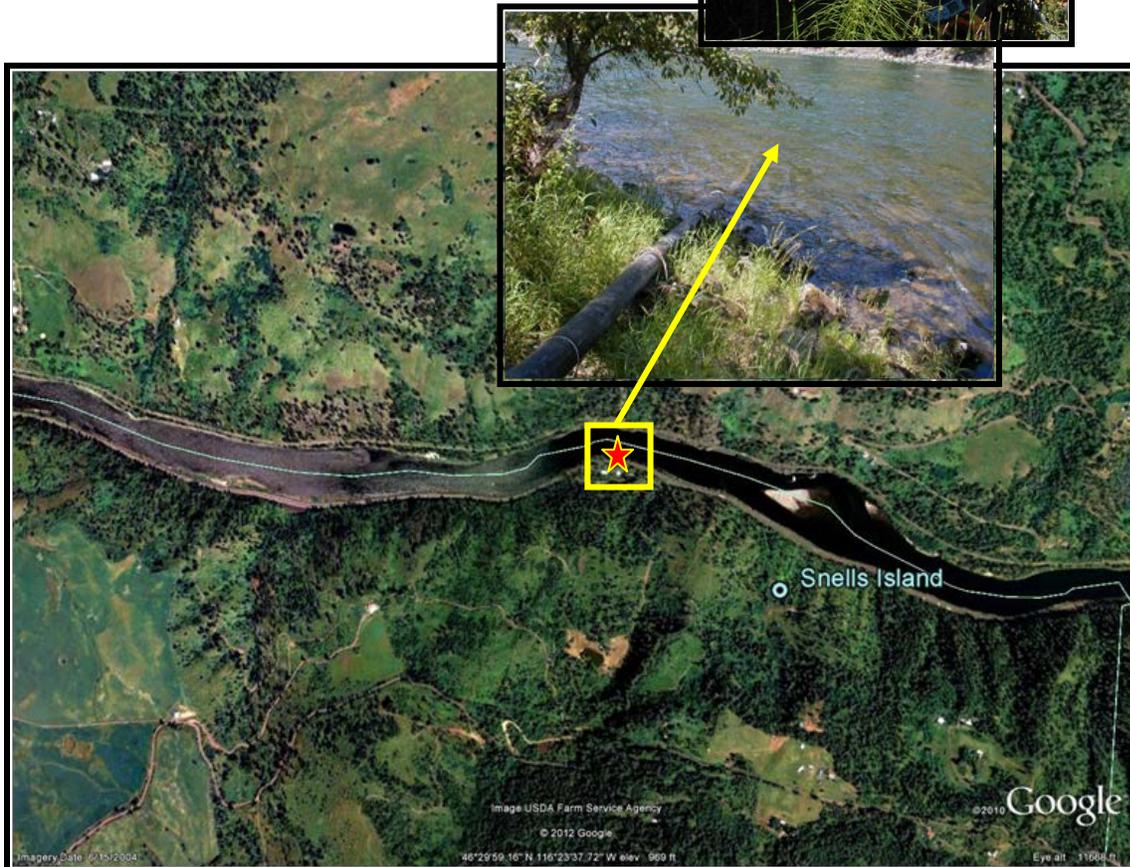
## 25. Peck TDG Monitoring Station (PEKI)

**Location:** On the southern shore of the Clearwater River approximately 3.5 miles downstream of the North Fork Clearwater River confluence.

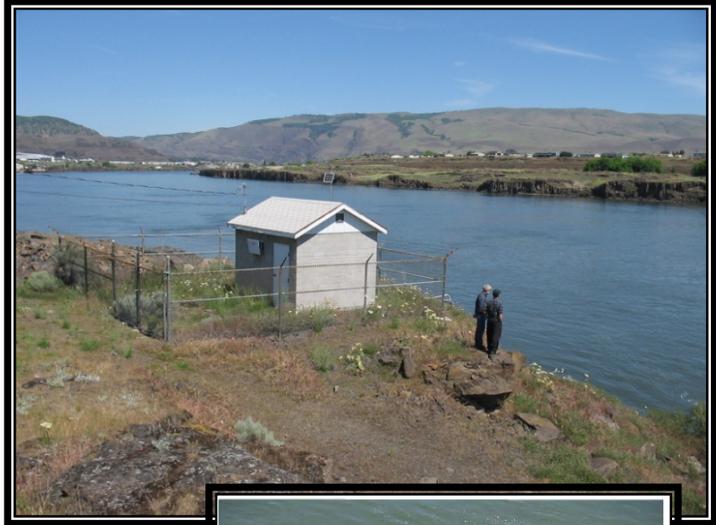
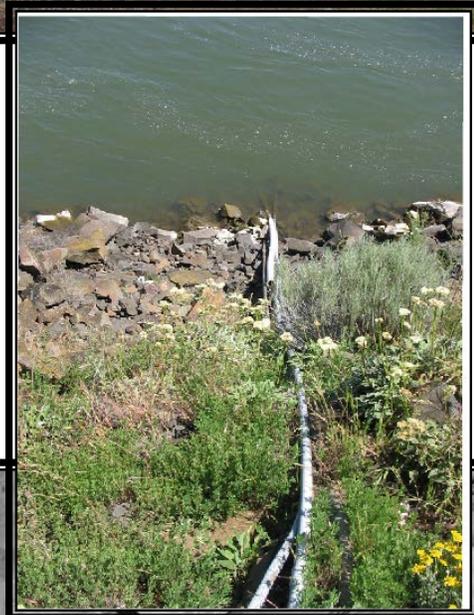
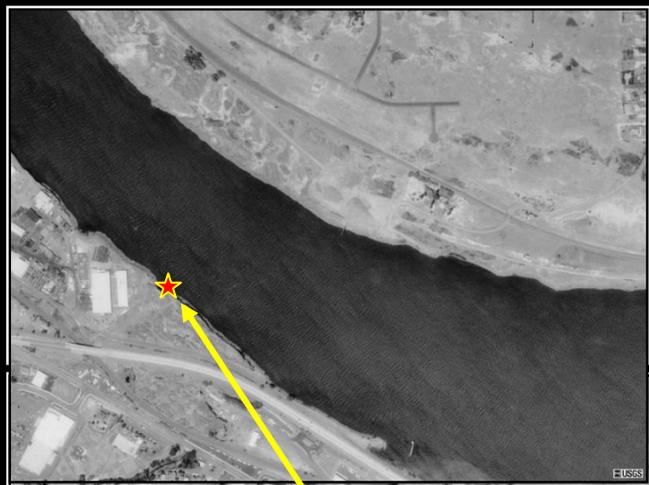
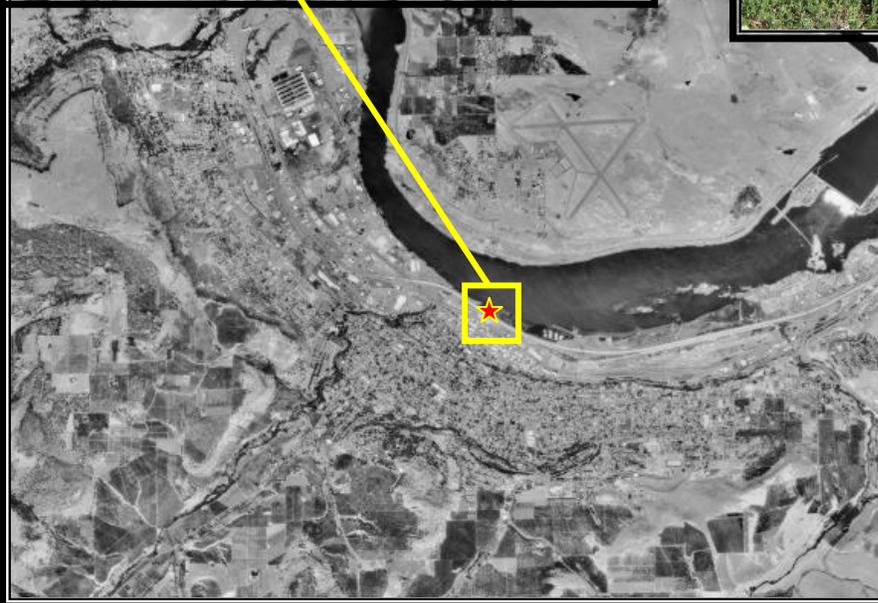
**27. The Dalles Tailwater TDG Monitoring Station (TDDO)**

**Gauge Elevation:** Fixed (107.6 ft)  
**Latitude:** 45° 36' 26.43330" N  
**Longitude:** 121° 10' 24.25569" W  
**Distance from Dam:** 2.5 miles  
**Datum:** NAD83  
**River:** Columbia  
**River Mile:** 189.1  
**USGS-ID:** 14105700  
**Owner:** U.S. Army Corps of Engineers-NWP  
**Gauge Type:** Hydrosonde  
**Data Transmission:** GOES Satellite  
**Dates of Operation:** Was seasonal prior to 2006, now year around  
**Years of Operation:** 1996 – Present  
**Water Conditions:** Mixed  
**Location:** Off Bargeway Road from Webber Street, near industrial complex.  
**This gauge replaced:** N/A  
**Reason for replacement:** N/A  
**Comments:** --

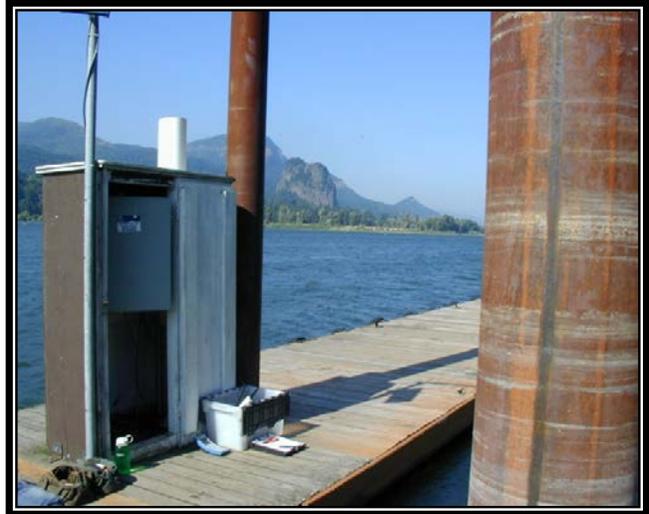
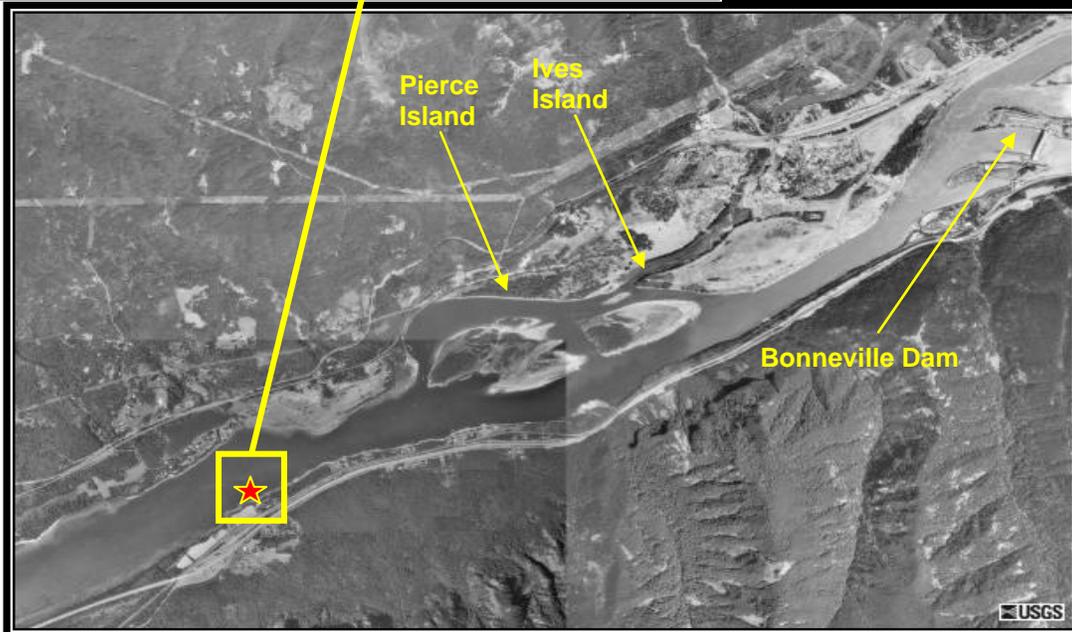
**28. Warrendale TDG Monitoring Station (WRNO)**

**Data Transmission:** GOES Satellite  
**Dates of Operation:** Year around  
**Years of Operation:** 1985 – Present  
**Water Conditions:** Mixed  
**Location:** This gauge is fixed to the boat dock at “The Fishery” off NE Enquist Pl in Dodson, Oregon (Near Warrendale) approximately 6 miles downstream of Bonneville Dam.

**This gauge replaced:** N/A  
**Reason for replacement:** N/A  
**Comment:** Up until the 2004 spill season, this gauge was used as the BON tailwater gauge for spill management and was operated year around. Currently, this gauge is being used as a fall, winter, and spring TDG monitor for Chum spawning.
