**2015 Seattle District TDG Report
(Includes Chief Joseph Dam)**

Total Dissolved Gas and Temperature Monitoring at Chief Joseph Dam, Washington, 2015: Data Review and Quality Assurance

By Kent Easthouse
U.S. Army Corps of Engineers, Seattle District
Water Management Section

November 2015

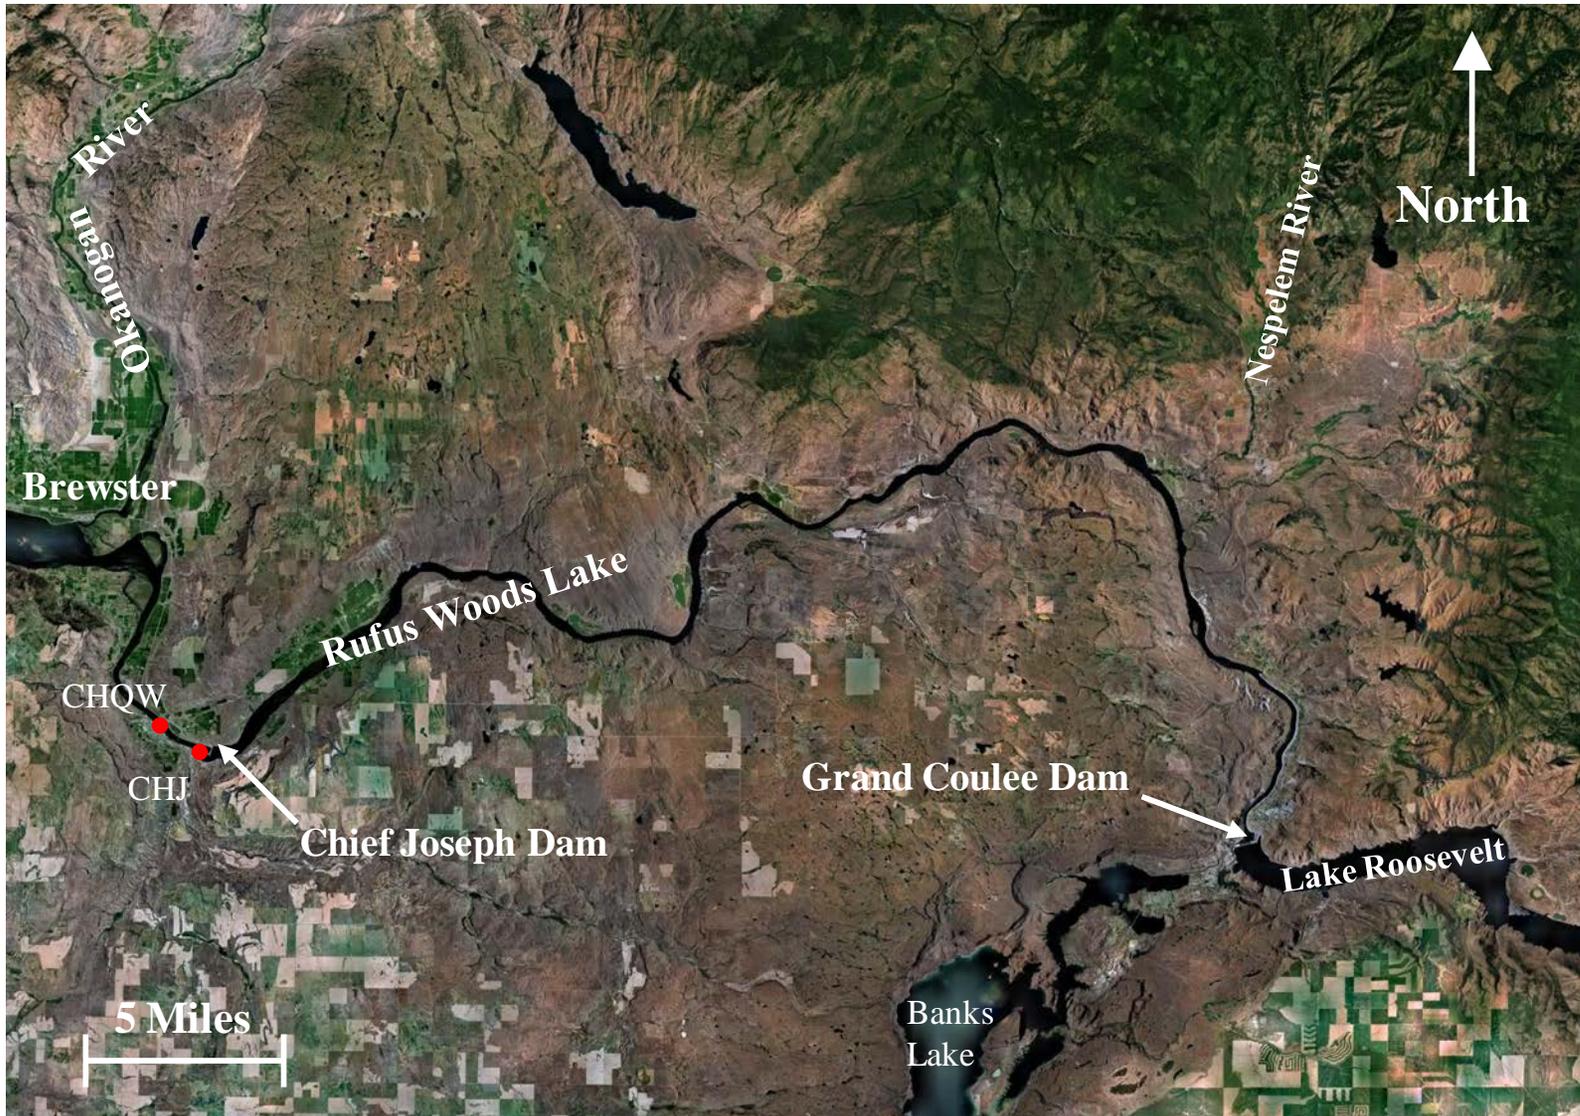
Figure 2. Locations of TDG monitoring stations in 2015 in Rufus Woods Lake, Chief Joseph Dam, Washington.

Data were collected at two fixed monitoring stations at Chief Joseph Dam (CHJ and CHQW) during the 2015 spill season (Figure 2). Fixed monitoring station location details and dates of operation are summarized in Table 1 and shown in Figure 2. Parameters monitored at each location included hourly measurements of water temperature, barometric pressure, TDG pressure, and TDG probe depth.

At the Chief Joseph Dam forebay station (CHJ) the water quality probe was located in Lake Rufus Woods near the left bank by the powerhouse. The probe was deployed directly into the water off of the boathouse's floating dock at a depth of 20 feet (see Figure 2). At the Chief Joseph Dam tailwater station (CHQW) the water quality probe was deployed along the right bank of the river, 1.3 miles downstream from the spillway. Data collected at CHQW during the 2009 spillway deflector TDG exchange study showed that the TDG probe was slow to respond to changes in spill when it was placed inside the anchored, perforated PVC pipe located at the station (Schneider 2012). Therefore, for the 2015 spill season the TDG probe was placed directly into the water to a depth of at least 10 feet during spillway flow conditions from April through September.
