Appendix A

2016 Total Dissolved Gas Fixed Monitoring Stations

Updated October 2016

Introduction

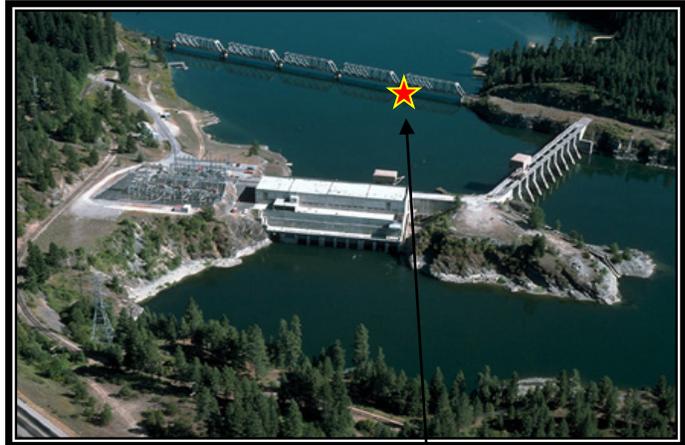
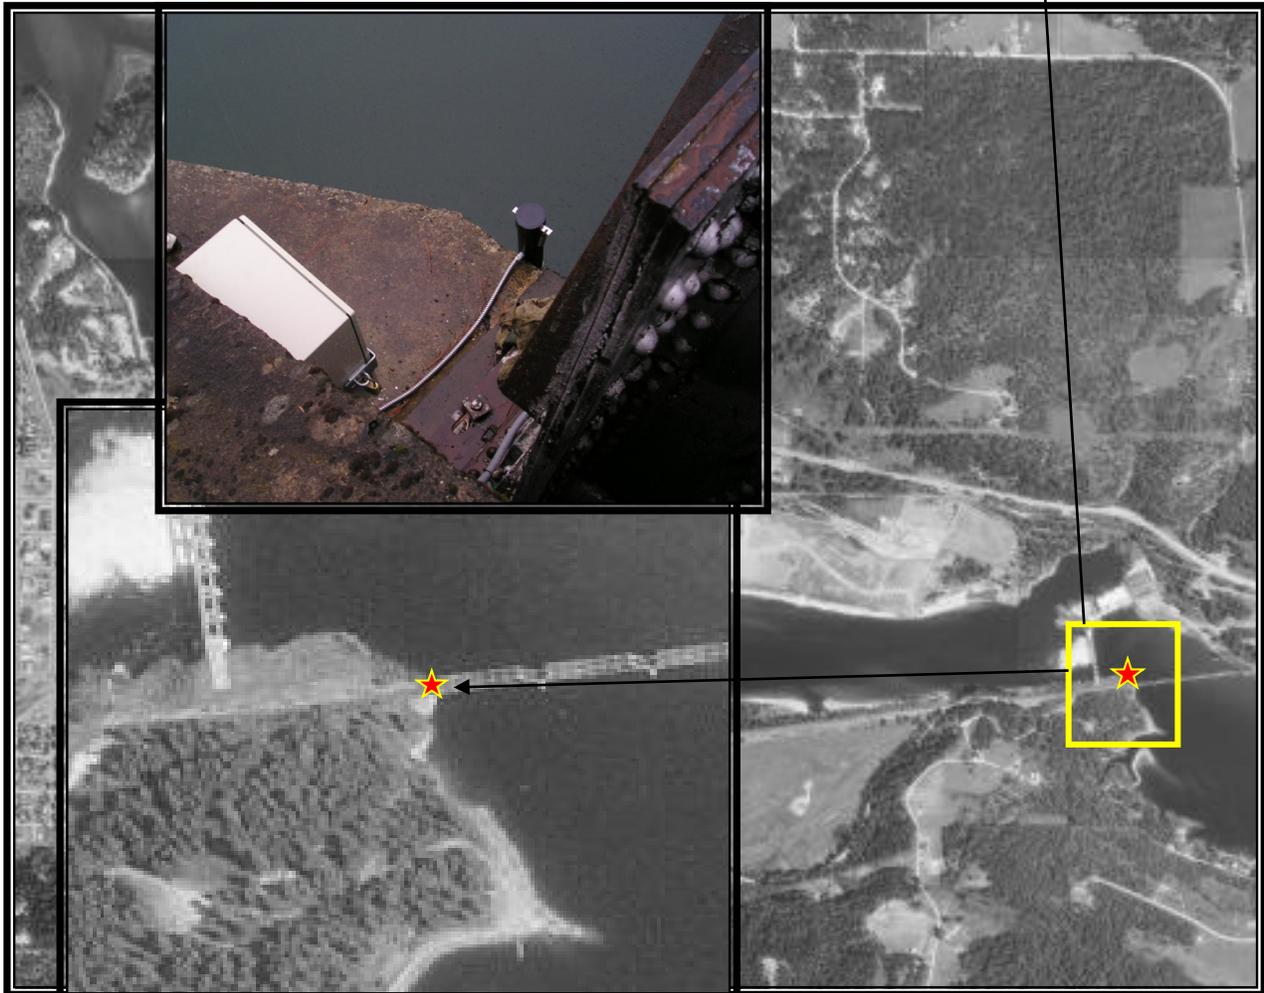
1. Albeni Falls Forebay TDG Monitoring Station (ALFI)

Location: Attached to the railroad bridge pier on the southern shoreline of the Pend Oreille River

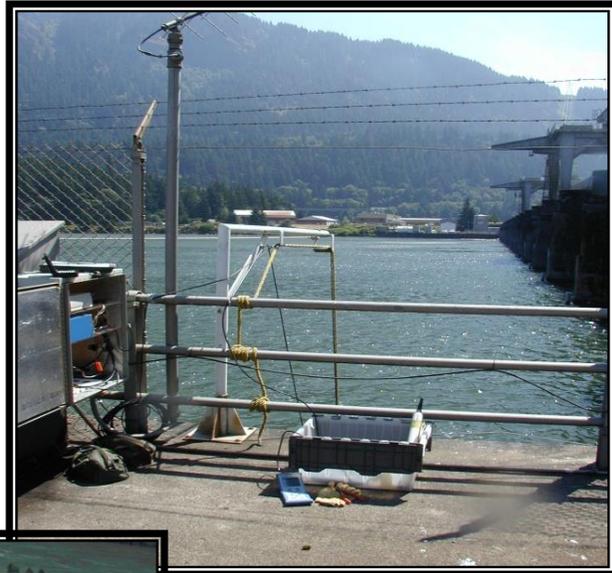
4. Bonneville Forebay TDG Monitoring Station (BON)

Gage Elevation: Fixed
Latitude: 45° 38' 44.42147" N
Longitude: 121° 56' 24.29279" W
Distance from Dam: On face of dam
Datum: NAD83
River: Columbia
River Mile: 146.1
USGS-ID: 453845121562000
Owner: U.S. Army Corps of Engineers-NWP
Gauge Type: Hydrosonde
Data Transmission: GOES Satellite
Dates of Operation: April 1 – August 31*
Years of Operation: 1986 – Present
Water Conditions: Mixed
Location: On the northern side of the spillway channel on Cascade Island just upstream of Spillbay #1.
This gage replaced: N/A
Reason for replacement: N/A
Comments: *The seasonal gauges may go in several weeks before April 1 and remain in operation several weeks after August 31.

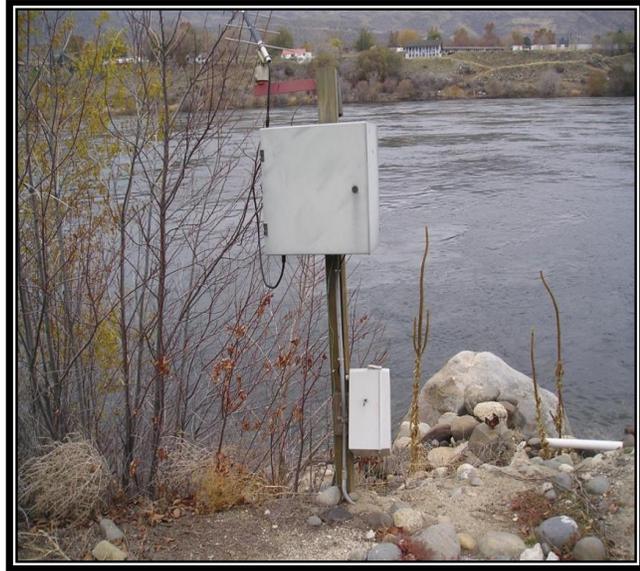
8. Chief Joseph Tailwater TDG Monitoring Station (CHQW)

Gage Elevation: Fixed
Latitude: 48° 00' 17.2" N
Longitude: 119° 39' 30.3" W
Distance from Dam: 1 mile
Datum: NAD83
River: Columbia
River Mile: 543.8
USGS-ID: --
Owner: U.S. Army Corps of Engineers-NWS
Gauge Type: Hydrosonde
Data Transmission: GOES Satellite
Dates of Operation: April 1 – Aug 31*
Years of Operation: 1985 – Present
Water Conditions: Spillway
Location: North bank of the river, just downstream of the Highway 17 Bridge.
This gage replaced: N/A
Reason for gage replacement: N/A
Comments: *The seasonal gauges may go in several weeks before April 1 and remain in operation several weeks after August 31.

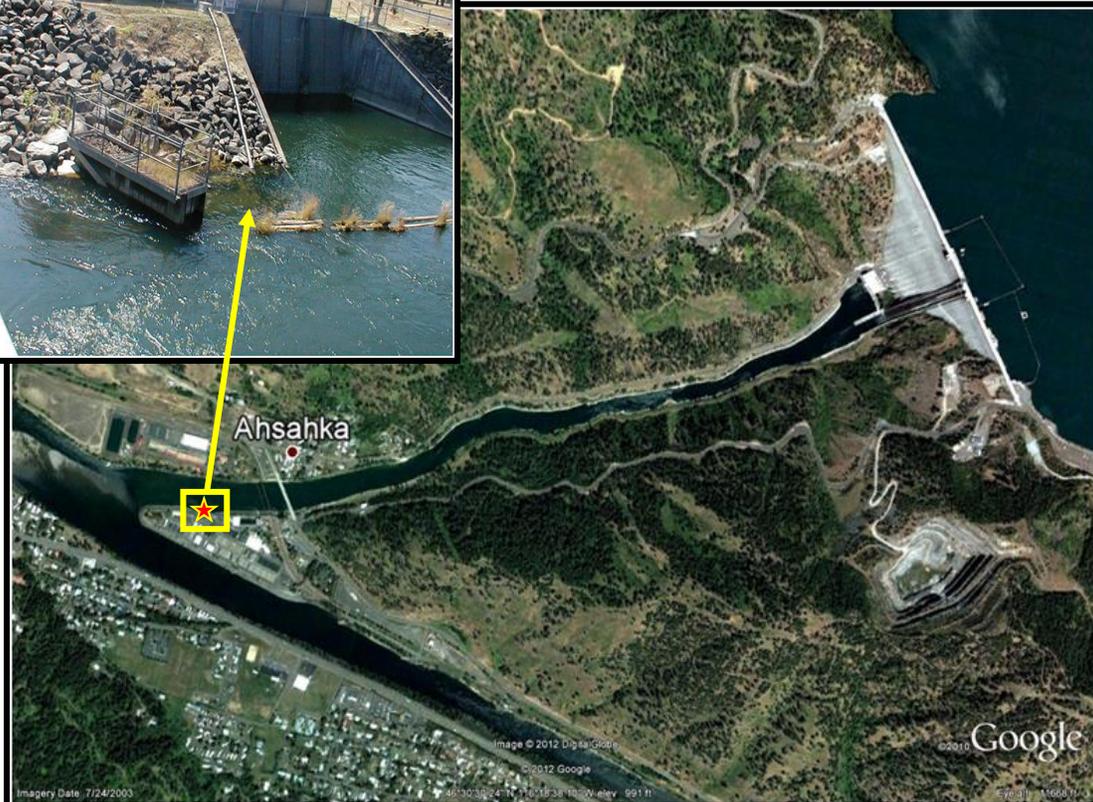
9. Dworshak TDG Monitoring Station (DWQI)

Gage Elevation: Fixed
Latitude: 46° 30' 11.6464" N
Longitude: 116° 19' 16.4090" W
Distance from Dam: 1.5 miles
Datum: NAD83
River: North Fork, Clearwater River
River Mile: 0.5
USGS-ID: 13341000
Owner: U.S. Army Corps of Engineers-NWW
Gauge Type: Hydrosonde
Data Transmission: GOES Satellite
Dates of Operation: Year round
Years of Operation: 1993 - Present
Water Conditions: Mixed
Location: On the southern bank of the North Fork, Clearwater River between the bridge and the U.S. Fish and Wildlife Service Fish Hatchery outflow pipe.
This gage replaced: N/A
Reason for replacement: N/A
Comments: --

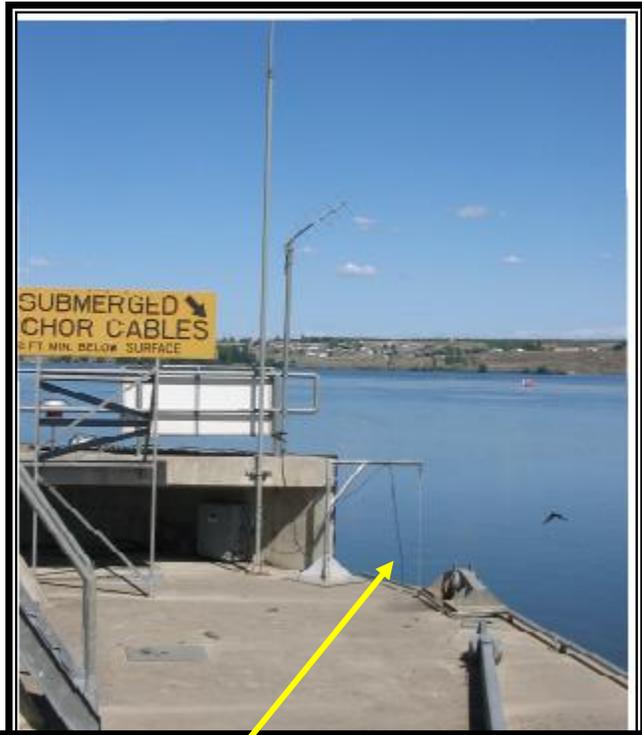
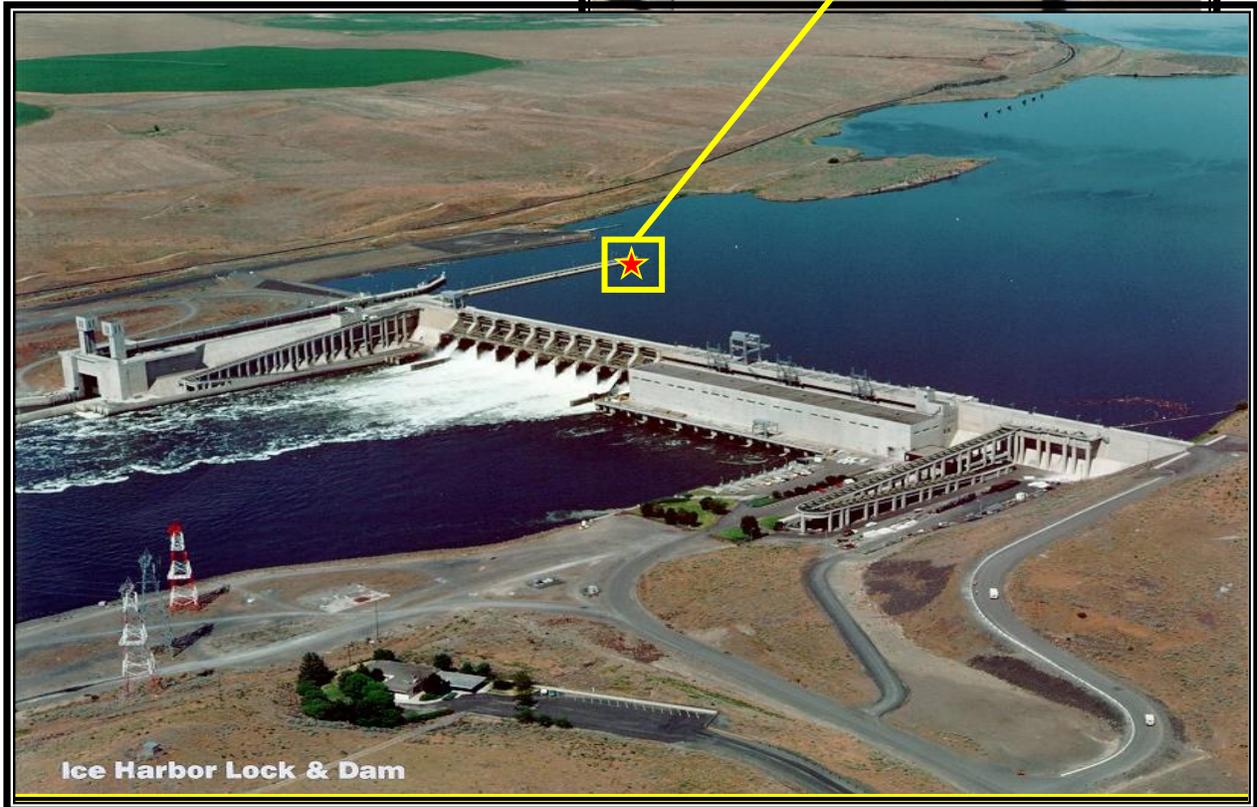
10. Ice Harbor Forebay TDG Monitoring Station (IHRA)

Gage Elevation: Fixed
Latitude: 46° 15' 5.2792" N
Longitude: 118° 52' 43.0096" W
Distance from Dam: 695 ft
Datum: NAD83
River: Snake
River Mile: 10.2
USGS-ID: 13352950
Owner: U.S. Army Corps of Engineers-NWW
Gauge Type: Hydrosonde
Data Transmission: GOES Satellite
Dates of Operation: Was year round prior to 2006, now seasonal (April 1 – Aug. 31*).
Years of Operation: 2005 – Present.
Water Conditions: Mixed
Location: At the upstream end of the navigation lock guidewall.
This gage replaced: IHR
Reason for replacement: Moved due to thermal influences and lowered from 15 ft to 45 ft.
Comments: *The seasonal gauges may go in several weeks before April 1 and remain in operation several weeks after August 31.

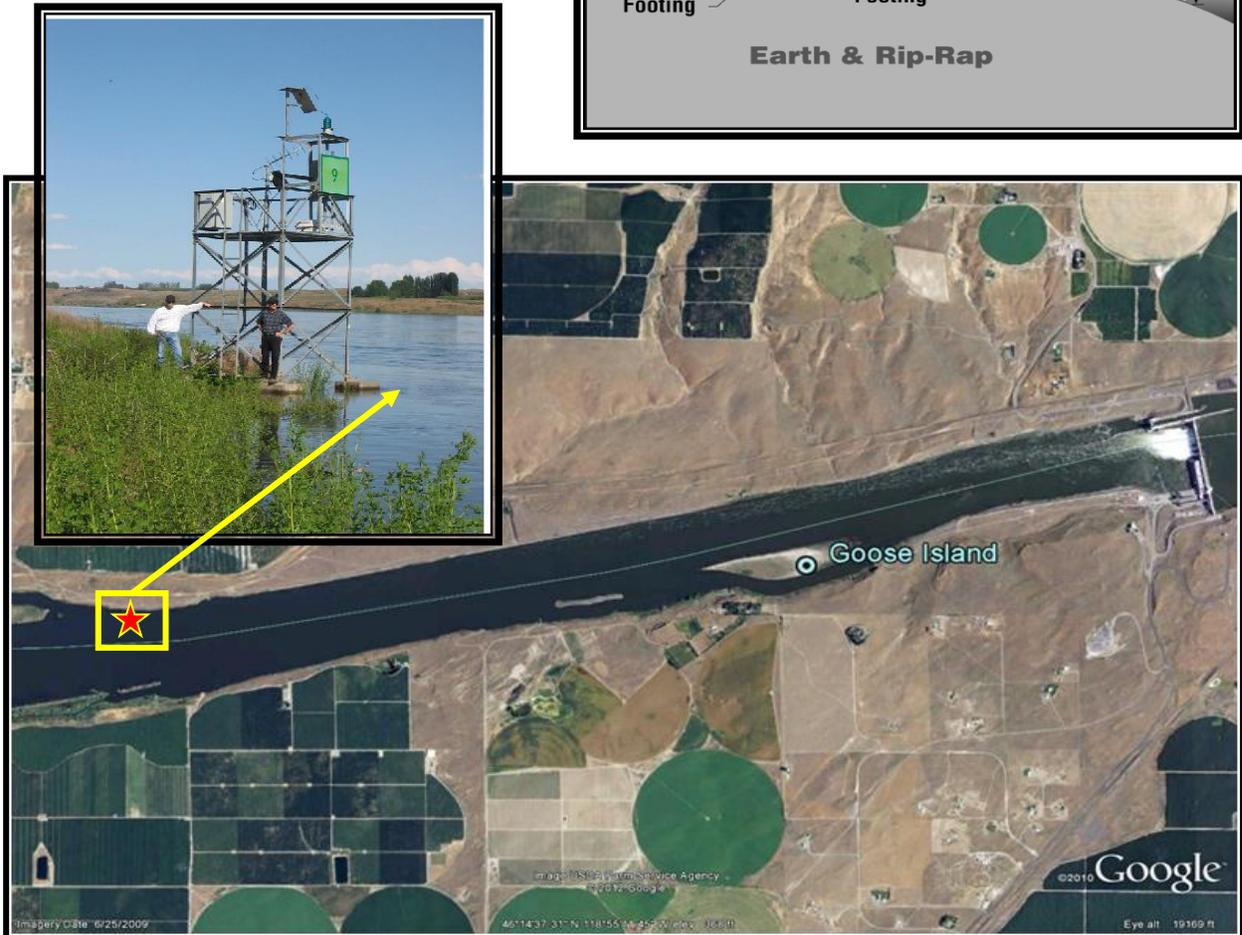
11. Ice Harbor Tailwater TDG Monitoring Station (IDSW)

Gage Elevation: Fixed
Latitude: 46° 14' 27.5868" N
Longitude: 118° 57' 13.7130" W
Distance from Dam: 3.6 miles
Datum: NAD83
River: Snake
River Mile: 6.1
USGS-ID: 13353010
Owner: U.S. Army Corps of Engineers-NWW
Gauge Type: Hydrosonde
Data Transmission: GOES Satellite
Dates of Operation: Was seasonal prior to 2006, now year round.
Years of Operation: 1994 – Present.
Water Conditions: Mixed & spillway
Location: On the northern shore of the Snake River
This gage replaced: N/A
Reason for replacement: N/A
Comments: --

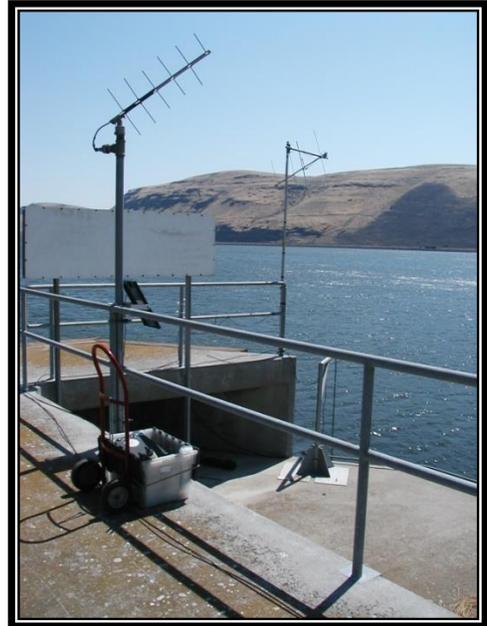
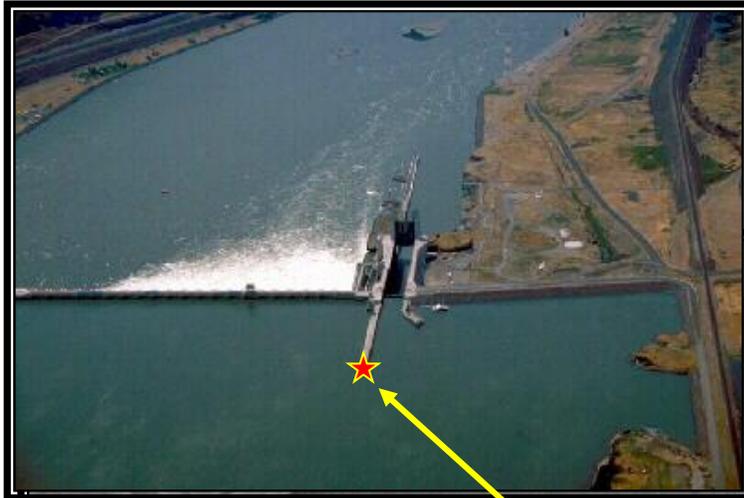
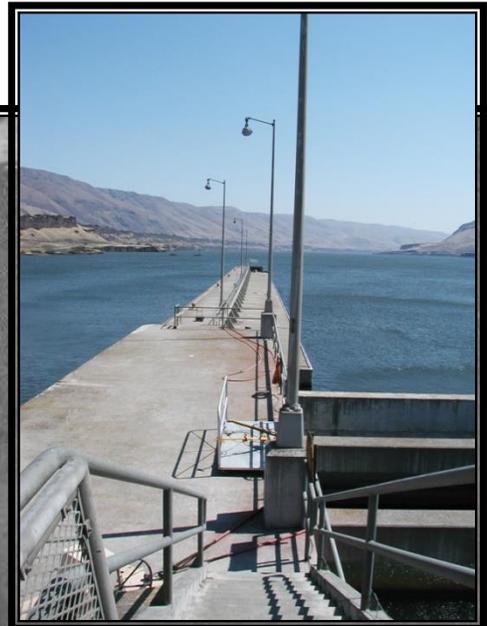
12. John Day Forebay TDG Monitoring Station (JDY)

Location: At upstream end of the navigation lock guidewall.

Reason for replacement: Moved due to thermal influences and lowered from 15 ft to 45 ft.

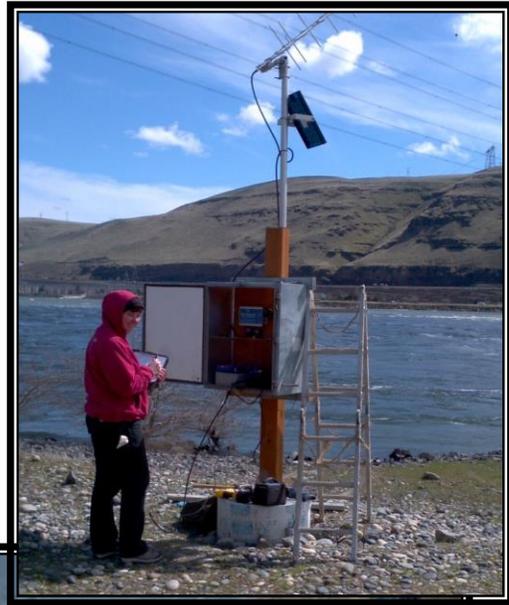
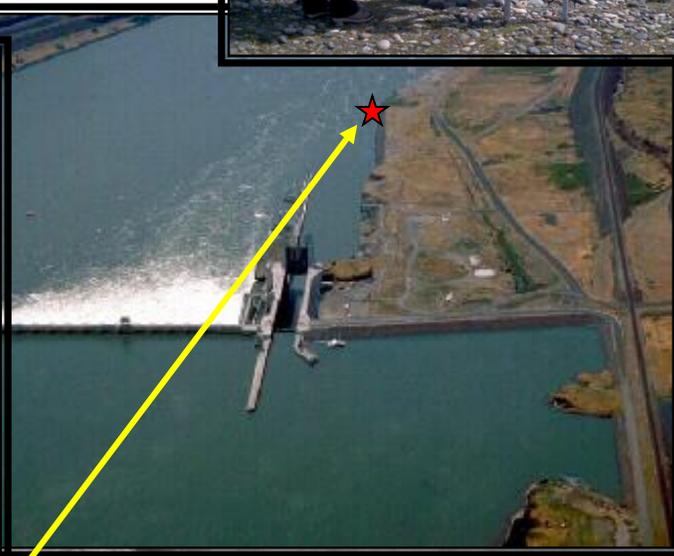
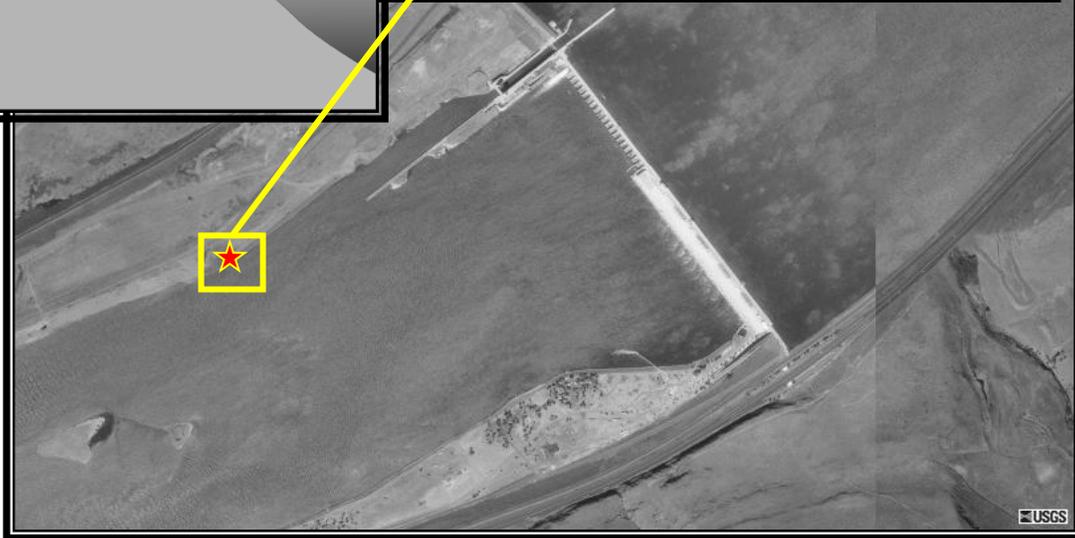
13. John Day Tailwater TDG Monitoring Station (JHAW)

Gage Elevation: Fixed
Latitude: 45° 42' 48.44859" N
Longitude: 120° 42' 39.21477" W
Distance from Dam: 0.8 miles
Datum: NAD83
River: Columbia
River Mile: 214.8
USGS-ID: 454249120423500
Owner: U.S. Army Corps of Engineers-NWP
Gauge Type: Hydrosonde
Data Transmission: GOES Satellite
Dates of Operation: Was seasonal prior to 2006, now year round.
Years of Operation: 1995 – Present
Water Conditions: Spillway
Location: Other Washington shore.
This gage replaced: September 2011
Reason for replacement: Rising flows
Comments: Location of station moved about 12 feet higher elevation from shore, further up the hill.

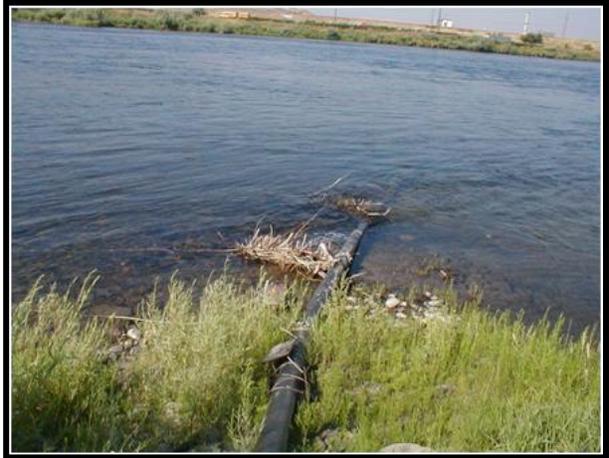
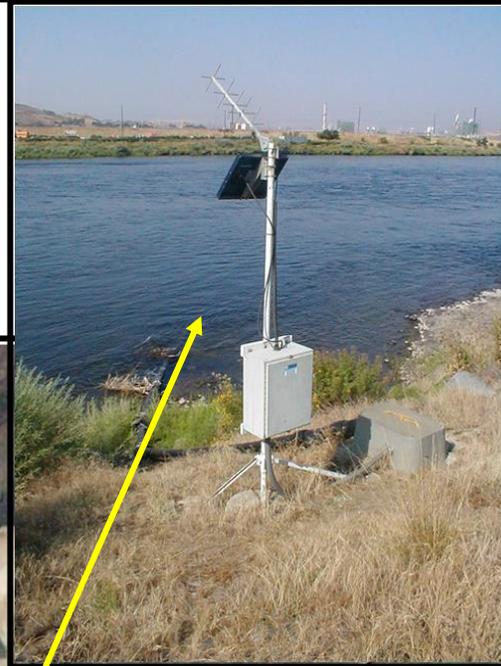
14. Lewiston TDG Monitoring Station (LEWI)

Gage Elevation: Fixed
Latitude: 46° 25' 52.0867" N
Longitude: 116° 56' 43.9589" W
Distance from Dam: N/A
Datum: NAD83
River: Columbia
River Mile: 5.0
USGS-ID: 13343000
Owner: U.S. Army Corps of Engineers-NWW
Gauge Type: Hydrosonde
Data Transmission: GOES Satellite
Dates of Operation: April 1 – Aug. 31*
Years of Operation: 1996 – Present
Water Conditions: Open River
Location: On the northern shore of the Clearwater River just east of the City of Lewiston, Idaho near the junction of Hatwai Road and Central Grade Road.
This gage replaced: N/A
Reason for replacement: N/A
Comments: --

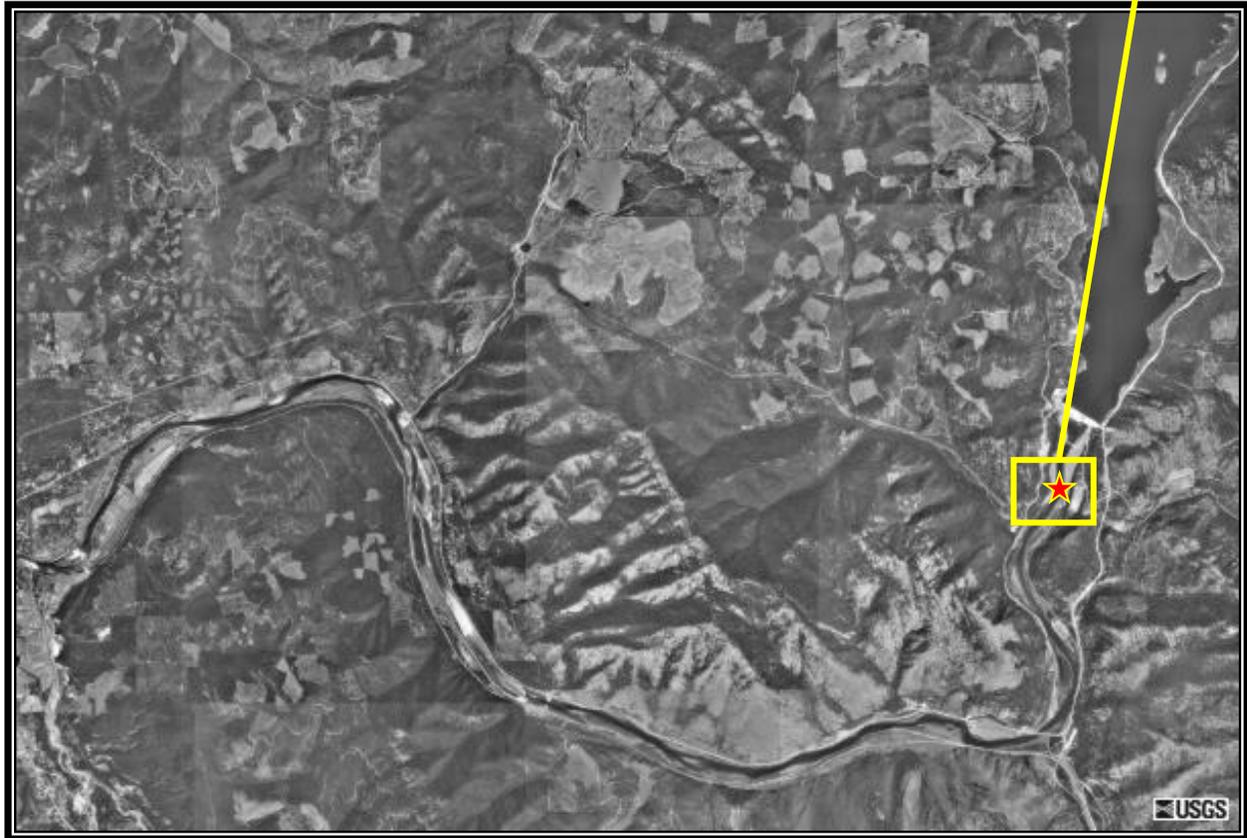
15. Libby Tailwater TDG Monitoring Station (LBQM)

Gage Elevation: Fixed
Latitude: 48° 24' 2.4" N
Longitude: 115° 19' 7.0" W
Distance from Dam: --
Datum: NAD83
River: Kootenai
River Mile: 221.5
USGS-ID:
Owner: U.S. Army Corps of Engineers-NWS
Gauge Type: Hydrosonde
Data Transmission: GOES Satellite and Radio Transmission
Dates of Operation: April 1 – Aug 31*
Years of Operation: 2004 – Present
Water Conditions: Open River
Location: This gauge is located on the eastern shore of the Kootenai River approximately 750 feet downstream of the Libby Dam access road bridge.
This gage replaced: N/A
Reason for replacement: N/A
Comments: *The seasonal gauges may go in several weeks before April 1 and remain in operation several weeks after August 31.

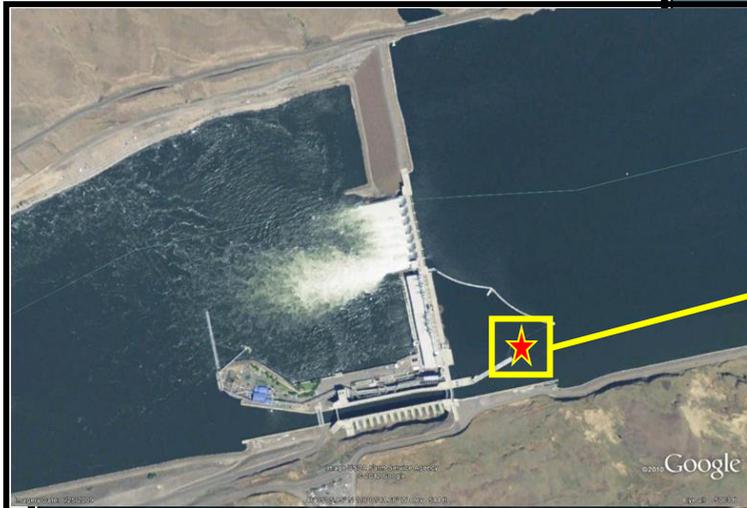
16. Little Goose Forebay TDG Monitoring Station (LGSA)

Location: At the upstream end of the navigation lock guidewall.

Reason for replacement: Move due to thermal influences and lowered from 15 ft to 45 ft.

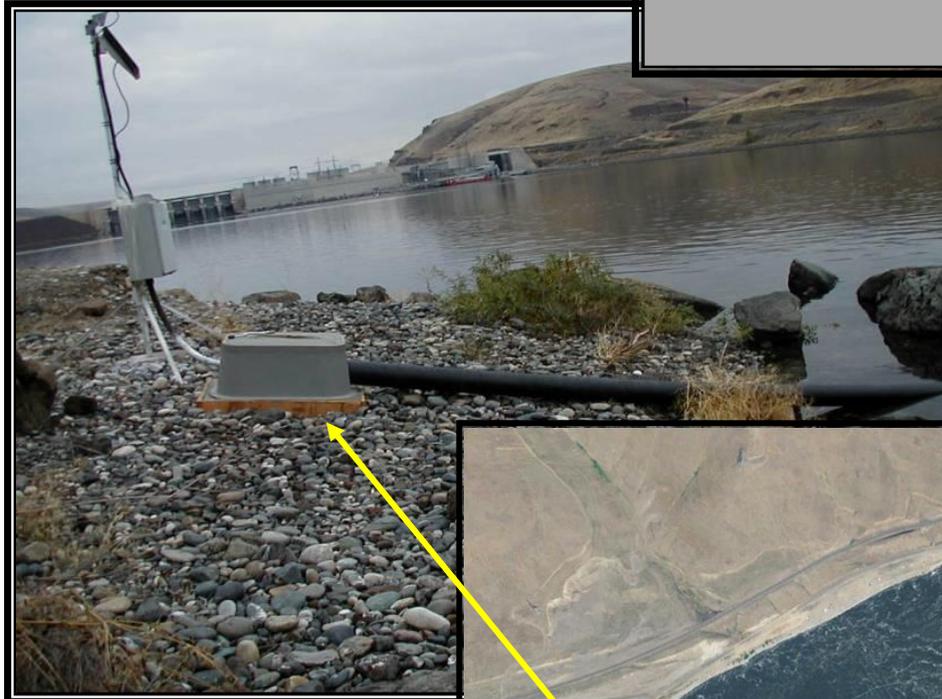
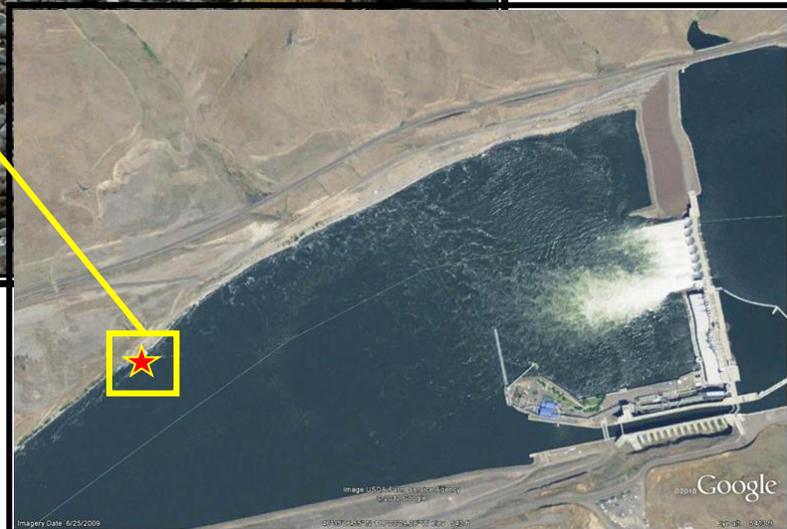
17. Little Goose Tailwater TDG Monitoring Station (LGSW)

Gage Elevation: Fixed
Latitude: 46° 35' 00.5280" N
Longitude: 118° 02' 37.4186" W
Distance from Dam: 0.7 miles
Datum: NAD83
River: Snake
River Mile: 69.6
USGS-ID: 13343860
Owner: U.S. Army Corps of Engineers-NWW
Gauge Type: Hydrosonde
Data Transmission: GOES Satellite
Dates of Operation: Was seasonal prior to 2006, now year round.
Years of Operation: 1995 – Present.
Water Conditions: Switches between mixed & spillway
Location: On the northern shore of the Snake River
This gage replaced: N/A
Reason for replacement: N/A
Comments: --

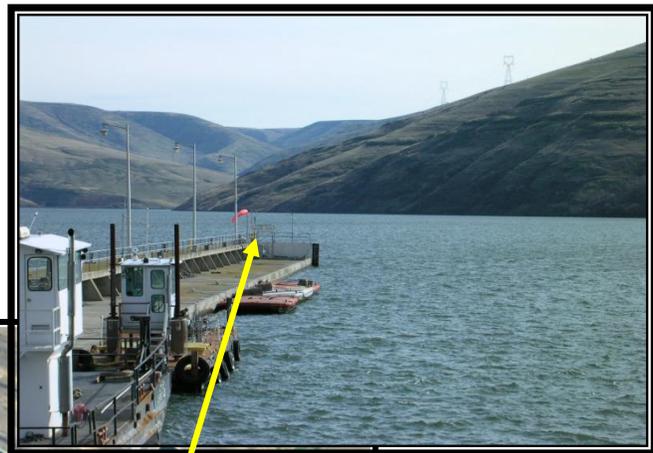
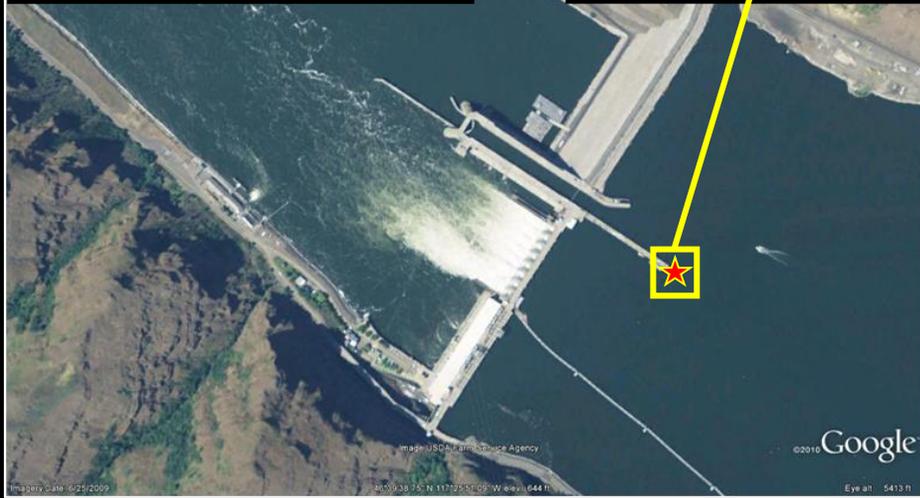
18. Lower Granite Forebay TDG Monitoring Station (LWG)

Location: At the upstream end of the navigation lock guidewall.

Reason for replacement: In March, 2005, this gauge was moved from a depth of 15 ft to 45 ft to avoid thermal influences. The geographic location of the gauge was not changed.

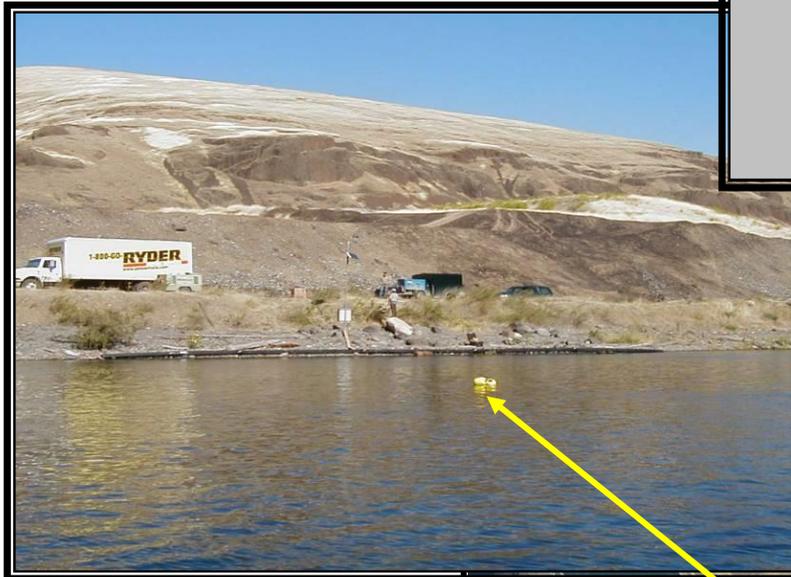
19. Lower Granite Tailwater TDG Monitoring Station (LGNW)

Gage Elevation: Fixed
Latitude: 46° 39' 58.0726" N
Longitude: 117° 26' 19.2595" W
Distance from Dam: 0.8 miles
Datum: NAD83
River: Snake
River Mile: 106.7
USGS-ID: 13343595
Owner: U.S. Army Corps of Engineers-NWW
Gauge Type: Hydrosonde
Data Transmission: GOES Satellite
Dates of Operation: Year around
Years of Operation: 1995 – Present.
Water Conditions: Switches between mixed & spillway
Location: On the northeastern shore of the Snake River.
This gage replaced: N/A
Reason for replacement: N/A
Comments: --

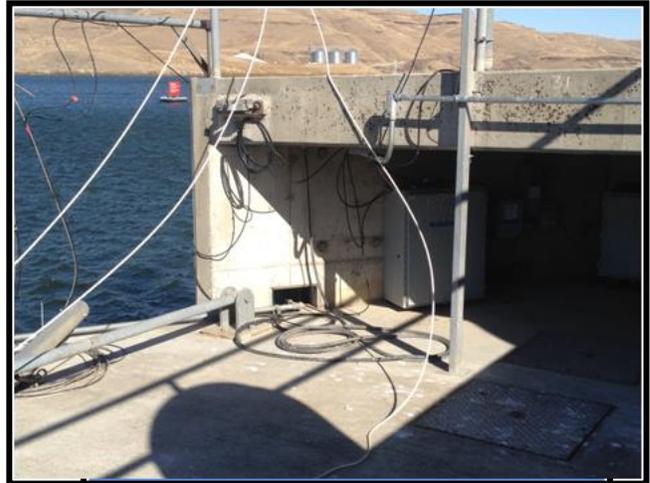
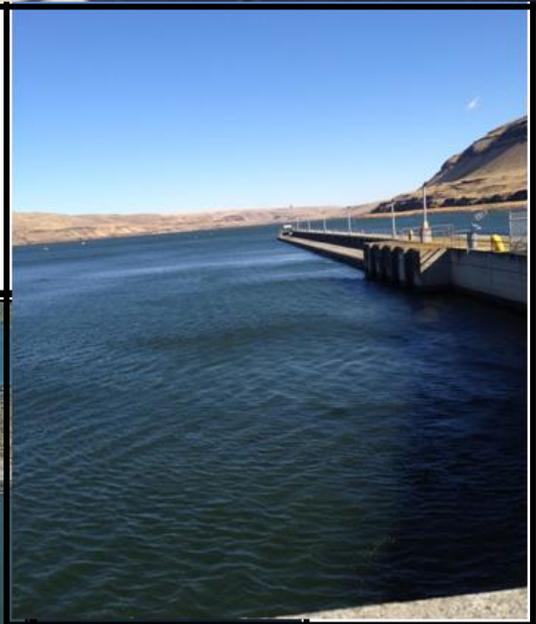
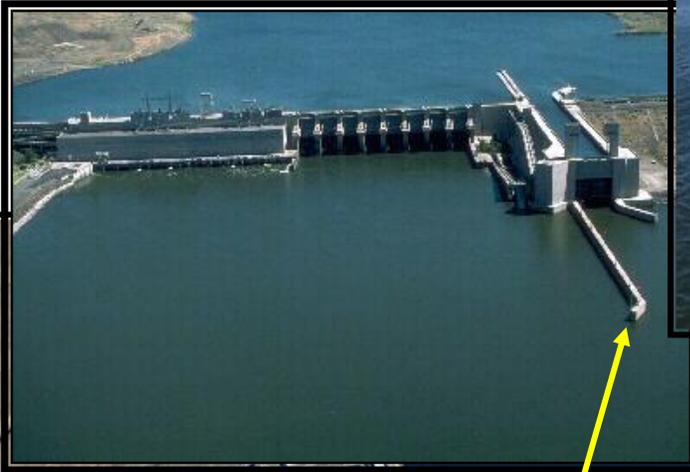
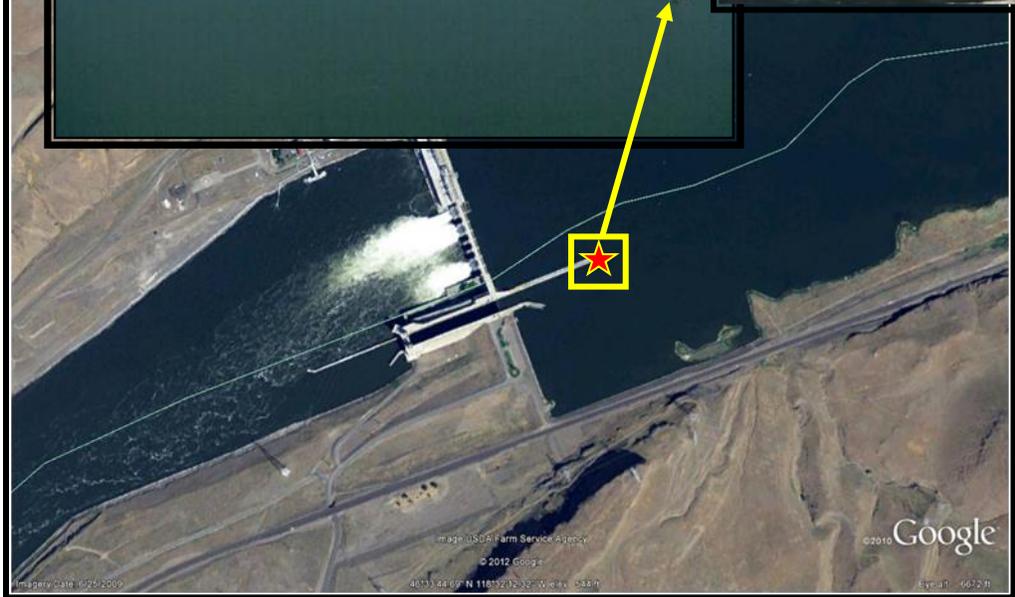
20. Lower Monumental Forebay TDG Monitoring Station (LMNA)

Gage Elevation: Fixed
Latitude: 46° 33' 44.6559" N
Longitude: 118° 32' 08.3477" W
Distance from Dam: 700 ft
Datum: NAD83
River: Snake
River Mile: 41.7
USGS-ID: 13352595
Owner: U.S. Army Corps of Engineers-NWW
Gauge Type: Hydrosonde
Data Transmission: GOES Satellite
Dates of Operation: April 1-Aug. 31*
Years of Operation: 2005 – Present
Water Conditions: Mixed
Location: At the upstream end of the navigation lock guidewall.
This gage replaced: Replaced LMN in 2005
Reason for replacement: Moved due to thermal influences and lowered from 15 ft to 45 ft.
Comments: * The seasonal gauges may go in several weeks before April 1 and remain in operation several weeks after August 31.

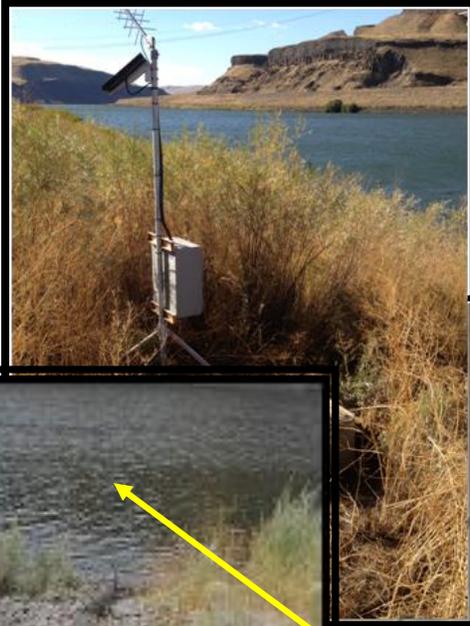
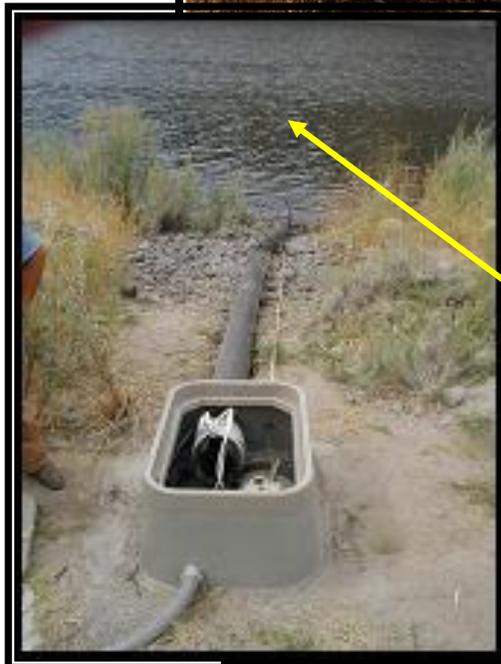
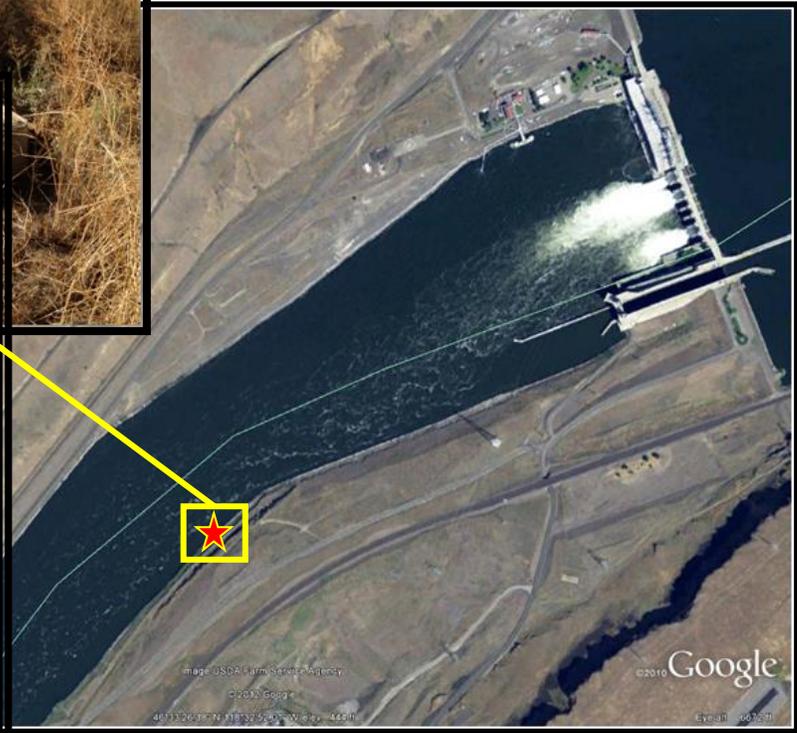
21. Lower Monumental Tailwater TDG Monitoring Station (LMNW)

Gage Elevation: Fixed
Latitude: 46° 33' 04.5051" N
Longitude: 118° 32' 58.9500" W
Distance from Dam: 1 mile
Datum: NAD83
River: Snake
River Mile: 40.4
USGS-ID: 13352600
Owner: U.S. Army Corps of Engineers-NWW
Gauge Type: Hydrosonde
Data Transmission: GOES Satellite
Dates of Operation: Was seasonal prior to 2006, now year around.
Years of Operation: 1995 – Present
Water Conditions: Switches between mixed & spillway.
Location: On the southeastern shore of the Snake River.
This gage replaced: N/A
Reason for replacement: N/A
Comments: --

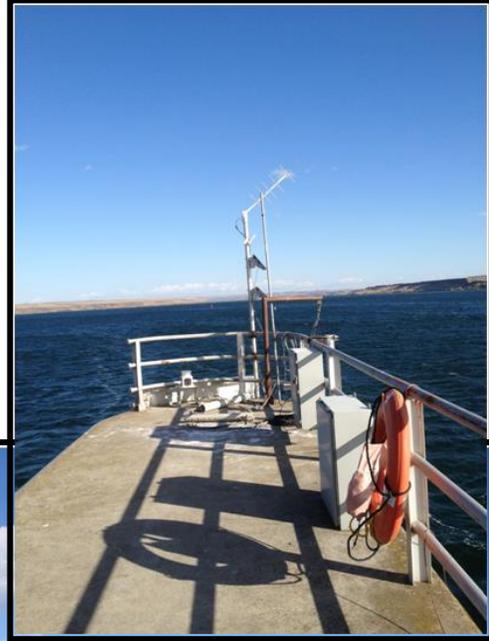
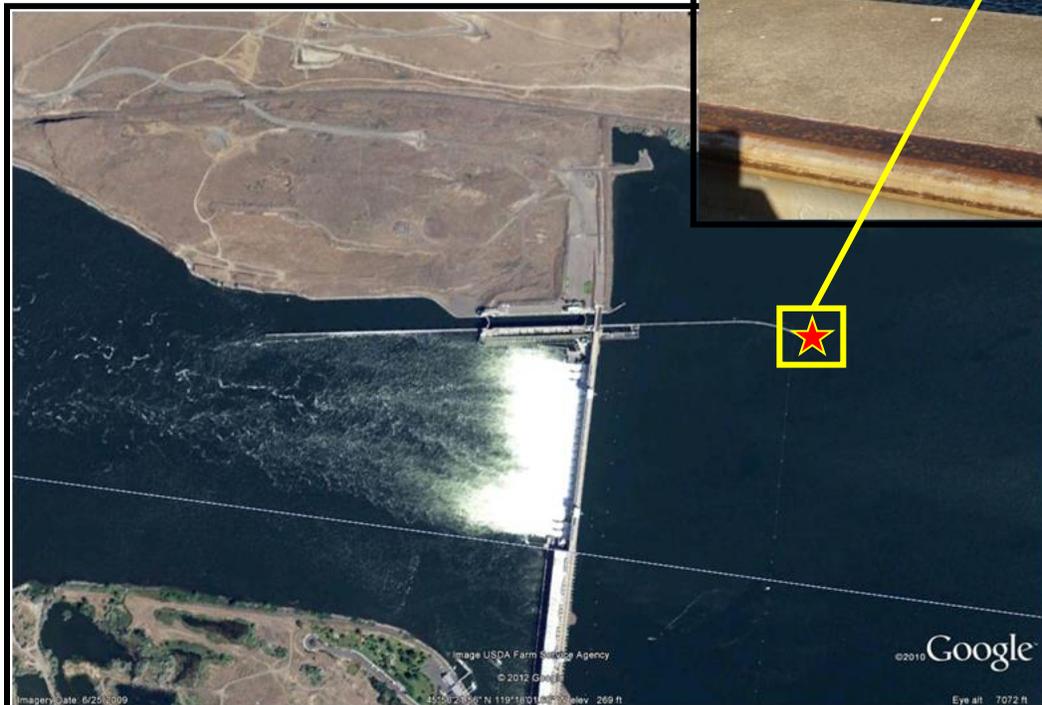
22. McNary Forebay TDG Monitoring Station (MCNA)

Location: At the end of the navigation lock guidewall near the Washington shoreline.

Reason for replacement: Moved due to thermal influences and lowered from 15 ft to 45 ft.

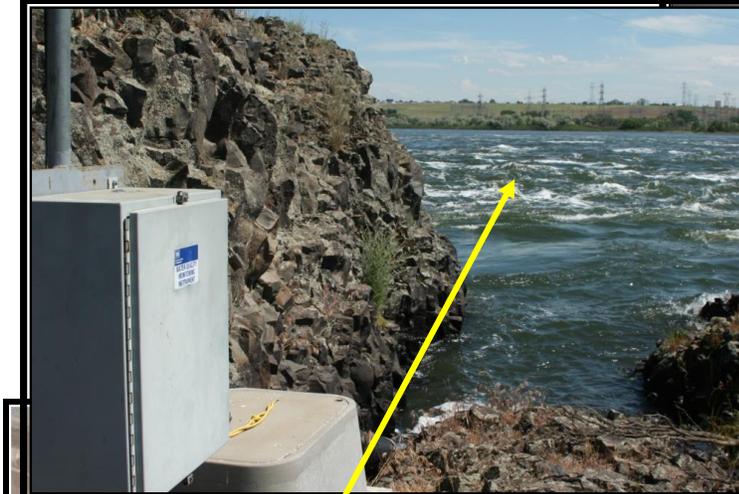
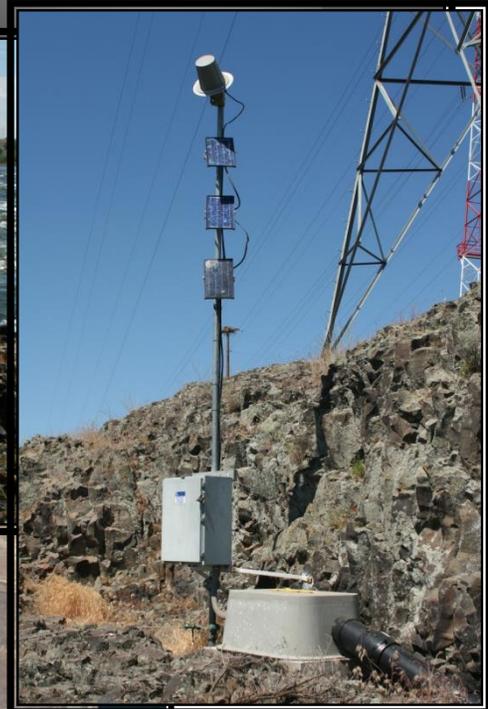
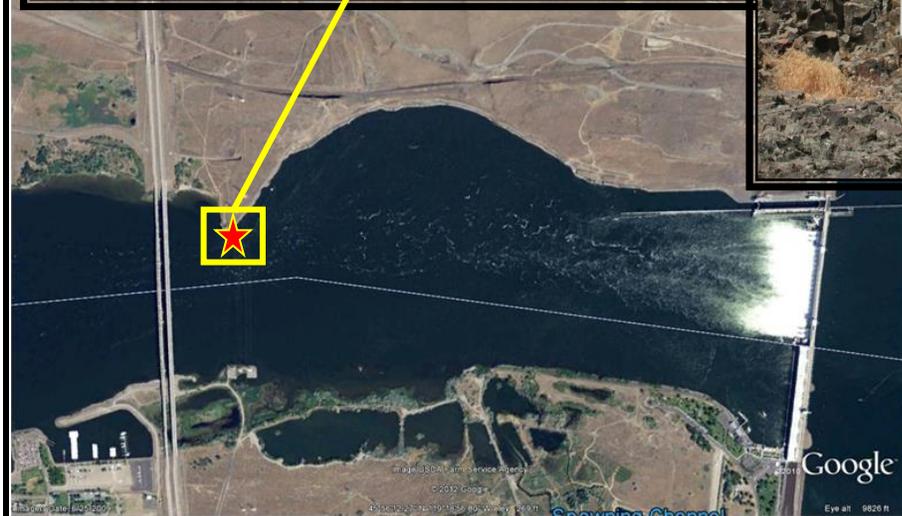
23. McNary Tailwater TDG Monitoring Station (MCPW)

Gage Elevation: Fixed
Latitude: 45° 56' 02.7775" N
Longitude: 119° 19' 35.4628" W
Distance from Dam: 1.3 miles
Datum: NAD83
River: Columbia
River Mile: 290.7
USGS-ID: 14019240
Owner: U.S. Army Corps of Engineers-NWW
Gauge Type: Hydrosonde
Data Transmission: GOES Satellite
Dates of Operation: Year around
Years of Operation: 1995 - Present
Water Conditions: Spillway
Location: On a rocky outcrop on the Washington shore and just upstream of the Highway 395 Bridge.
This gage replaced: N/A
Reason for replacement: N/A
Comments: --

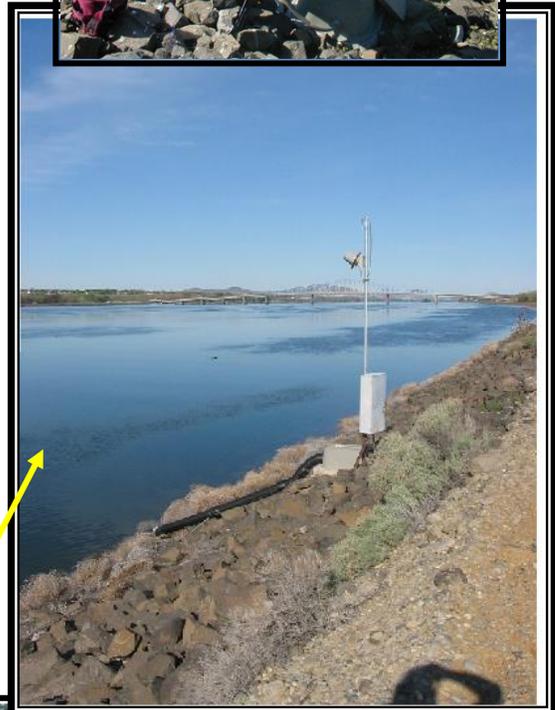
PAQW (Looking Downstream)

Location: On the northern shore of the Columbia River between the S. 10th Avenue Bridge and the Highway 395 Bridge in Pasco, WA. It is on the levee adjacent to a wetland area near the Pasco Youth Baseball Complex. The site is within Lake Wallula approximately 5 miles upstream of the Snake River confluence.

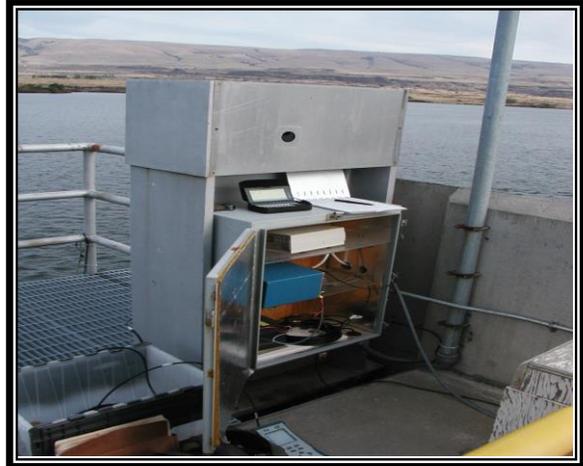
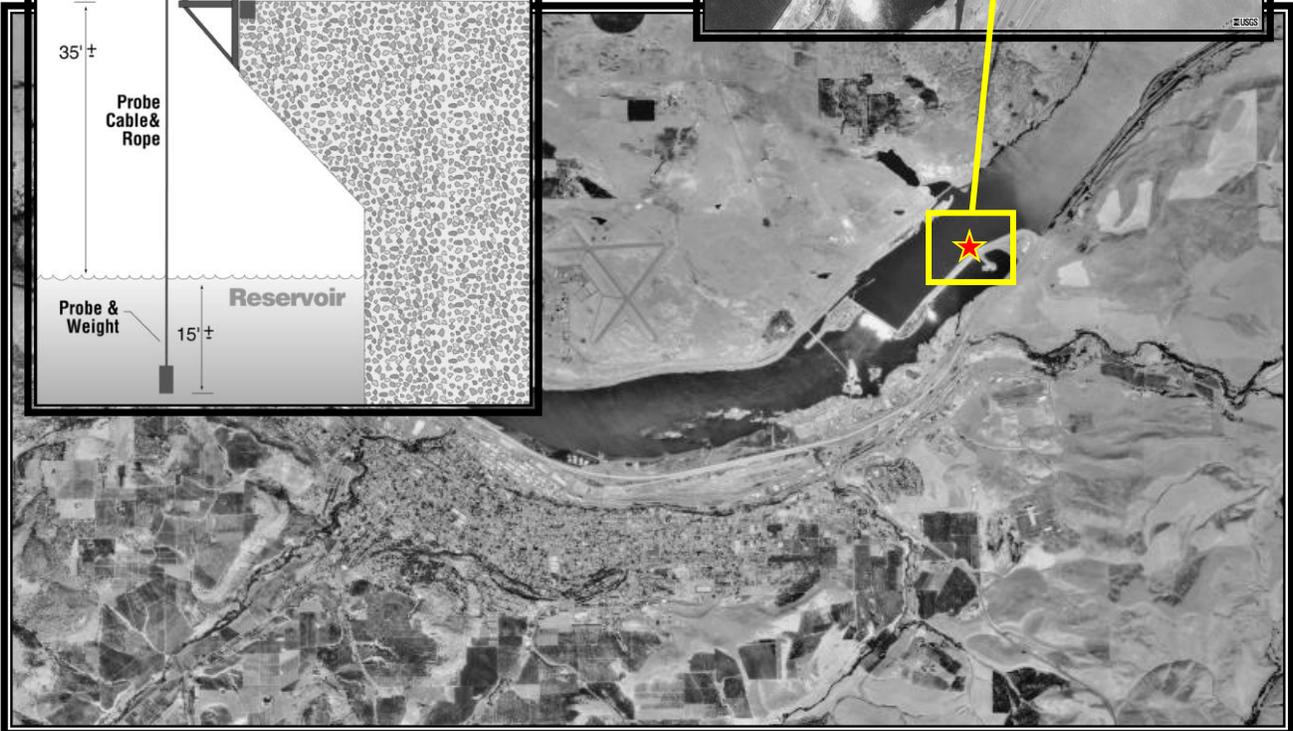
26. The Dalles Forebay TDG Monitoring Station (TDA)

Gage Elevation: Fixed
Latitude: 45° 37' 11.43618" N
Longitude: 121° 07' 16.25220" W
Distance from Dam: On part of dam
Datum: NAD83
River: Columbia
River Mile: 192.4
USGS-ID: 453712121071200
Owner: U.S. Army Corps of Engineers-NWP
Gauge Type: Hydrosonde
Data Transmission: GOES Satellite
Dates of Operation: April 1 – August 31*
Years of Operation: 1985 – Present
Water Conditions: Mixed
Location: In forebay of dam near the end of Powerhouse Unit 22.
This gage replaced: N/A
Reason for replacement: N/A
Comments: * The seasonal gauges may go in several weeks before April 1 and remain in operation several weeks after August 31.
