Appendix A

2016 Total Dissolved Gas Fixed Monitoring Stations

Updated October 2016

Introduction

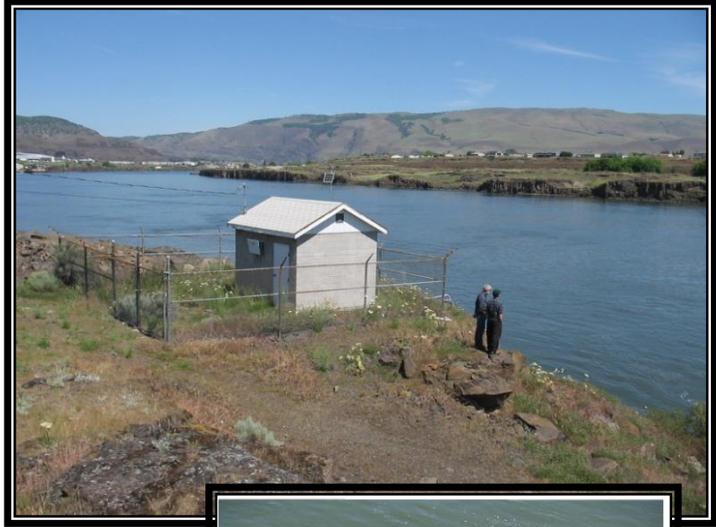
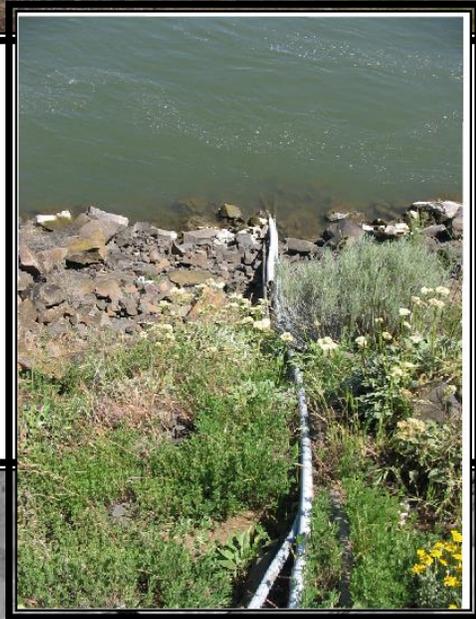
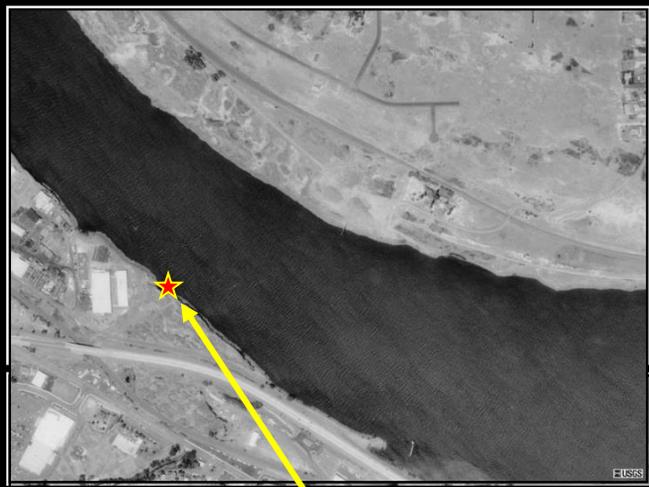
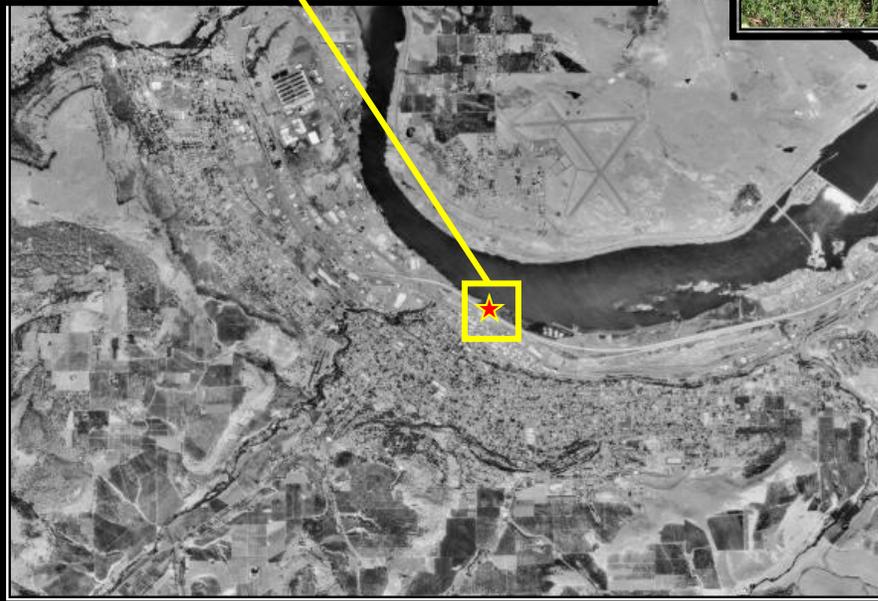
27. The Dalles Tailwater TDG Monitoring Station (TDDO)

Gage Elevation: Fixed (107.6 ft)
Latitude: 45° 36' 26.43330" N
Longitude: 121° 10' 24.25569" W
Distance from Dam: 2.5 miles
Datum: NAD83
River: Columbia
River Mile: 189.1
USGS-ID: 14105700
Owner: U.S. Army Corps of Engineers-NWP
Gauge Type: Hydrosonde
Data Transmission: GOES Satellite
Dates of Operation: Was seasonal prior to 2006, now year around
Years of Operation: 1996 – Present
Water Conditions: Mixed
Location: Off Bargeway Road from Webber Street, near industrial complex.
This gage replaced: N/A
Reason for replacement: N/A
Comments: --

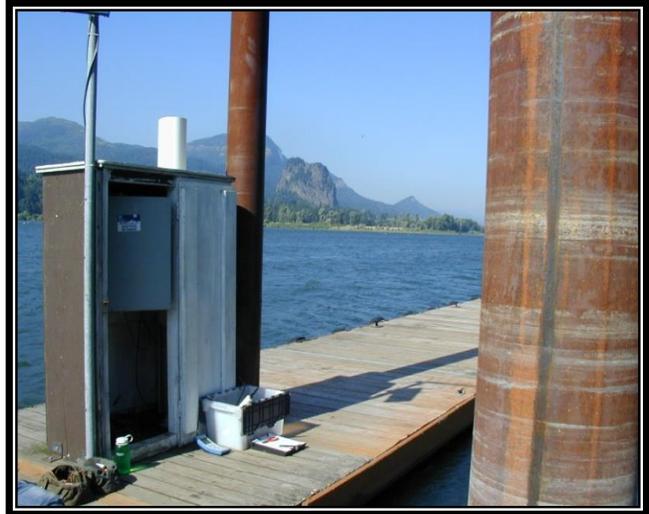
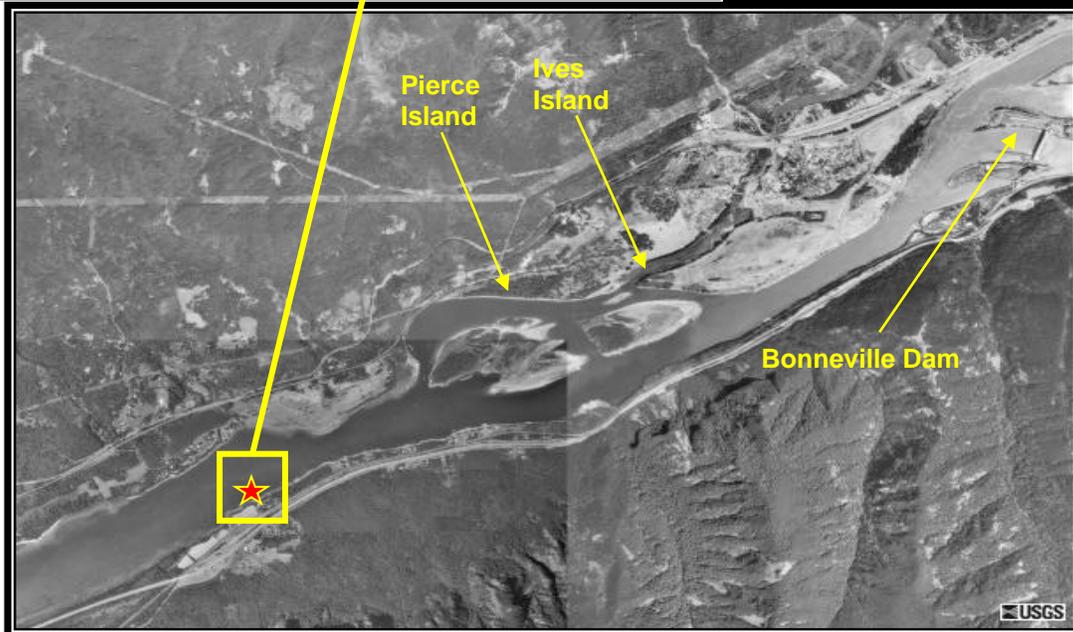
28. Warrendale TDG Monitoring Station (WRNO)

Gage Elevation: Variable
Latitude: 45° 36' 29.42299" N
Longitude: 122° 02' 18.30278" W
Distance from Dam: Approximately 6 miles downstream of dam
Datum: NAD83
River: Columbia
River Mile: 140.3
USGS-ID: 453630122021400
Owner: U.S. Army Corps of Engineers-NWP
Gauge Type: Hydrosonde
Data Transmission: GOES Satellite
Dates of Operation: Year around
Years of Operation: 1985 – Present
Water Conditions: Mixed
Location: This gauge is fixed to the boat dock at “The Fishery” off NE Enquist Pl in Dodson, Oregon (Near Warrendale) approximately 6 miles downstream of Bonneville Dam.
This gage replaced: N/A
Reason for replacement: N/A
Comment: Up until the 2004 spill season, this gauge was used as the BON tailwater gauge for spill management and was operated year around. Currently, this gauge is being used as a fall, winter, and spring TDG monitor for Chum spawning.
