Libby Dam June 2006 Spill: Total Dissolved Gas Monitoring

Libby Dam June 2006 Spill

- Introduction

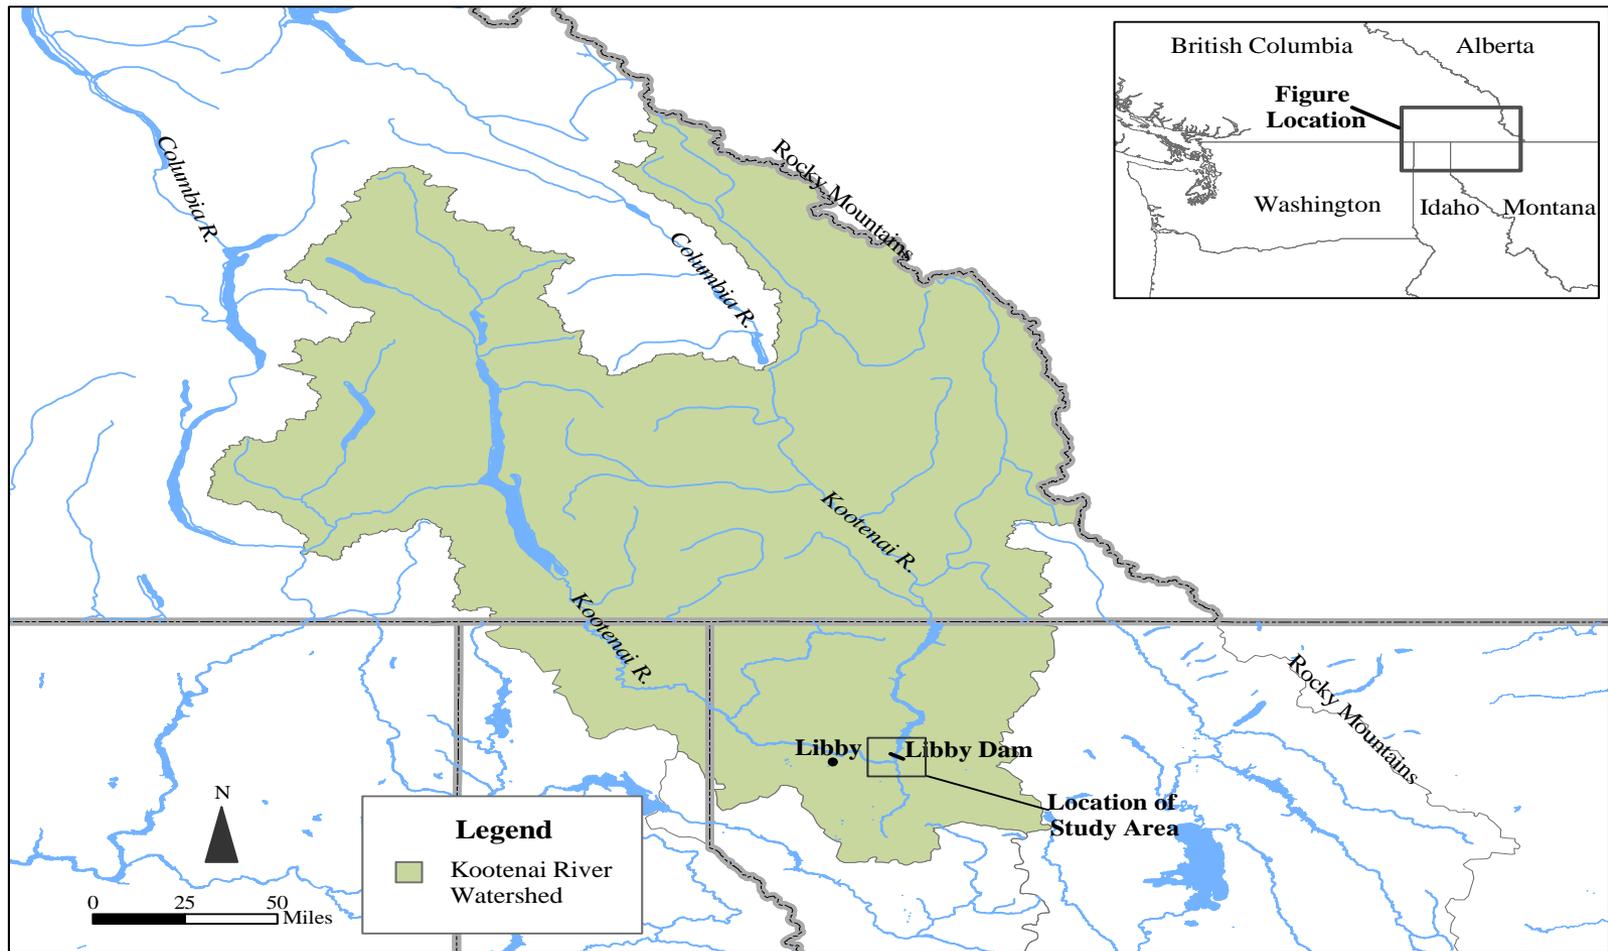
Location of Libby Dam and Lake Koocanusa in the Kootenai River Basin.

- Headwater project.
 - Straight concrete gravity gate controlled dam, 370 feet high and 2,887 feet long, located at RM 221.9 on the Kootenai River.
 - Built by the COE (1966-1972) for flood control.
 - Selective withdrawal system used to maintain downstream temperatures.
 - Full pool elevation 2459 ft, spillway crest 2405 ft.

- Reservoir is approximately 90 miles long.
 - Provides 4.98 million acre-feet of storage.

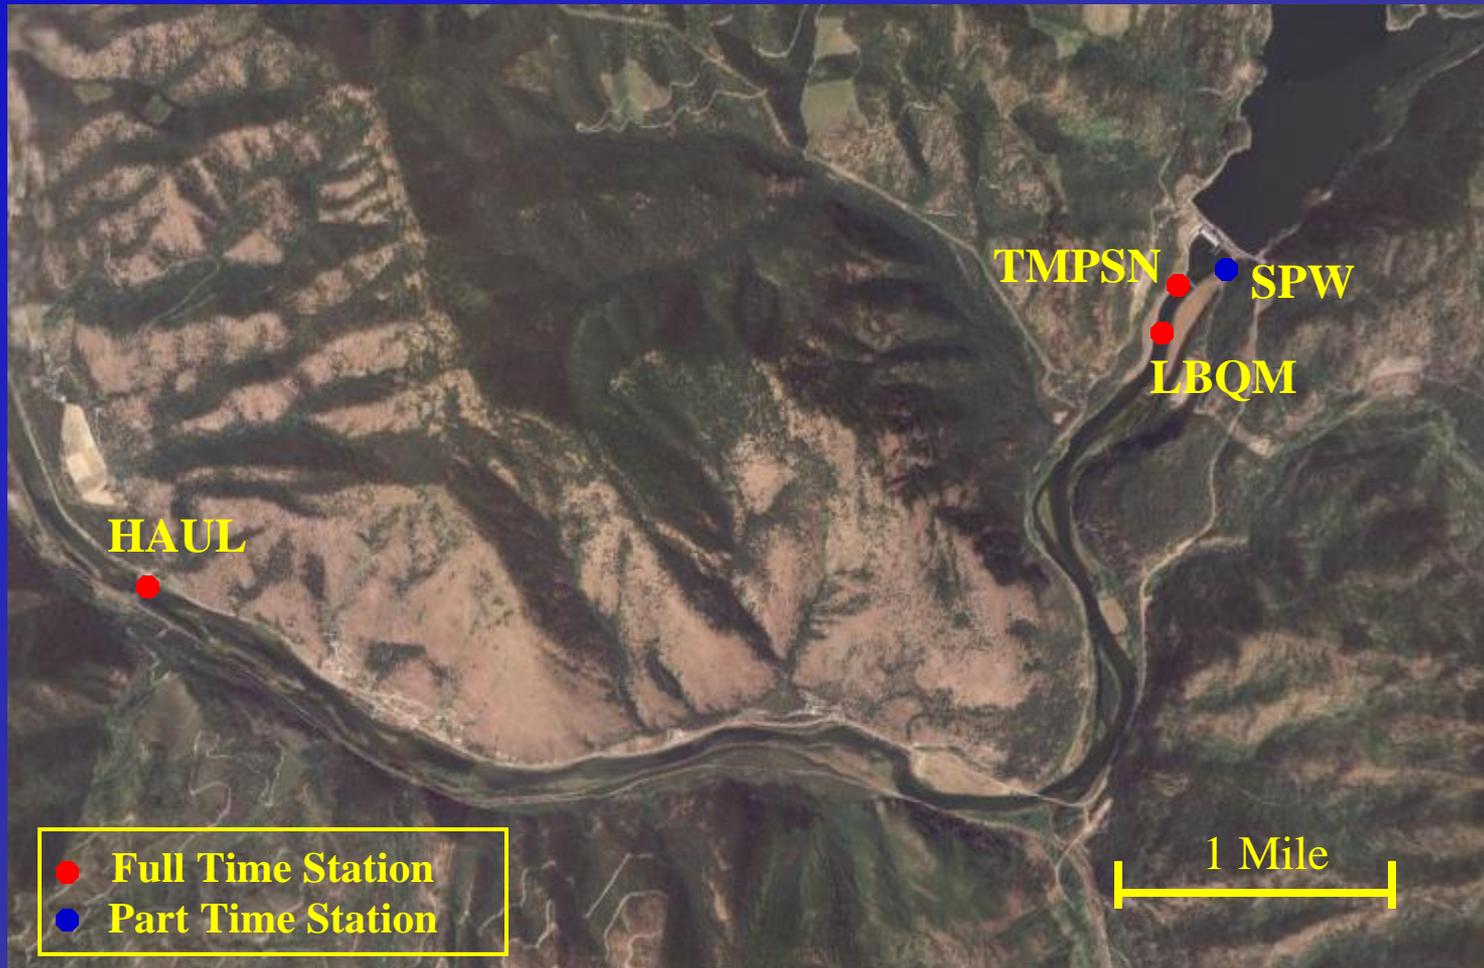
TDG Sampling Stations in the Kootenai River Near Libby Dam

- Station LBQM at USGS tailwater gage
 - Located 0.6 miles downstream on left bank to capture maximum TDG

- Transect of 3 instruments at Thompson Bridge (Station TMPSN1-3), located immediately downstream of Libby Dam to measure lateral TDG distribution
 - One instrument located 8.5 miles downstream at a constriction in the Kootenai River (Station HAUL) represents mixed river conditions
 - One instrument located in back eddy of spill (Station SPW3)

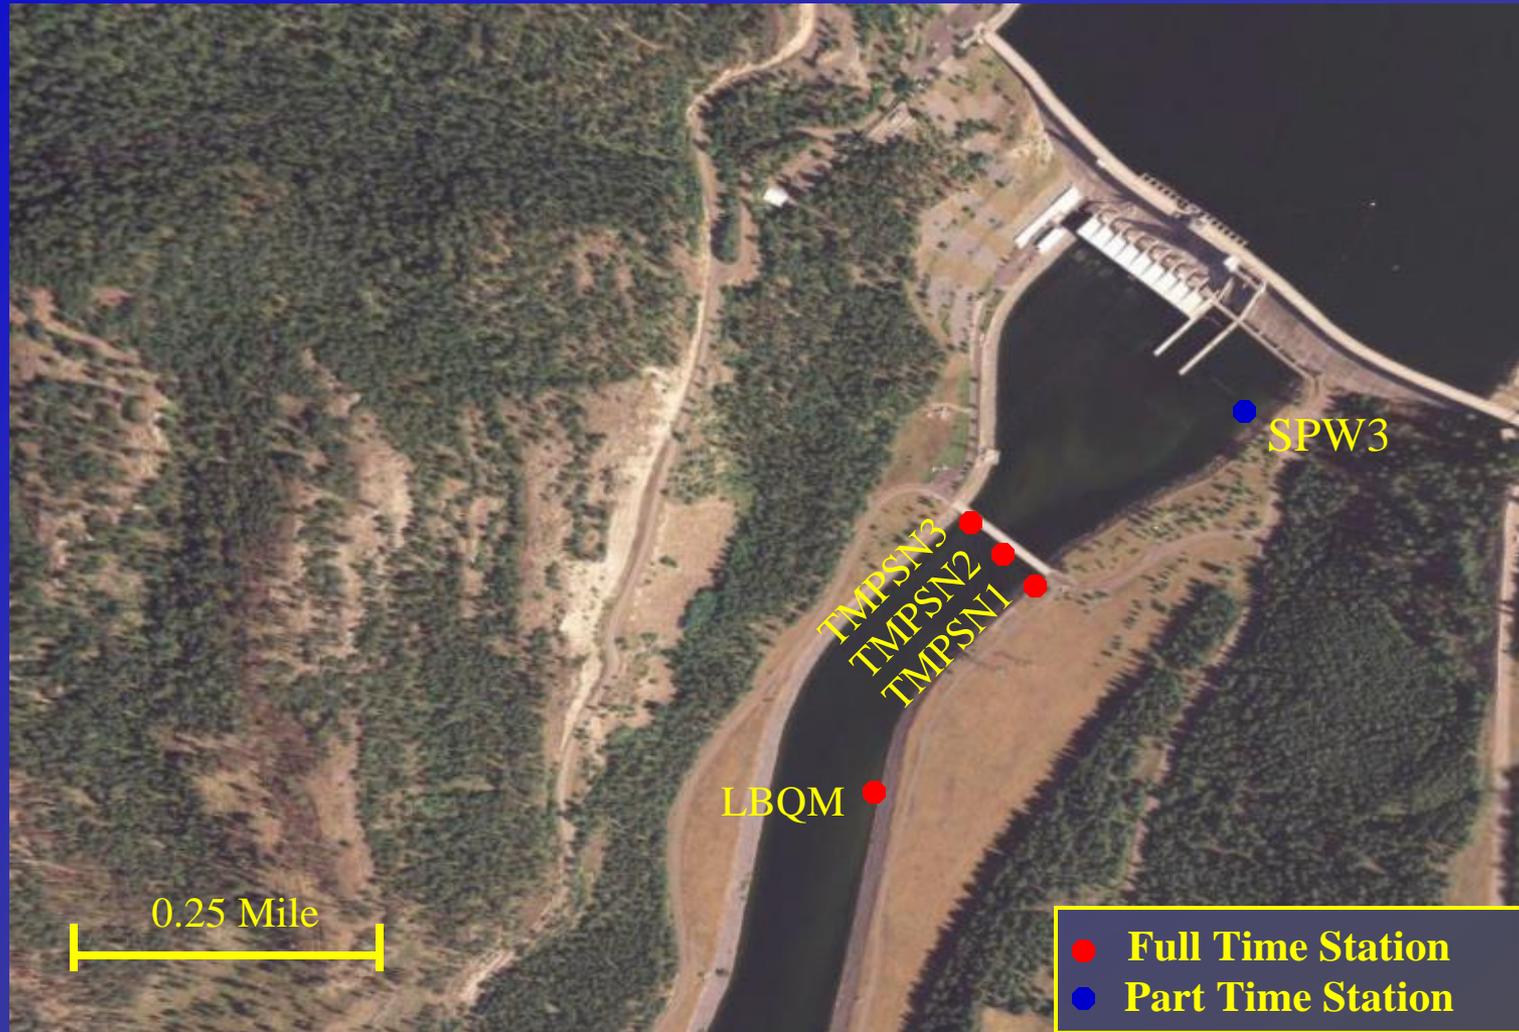
TDG Sampling Stations in the Kootenai River Immediately Below Libby Dam

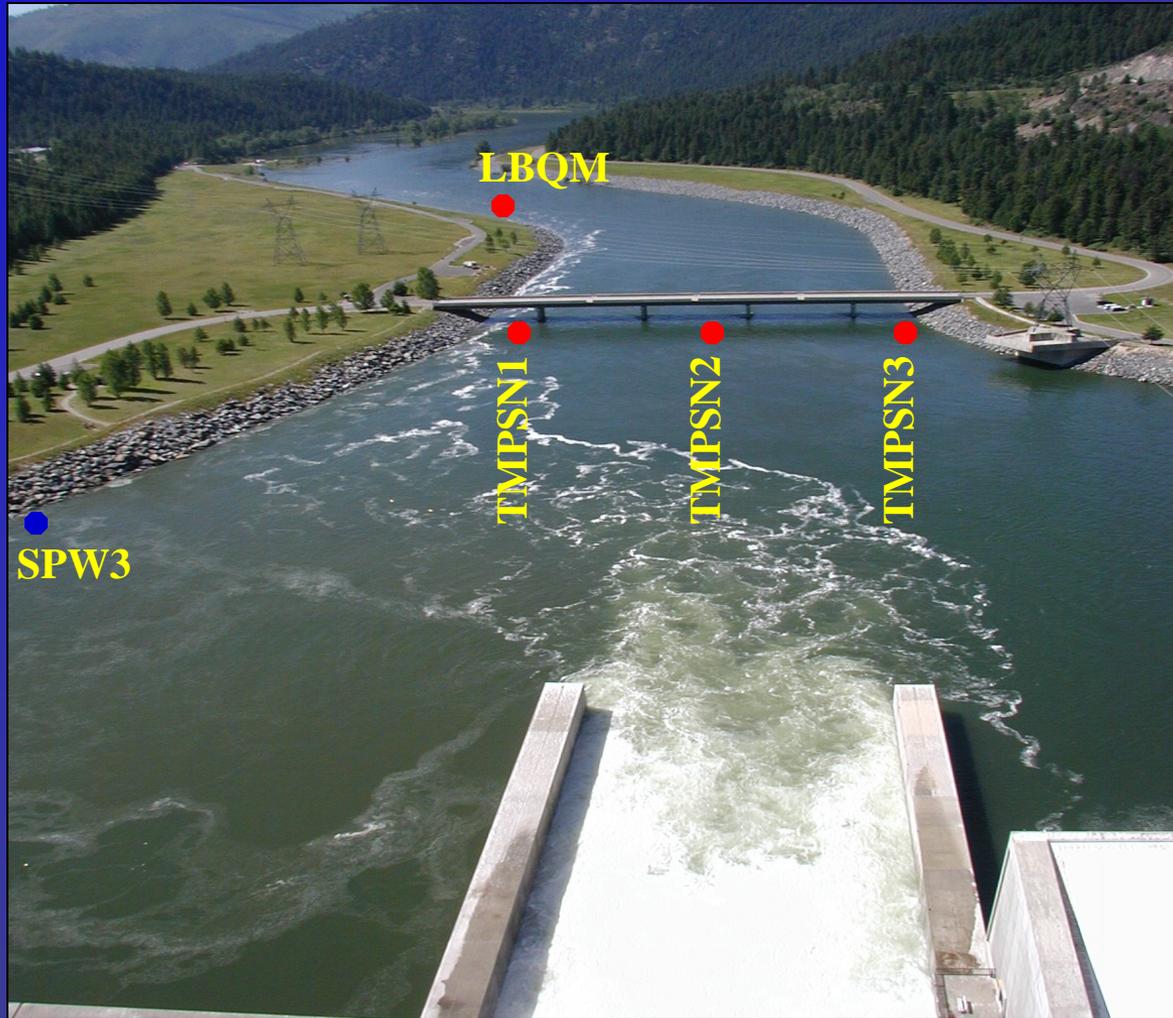
TDG monitoring stations at Libby Dam tailwater

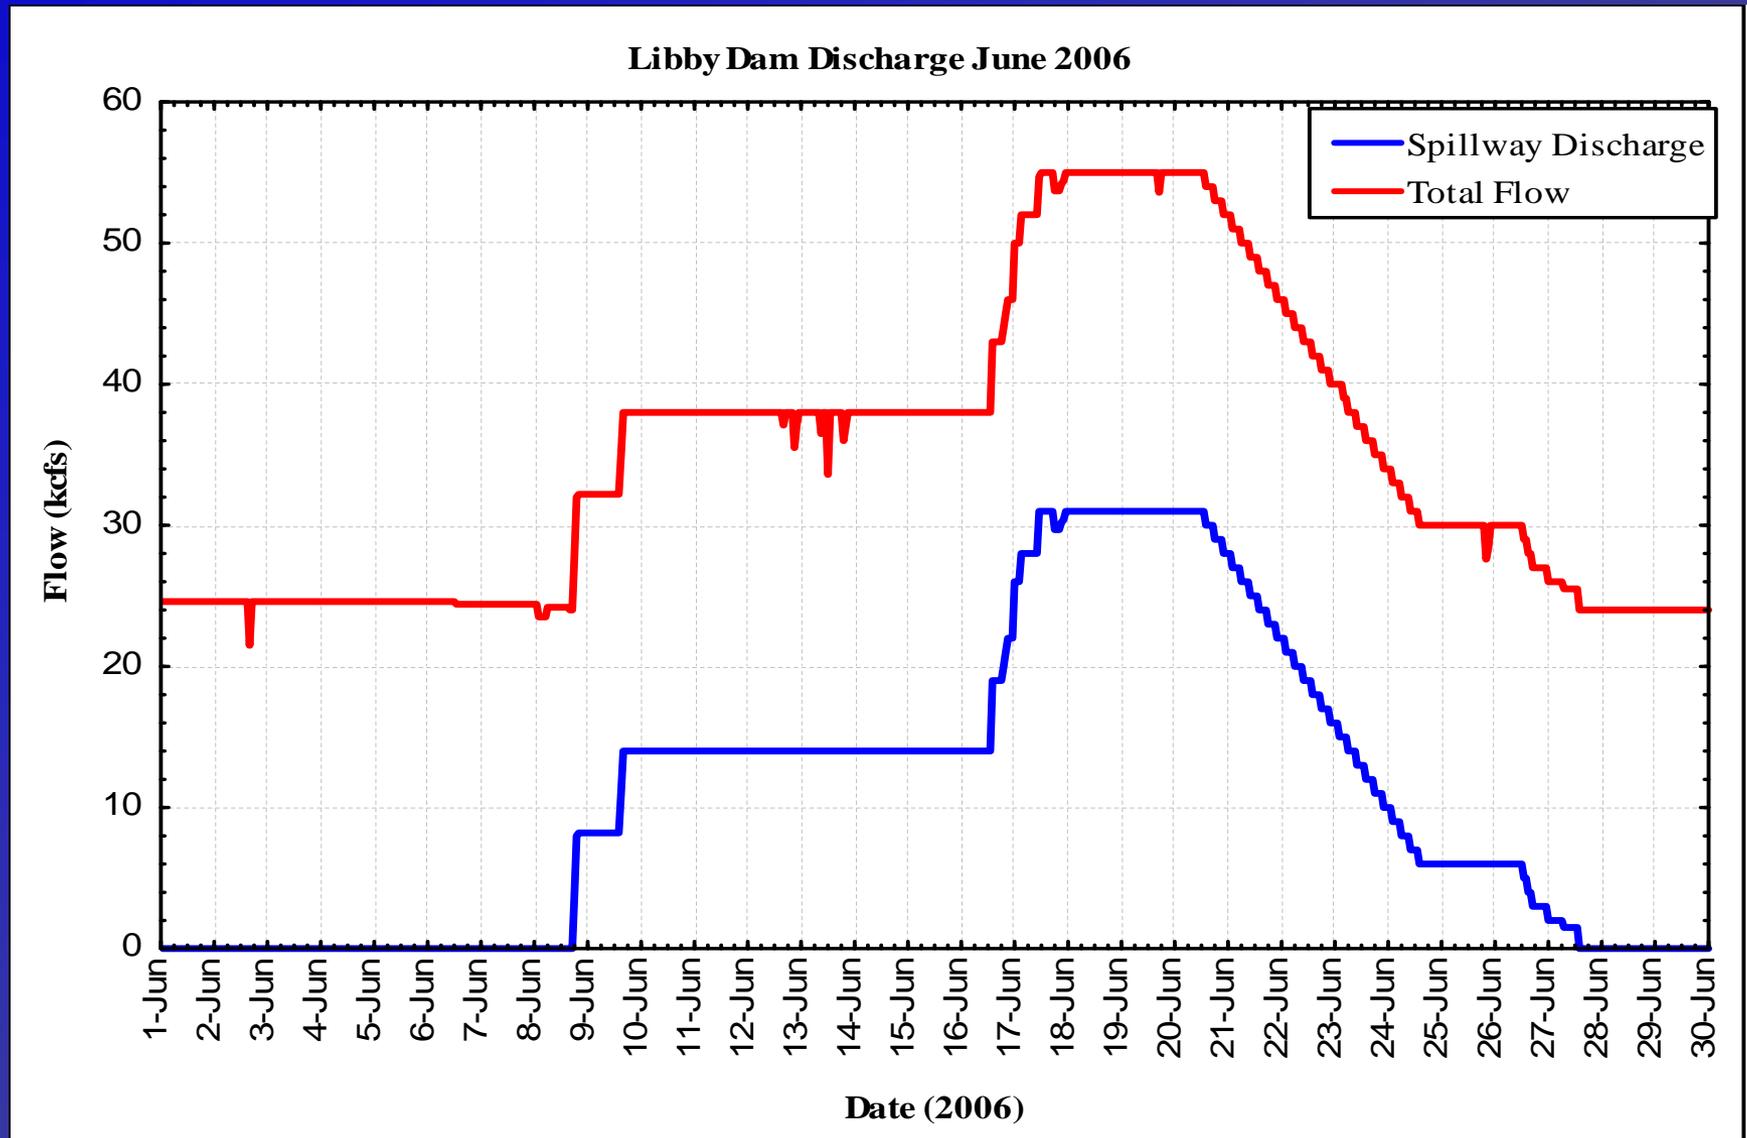
Libby Dam discharge June 2006.

- Spill occurred between June 8 – June 27
 - Spillway discharge 1.5 to 31 kcfs
 - Total discharge 25.5 to 55 kcfs

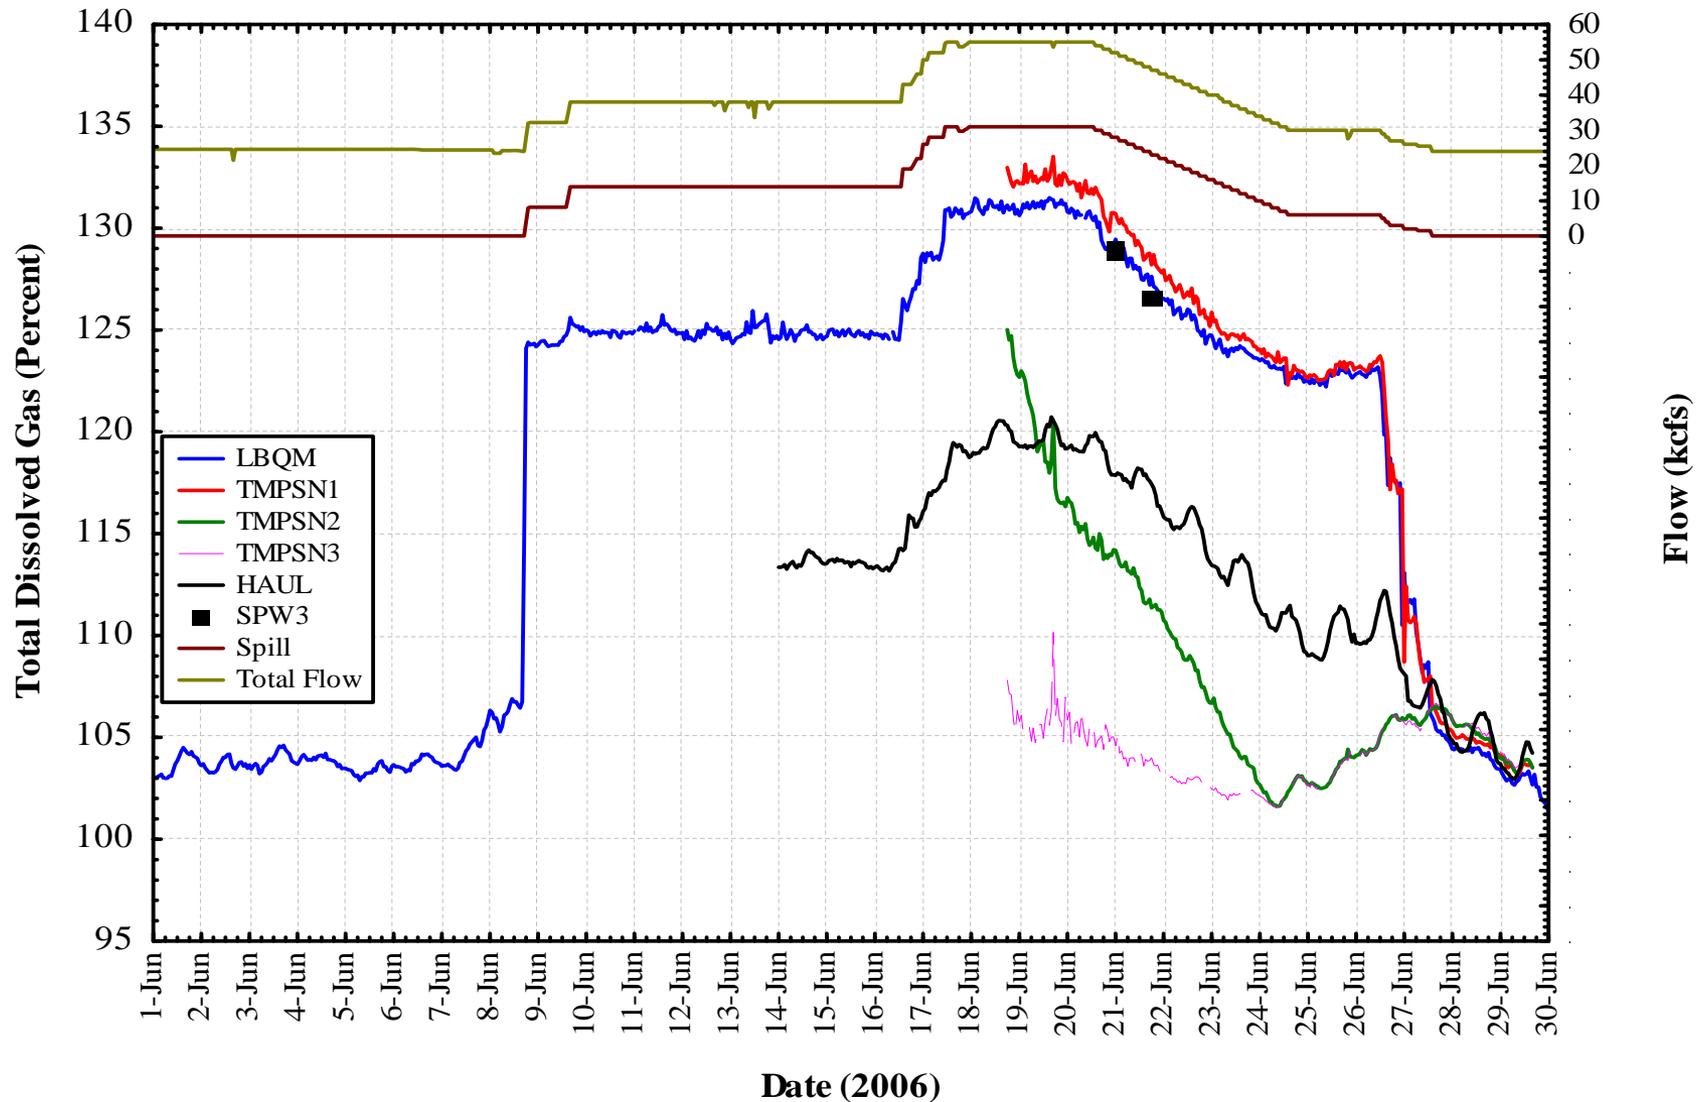
Kootenai River TDG Summary June 2006

- Lateral and longitudinal TDG gradients were apparent in the Kootenai River at all spillway flows
 - Maximum TDG saturations along the left channel bank
 - Lowest TDG saturations associated with powerhouse flows along the right channel bank
 - Mixing of powerhouse flows and riverine processes caused diminishing TDG saturations downstream
 - Maximum TDG saturation at TMPSN1 (133%), at LBQM (131%), and at HAUL (120%)

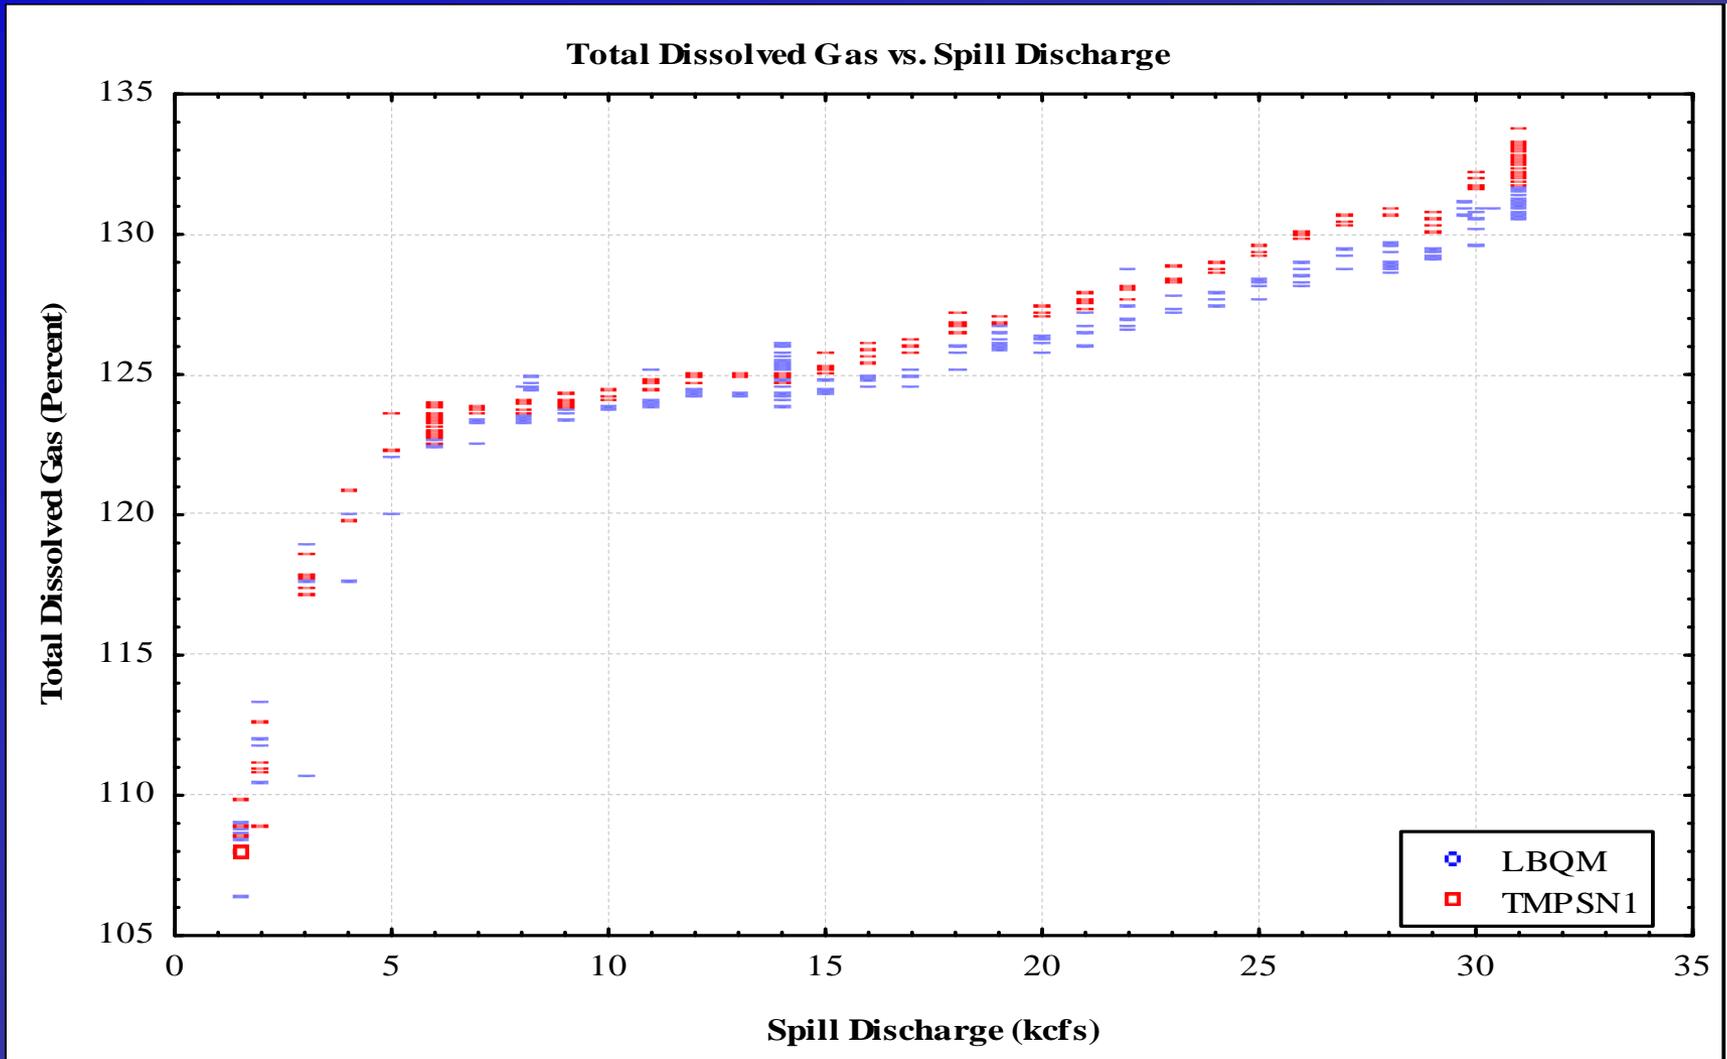
Observed total dissolved gas saturation versus total spillway discharge at Libby Dam, June 2006.

- Spillway Releases Resulted in Elevated of TDG Pressures in Kootenai River
 - TDG saturation at station TMPSN1 and LBQM were similar during 2006 spill
 - Abrupt increase (107-123%) in TDG Pressure as a function of Spill 1.5-6 kcfs
 - Little increase (123-125%) in TDG pressure as a function of spill 6-15 kcfs
 - Mild Increase (124-133%) in TDG Pressure as a Function of Spill 15-31 kcfs
 - TDG saturation at station LBQM was at or below the Montana standard of 110% at spillway releases less than 2 kcfs
 - TDG saturation at station HAUL represented nearly well mixed conditions

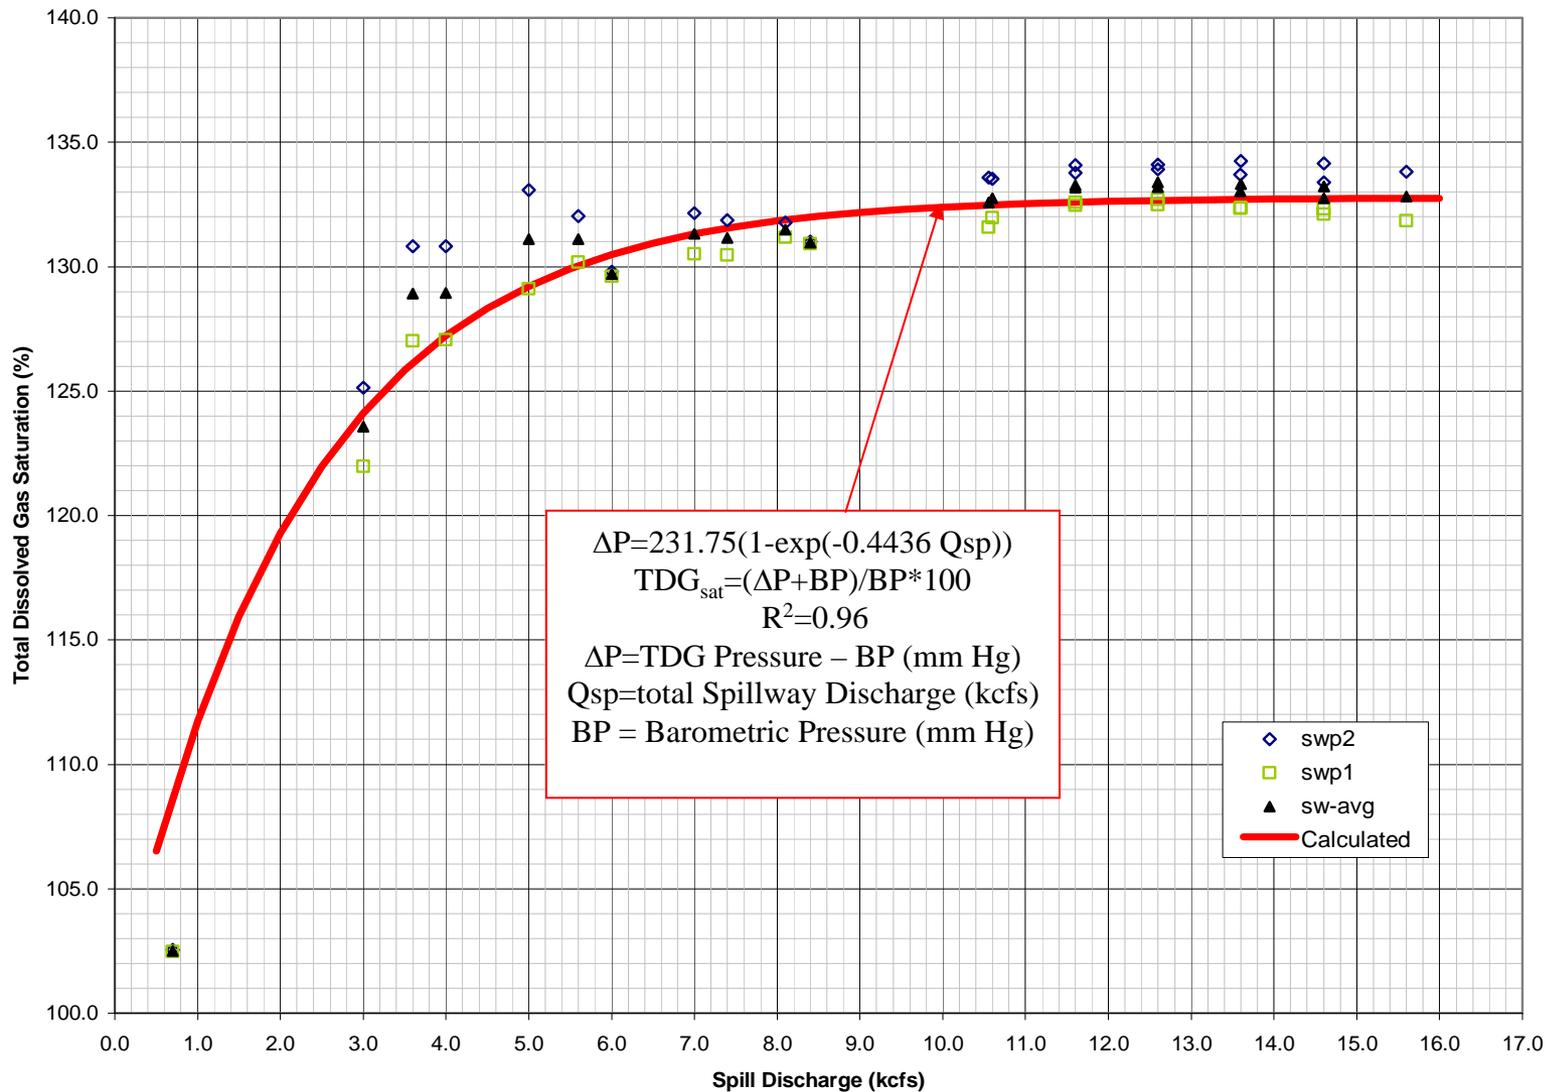
Observed and calculated stilling basin total dissolved gas saturation versus total spillway discharge at Libby Dam, summer 2002.

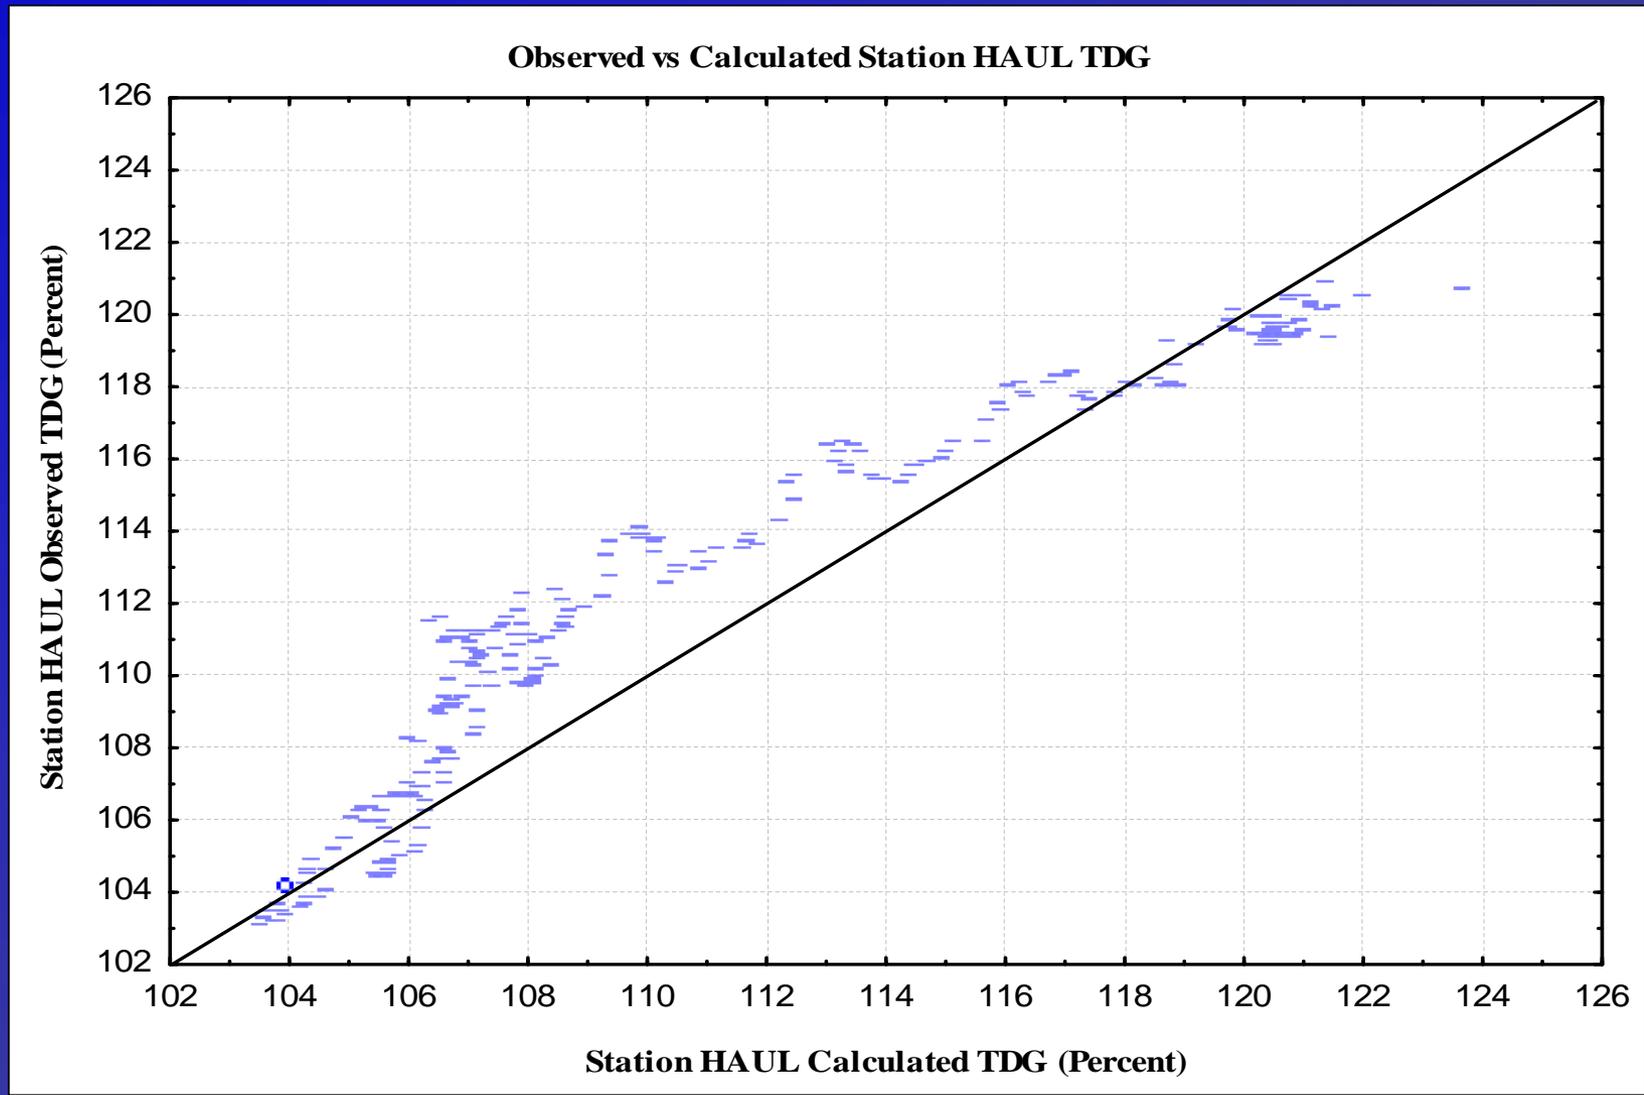
Relationship between observed and calculated Station HAUL total dissolved gas saturation versus total spillway discharge at Libby Dam, June 2006.

- Fixed monitoring station at Libby Dam (LBQM) was representative of river conditions for TDG
- Strong lateral gradient in TDG saturations in the Kootenai River below Libby Dam at all spillway flows
- Maximum TDG saturations observed at Thompson Bridge (133%)
- Kootenai River nearly well mixed at station HAUL with a maximum TDG saturation of 120%
